Walka Water Works Contamination Summary

Contamination Assessment

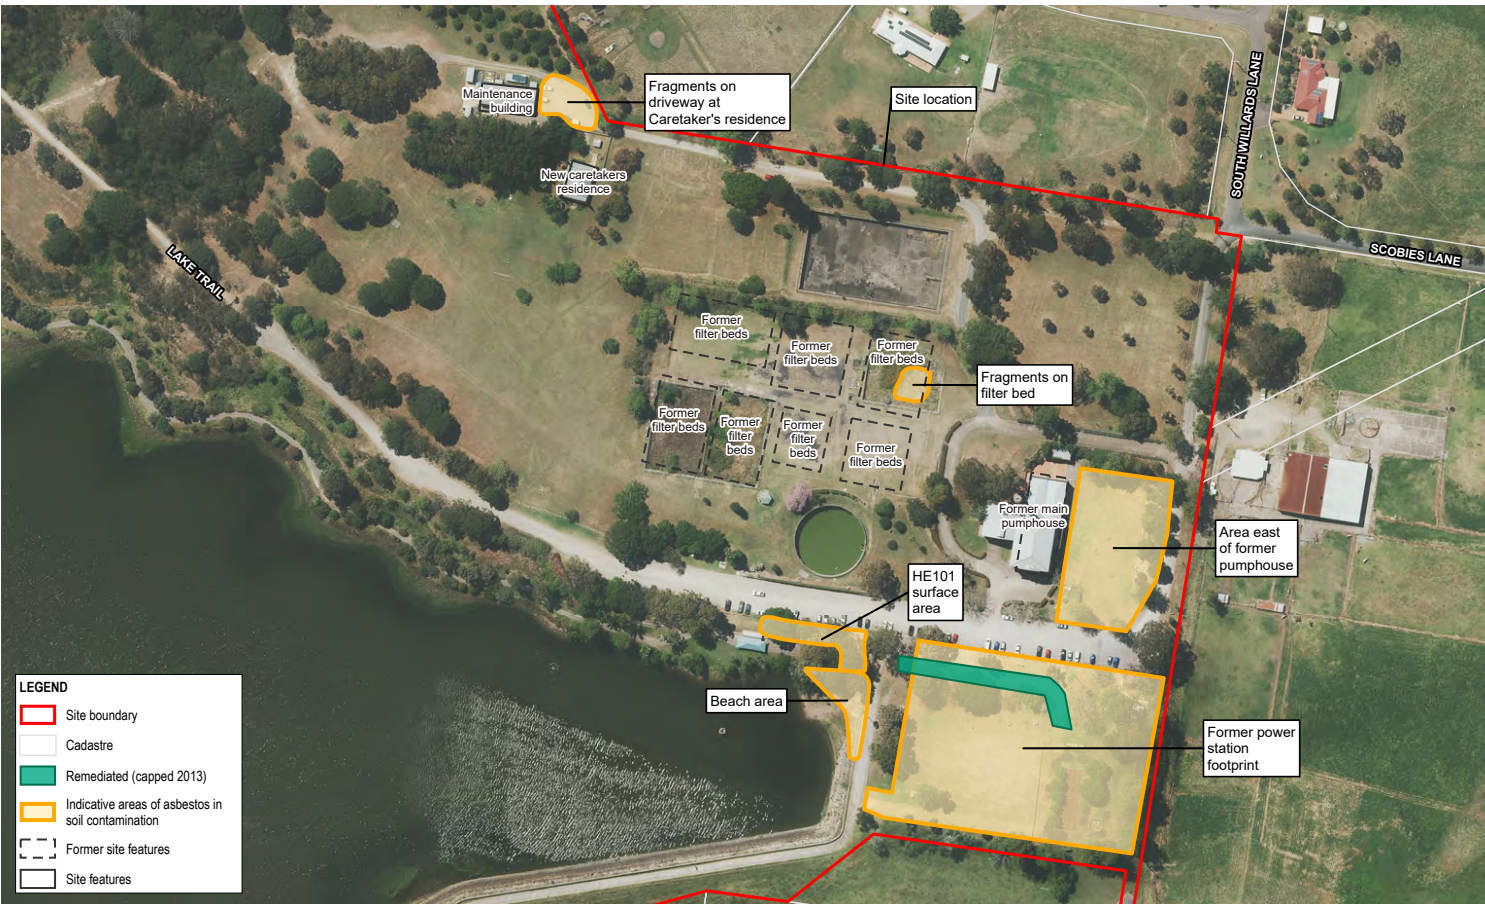
- The level lawn area to the East of the Pump House (ACM Fragments, Friable Asbestos)
 - The site of the previous Power Station (ACM Fragments, Friable Asbestos)

- The Southern perimeter of the children's playground area (ACM Fragments, Asbestos Fines, Friable Asbestos)
 - The embankment to the reservoir beach (ACM Fragments, Friable Asbestos)

- The Northeast of the amenities building (ACM Fragments, Friable Asbestos).

Site location layout and indicative areas of asbestos in soil contamination
