## Arboricultural Impact Assessment

Proposed Residential Sub-division  
36 Sanctuary Drive, Lochinvar 2321  
Lot 1 DP1309170

**AEP Ref: 5553**

**May 2025**

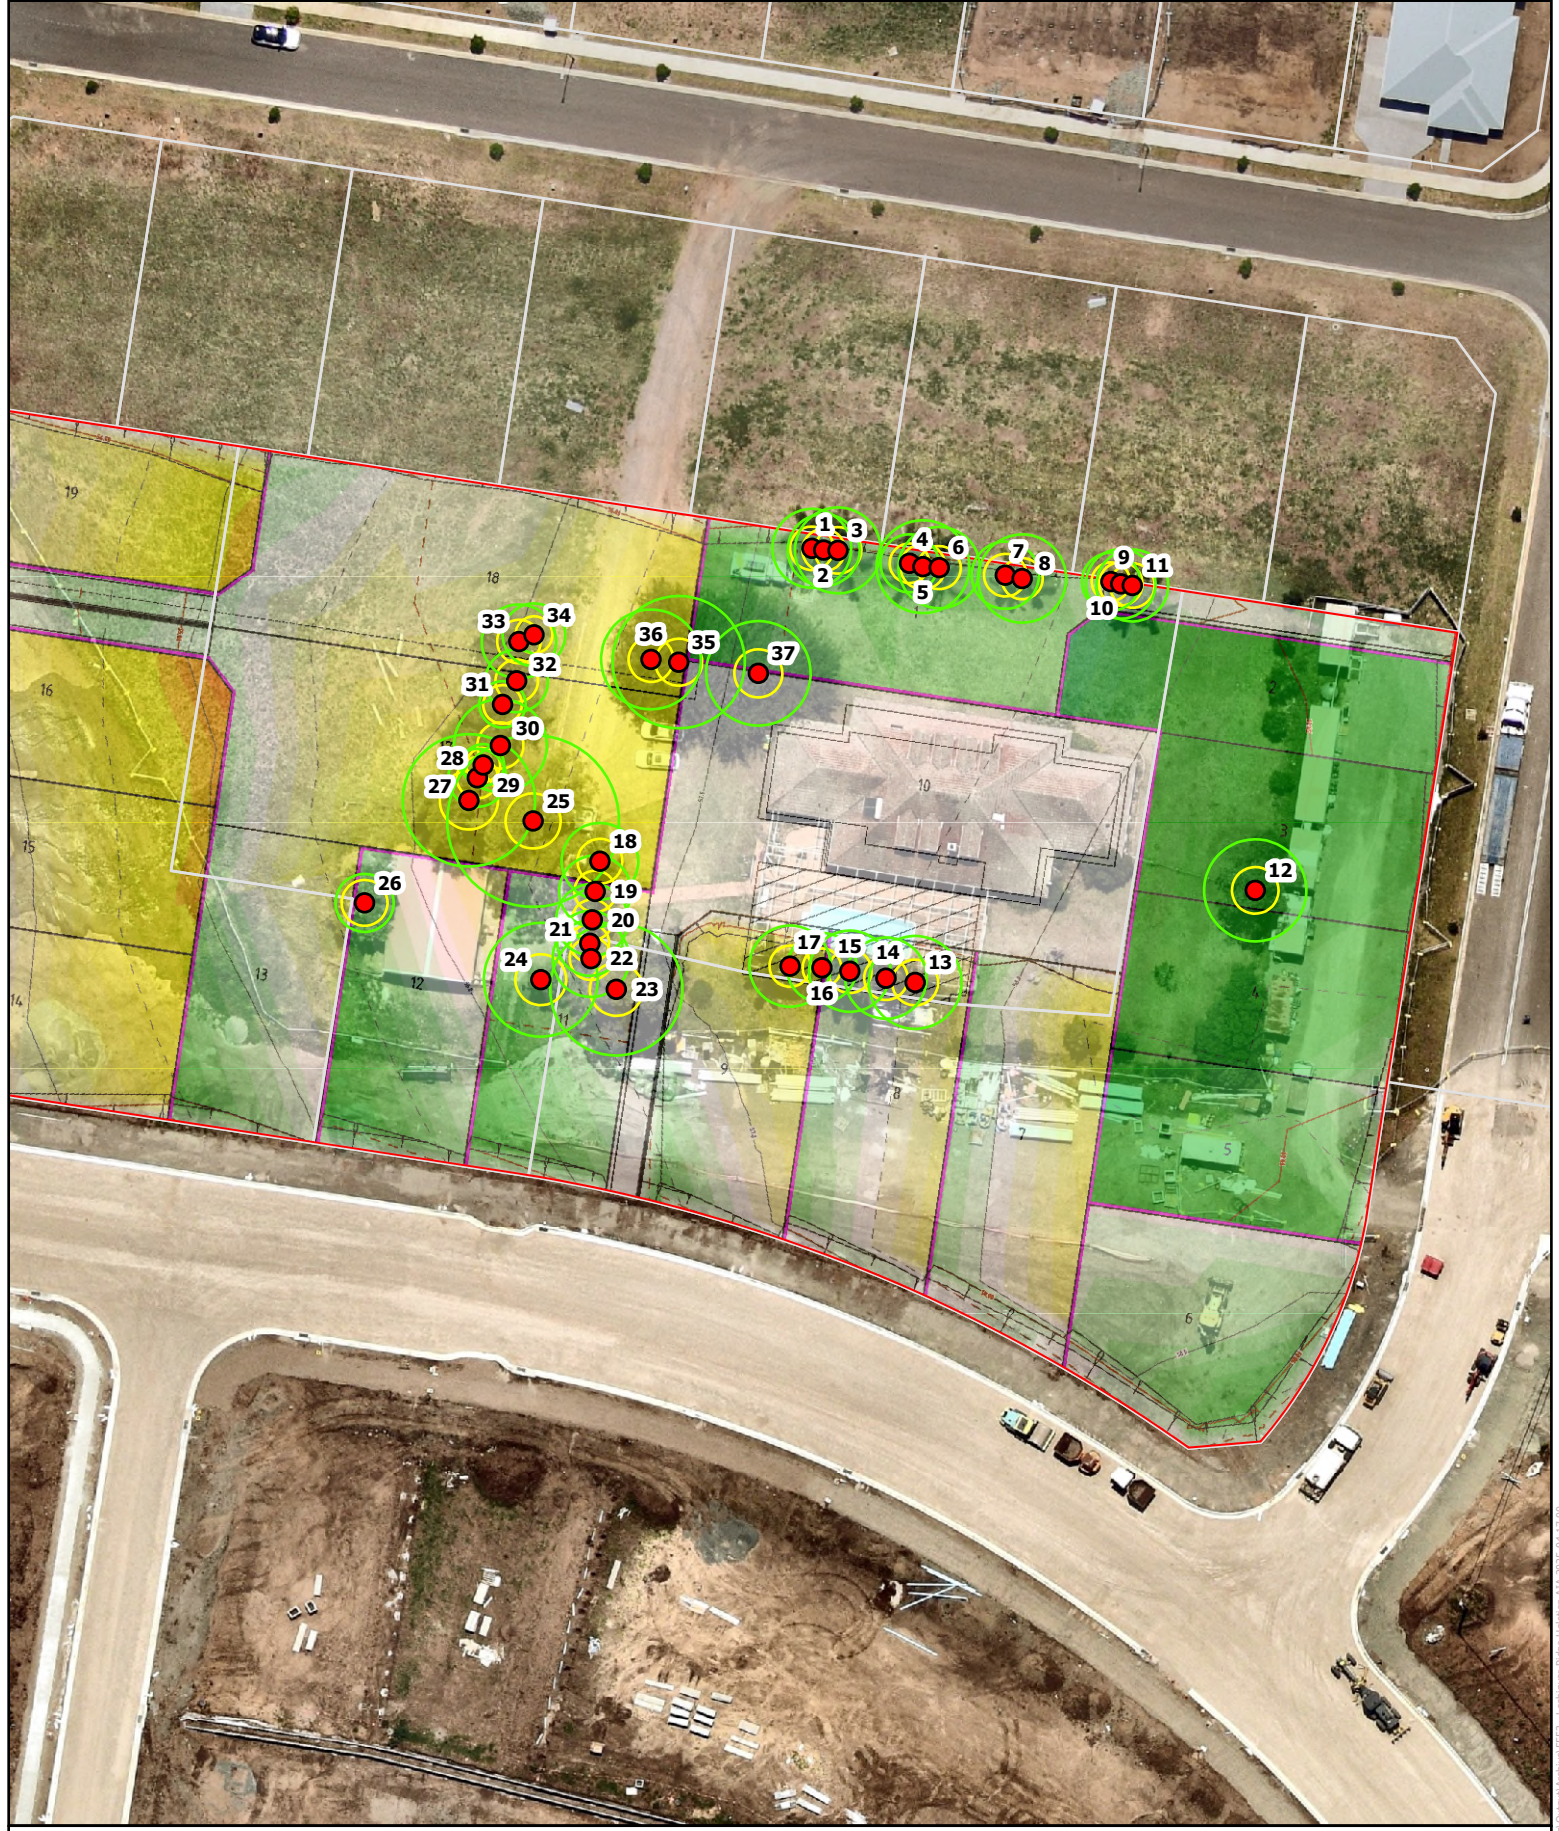
**Figure 4 - Tree Assessment**

- Trees 1-11, 13-22, 24, 25, 27-36 will have both major encroachment to their SRZ/TPZ zones from the proposed storm water pipe or the cut and fill civil works.
- Tree 12 will have major impacts to SRZ/TPZ from the proposed cut and fill civil works.
- Tree 23 will have major encroachment to their SRZ/TPZ zones from the proposed Sewer line.
- Tree 26,35 and 37 will have major impacts to the SRZ/TPZ from the proposed retaining wall and the cut and fill civil works.

These trees will require removal to facilitate the development. Impacts are unlikely to be mitigated through tree protection measures without major design changes, and tree stability and viability cannot be guaranteed.

- Trees designated for removal within this report as outlined in **Section 6** should be removed by a qualified tree worker with appropriate professional liability insurance.
- Selection of suitable species to replace the removed trees is key to ensuring long-term tree health and minimal conflict with built infrastructure. A well-planned landscape strategy will help restore canopy cover, contribute to environmental resilience, and support the overall character of the new development.

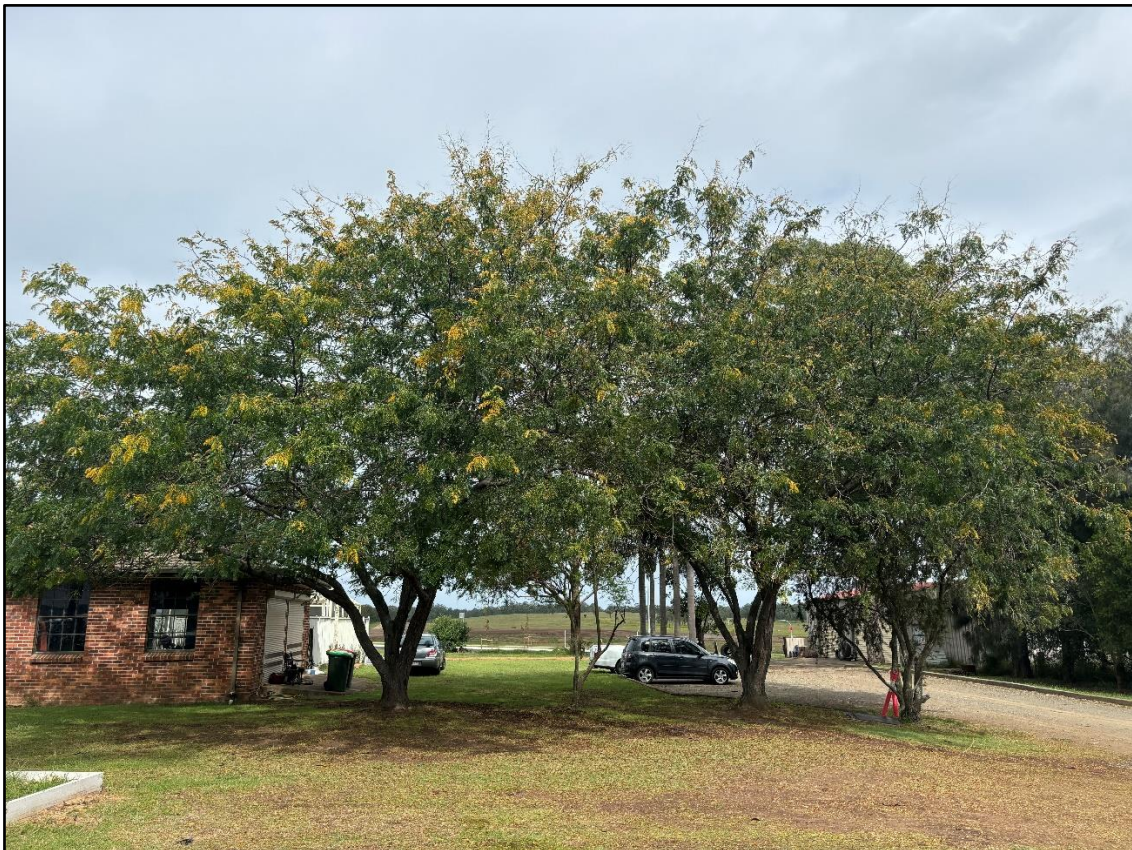
- Tree 35 – *Gleditsia triacanthos* (Honey locust) exhibits overall good health, with no visible signs of canopy decline or pest infestation. Co-dominant leaders with visible cracking at the union, indicating a potential point of structural weakness. Previous branch failure at the main union present.

**Plate 4 Below: Tree 35 and 37 – *Gleditsia triacanthos*.**

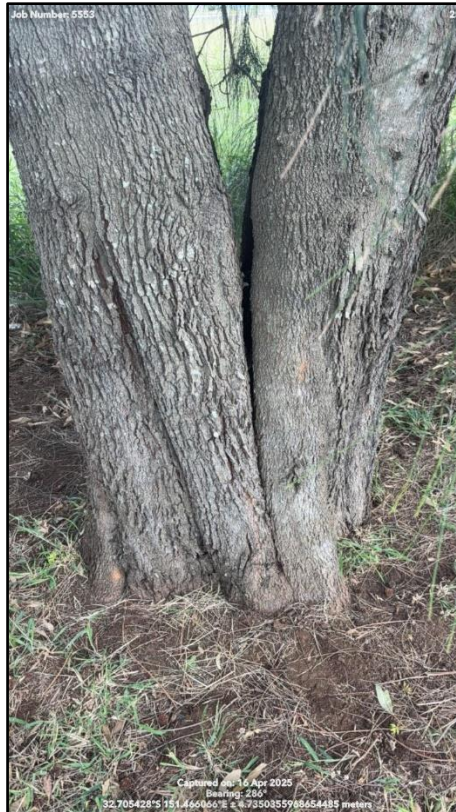
- Tree 34 – Deceased *Casuarina sp.* with no live canopy observed at the time of assessment.
- Trees 27 – *Casuarina glauca* (Swamp oak) exhibits overall good health, with no visible signs of canopy decline or pest infestation. A significant structural defect is present at approximately 1 metre above ground level, where a large co-dominant stem exhibits both visible decay and cracking at the union. Additionally, a large cavity is present within the main stem, impacting the tree's structural stability.

**Plate 5 Above: Tree 27 – *Casuarina glauca* trunk section showing co-dominant leaders, cracking and decay.**

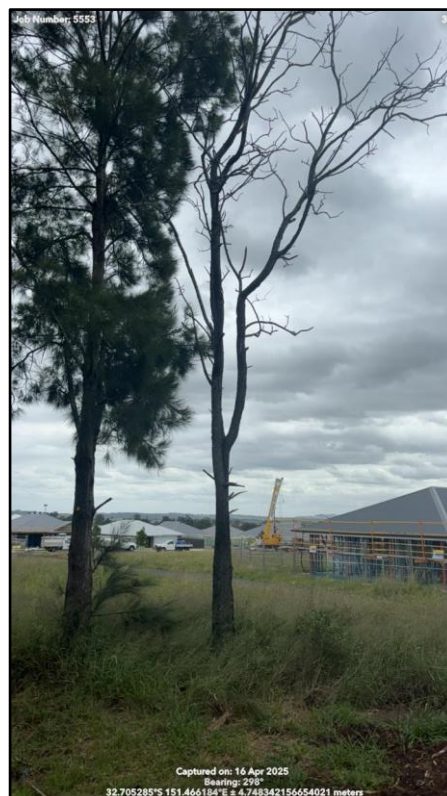
**Plate 6 Below: Tree 34 – *Casuarina* sp. stag tree (deceased).**

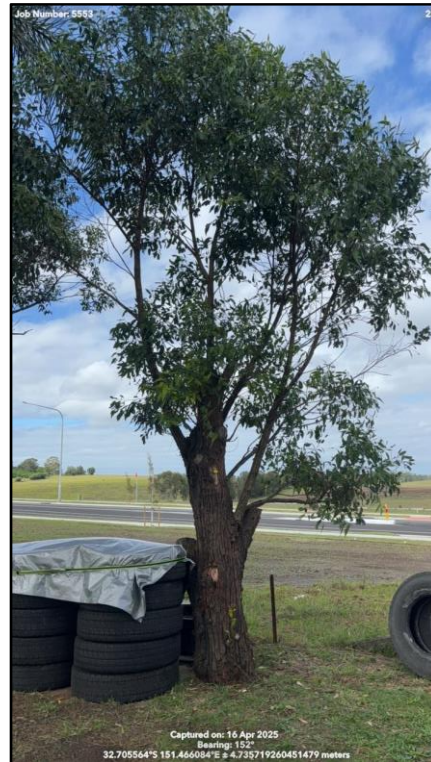
- Tree 24 – *Eucalyptus robusta* (Swamp mahogany) presents having poor structure and poor health resulting from previous pruning techniques causing an un-even canopy with epicormic re-growth.

**Plate 7 Above: Tree 24 - *Eucalyptus robusta* showing epi-cormic re-growth.**

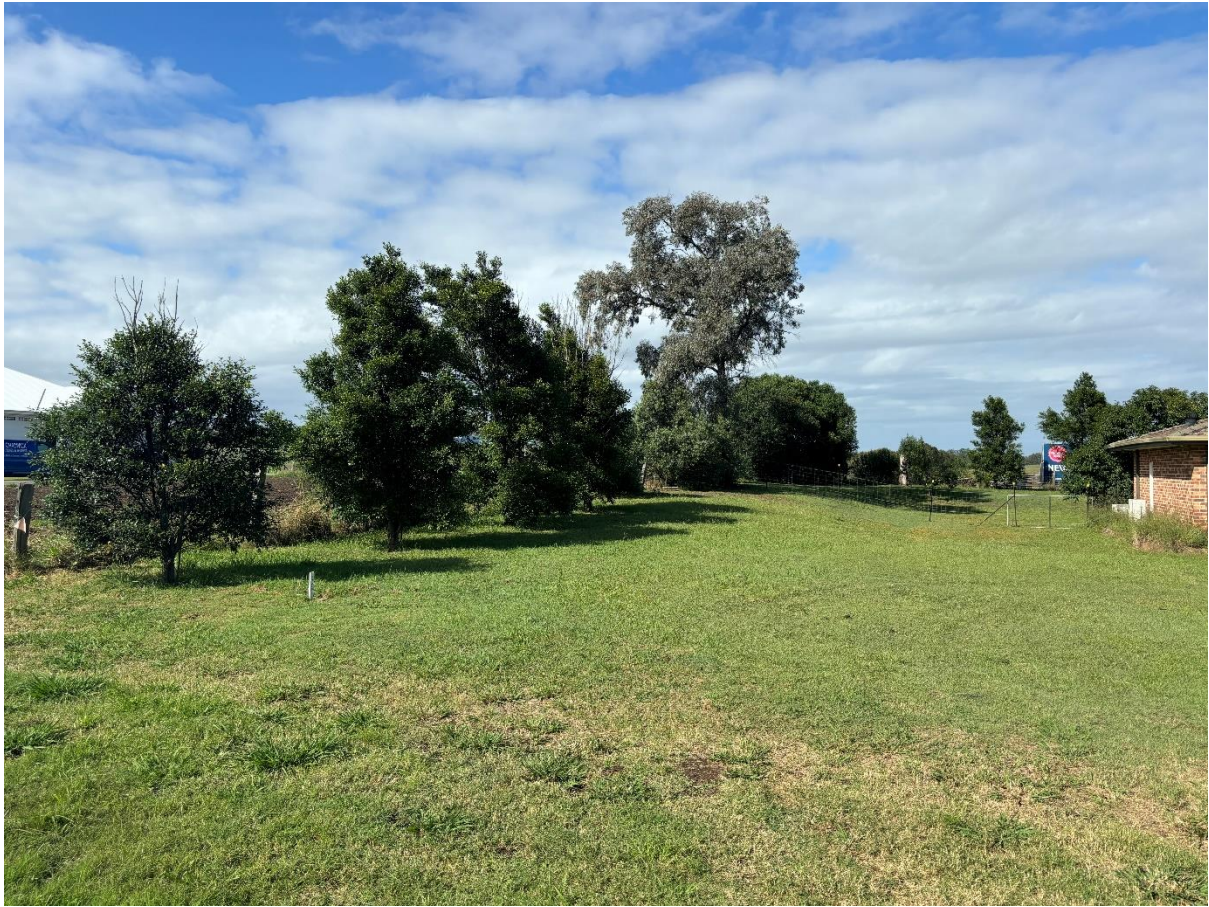
In addition to the assessed trees, various small *Olea europaea* (African Olive trees) and *Syzygium* species are scattered throughout the site. These specimens do not meet the minimum size threshold to be classified as trees under relevant assessment criteria, but will also require removal to accommodate the proposed works.

**Plate 9 Above: Eastern boundary aspect. Showing small *Olea europaea* and *syzigium sp.* trees.**
