Arborist Report

Client: MMC Integrated Services Pty Ltd

**Address: 106 New England Highway,
LOCHINVAR N.S.W 2321**

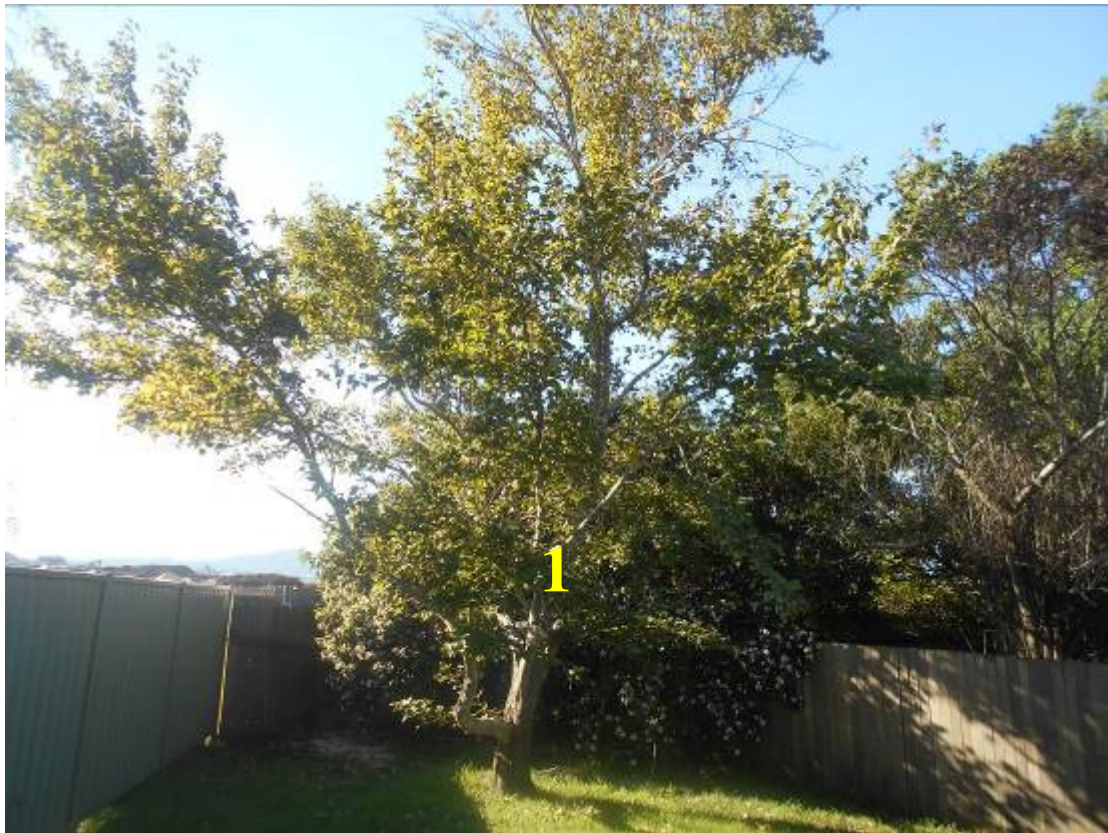
All trees require a S.R.Z and a T.P.Z with Australian Standards 4970- 2009 being used as a guideline. Tree 1 has been given an SRZ and TPZ of 2.10 & 3.36 metres in accordance with Australian Standards 4970 - 2009. The proposed development is located outside of the TPZ. This includes the proposed car parking bays (1 – 4). The applicant would like to erect a shed and slab construction to the rear of the car parking bays. The proposed shed will be located within 1 metre of the trunk. After completion of the hardstand areas this is the only location that would be suitable. Any slab design would be inside the SRZ by 44.29%. This would remove a large percentage of the SRZ. This species is non-native and had a low landscape significance. Due to this the applicant would prefer to remove the tree in order to erect the shed. Tree 1 is earmarked for removal before commencement of civil works on site.

Figure 3 – showing the location of Tree 1 in the backyard of the subject property.

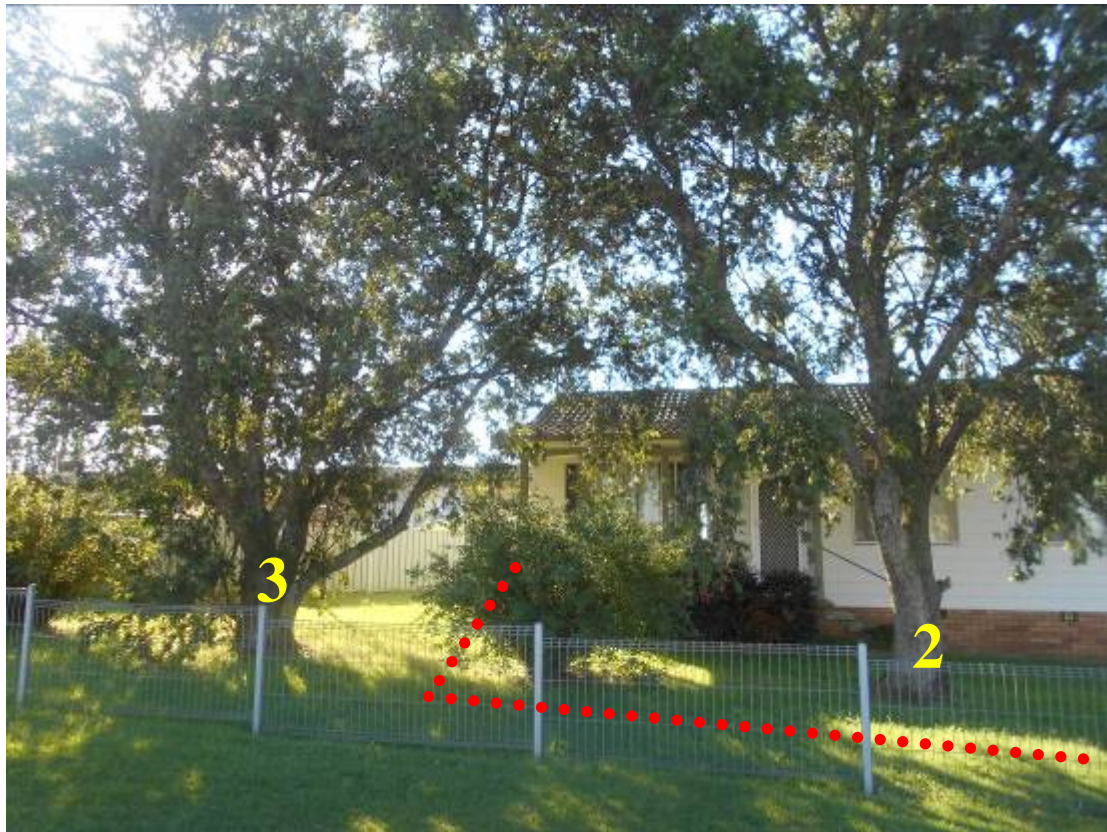
Tree 2 has been given an SRZ and TPZ of 2.65 & 5.52 metres in accordance with Australian Standards 4970 - 2009. Tree 2 is located in the front yard of the subject property. Tree 2 is located inside the proposed car parking and associated civil works. In order to construct the car parking at the front of the subject property will require the removal of Tree 2. Tree 2 is earmarked for removal before commencement of building works on site.

Figure 4 – showing the location of Trees 2 & 3 in the front yard of the subject property. Tree 2 is located inside the proposed hardstand area associated with the car parking. The proposed car parking and hardstand area will extend to the edge of the house as shown in red.

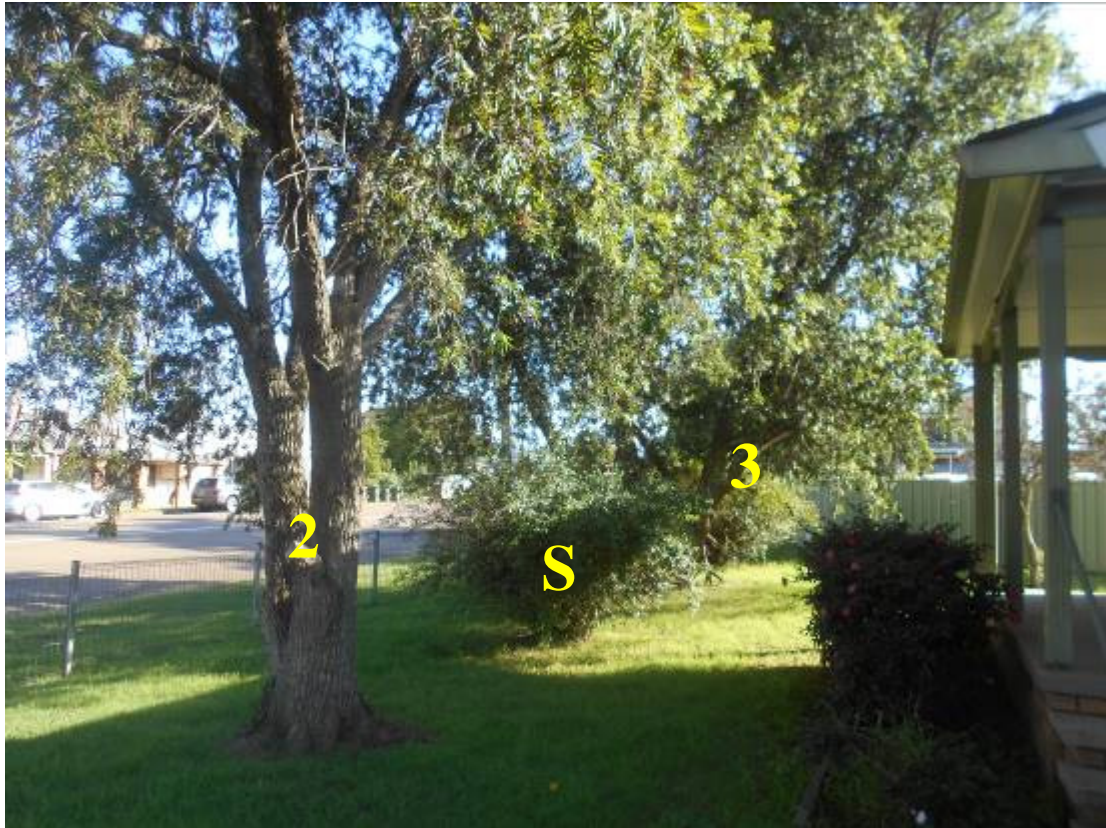
Tree 3 has been given an SRZ and TPZ of 2.30 & 5.64 metres in accordance with Australian Standards 4970 - 2009. Tree 3 is located in the front yard of the subject property. Tree 3 is located 1.2 metres to the proposed hardstand area and associated civil works. AS 4970 – 2009 indicates that the TPZ radius is taken from the centre of the trunk. This leaves a spatial separation of 1.49 metres from the centre of the trunk to the proposed carpark and associated civil works. The overall loss of TPZ has been calculated at 33.83% that doesn't comply with AS 4970 – 2009. The incursion into the SRZ has been calculated at 35.22% that will lead to loss of structural integrity. Tree 3 is earmarked for removal before commencement of building works on site.

Figure 5 – Tree 2 will be located inside the proposed car parking space. Tree 3 is located within close proximity to the proposed civil works associated with the car park. The works do not comply with AS 4970 – 2009. The shrub marked with an S is too small to come under council requirements.

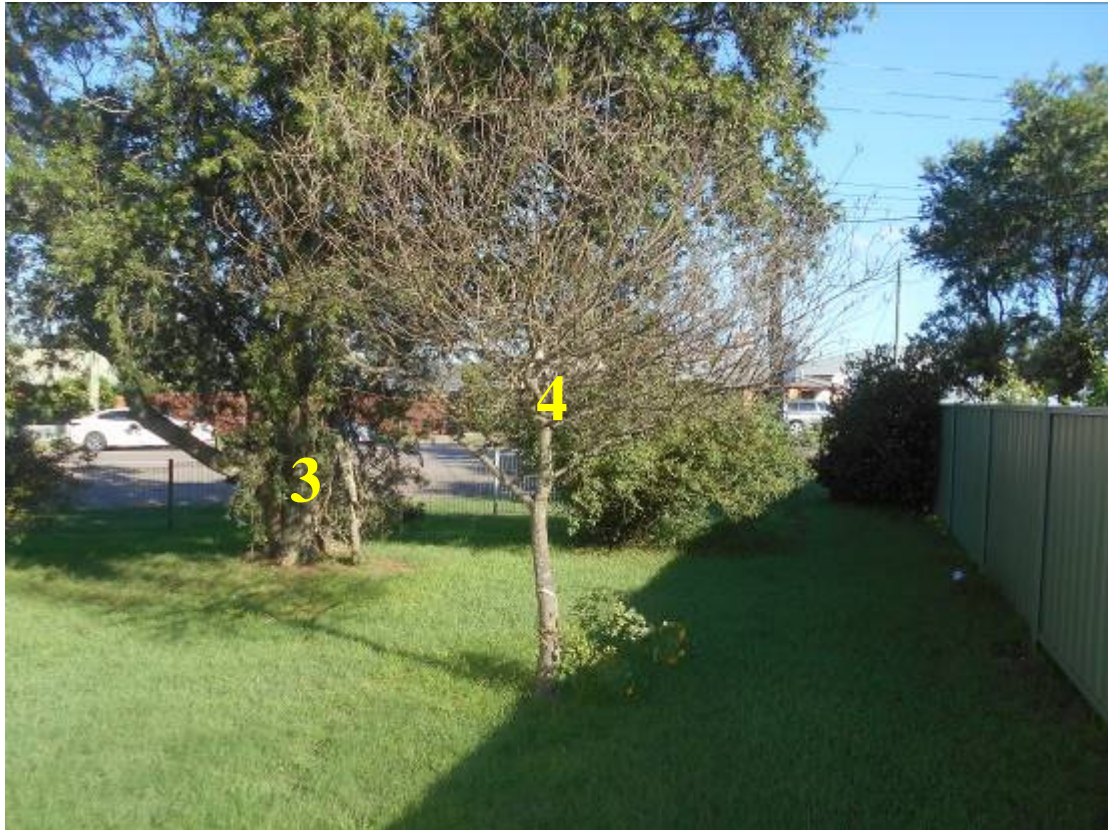
Tree 4 has been given an SRZ and TPZ of 1.50 & 2.00 metres in accordance with Australian Standards 4970 - 2009. Tree 4 is located outside the scope of all civil and building works. This species doesn't come under council requirements and can be removed without council permission. Tree 4 is earmarked for removal before commencement of building works on site.

Figure 6 – showing the location of Trees 3 & 4.
