# ARBORIST'S REPORT

| PROPERTY OF THE PROPOSED DEVELOPMENT: | 8 Allan Street, Lorn NSW |
| DATE OF REPORT: | 3 July 2025 |
| REQUESTED BY: | Your Home Designs |

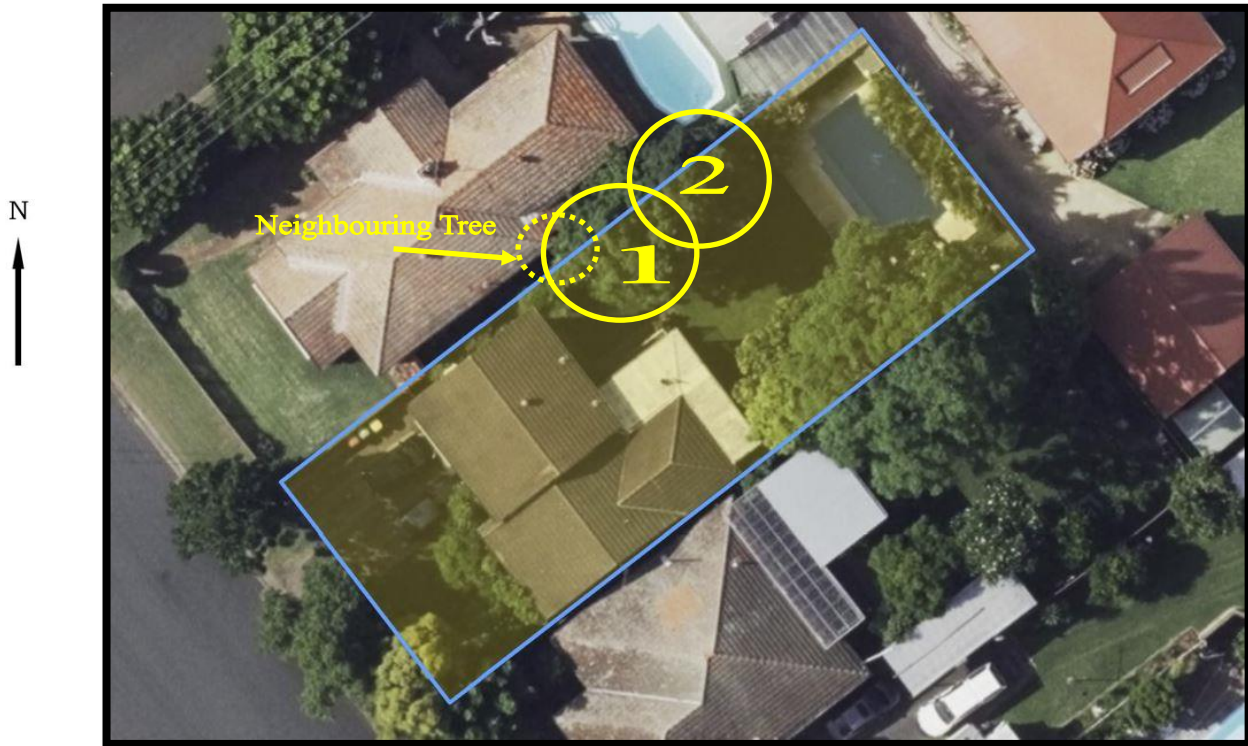
An aerial photograph (SDT Explorer) used as a site plan, showing the position of the subject trees with approximate canopy extents.

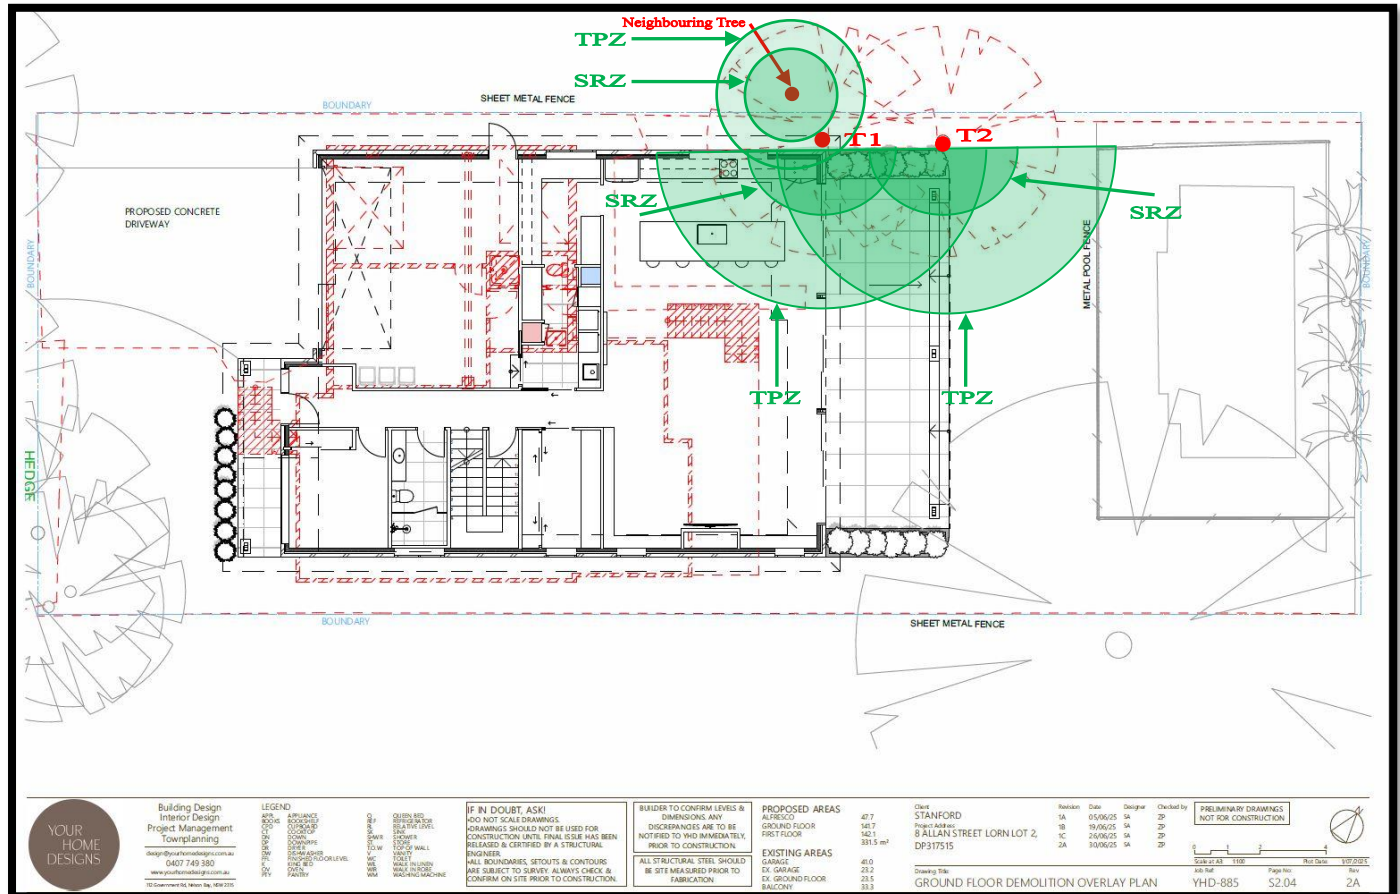
A supplied plan of the proposed development showing the position of the subject trees with TPZs/SRZs (green areas, inserted by the Arborist).

The encroachment consists of the demolition of the existing house, and the construction of a new dwelling. Major encroachment will be required into the TPZs/SRZs of Trees 1 & 2 for this to be carried out.

The Arborist cannot demonstrate that Trees 1 & 2 would remain viable, and their proximity to the proposed development and boundary prevents contiguous compensation of the TPZs.

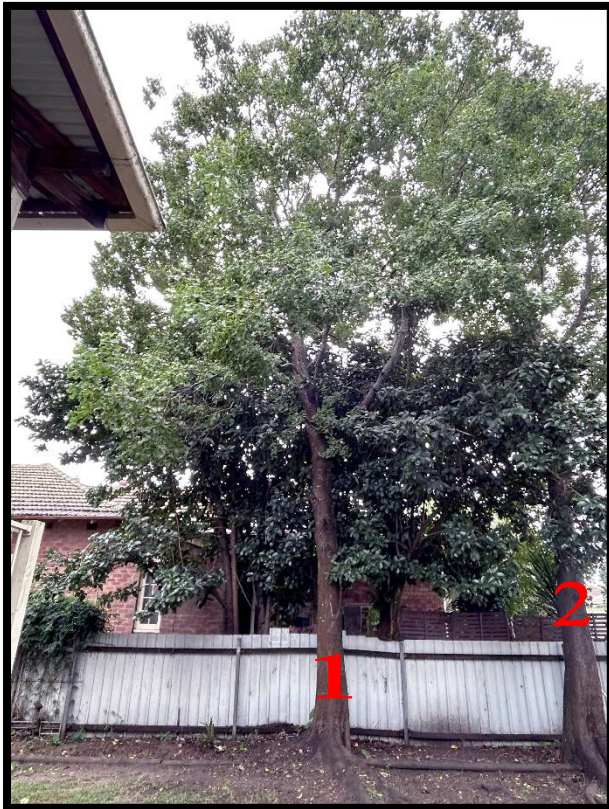
Tree 1 is in good health, structurally sound with a good shape, located in an urban environment.

Tree 2 is in good health, structurally sound with a good shape, located in an urban environment.

Trees 1 & 2 cannot be adequately protected during and after construction, and removal and replacement is considered the only option for these trees.

Trees 1 & 2 viewed from the SE.

1. Trees 1 & 2 be removed and replaced for the project.
2. The neighbouring tree be retained and protected as discussed.

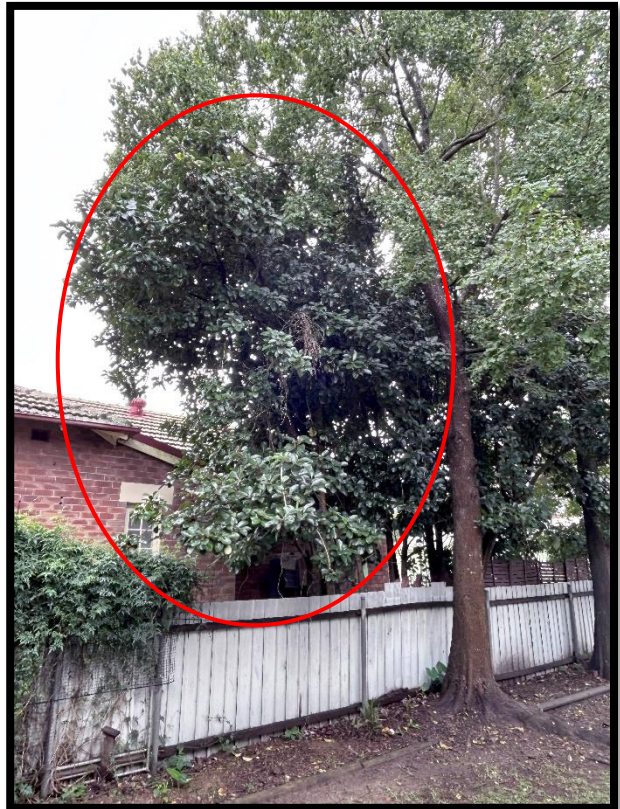
The neighbouring tree is a specimen of *Viburnum odoratissimum* (Sweet Viburnum), 7.5 metres high, and 600 mm from the fence (centre of stems). It is in good condition and has a TPZ/SRZ of 2.5/1.8 metres radius which extends into the subject property by 1.9/1.2 metres.

The encroachment into the TPZ/SRZ for the project will be 11.58/2.19%, and only slight impact is expected providing the protection plan p.7 is adhered to.

The neighbouring tree viewed from the south.

1. Steel mesh fencing [around the TPZ] would be impractical; the TPZ of the tree should be measured and marked with road marking paint, and construction staff informed that each area is a Tree Protection Zone. Staff should be informed as to what a SRZ is and the importance of minimal disturbance within this zone (potential loss of anchorage of the tree).
