1 OAKHAMPTON ROAD MAITLAND

ARBORICULTURAL IMPACT ASSESSMENT

JULY 2025

Arboricultural Impact Assessment

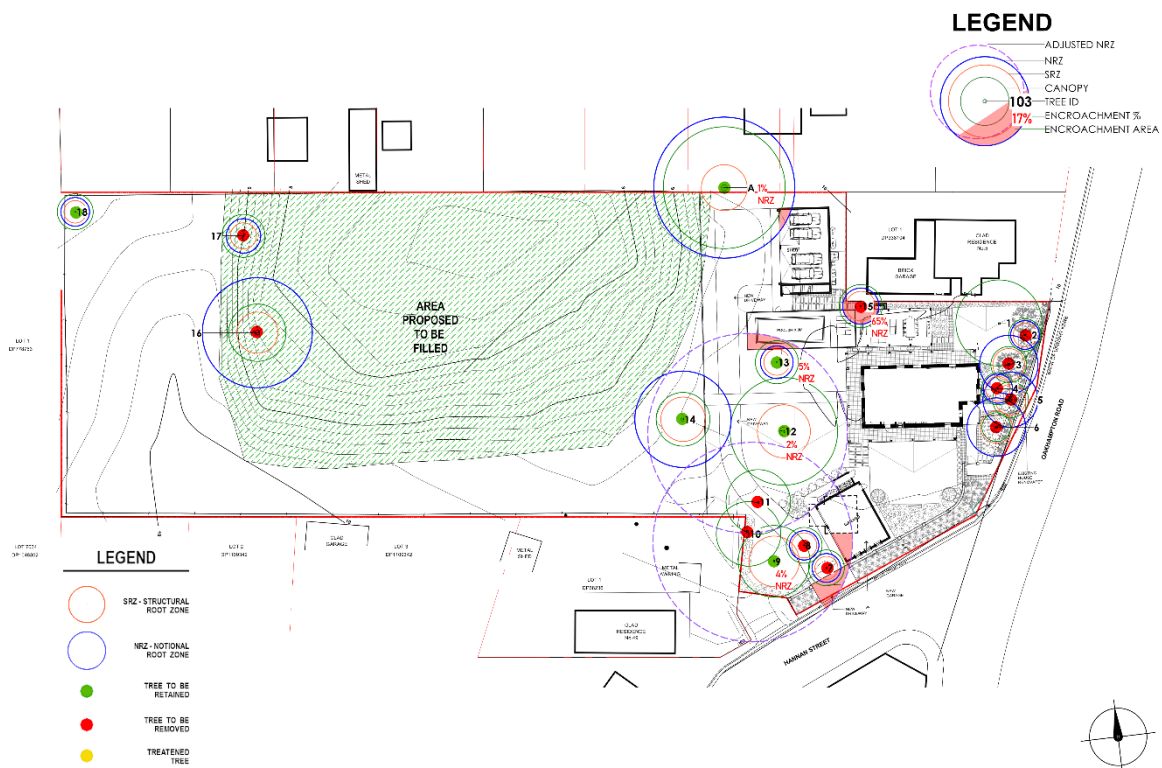
FIGURE 7: TREE IMPACT ASSESSMENT DIAGRAM.
[SOURCE: HUTCH ARCHITECTURE & OCTOPUS GARDEN DESIGN]

Figure 7 (and Appendix C2) indicates that Trees 2-8, 10, 11 and 15-17 will need to be removed based on the proposed design.

- that permission be sought to remove Trees 2-8, Trees 10-11 and Trees 15-17 (a total of 12 trees);
- that Trees 1, 9 12-14 and Tree 18 be retained and protected as required;
- that permission be sought to selectively remove branches to Tree 9 for the purpose of providing access and for general tree maintenance with the work being done in accordance with AS4373-2007 and *Guide to Managing Risks of Tree Trimming and Removal Work*; and,
- that the Preliminary Tree Protection Plan (refer Appendix D) be developed as part of the detailed design phase of the project and implemented as a means of safeguarding the trees to be retained.

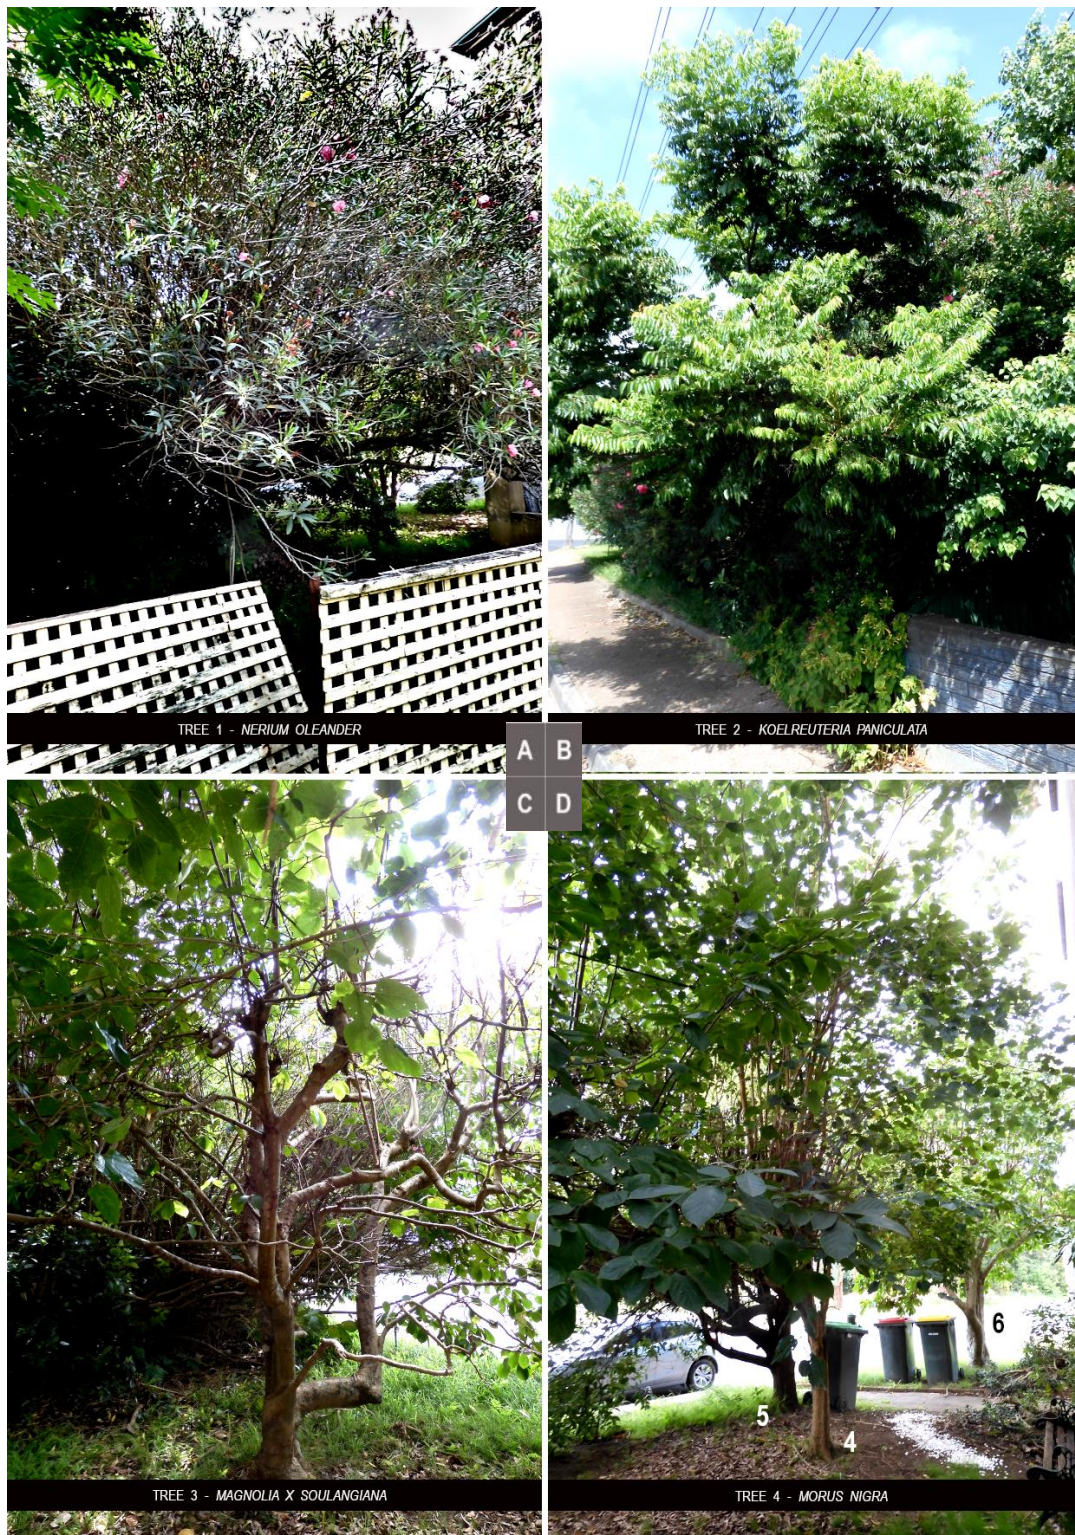
FIGURE A1: Trees 1-4 (INSPECTED 2025/02/25)

The trees located along the Oakhampton Road frontage (Trees 1-6) have been planted close to one another resulting in over-crowding and suppressed growth. These trees have also been routinely pruned and lopped to avoid the overhead powerlines.

4	<i>Morus nigra</i>	Black Mulberry	SM	9	170	2.04	210	1.72	15-40	P	F	Z10	A1D	4. SUPPRESSED GROWTH ARISING FROM OVERCROWDING. PAST PRUNING OF LOWER BRANCHES. SOME DEAD BRANCHES PRESENT WITH SIGNS OF DECAY. POTENTIAL TO IMPACT OVERHEAD POWERLINES.
5	<i>Cinnamomum camphora</i>	Camphor Laurel	SM	7	320	3.84	350	2.13	15-40	P	AV	A1	A2A	5. SIGNS OF EXTENSIVE PREVIOUS PRUNING WITH NUMEROUS WATERSHOOTS PRESENT. POTENTIAL TO IMPACT OVERHEAD POWERLINES.
6	<i>Magnolia x solangeana</i>	Saucer Magnolia	M	7	340 ¹	4.08	390	2.23	15-40	AV	AV	A1	A2B	6. [DBH: 260/170/130] GOOD SPECIMEN, GROWING FREELY WITH WELL-DEVELOPED TRUNK AND FREE OBSTRUCTIONS. SOME PREVIOUS TOPPING HAS OCCURRED. SLIGHT DAMAGE CAUSED BY ROOTS TO ENTRY PATH.
7	<i>Callistemon sp.</i>	Bottlebrush	M	6	150*	2.0 [MIN]	180*	1.61	5-15	AV	F	Z10	A2C	7.* ESTIMATES ONLY DUE TO PRESENCE OF VINE ENCIRCLING TRUNK. REDUCE LONGEVITY DUE TO RAMPANT VINE (GROWING THROUGH CANOPY. POSSIBLY C. CITRINUS. OCCURRING IN IN HEAVILY PLANTED GARDEN BED WITH SYNGONIUM AURITUM (ARROWHEAD VINE) GROWING EXTENSIVELY THROUGH CANOPY.

Trees 2-6 are being removed to allow for the implementation of a formal garden to the front of the residence. These trees are not good specimens primarily due to overcrowding and the frequent need for topping to maintain clearances to the overhead power lines.

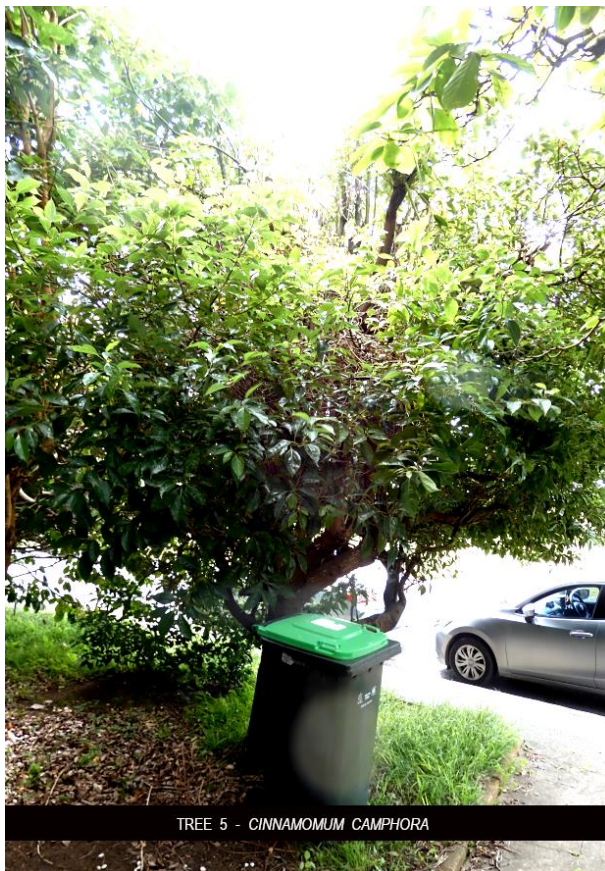
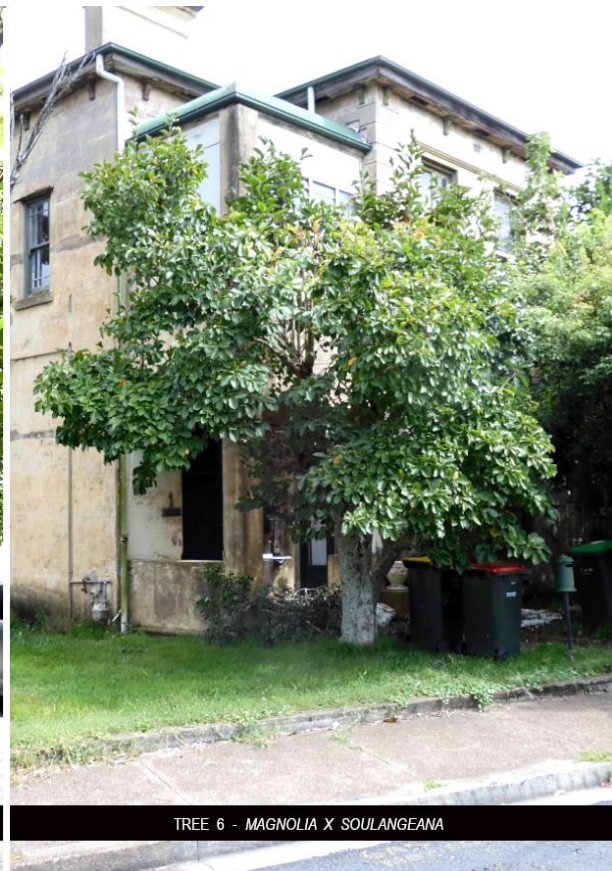
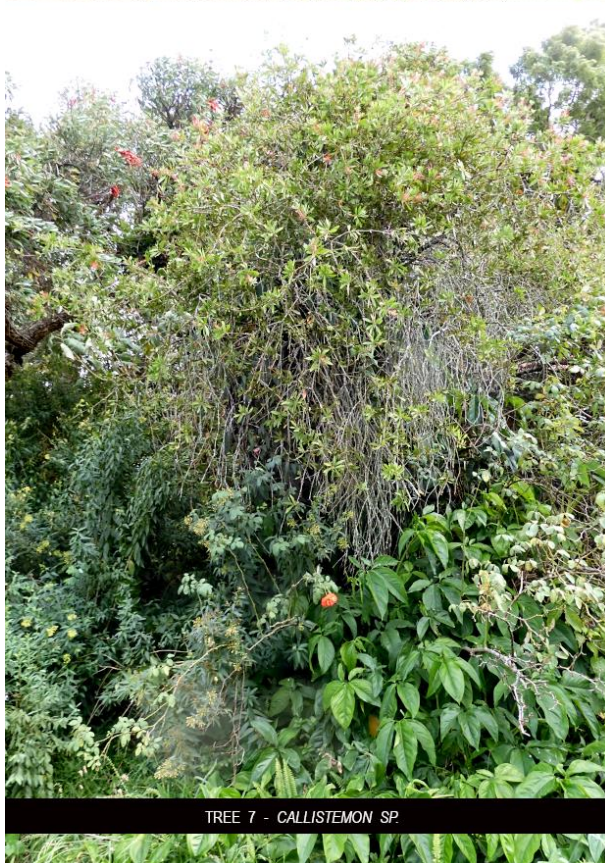
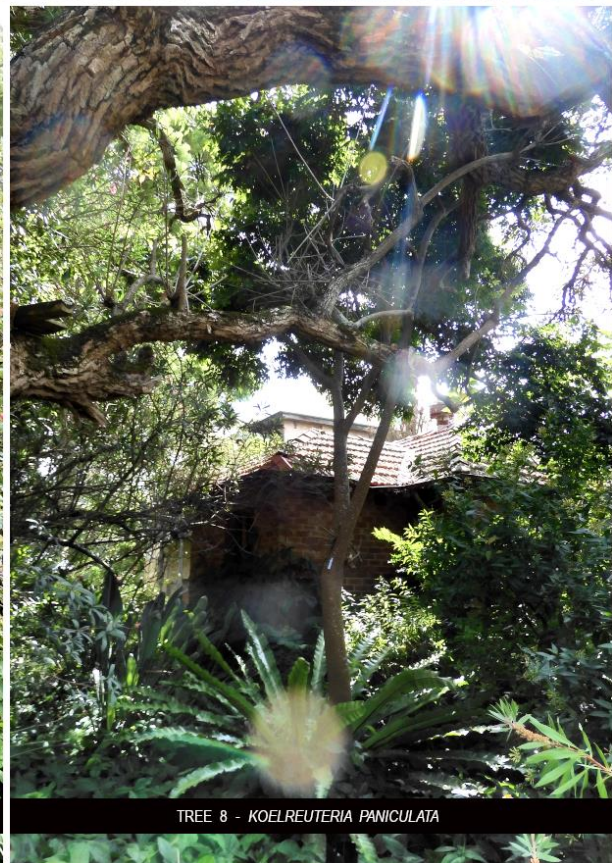
FIGURE A2: Trees 5-8 (INSPECTED 2025/02/25)

8	<i>Koelreuteria paniculata</i>	Golden Rain Tree	SM	8	170	2.04	220	2.05	15-40	AV	AV	Z10	A2D	8. FOLIAGE GENERALLY OCCURRING TO THE OUTER CANOPY DUE TO COMPETITION FROM OTHER TREES. CO-DOMINANT TRUNK AT 2M AGL WITH INCLUDED BARK ALTHOUGH UNLIKLEY TO BE A PROBLEM IN THE SHORT-TERM DURE TO UPRIGHT FORM OF THE TREE.
9	<i>Erythrina crista-galli</i>	Cockspur Coral Tree	M	11	1160 ¹	13.92	1150	3.51	15-40	F	F	A2	A3A	9. [DBH: 650/700/650] VERY OLD SPECIMEN WITH THREE, SPREADING CO-DOMINANT TRUNKS OCCURRING 1200MM AGL WITH GOOD UNIONS.SOME LARGE BRANCHES HAVE ALREADY FAILED. SOME DEAD BRANCHES HELD IN CANOPY.
10	<i>Nerium oleander</i>	Oleander	M	6	N/A	-	N/A	-	15-40	F	AV	A1	A3B	10. A TREE WITH NUMEROUS CANES ARISING FROM ITS BASE INDICATING PREVIOUS HEAVY PRUNING. SOME DEADWOOD PRESENT.
11	<i>Nerium oleander</i>	Oleander	M	7	N/A	-	N/A	-	15-40	F	AV	A1	AEC	11. SIMILAR TO TREE 10. SELF-SOWN PRIVET OCCURRING BETWEEN CANES.

Trees 7, 8, 10 and 11 are required for removal to enable the driveway and side fencing to be installed. Once again, these trees are not good specimens. It may be possible to retain Tree 10; however, its thick base, as the result of heavy past pruning, will make the installation of a fence difficult and requiring a large portion of the tree to be removed, hence the recommendation for its removal.

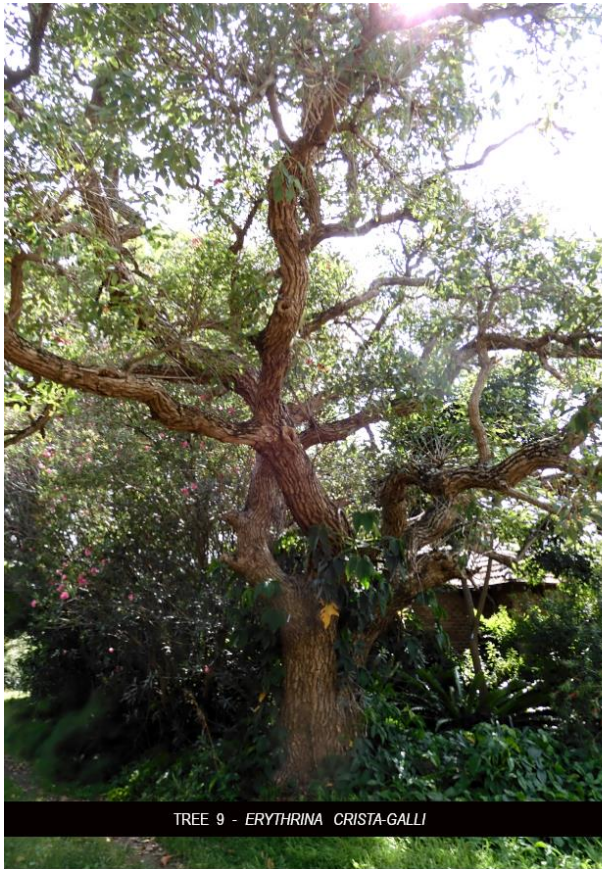
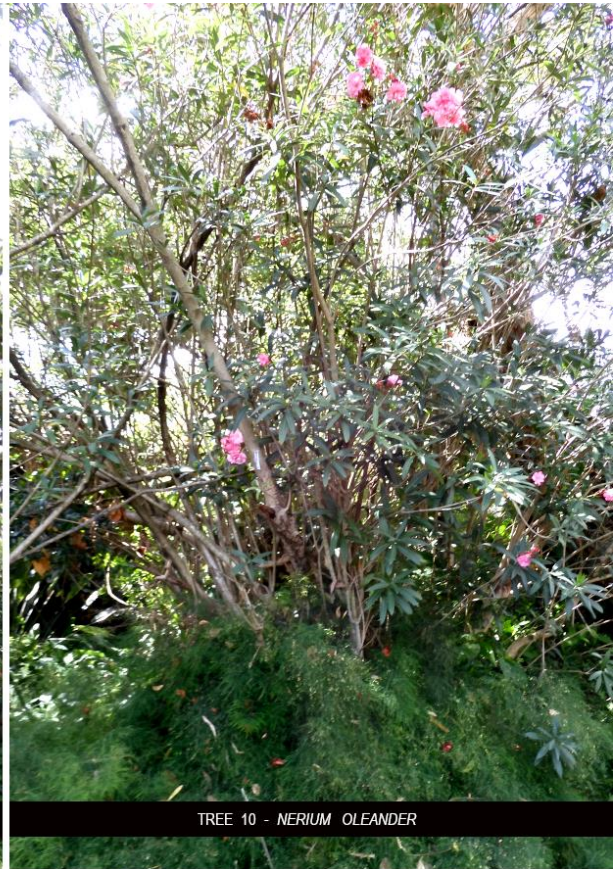
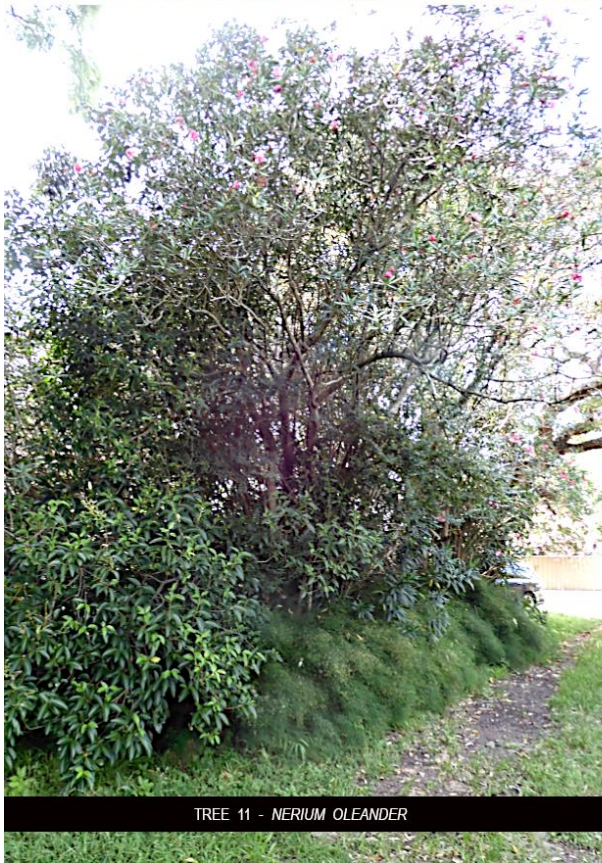
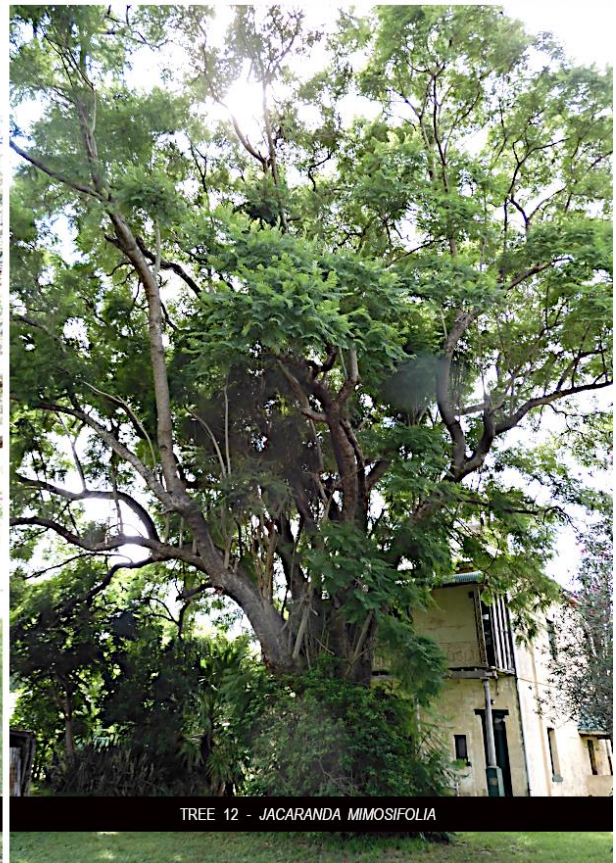
FIGURE A3: Trees 9-12 (INSPECTED 2025/02/25)

Trees 7-11 are growing in densely planted and overgrown garden beds close to the former surgery with Arrowhead Vine (*Syngonium auritum*) growing up their trunks and into the canopies of trees. As noted above, Tree 9 is a significant tree and although it has lost some large branches recently, it has the potential to live successfully for at least another 40 years if properly managed and maintained.

Tree 12 dominates the backyard and is showing no evidence of decline despite sustaining some previous storm damage.

12	<i>Jacaranda mimosifolia</i>	Jacaranda	M	22	1180	14.16	1300	3.69	+40	F	AV	A2	A3D	12. DOMINANT TREET WITHIN THE GARDEN. OLD, WELL-DEVELOPED SPECIMEN. PREVIOUS LOSS OF A LARGE BRANCH WITH NOW THE APPEARANCE OF WATERSHOOTS.
13	<i>Koelreuteria paniculata</i>	Golden Rain Tree	SM	7	190	2.28	240	1.81	15-40	F	AV	A2	A4A	13. TREE WITH PRONOUNCED LEAN TO THE WEST AS THE RESULT OF PHOTOTROPIC GROWTH AS THE RESULT OF OVERSHADOWING BY TREE 12. LIKELY TO HAVE BEEN SELF-SOWN.
14	<i>Melaleuca bracteata</i>	Black Tea-tree	M	14	560	6.72	850	3.09	+40	AV	F	A2	A4B	14. ASSUMED TO BE A CULTURAL PLANTING AS NOT NATURALLY OCCURRING AS A COMPONENT OF PRE-CLEARING VEGETATION. LAT-RGE OLD WOUND AT BASE OF TRUNK NOW STABILISED.
15	<i>Koelreuteria paniculata</i>	Golden Rain Tree	M	7	210 ¹	2.52	320	2.05	15-40	F	AV	A2	A4C	15. [DBH: 130/160] TREE LIKELY TO HAVE BEEN SELF-SOWN BASED ON LOCATION CLOSE TO FENCE AND TYPE OF SPECIES. CO-DOMINANT TRUNK FROM BASE.

It is likely that low branches to Tree 9 will need to be removed so as to allow access to the garage and the shed by larger vehicles. This work would be additional to other tree maintenance work required to improve the long term retention of the trees. All such work will need to be supervised by the Project Arborist and carried out in accordance with the requirements of AS4373-2007.

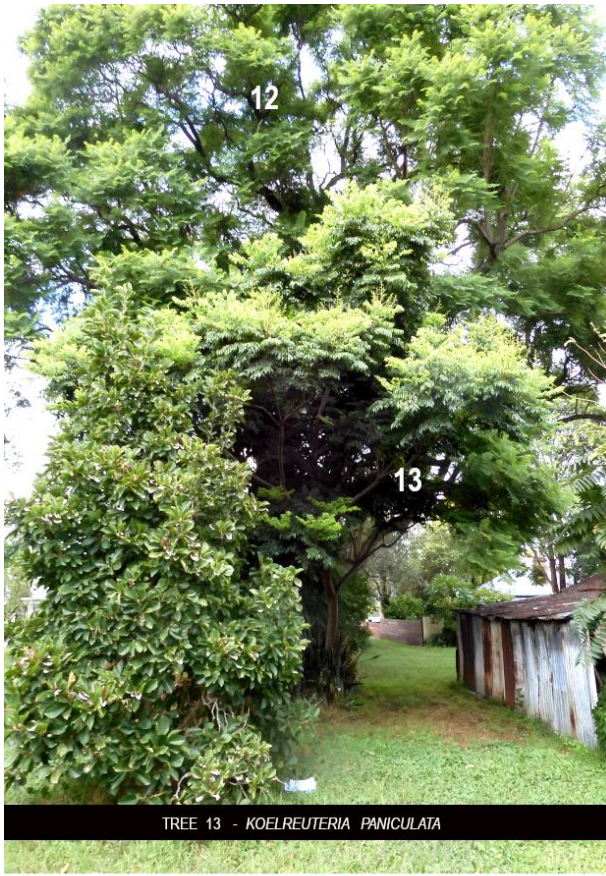
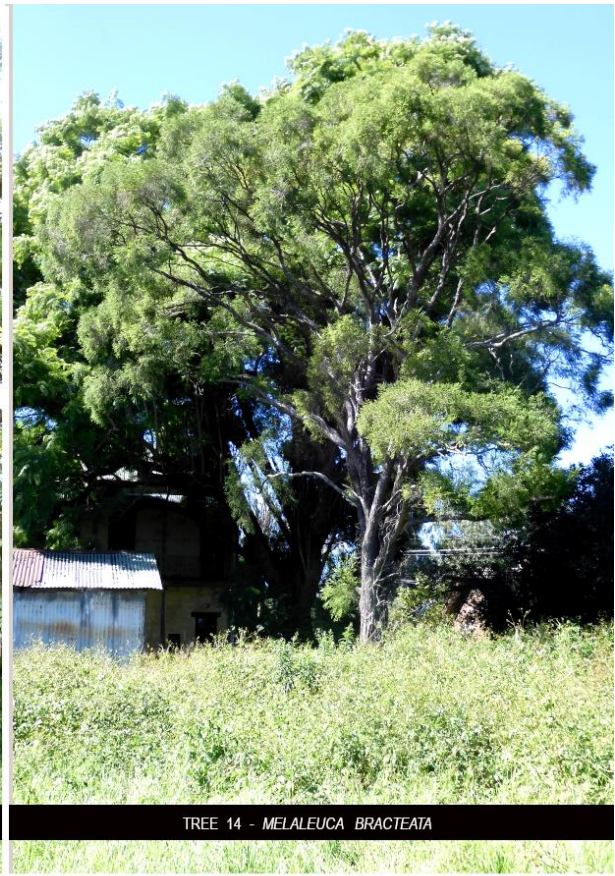
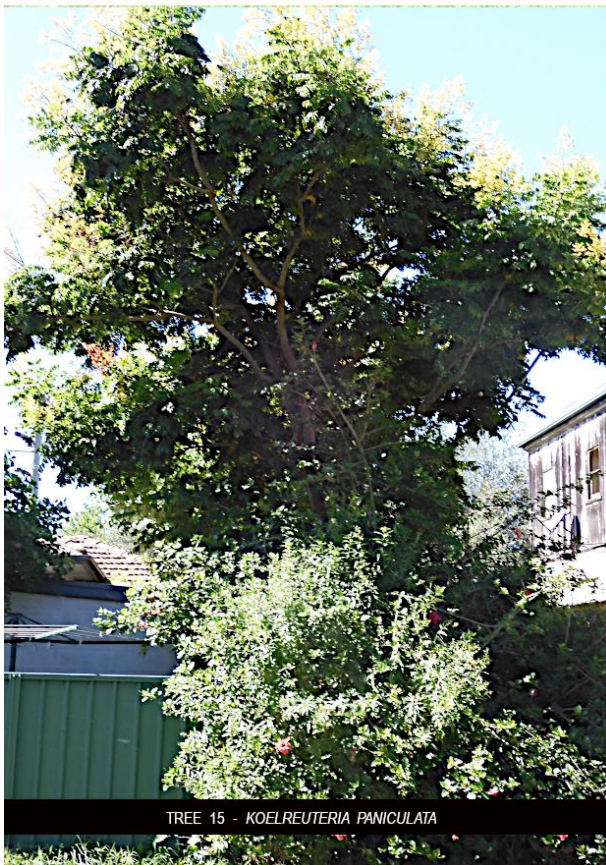
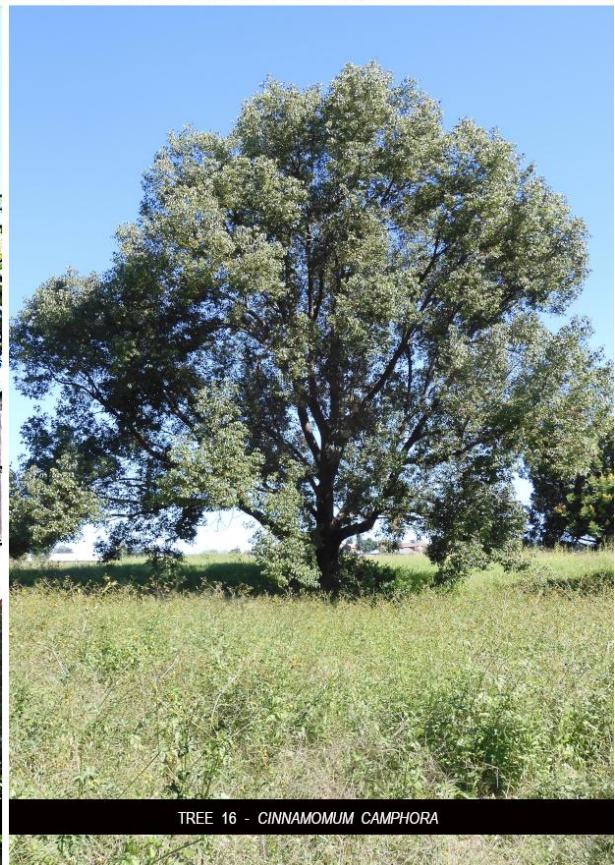
FIGURE A4: Trees 13-16 (INSPECTED 2025/02/25 & 2025/04/07)

16	<i>Cinnamomum camphora</i>	Camphor Laurel	M	12	640	7.68	710	2.87	+40	AV	AV	A1	A4D	16. TREE WITH SLIGHT LEAN TO THE EAST AND AN ASYMMETRIC CANOPY. LOCATED ON SIDE OF EMBANKMENT. ASSUMED TO BE SELF-SOWN. EPICORMIC GROWTH THROUGHOUT CANOPY. PREVIOUS PRUNING OF LOWER BRANCHES.
17	<i>Koelreuteria paniculata</i>	Golden Rain Tree	SM	7	200	2.40	240	1.82	+40	P	AV	A1	A5A	17. LARGE SWEEP IN LOWER TRUNK. ASSUMED TOT BE SELF-SOWN
18	<i>Koelreuteria paniculata</i>	Golden Rain Tree	SM	7	160	2.0 [MIN]	170	1.57	+40	F	AV	A2	A5B	18. [DBH: 100/110/60] CO-DOMINANT TRUNK @ 600MM AGL. ASSUMED TOT BE SELF-SOWN
TREES OCCURRING ON NEIGHBOURING SITES THAT ARE LIKELY TO BE AFFECTED BY THE WORKS														
A	<i>Jacaranda mimosifolia</i>	Jacaranda	M	17	820	9.84	920	3.20	+40	F	AV	A2	A5C	A. LOCATED 1200 OFF FENCELINE TO CENTRE OF TRUNK. THE TREE HAS SUFFERED STORM DAMAGE RESULTING IN THE LOSS OF LARGE LIMBS AS EVIDENCED BY THE PRESENCE OF BRANCH TERAS. SOME PRUNING OF OVERHANGING BRANCHES INTO THE SITE HAS OCCURRED WITH LARGE WATERSHOOTS HAVING FORMED.

Trees 15-17 are required to be removed to enable the construction of the outdoor living area/pool and to regrade and fill the western paddock. It has been assumed that these trees are self-sown.

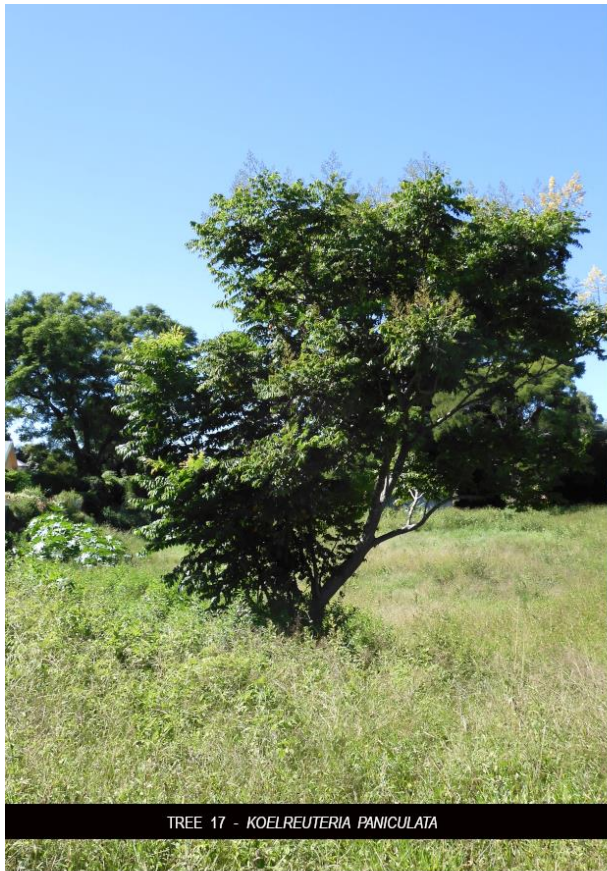
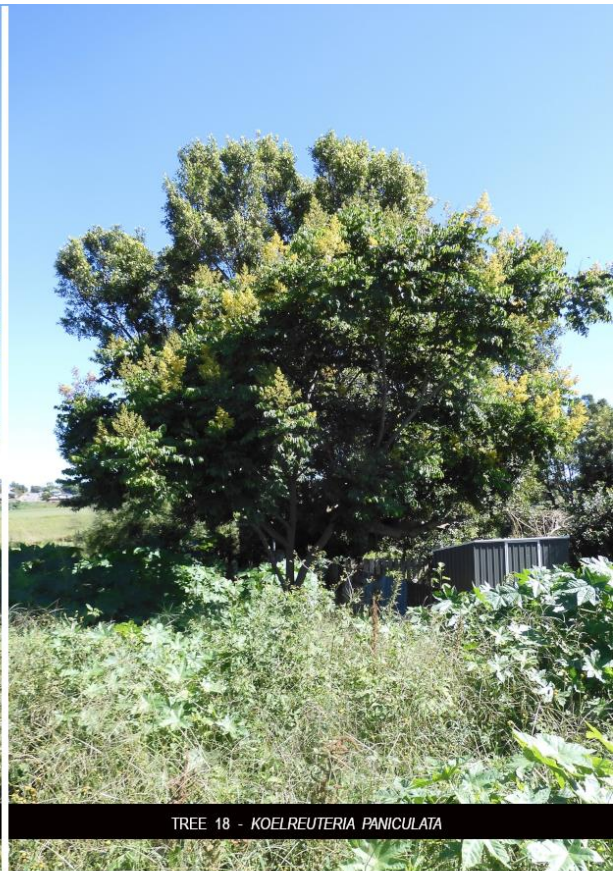
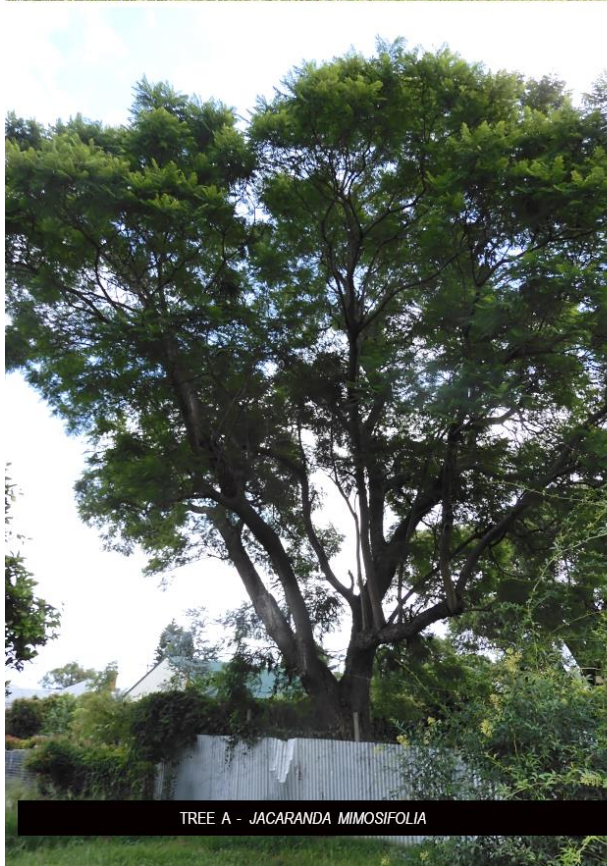
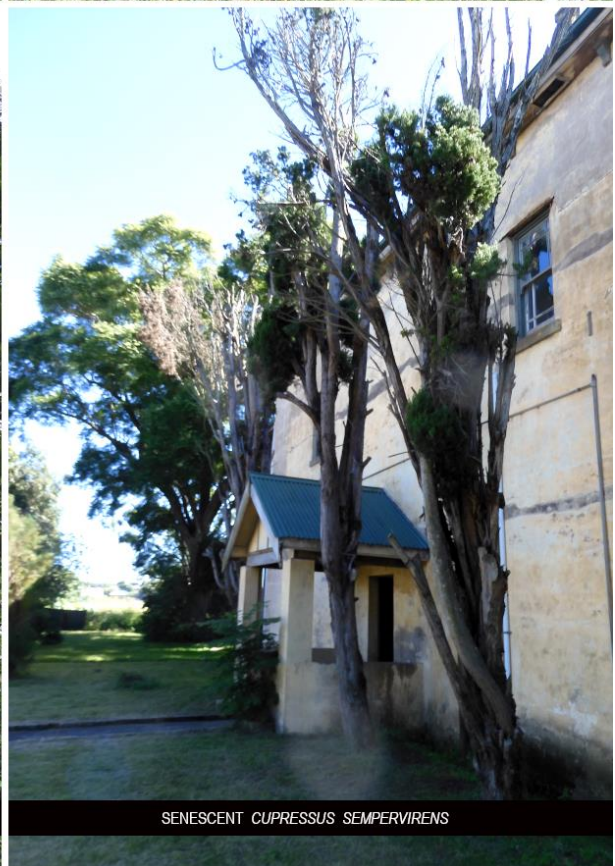
FIGURE A5: Trees 17- 18, A (INSPECTED 2025/02/25 & 2025/04/07)

A total of 19 trees were assessed: 18 on site and 1 on an adjoining site (5 Mount Pleasant Street). Three senescent Cypress Pines (Figure A5D) growing close to the southern façade of the residence were not included in the assessment.

Only one tree, Tree A (*Jacaranda mimosifolia*), is growing on an adjoining property with the potential to be affected by the works carried out on site due to its size and location near to the common boundary.

Tree A will not be affected resulting from the avoidance of hard surfacing. If required, products such as Truegrid or Geohex can be used to retain gravel where vehicles are making turning movements that normally would displace gravel. The raising of levels within the NRZ of Tree A is to be avoided unless done in 150mm increments with six months provided between the installation of subsequent layers.
