# Arboricultural Impact Assessment

Site Address: 127 New England Hwy Lochinvar

Client: Brown Commercial Building Pty Ltd

Date: June 2025

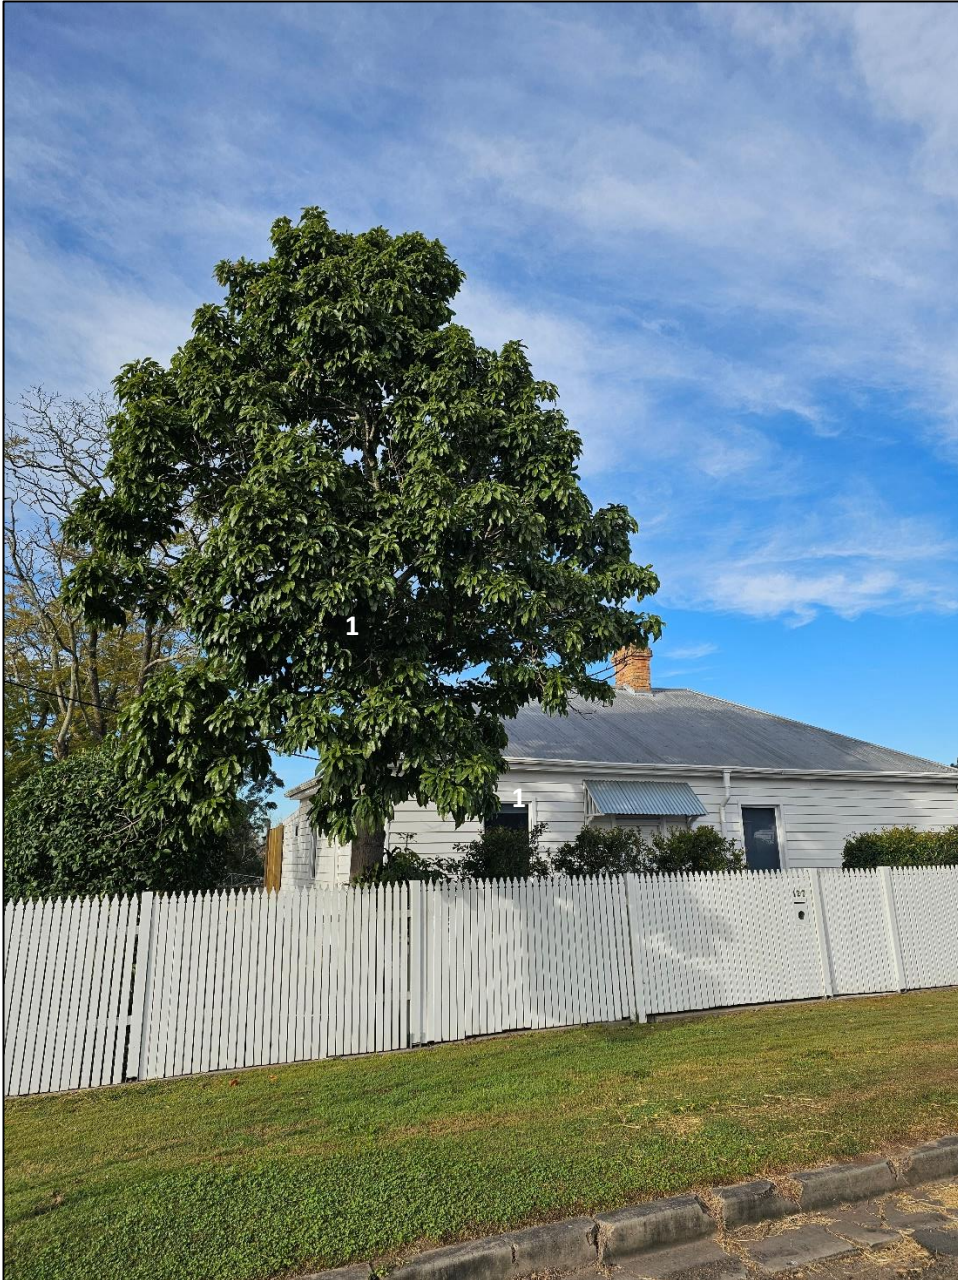
**Figure 1 Tree 1 *Brachychiton acerifolius*.**

| No. | Species<br>(Common name) | DSH<br>(M) | NRZ<br>(M Radius) | SRZ<br>(M Radius) | HEIGHT<br>(M) | SPREAD<br>(M) | Vigour | Age<br>Class | SULE | Retention<br>value | Comments<br>(Encroachment %) | Proposal |
|---|---|---|---|---|---|---|---|---|---|---|---|---|
| 1 | <i>Brachychiton acerifolius</i><br>(Illawarra Flame tree) | 0.4 | 4.8 | 2.47 | 9 | 6 | g | m | 1a | High | Appears structurally sound,<br>3.7m from existing dwelling.<br>(5% NRZ, proposed parking) | Retention |

Tree 1 *Brachychiton acerifolius* appears in good that and vigour and is assessed with thigh retention value. The tree is located adjacent to the front boundary fence and will be within the proposed landscaping; construction of the proposed carpark will cause a minor encroachment of the NRZ.

Tree 1 is therefore proposed for retention and will be protected by the installation of temporary fencing panels to enclose the TPZ at 4 metres radius from the trunk of the tree.

That temporary fencing is installed at 4 metres radius from the trunk of Tree 1 and across the rear of the property adjacent to the sewer easement to create a Tree Protection Zone covering the rear of the property.

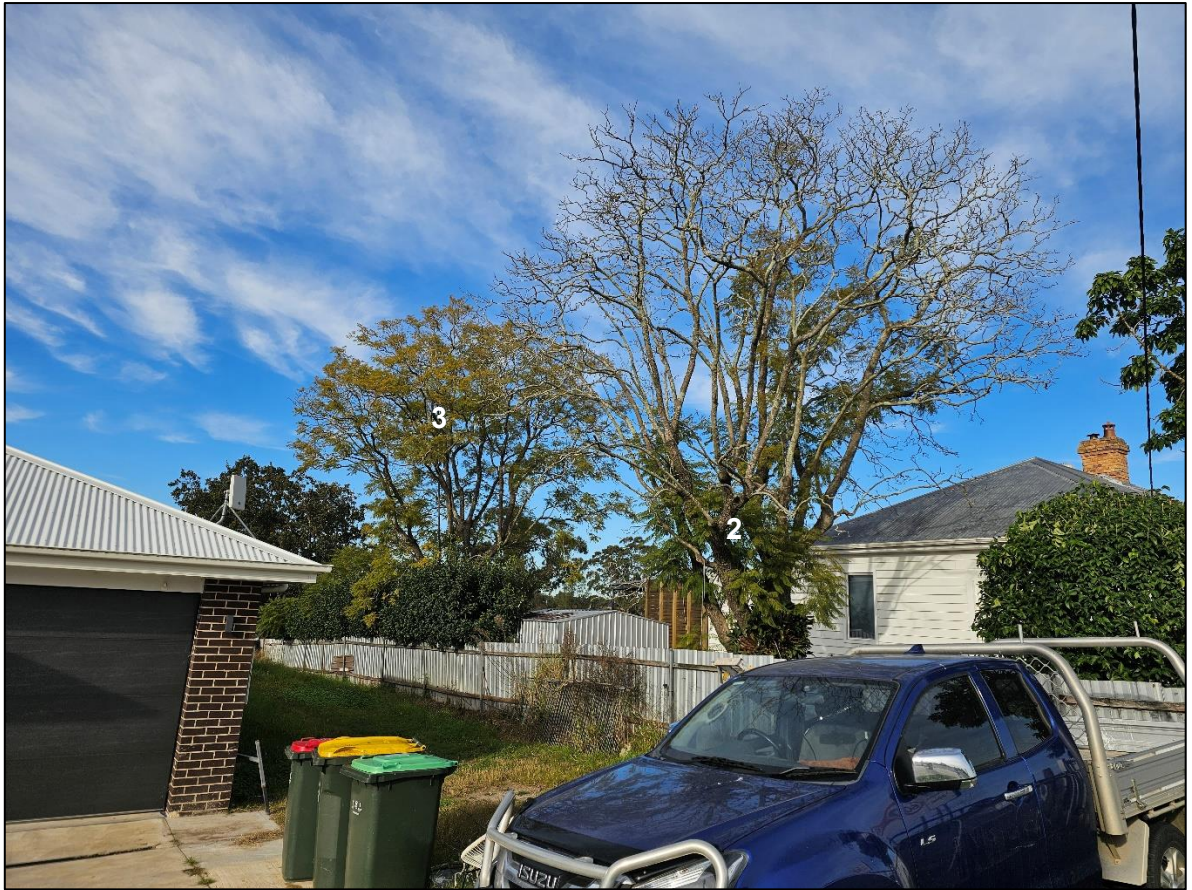
**Figure 3 Trees 2 and 3 *Jacaranda mimosifolia*.**

| No. | Species<br>(Common name) | DSH<br>(M) | NRZ<br>(M Radius) | SRZ<br>(M Radius) | HEIGHT<br>(M) | SPREAD<br>(M) | Vigour | Age<br>Class | SULE | Retention<br>value | Comments<br>(Encroachment %) | Proposal |
|---|---|---|---|---|---|---|---|---|---|---|---|---|
| 2 | <i>Jacaranda mimosifolia</i><br>(Jacaranda) | 0.65 | 7.8 | 2.93 | 10 | 10 | av | m | 2a | Moderate | Excessive deadwood noted,<br>4.2m from existing dwelling<br>(60% NRZ, 71% SRZ,<br>proposed parking) | Removal |
| 3 | <i>Jacaranda mimosifolia</i><br>(Jacaranda) | 0.4, 0.3 | 6.0 | 2.47 | 10 | 10 | gm | 1a | 2a | Moderate | Appears structurally sound,<br>4.8m from existing dwelling<br>(60% NRZ, 75% SRZ,<br>proposed building) | Removal |

Trees 2, 3 *Jacaranda mimosifolia* and 4 *Quercus robur* are mature exotic trees in average to good health and vigour located between the existing dwelling and the Eastern boundary and are assessed with moderate retention value.

The trees will be within the plan area of the proposed car park and building conflicting with the proposed design. Consent is sought for the removal of the trees to allow the development to proceed as planned.

That Trees 2, 3 *Jacaranda mimosifolia*, 4 *Quercus robur*, 5 *Pyrus sp.*, 6 *Eucalyptus scoparia* and 7 *Corymbia citriodora* are approved for removal subject to the provision of suitable compensatory replacement planting.

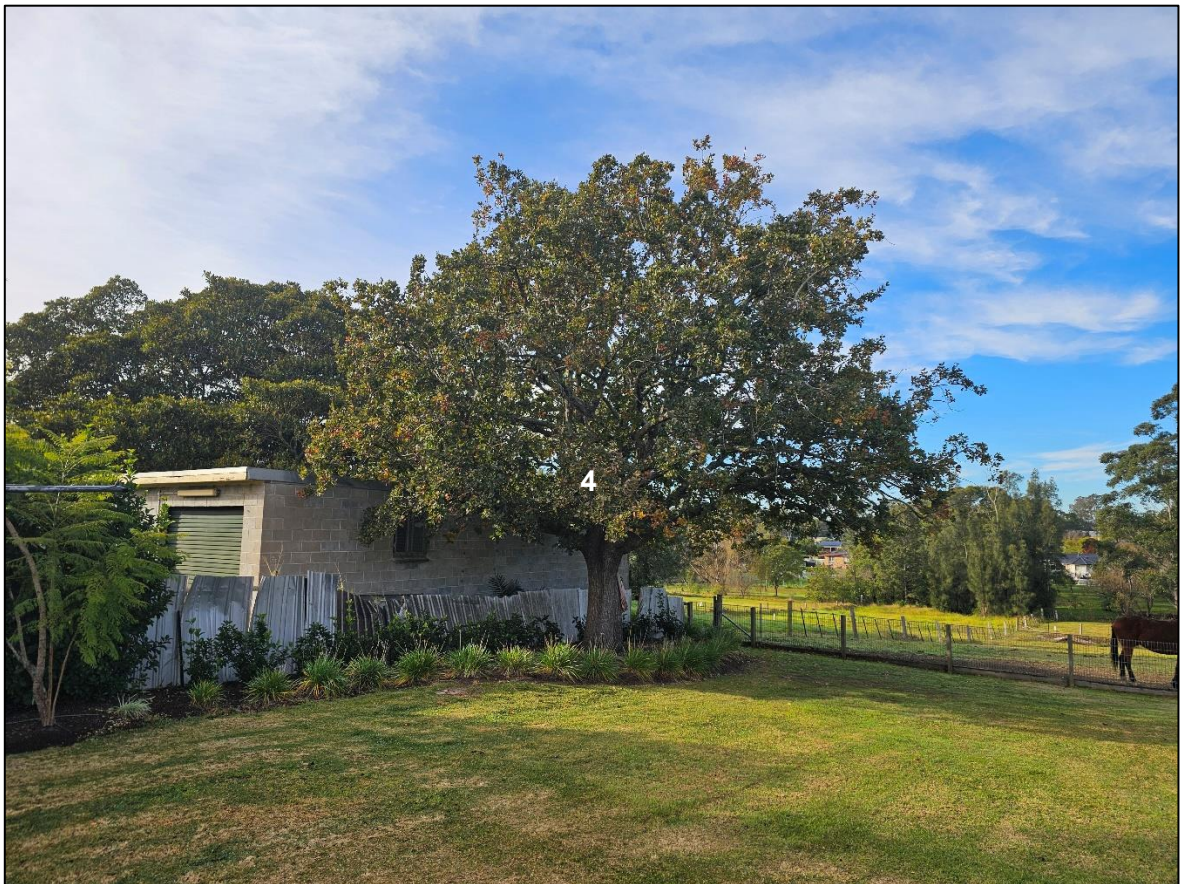
**Figure 4 Trees 4 *Quercus robur*.**

| No. | Species<br>(Common name) | DSH<br>(M) | NRZ<br>(M Radius) | SRZ<br>(M Radius) | HEIGHT<br>(M) | SPREAD<br>(M) | Vigour | Age<br>Class | SULE | Retention<br>value | Comments<br>(Encroachment %) | Proposal |
|---|---|---|---|---|---|---|---|---|---|---|---|---|
| 4 | <i>Quercus robur</i> (English<br>oak) | 0.7 | 8.4 | 3.01 | 9 | 10 | g | m | 1a | Moderate | appears structurally sound<br>(57% NRZ, 70% SRZ, proposed<br>building) | Removal |

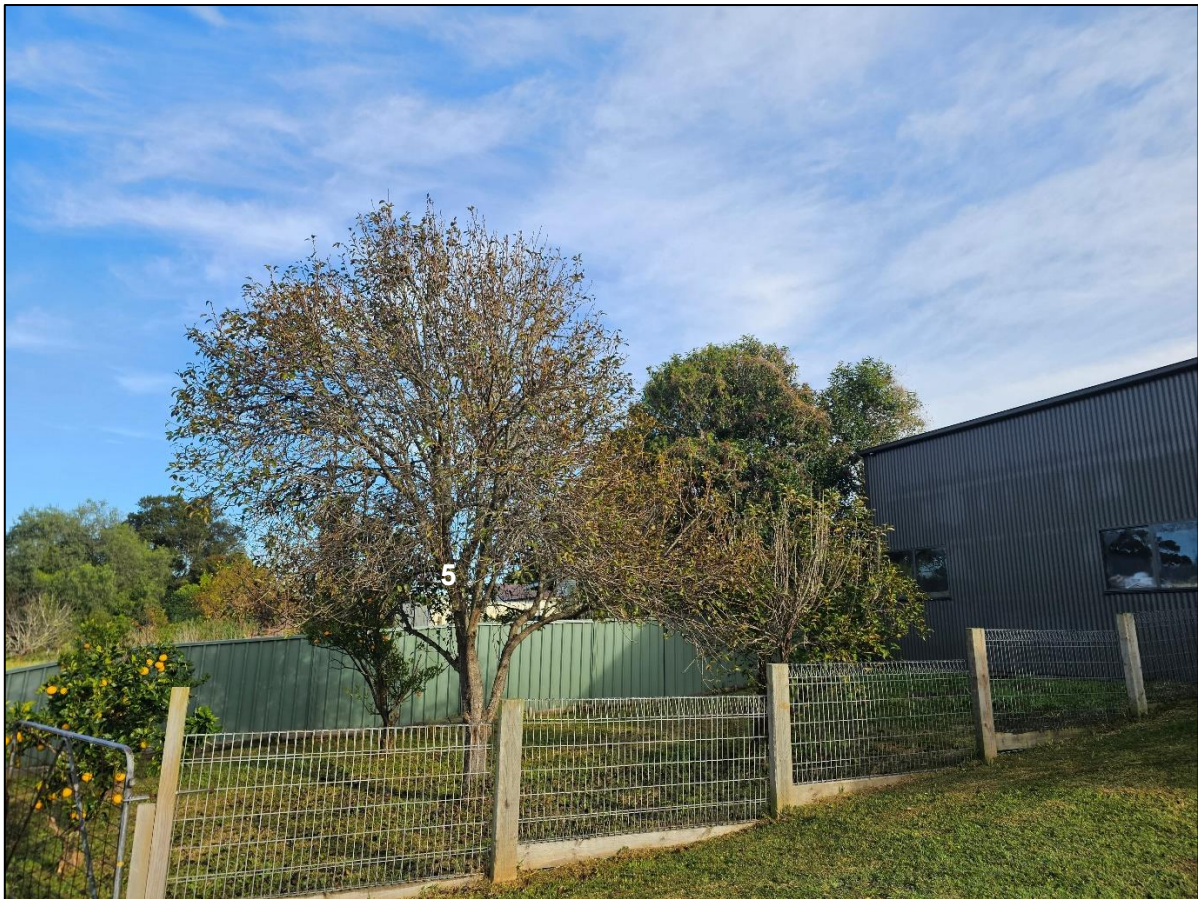
**Figure 5 Tree 5 *Pyrus sp.***

| No. | Species<br>(Common name) | DSH<br>(M) | NRZ<br>(M Radius) | SRZ<br>(M Radius) | HEIGHT<br>(M) | SPREAD<br>(M) | Vigour | Age<br>Class | SULE | Retention<br>value | Comments<br>(Encroachment %) | Proposal |
|---|---|---|---|---|---|---|---|---|---|---|---|---|
| 5 | <i>Pyrus sp.</i> (Pear) | 0.25 | 3.0 | 1.85 | 4 | 4 | g | m | 1a | Moderate | appears structurally sound<br>(100%NRZ/SRZ, proposed<br>driveway) | Removal |

5 *Pyrus sp.* 6 *Eucalyptus scoparia* 7 *Corymbia citriodora* are mature exotic and native trees in average to good health and vigour located adjacent to the Western boundary and are assessed with moderate to high retention value.

The trees will be within the plan area of the driveway conflicting with the proposed design. Consent is sought for the removal of the trees to allow the development to proceed as planned.

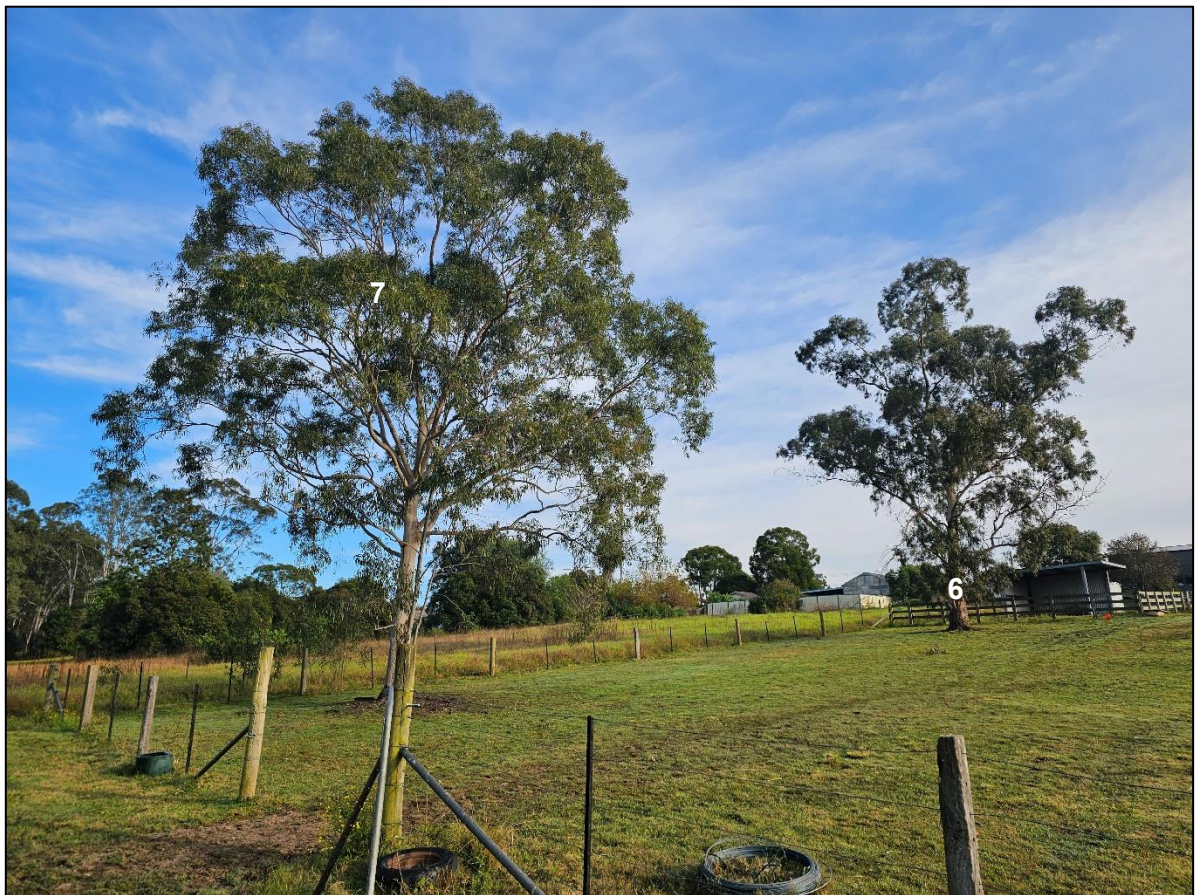
**Figure 6 Trees 6 *Eucalyptus scoparia* and 7 *Corymbia citriodora*.**

| No. | Species<br>(Common name) | DSH<br>(M) | NRZ<br>(M Radius) | SRZ<br>(M Radius) | HEIGHT<br>(M) | SPREAD<br>(M) | Vigour | Age<br>Class | SULE | Retention<br>value | Comments<br>(Encroachment %) | Proposal |
|---|---|---|---|---|---|---|---|---|---|---|---|---|
| 6 | <i>Eucalyptus scoparia</i><br>(Wallangarra White<br>Gum) | 0.67 | 8.0 | 0.00 | 16 | 10 | av | m | 2a | High | Large diameter deadwood<br>noted, extensive epicormic<br>growth<br>(60%NRZ/SRZ, proposed<br>driveway) | Removal |
| 7 | <i>Corymbia citriodora</i><br>(Lemoin-scented Gum) | 0.4 | 4.8 | 2.47 | 12 | 10 | g | sm | 1a | High | Appears structurally sound<br>(80%NRZ/SRZ, proposed<br>driveway) | Removal |

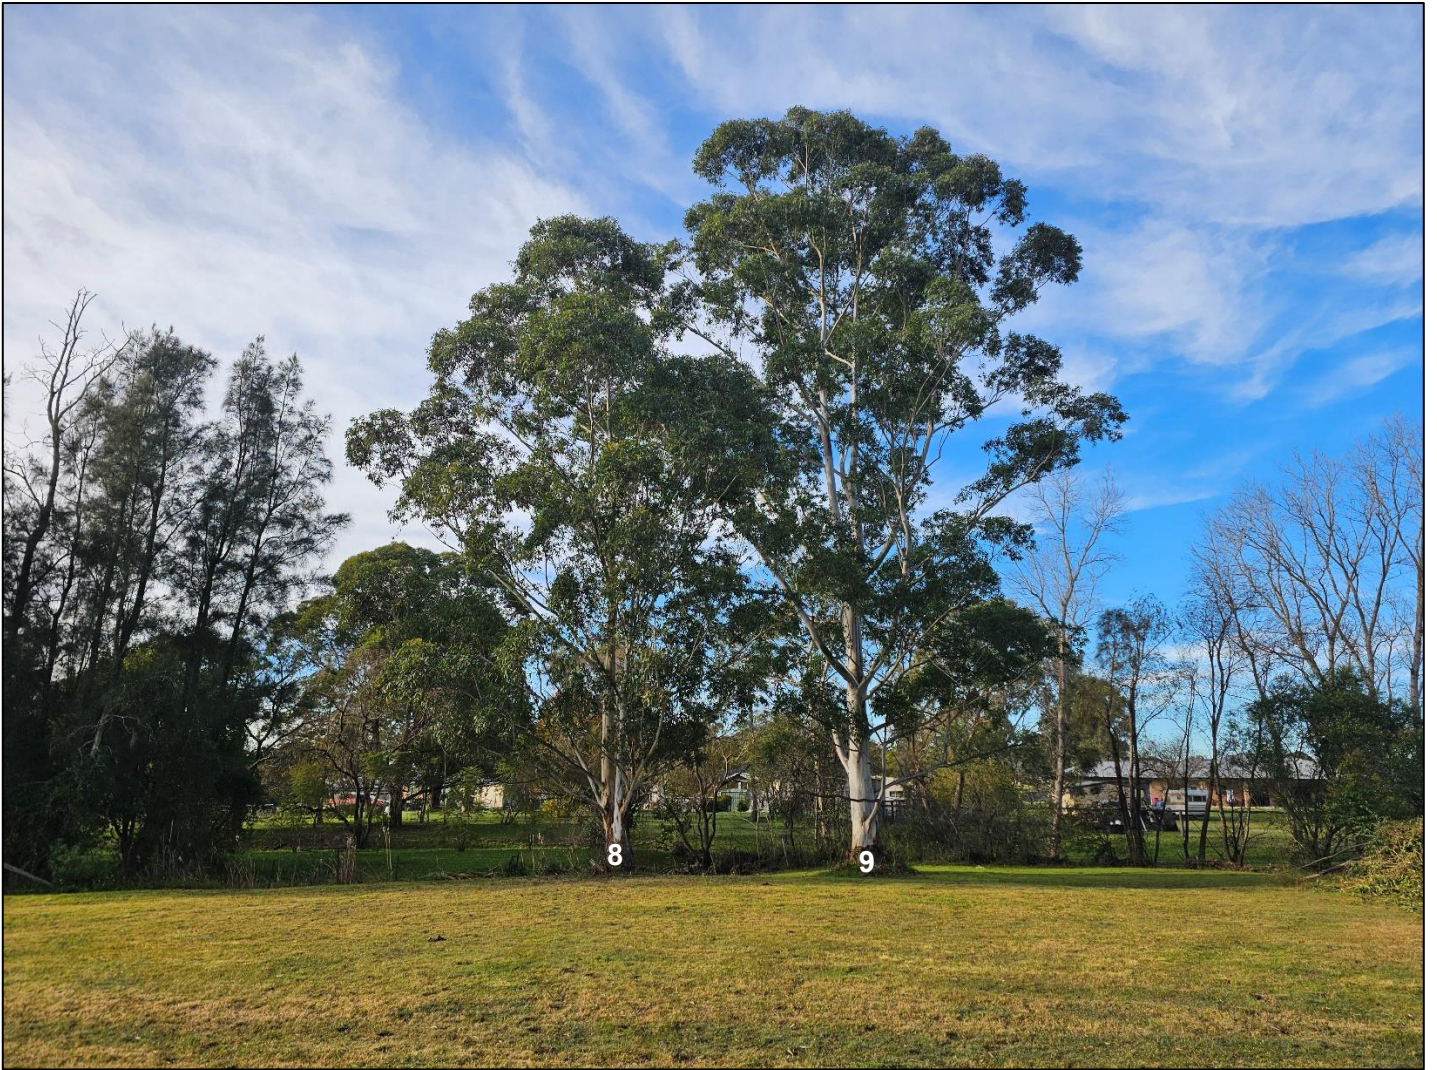
**Figure 7 Trees 8 and 9 *Eucalyptus saligna*.**

| No. | Species<br>(Common name) | DSH<br>(M) | NRZ<br>(M Radius) | SRZ<br>(M Radius) | HEIGHT<br>(M) | SPREAD<br>(M) | Vigour | Age<br>Class | SULE | Retention<br>value | Comments<br>(Encroachment %) | Proposal |
|---|---|---|---|---|---|---|---|---|---|---|---|---|
| 8 | <i>Eucalyptus saligna</i><br>(Sydney Blue Gum) | 0.32,<br>0.57 | 7.8 | 2.93 | 14 | 9 | g | m | 1a | High | Appears structurally sound<br>(Nil) | Retention |

| No. | Species<br>(Common name) | DSH<br>(M) | NRZ<br>(M Radius) | SRZ<br>(M Radius) | HEIGHT<br>(M) | SPREAD<br>(M) | Vigour | Age<br>Class | SULE | Retention<br>value | Comments<br>(Encroachment %) | Proposal |
|---|---|---|---|---|---|---|---|---|---|---|---|---|
| 9 | <i>Eucalyptus saligna</i><br>(Sydney Blue Gum) | 1.0 | 12.0 | 3.57 | 20 | 15 | g | m | 1a | High | Appears structurally sound<br>(Nil) | Retention |

Trees 8 and 9 *Eucalyptus saligna* are mature native trees in apparently good health and vigour and are assessed with high retention value due to their large size which contributes significantly to amenity and environmental values in the local landscape.

The trees are located at the rear of the subject site and will not be affected by any element of the proposed development. Accordingly, the trees will be retained and protected by establishing a Tree Protection Zone (TPZ) covering the rear of the site.

The undeveloped area South of the sewer easement is to be fenced across the width of the property using temporary fencing panels prior to the commencement of any works on site to restrict access by pedestrians and machinery for the duration of the project.

That Trees 1 *Brachychiton acerifolius*, 8 and 9 *Eucalyptus saligna* are retained and protected for the duration of the project.
