Arborist Report

Client: Kaine Tarlinton

Address: 29 – 33 Cessnock Road,
GILLESTON HEIGHTS N.S.W 2321

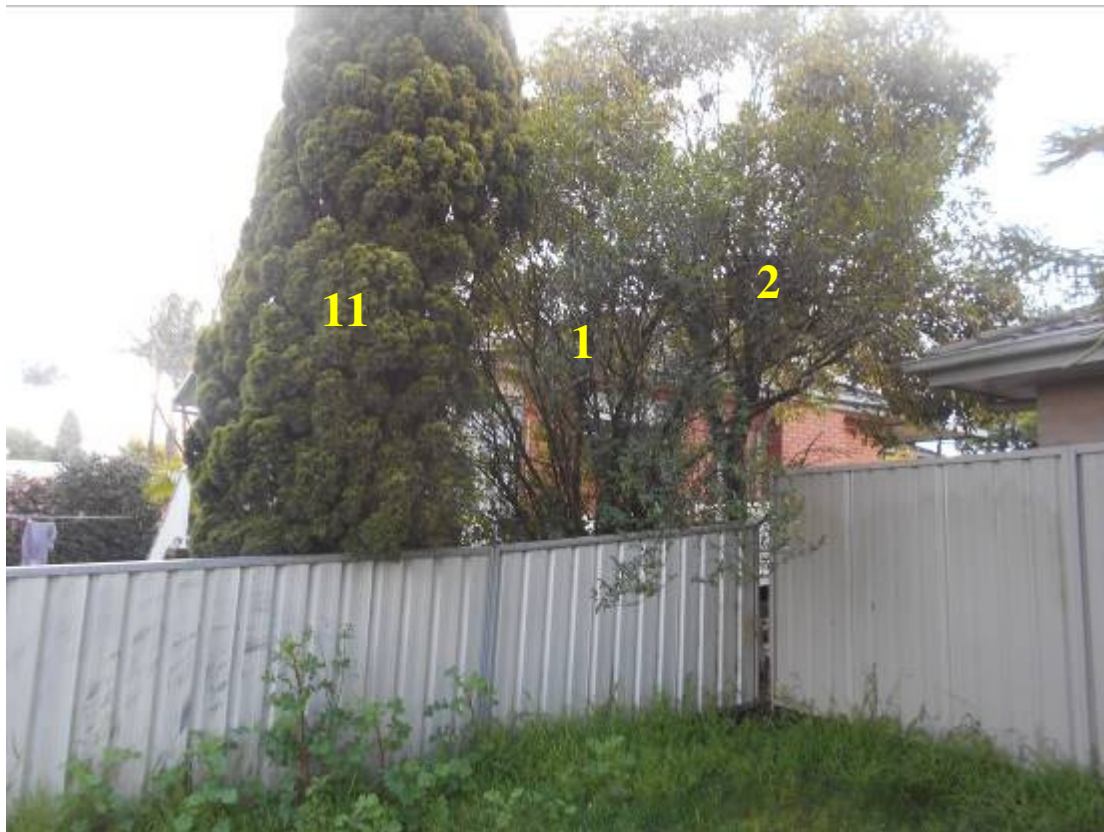
All trees require a S.R.Z and a T.P.Z with Australian Standards 4970- 2025 being used as a guideline. Tree 1 has been given an SRZ and TPZ of 1.72 & 2.16 metres in accordance with Australian Standards 4970 - 2025. Tree 1 is located 0.9 metres to the side boundary fence. Tree 1 is located outside of the proposed development. The first 1.26 metres inside the subject property within the TPZ will need to be at existing soil levels in order to retain Tree 1. This will include the first 1.26 metres of proposed open space. If this can be achieved will allow the retention of Tree 1. Tree 1 is earmarked for retention.

Figure 5 – showing the location of Trees 1, 2 & 11.

Tree 2 has been given an SRZ and TPZ of 1.50 & 2.40 metres in accordance with Australian Standards 4970 - 2009. Tree 2 is located 0.4 metres to the boundary fence. Tree 2 is located outside of the proposed development. In order to retain Tree 2 will require the first 2 metres inside the subject property within the TPZ to be retained at existing soil levels. This will include the first 2 metres of proposed open space. If this can be achieved will allow the retention of Tree 2. Tree 2 is earmarked for retention.

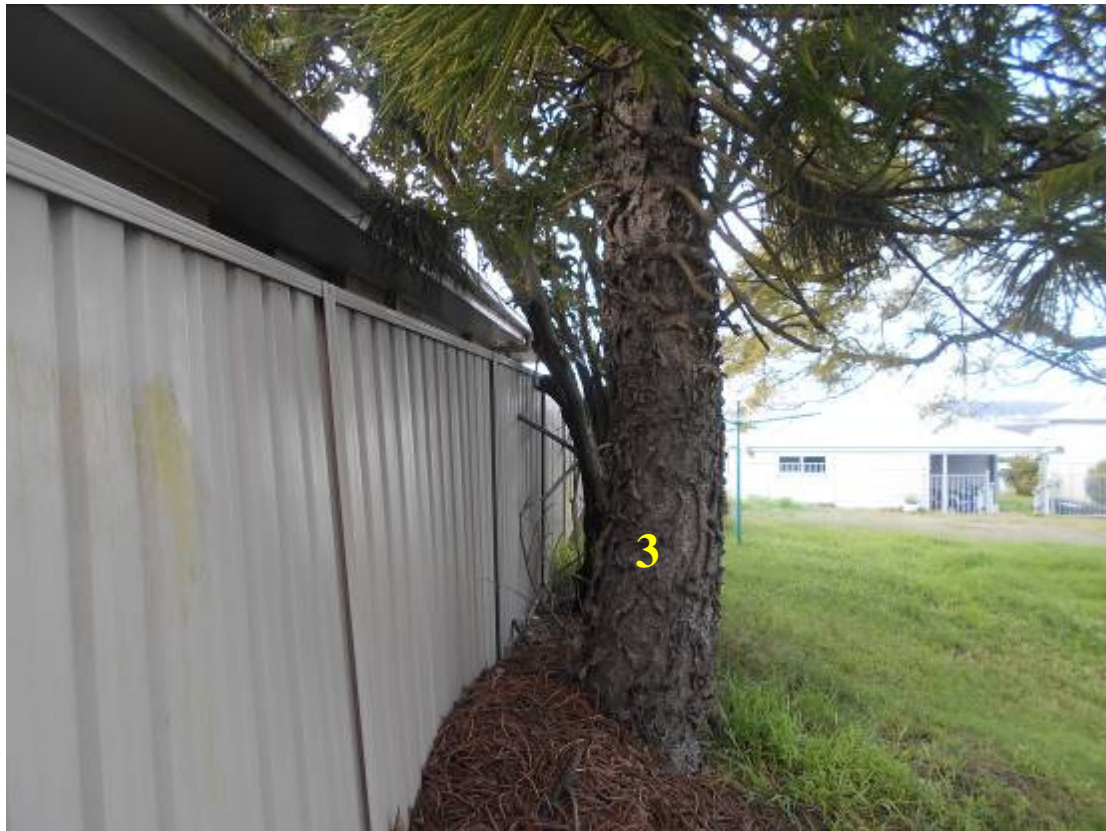
Tree 3 has been given an SRZ and TPZ of 2.65 & 6.18 metres in accordance with Australian Standards 4970 - 2009. Tree 3 is located towards the north western side of the subject property. Tree 3 is a young mature species with the potential for moderate future growth. Tree 3 is located 1.6 metres to the neighbour's property. This type of species has the potential to reach a TPZ of 12 metres (minimum) when fully mature. This would extend the TPZ into the neighbours existing building by 84.21% on one side taken from the centre of the trunk. This has the potential to cause major damage to the building foundations in a mature phase. There is also the potential that this species has also suffered SRZ and TPZ loss as the neighbours building appears to be constructed in the past 10 years. Tree 3 is located in the private open space area. If retained would require existing soil levels to be retained inside the TPZ. No below ground excavation works could be undertaken inside the TPZ. If this can be achieved will allow the retention of Tree 3. This species has the potential to be considered exempt on the proviso that it meets the requirements of Maitland DCP (Section 1.1). Tree 3 is earmarked for removal.

Figure 6 – Tree 3 has had SRZ/TPZ removed due to the neighbouring property. This species if left unabated would impede on the neighbouring development.

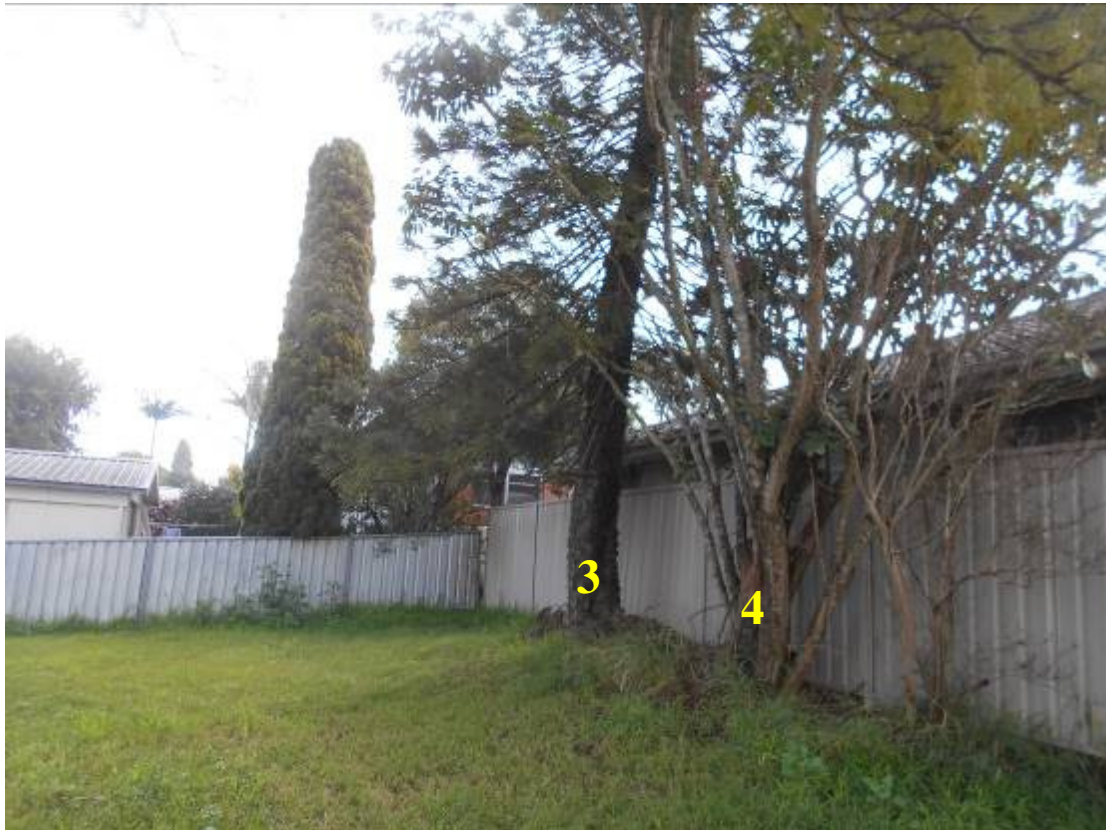
Tree 4 has been given an SRZ and TPZ of 2.26 & 6.24 metres in accordance with Australian Standards 4970 - 2025. Tree 4 is located outside of the proposed development. Tree 4 would be located in the proposed private open space area. Tree 4 is classified as a weed species in accordance with the Department of Primary Industries. This species also is identified as a species with extensive root plates. This species has a very low retention value. Tree 4 is earmarked for removal due to being an environmental weed. Tree 4 is earmarked for removal.

Figure 7 – Trees 3 & 4 are growing near the northern boundary fence within the subject property. These trees will outgrow there available growing space due to the location to the neighbours building. Tree 4 is also classified as a noxious weed in NSW with low landscape significance.

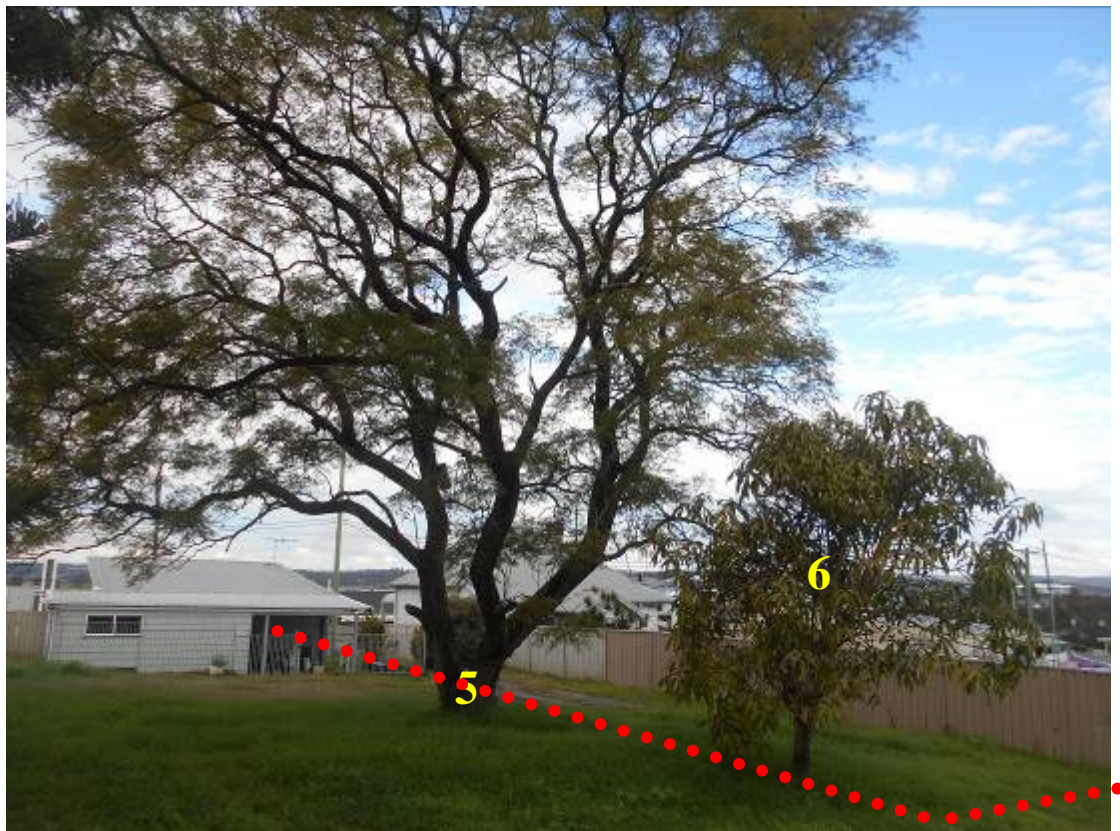
Tree 5 has been given an SRZ and TPZ of 3.09 & 8.76 metres in accordance with Australian Standards 4970 - 2025. Tree 5 is located inside the proposed outdoor play area. All proposed rock climbing, slide and seating areas are a minimum of 4 metres from the tree. There is the potential to retain Tree 5 however no change in the soil profile could occur in the SRZ. No change in the soil profile could occur up to the ancillary structures such as the rock climbing walls and seating areas. This will include retaining the existing soil levels up to these zones. No excavation works could be undertaken for a minimum of 5 metres from the trunk. If this can be achieved will allow the retention of Tree 5. The current layout and design will require below ground excavation works within both the SRZ and TPZ. These works would not allow the retention of Tree 5. In order to construct the proposed development will require the removal of Tree 5. Tree 5 is earmarked for removal

Figure 8 - showing the location of Tree 5 in the backyard of 29 Cessnock Road. Tree 5 will require removal in order to allow civil and excavation works to take place

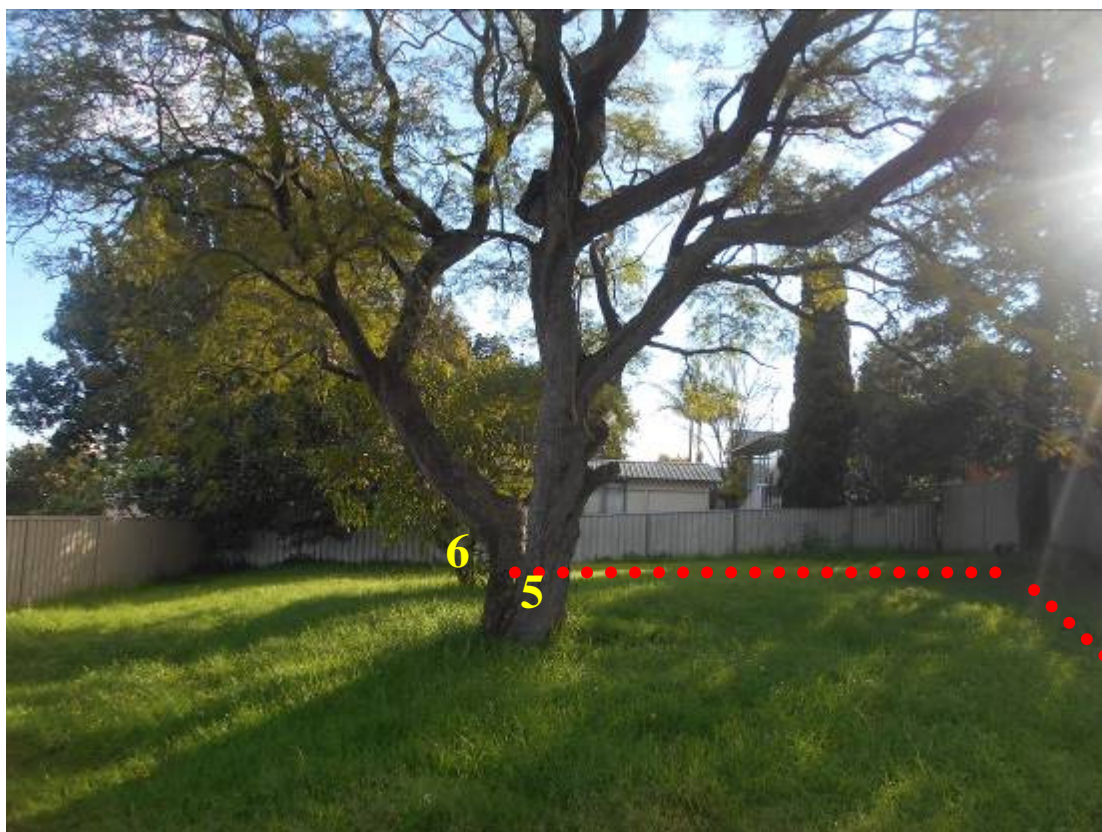
Tree 6 has been given an SRZ and TPZ of 1.88 & 2.64 metres in accordance with Australian Standards 4970 - 2025. Tree 6 is a small fruit tree that would not be suitable inside the playground area. Tree 6 is earmarked for removal before commencement of building works on site.

Figure 9 – showing the location of Trees 5 & 6

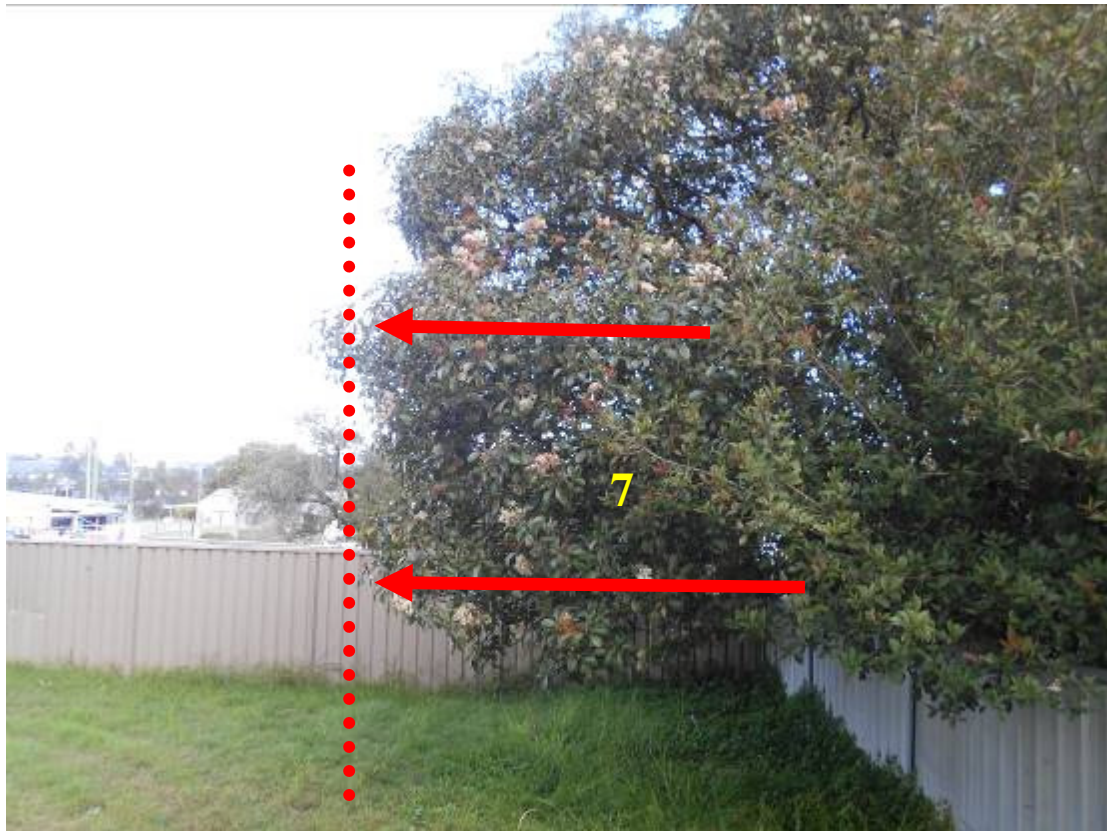
Tree 7 has been given an SRZ and TPZ of 2.20 & 4.32 metres in accordance with Australian Standards 4970 - 2025. Tree 7 is located in the neighbour's backyard. Tree 7 is located 0.4 metres to the back boundary fence. There is also 3 metres of canopy that extends into the subject property as noted in Figure 10. The proposed development including the undercover area, extension storeroom and rock climbing is 0.9 metres to the back boundary fence. AS 4970 – 2025 highlights that the TPZ is taken from the centre of the trunk. This leaves a distance of 1.51 metres from the centre of the trunk to the civil works. The overall loss of TPZ has been calculated at 28.21% that is considered a large encroachment into the TPZ. If retained will require no change in the soil profile within the green space and private open space. Tree 7 is earmarked for retention. Tree 7 will require moderate pruning works in accordance with AS 4373 – 2007. Tree 7 will require a minimum of 2.38 metres of the soil profile protected where no civil works occur. This will include all private open space areas to remain at existing soil levels within the 2.38 metre zone from the back boundary fence inside the TPZ..

Figure 10 – showing the location of Tree 7. The canopy associated with Tree 7 extends into the subject property by 3 metres. Tree 7 will require a minimum of 2.38 metres of the soil profile protected where no civil works occur.

- It is recommended that Tree 7 be pruned by no greater than 15 - 20%. This is to include directional pruning to the eastern quadrant. All directional pruning works are to be undertaken by a qualified arborist (minimum certificate 2 in arboriculture). It is recommended that professional indemnity and public liability insurances be current and sighted before commencement of works begin. The level of cover has to be one in agreement between Kaine Tarlinton and the arborist.

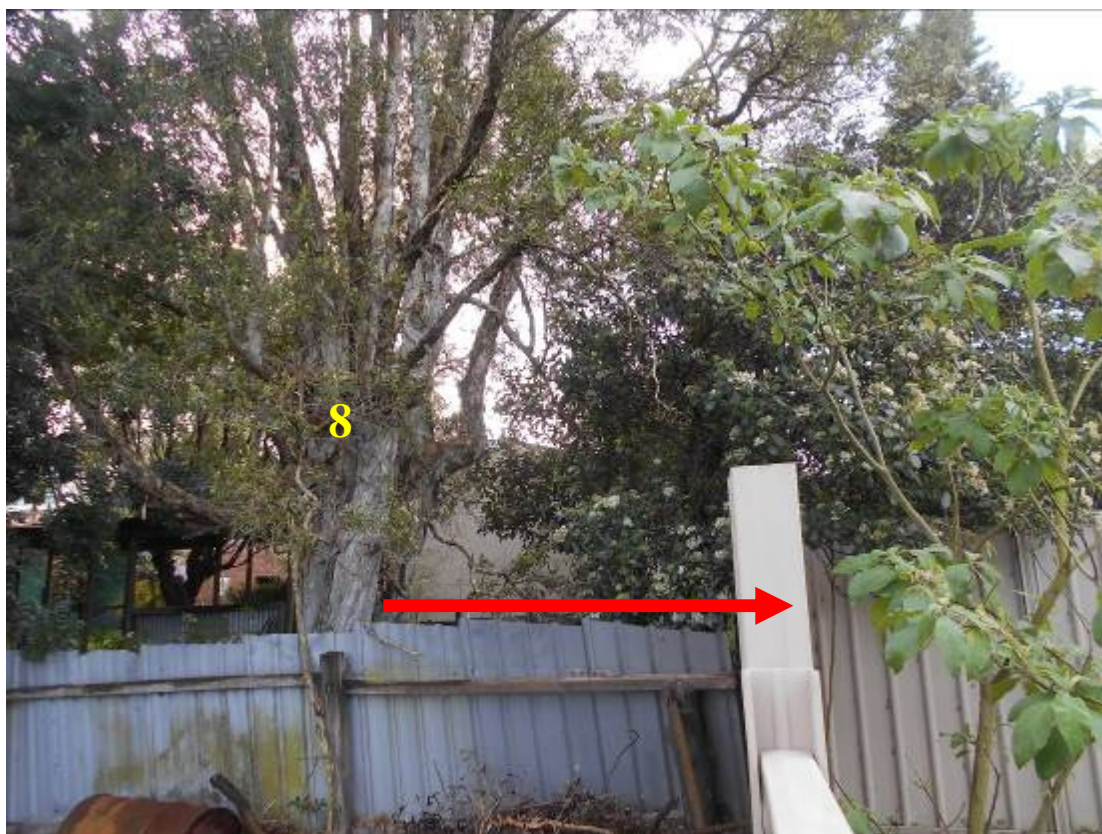
Tree 8 has been given an SRZ and TPZ of 3.01 & 7.20 metres in accordance with Australian Standards 4970 - 2025. Tree 8 is located in the neighbour's property as outlined in Figure 11. Tree 8 is located 3.3 metres to the back boundary fence. Majority of civil works and structures will occur 4.3 metres from the trunk. This leaves a distance of 8.80 metres from the trunk to the development. The development is outside of the TPZ. In order to retain Tree 8 and comply with AS 4970 – 2025. AS 4970 – 2025 highlights that the TPZ is taken from the centre of the trunk. This leaves a distance of 4.77 metres from the centre of the trunk to the proposed development. All civil works and development will be located outside of the SRZ. The loss of TPZ has been calculated at 11.15% that is considered a small loss of TPZ. All SRZ is located inside the neighbour's property. No change will occur in this zone. The loss of 11.51% can be compensated for within the neighbour's property. Tree 8 is earmarked for retention.

Figure 11 – showing the location of Tree 8 inside the backyard of the neighbour's property.

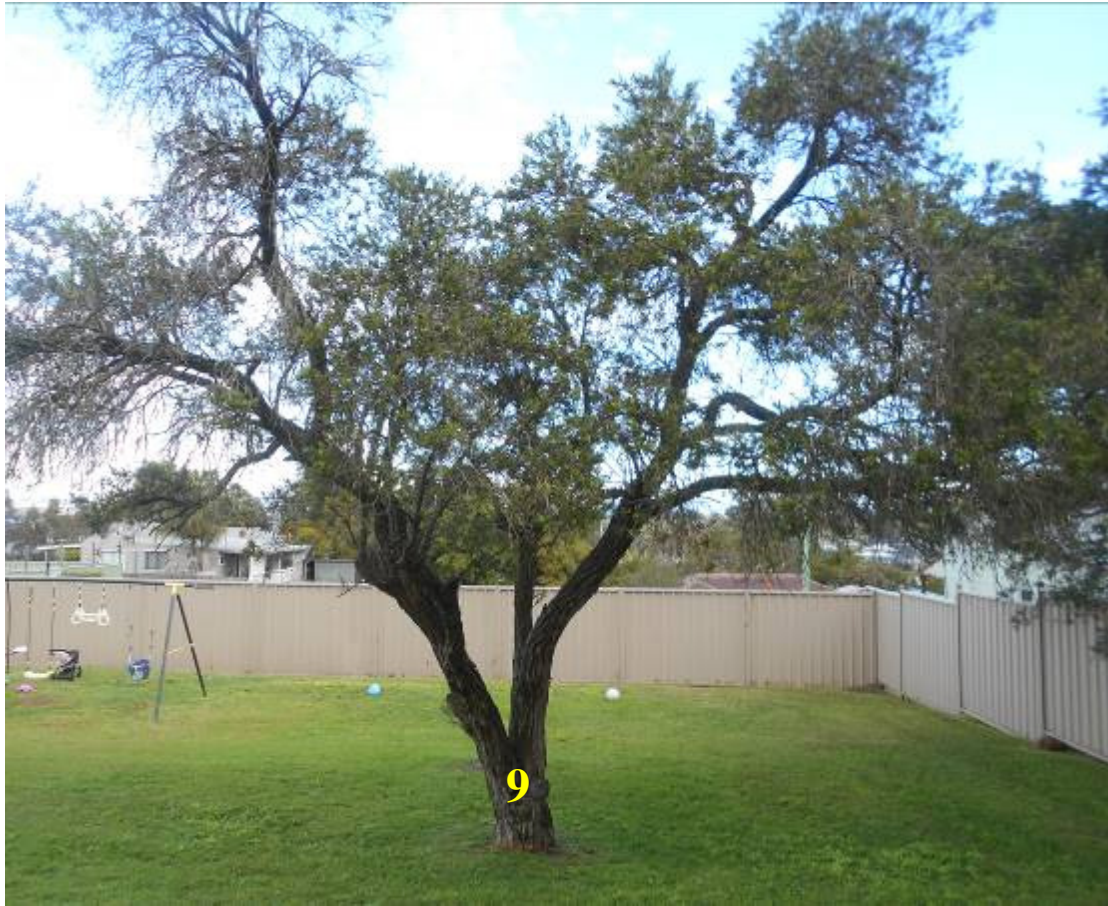
Tree 9 has been given an SRZ and TPZ of 2.30 & 3.96 metres in accordance with Australian Standards 4970 - 2009. Tree 9 is located in the backyard of 31 Cessnock Road. Tree 9 is located inside the proposed building footprint. In order to construct the proposed development will require the removal of Tree 9. Tree 9 is earmarked for removal before commencement of building works on site.

Figure 12 – showing the location of Tree 9. Tree 9 is located inside the proposed development.

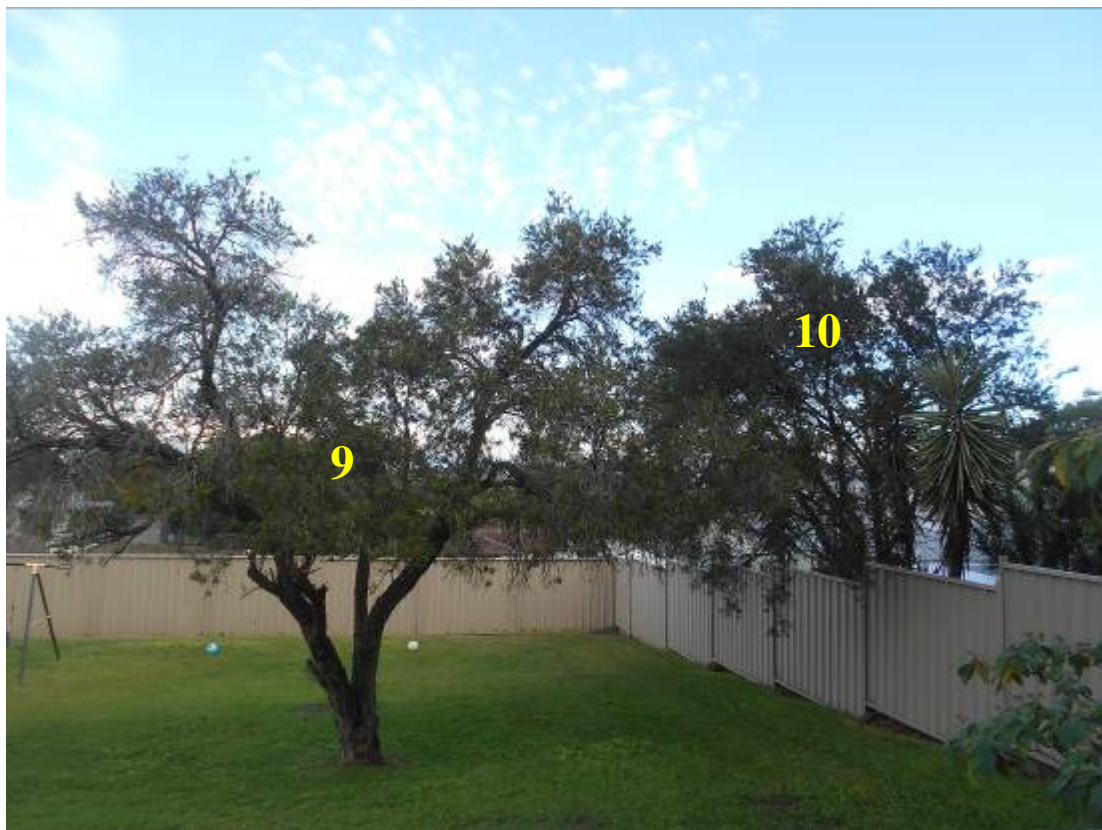
Tree 10 has been given an SRZ and TPZ of 2.21 & 3.18 metres in accordance with Australian Standards 4970 - 2009. Tree 10 is located in the backyard of the neighbour's property. Tree 10 is located 1 metre to the boundary fence. The proposed development and associated civil works are located 1 metre to the trunk. AS 4970 – 2025 highlights that the TPZ is taken from the centre of the trunk. This leaves a distance of 1.11 metres from the centre of the trunk to the proposed development. The overall loss of TPZ has been calculated at 28.24% that is considered a moderate loss of TPZ. The current layout and design would have an impact on Tree 10. Preferred option is to remove Tree 10 and replace with native trees. Tree 10 is earmarked for removal.

Figure 13 – showing the location of Trees 9 & 10. Tree 9 is located in the backyard of the subject property. Tree 10 is located
