Road Safety Audit

Anambah Road, Gosford – Existing Conditions

REFERENCE:
25.224r01v01

DATE:
12/09/2025

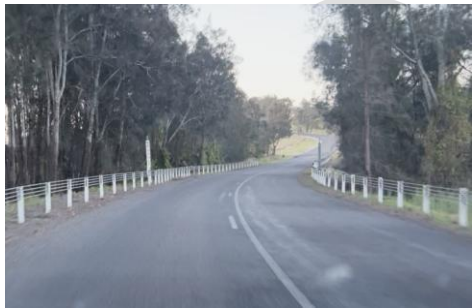
AUDIT FINDING REFERENCE	ROAD SAFETY AUDIT FINDING	LIKELIHOOD	SEVERITY	LEVEL OF RISK	PROJECT MANAGER RESPONSES
1- Overtaking at Chainage 1800 to 2000	<p>The centreline lane markings between approximate Chainage 1800 to 2000 permits overtaking in the northbound direction.</p> <p>The commencement of overtaking is partially within a horizontal curve with flexible wire barrier on either side of the carriageway. Sight lines through the curve are limited for northbound vehicles on approach to the overtaking area and within the 100 km/h speed zone area. There are no shoulders present and no run-off road area due to the presence of wire rope flexible safety barrier.</p> <p>There is a risk of head-on crashes with opposing vehicles within this Chainage.</p>

<p><i>Northbound view of overtaking centreline marking</i></p>	Rare	Serious	Medium (FSI)

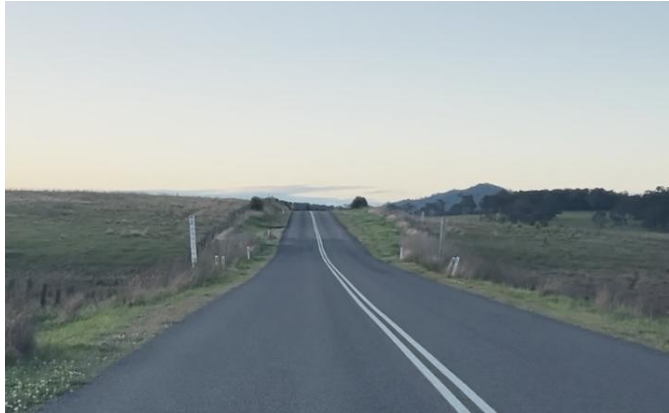
AUDIT FINDING REFERENCE	ROAD SAFETY AUDIT FINDING	LIKELIHOOD	SEVERITY	LEVEL OF RISK	PROJECT MANAGER RESPONSES
2 – Culvert Location on Straight Alignment	<p>There are unprotected culverts / headwalls located within the straight road alignment of Anambah Road. These headwalls present non-frangible hazards in close proximity to the travel lane.</p> <p>There is a risk that errant vehicles in these locations may impact with the headwall, resulting in increased severity of the crash. The likelihood of these locations are considered to be rare given they are on the straight road alignment.</p> <p>These are located at Chainage 1500, 2800, 4400,</p>

<p><i>Example of culvert in close proximity to travel lanes</i></p>	Rare	Serious	Medium (FSI)

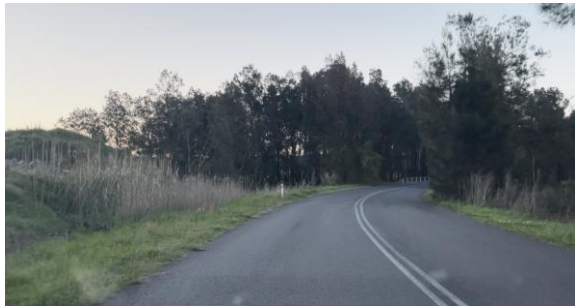
AUDIT FINDING REFERENCE	ROAD SAFETY AUDIT FINDING	LIKELIHOOD	SEVERITY	LEVEL OF RISK	PROJECT MANAGER RESPONSES
3 – Wire Rope Barrie Point of Need	<p>The position of the flexible wire-rope barrier located at approximate Chainage 1800 to 2000 may not adequately contain errant vehicles and their point of need.</p> <p>The location of the wire-rope barrier is within the horizontal curve with steep embankment and vegetation. The wire-rope does not extend the full length of the horizontal curve such that errant vehicles in this location may still encroach into the embankment or other rigid hazards, increasing the severity of a crash.</p>

<p><i>Northbound view of right-hand curve and wire-rope barrier in foreground. No barrier treatment within the curve.</i></p>	Unlikely	Serious	High (FSI)

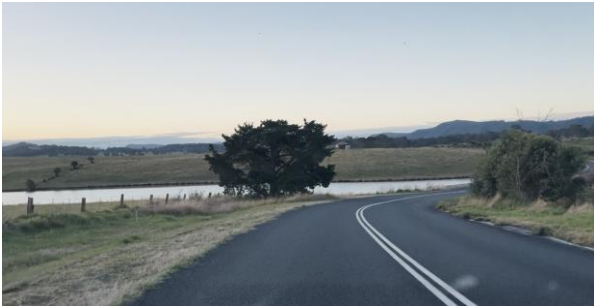
AUDIT FINDING REFERENCE	ROAD SAFETY AUDIT FINDING	LIKELIHOOD	SEVERITY	LEVEL OF RISK	PROJECT MANAGER RESPONSES
4 – Guardrail point of need	<p>There is horizontal curve located between Chainage 3000 to 3200 within a flood prone location. The horizontal curve is provided with guardrail however may not adequately contain errant vehicles are their point of need.</p> <p>An errant vehicle through the curve may not be contained by the barrier and encroach into the embankment area, or impact with the leading terminal of the barrier increasing the severity of a crash in this location. The severity of crash may be increased should their be presence of water nearby.</p>

<p><i>Northbound view of right hand curve with guardrail in foreground. No guardrail in advance of the floodway area.</i></p>	Unlikely	Serious	High (FSI)	
5 – Curve Advisory	Between Chainage 2800 to 3400, there are a series of horizontal curve alignment changes. A motorist proceeding in either the northbound or southbound direction may be unaware of the road alignment and travel through these curves at excess speed. There is a risk that inadequate information may result in increased likelihood of a crash between these Chainages.	Rare	Serious	Medium (FSI)

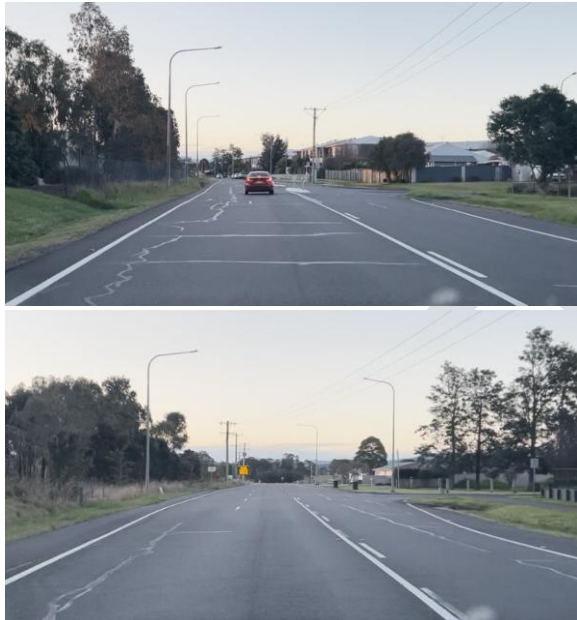
AUDIT FINDING REFERENCE	ROAD SAFETY AUDIT FINDING	LIKELIHOOD	SEVERITY	LEVEL OF RISK	PROJECT MANAGER RESPONSES
11 – Basic Axillary Right Turn Lanes	<p>The northbound lane on Anambah Road at the Cagney Road intersection and Niven Parade intersection is widened to facilitate passing of right-turn vehicles. The passing is within the 60 km/h speed zoning segment.</p> <p>Increased through traffic volumes in this location may increase the likelihood of rear-end crashes.</p>

<p>View of widening at Cagney Road (left) and Niven Parade (right)</p>	Rare	Moderate	Low

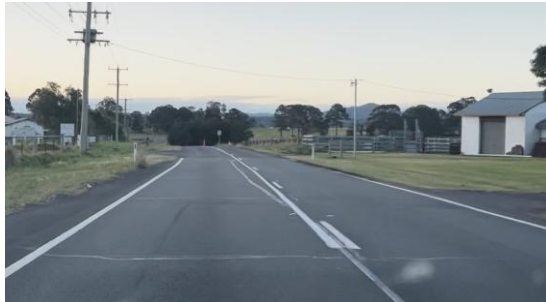
AUDIT FINDING REFERENCE	ROAD SAFETY AUDIT FINDING	LIKELIHOOD	SEVERITY	LEVEL OF RISK	PROJECT MANAGER RESPONSES
12 – Overtaking Near Intersections	<p>There is a short segment of linemarking which permits overtaking in the southbound direction on Anambah Road, north of Niven Parade. The location of overtaking is considered to be relatively close to the intersection and may impact decision making for vehicles entering or exiting Niven Parade.</p> <p>A vehicle entering or exiting Niven Parade may not identify a vehicle undertaking an overtake manoeuvring in the southbound direction of Anambah Road, increasing the likelihood of a near or far-side crash.</p>

<p>Northbound view of centreline marking</p>	Rare	Moderate	Low	
13 – Stockpile Driveway Sight Lines	<p>There appears to be a Stockpile site and driveway located at approximate Chainage 2000. The driveway is located slightly south of the horizontal curve on Anambah Road. Sight lines for vehicles exiting the Stockpile driveway may be inadequate due to the impacts of the horizontal curve and road side vegetation.</p> <p>There is a risk of far-side crashes between vehicles exiting the Stockpile driveway and southbound vehicles on Anambah Road.</p>	Rare	Serious	Medium (FSI)

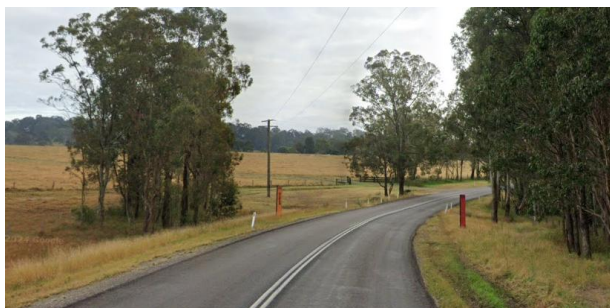
AUDIT FINDING REFERENCE	ROAD SAFETY AUDIT FINDING	LIKELIHOOD	SEVERITY	LEVEL OF RISK	PROJECT MANAGER RESPONSES
14 – Unprotected embankments	<p>There is an unprotected embankment and culvert / headwall located at Chainage 0 to 100. The location of this horizontal curve is downgrade for northbound vehicles. There is a curve advisory sign with 75 km/h advisory speed on approach for northbound vehicle.</p> <p>The location of the curve on a downgrade may result in a run-off road crash, particularly during inclement weather conditions or high travel speed. The presence of vertical drop and headwall near the culvert may increase the severity of a crash in this location.</p>

<p>Northbound view of right-hand curve with embankment on passenger (left-hand) side.</p>	Rare	Serious	Medium (FSI)
