## Walka Water Works

Conservation Management Plan

Maitland City Council

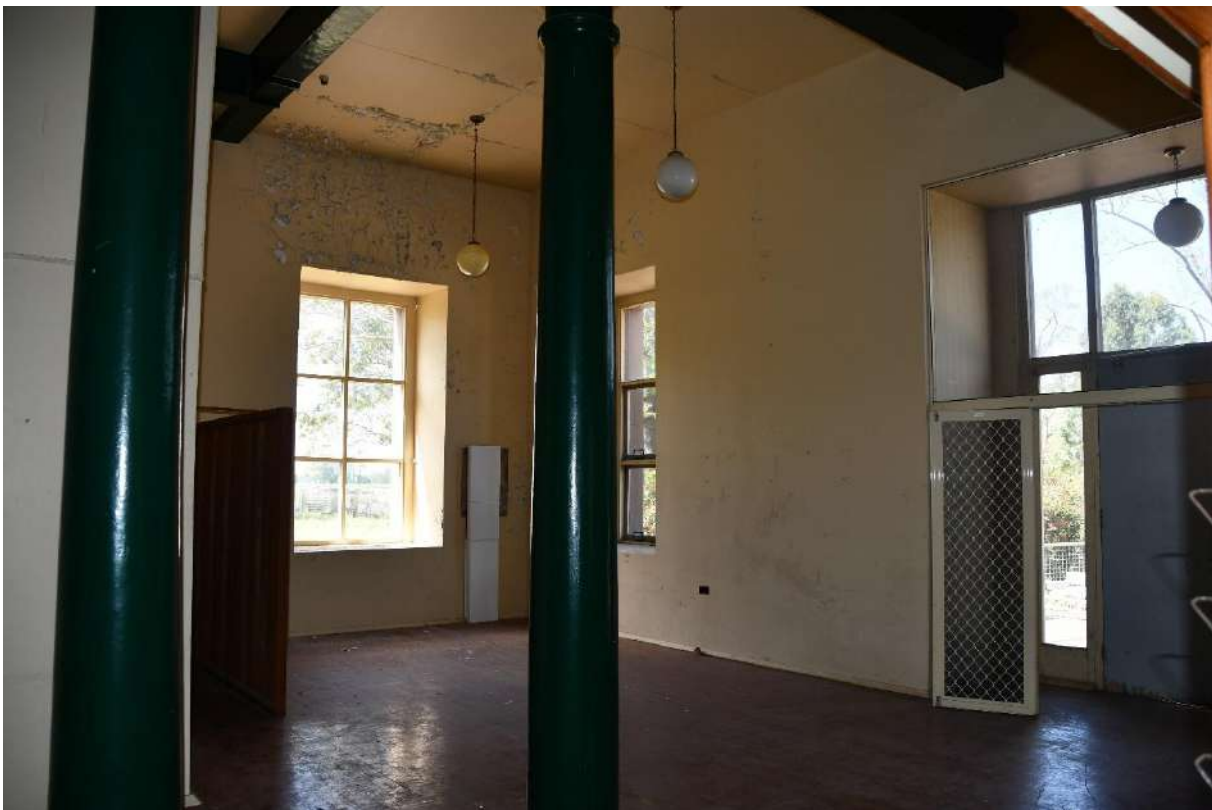
Figure 43: The Main Office (Room #01) looking towards the southeast corner. The entrance into the Main Pumphouse is visible. There is some paint flaking around the windows along with mould but otherwise, the room is in good condition.

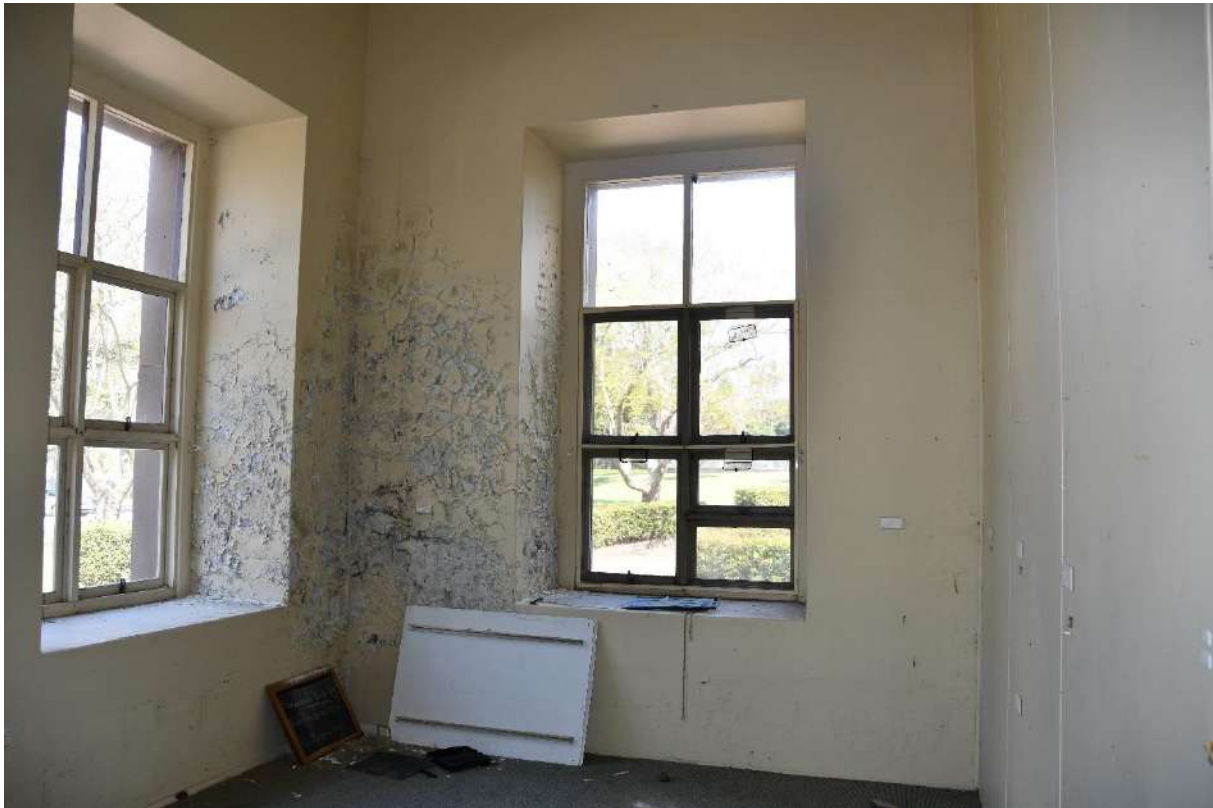
Figure 44: The Office (Room #02) in Main Pumphouse (A) demonstrating water damage. Cracks in the render are visible on the external wall.

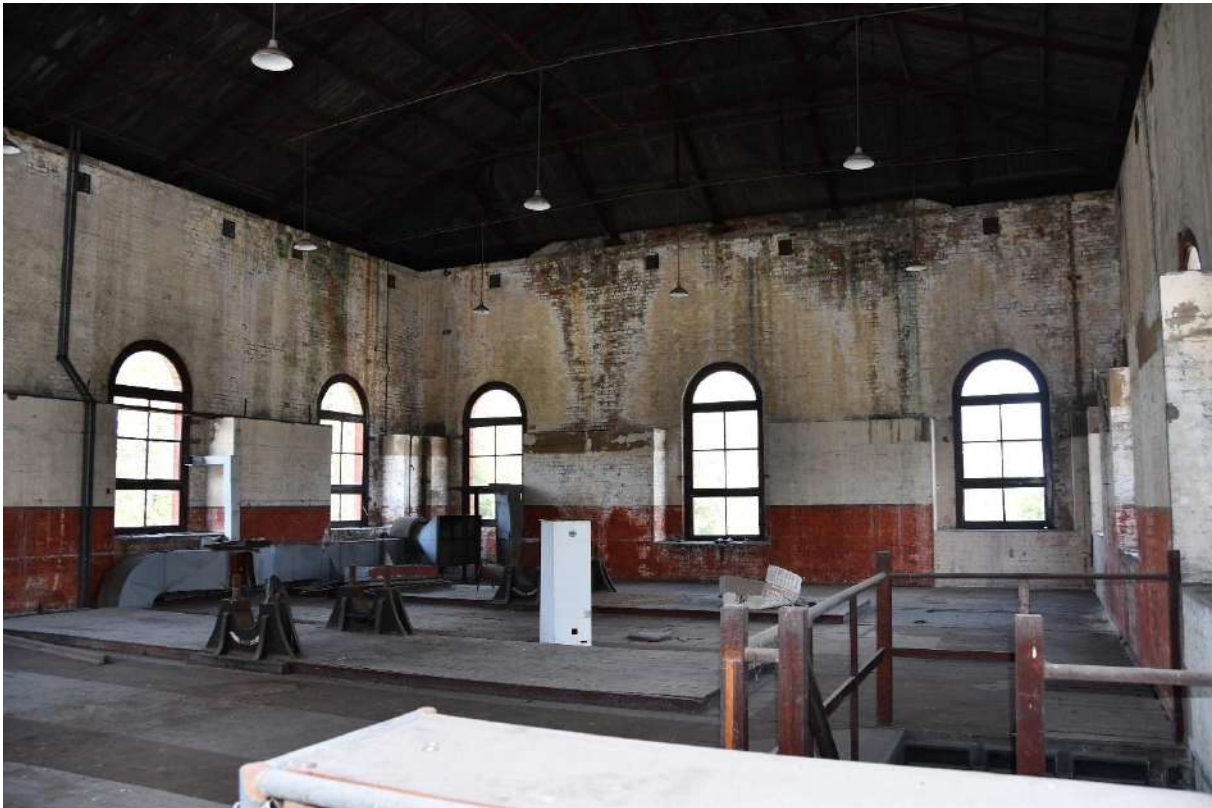
Figure 52: General view of the upper floor. Showing the original painted water damaged walls, floor and wheel brackets in place. Various later vents and ducting are additionally visible.

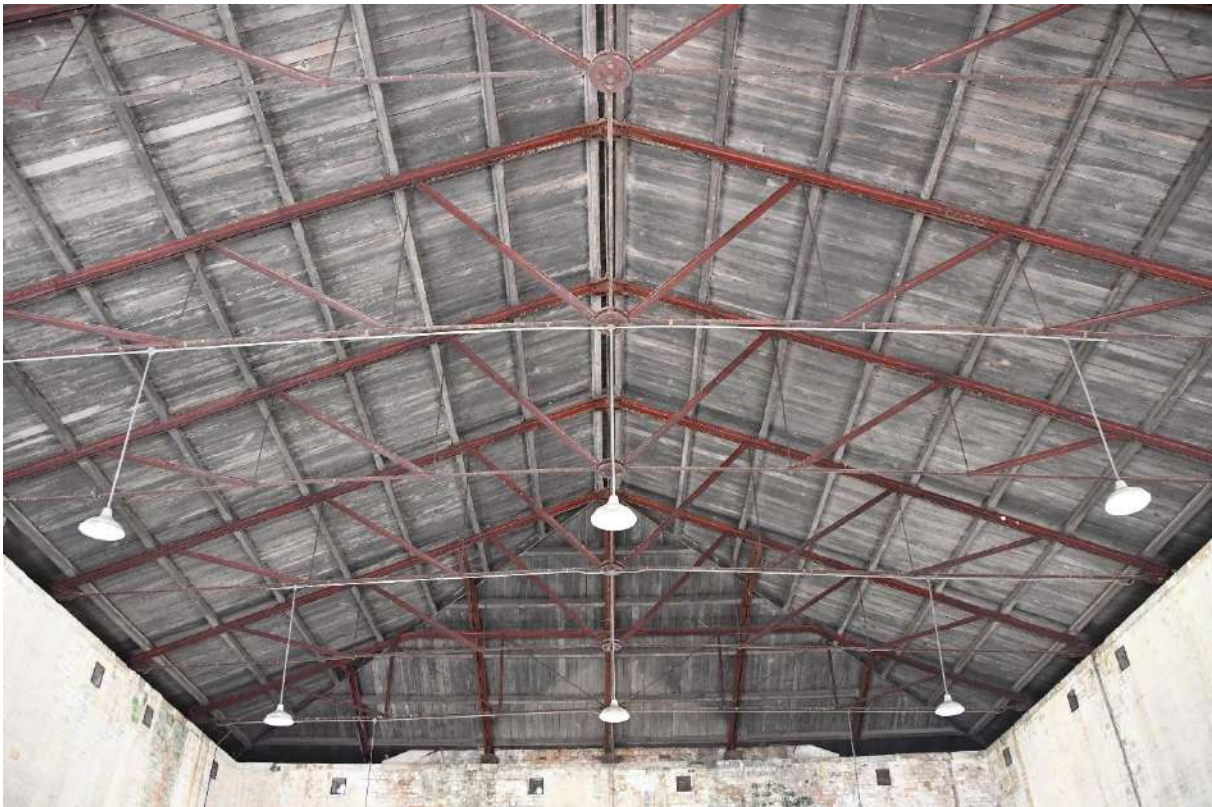
Figure 53: Internal view of the roof of the Main Pumphouse showing the roof trusses and water damaged walls.

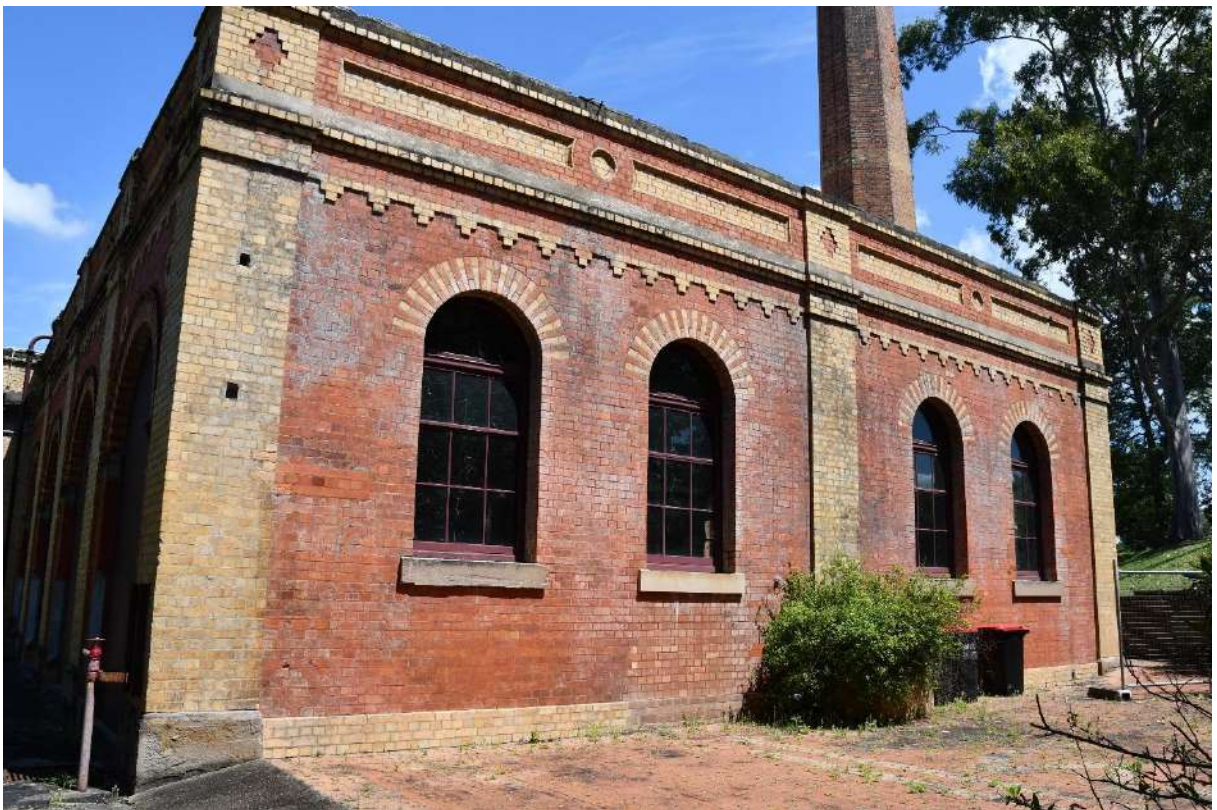
Figure 56: Northern elevation of Boiler Room (Item B). Evidence of the attachment of the former Addition (Item G) can be seen on the corner in the foreground and below the window frame where the brick work has been replaced.

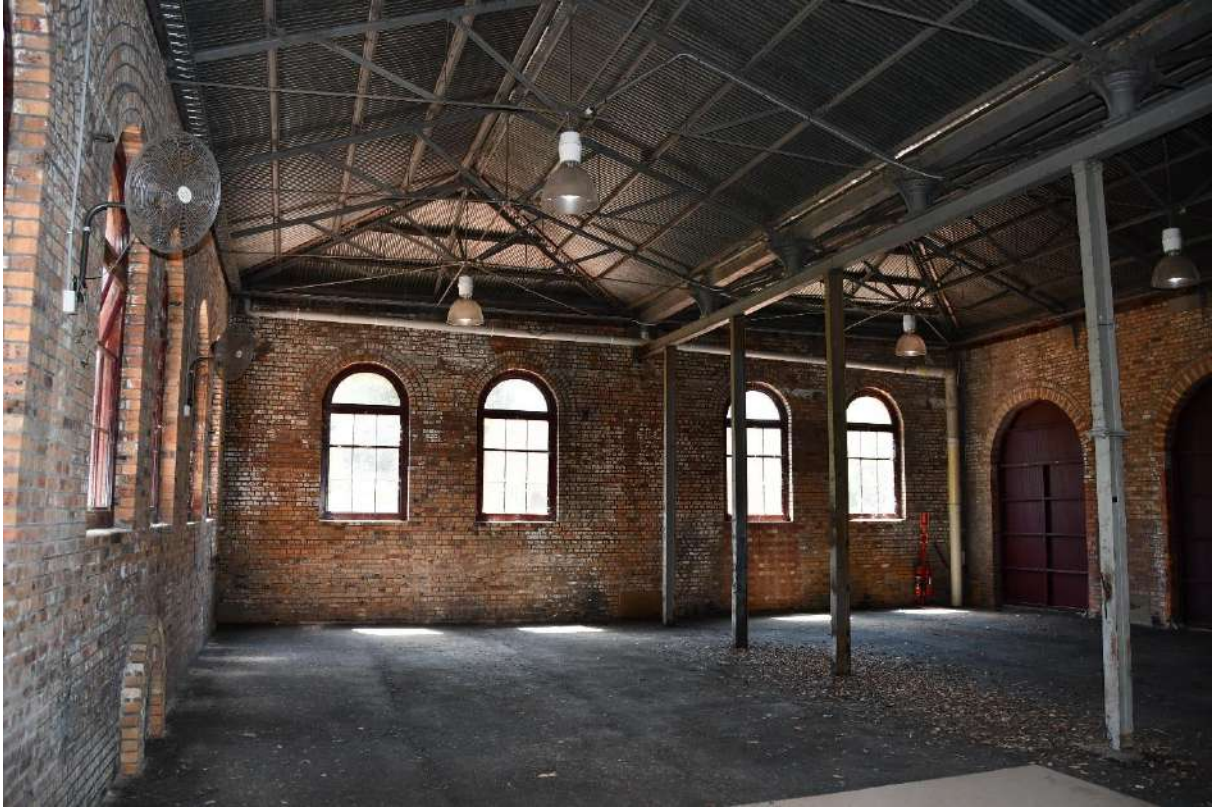
Figure 59: Northern wall of the Boiler Room (Item B). The repaired former doorway that accessed the former Addition (Item G) is visible on the windows to the right.

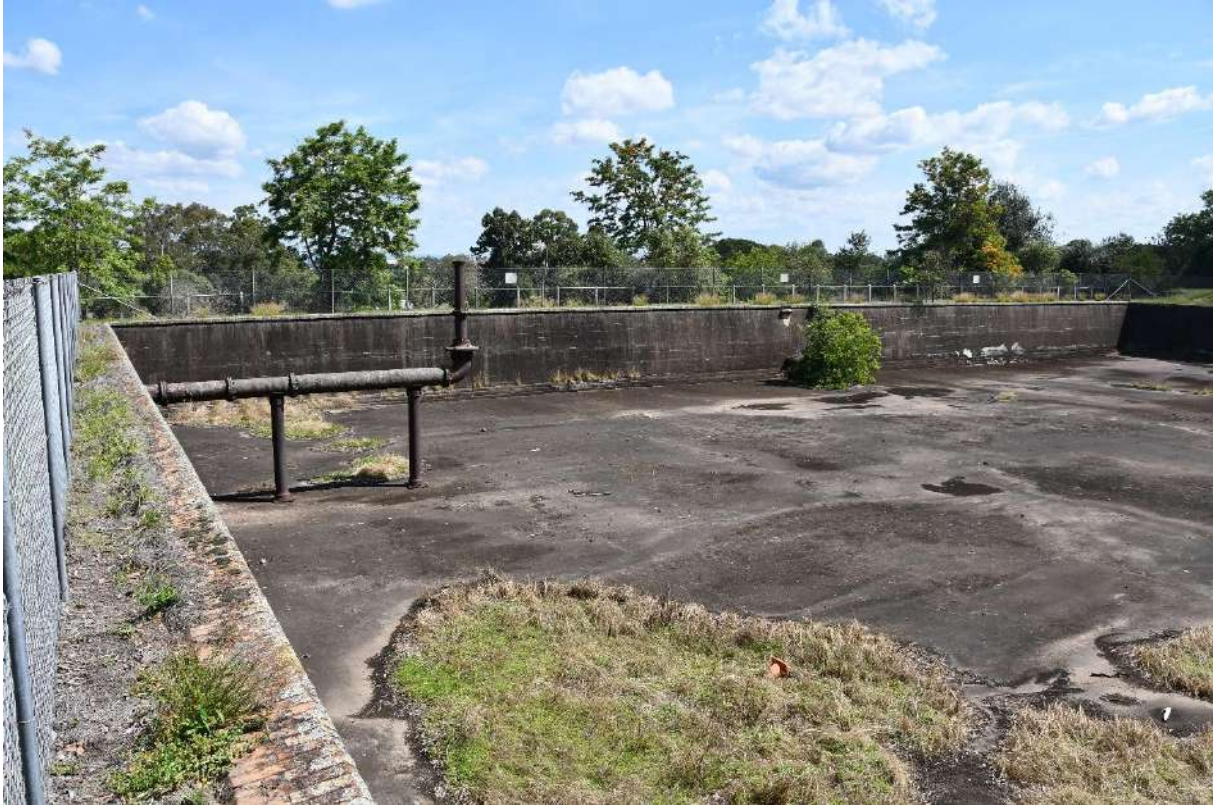
Figure 96: The Settling Tank. The inlet from the eastern wall is clearly visible. Outlets on the southern wall are obscured by trees. Cracking on the wall render is evident as well as the linear marks on the floor. View to the southwest.

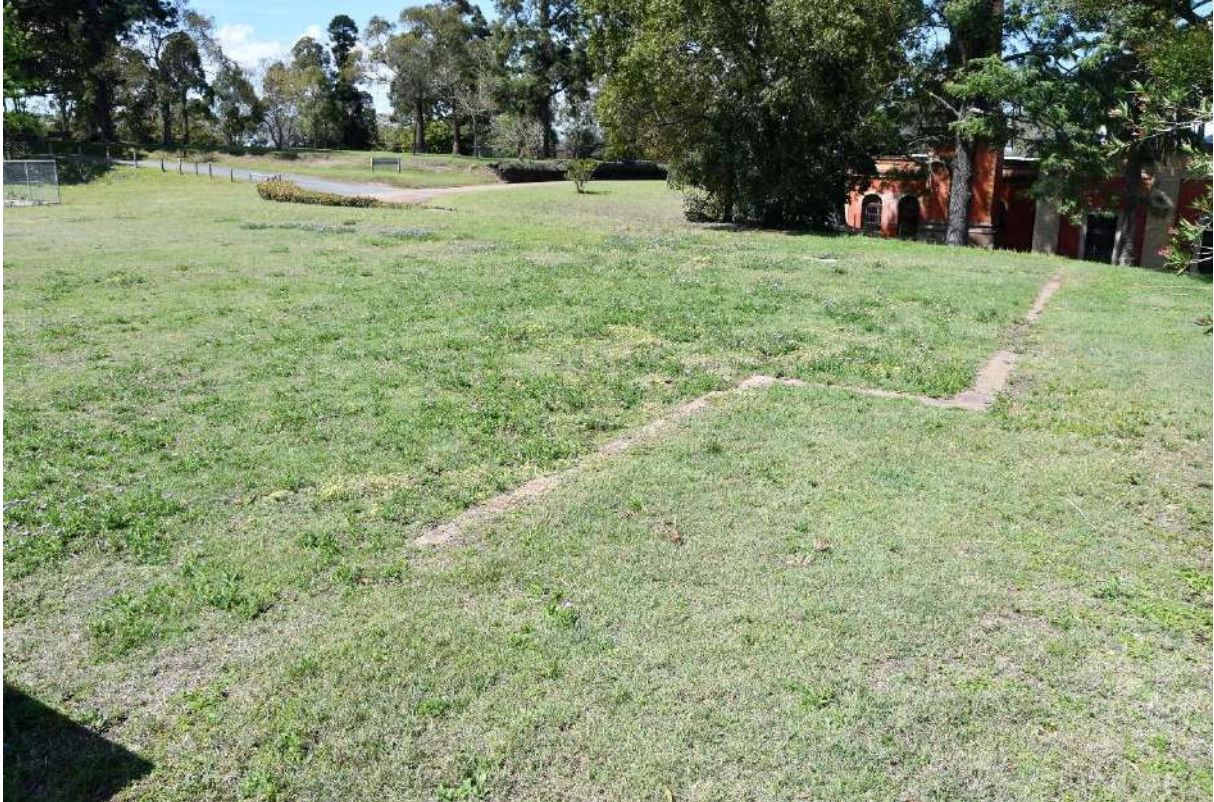
Figure 102: The southeastern corner of Filter Bed 4 (Item I-4) showing the modified footprint caused by the 1950s modifications. View to the east.

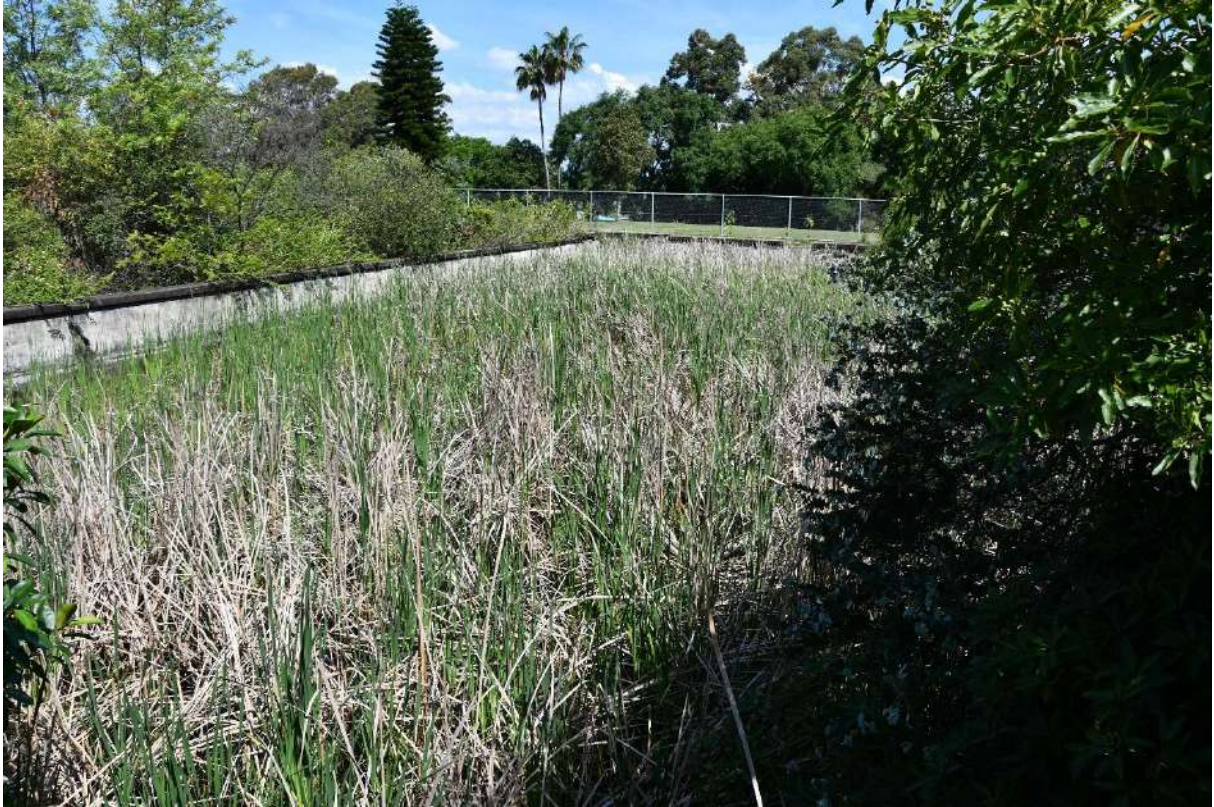
Figure 105: The central wall that divides Filter Bed 5 (Item J-5) and 6 (Item J-6). The intact concrete walls are in good condition however the beds are very overgrown.
