Geotechnical Investigation

Proposed Sports Field Development 15 Suncroft Street, Chisholm, NSW 2322

Report Ref: G0436-SCFP-001-Rev0

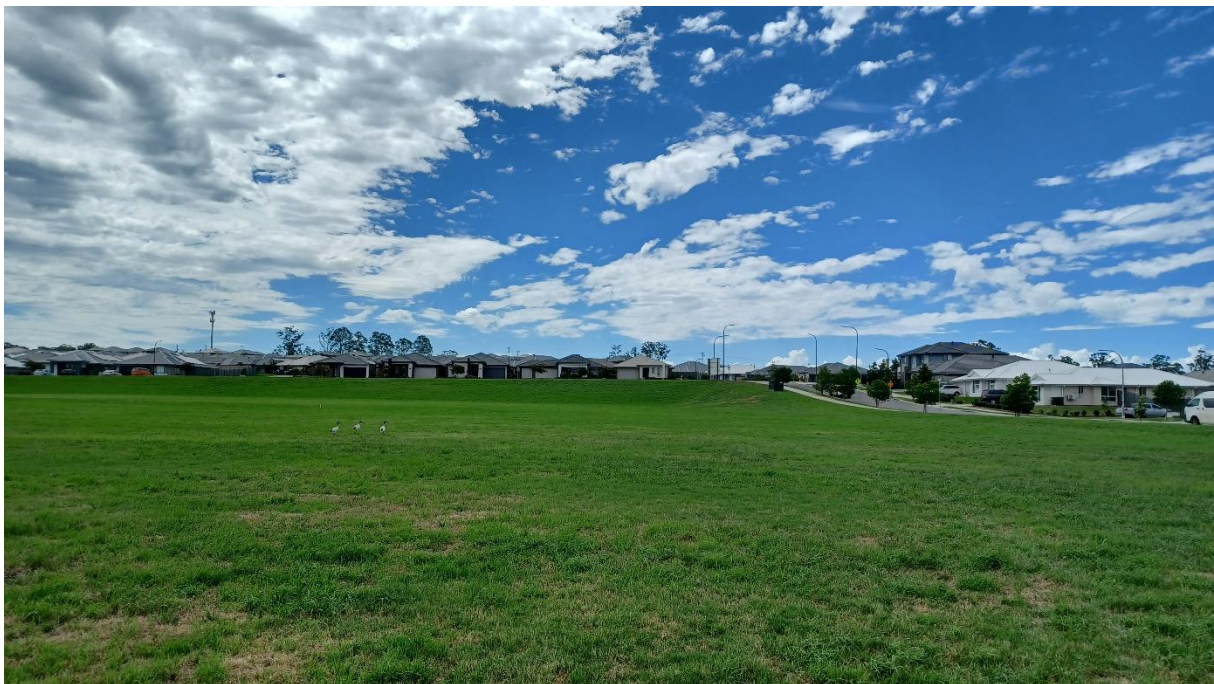
Figure 1 – An image of the site, looking north. Taken: 14 February 2024
