# Geotechnical Investigation Report

DA1 - 381 Anambah Road, Anambah NSW

Prepared for: DB20 Pty Ltd (Roche Group)  
EP3487.002 23 May 2025

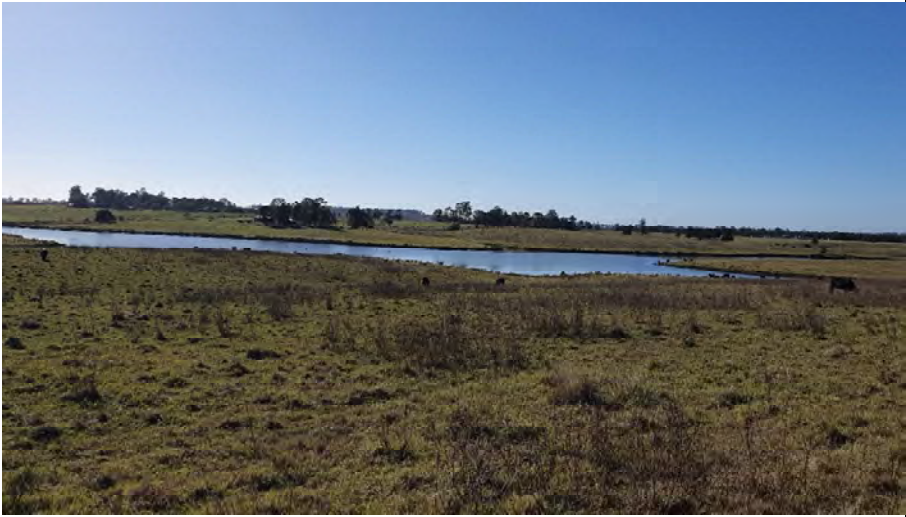
| | <p><b>Plate 1</b></p> <p><b>Description:</b><br/><b>Dam in the DA1 area</b></p> <p><b>Date: 24/01/2024</b></p> |

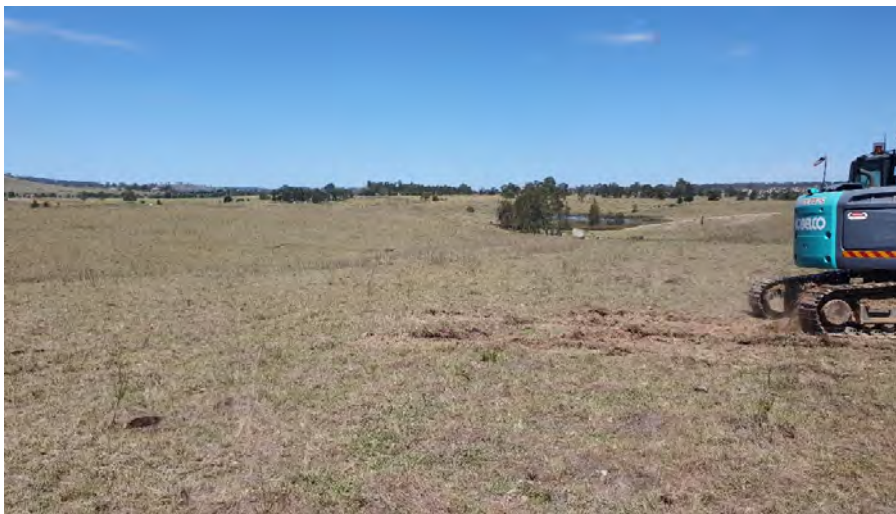
**Plate 5**

**Description:**  
Second water  
dam in DA1  
area

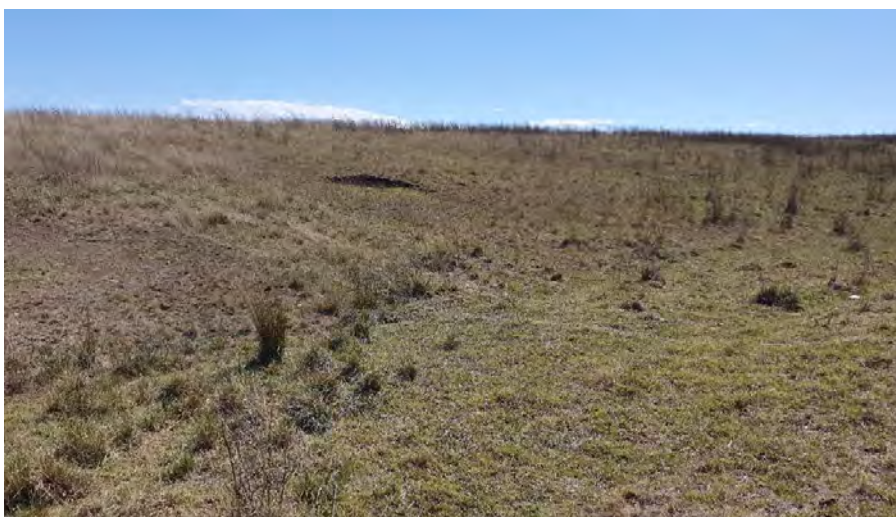
**Plate 6**

**Description:**  
Soil scarp in the  
DA1 area

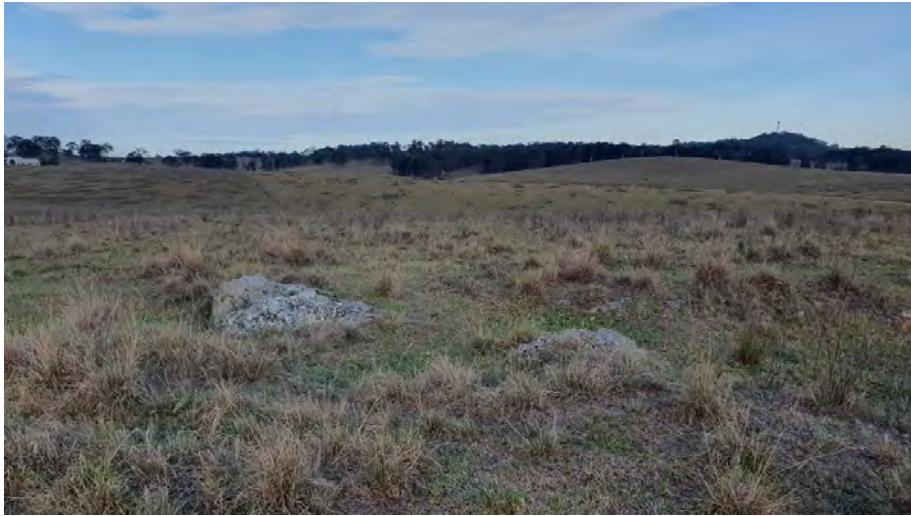
| | <p><b>Plate 9</b></p> <p><b>Description:</b><br/>Rock outcrops<br/>DA1 area</p> <p><b>Date:</b> 25/01/2024</p> |

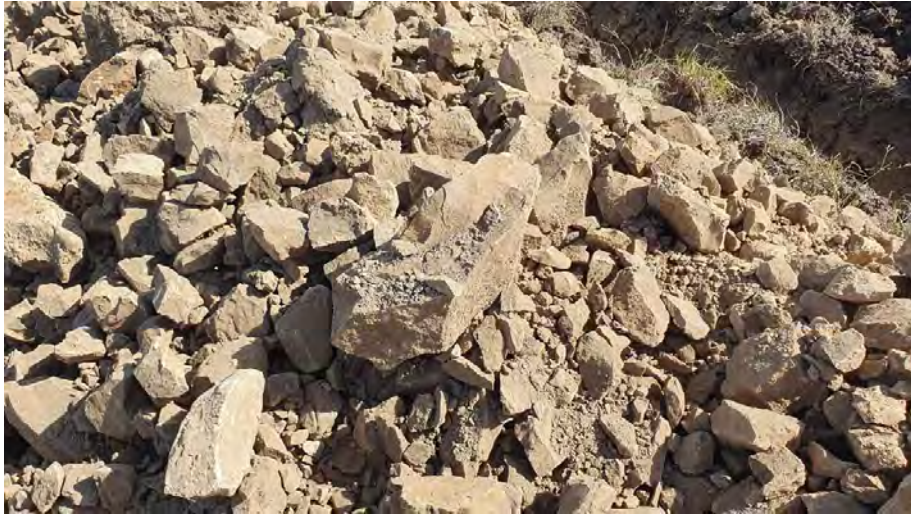
| | <p><b>Plate 10</b></p> <p><b>Description:</b><br/>Slightly<br/>weathered-<br/>fresh rock in<br/>DA1 area</p> <p><b>Date:</b> 25/01/2024</p> |
