Industrial Sheds and Rural Outbuildings

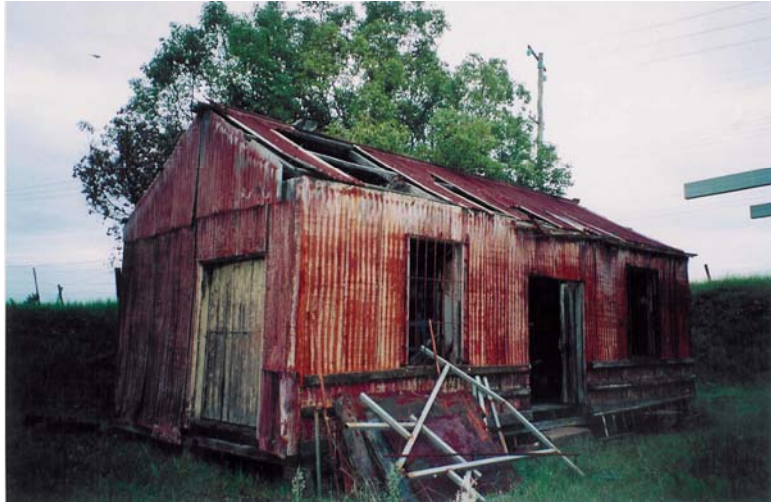
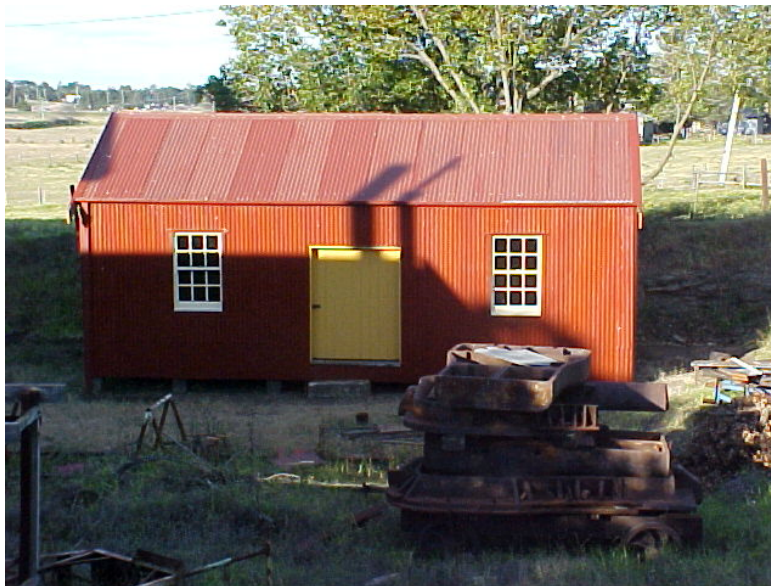
South Maitland Railways Workshop

The store building is thought to date to the first period of the workshops, however it fell into disuse and disrepair. Structural works were carried out so as to stabilise the structure, and it was reclad in materials matching those of the original structure. The stormwater system was also replaced.

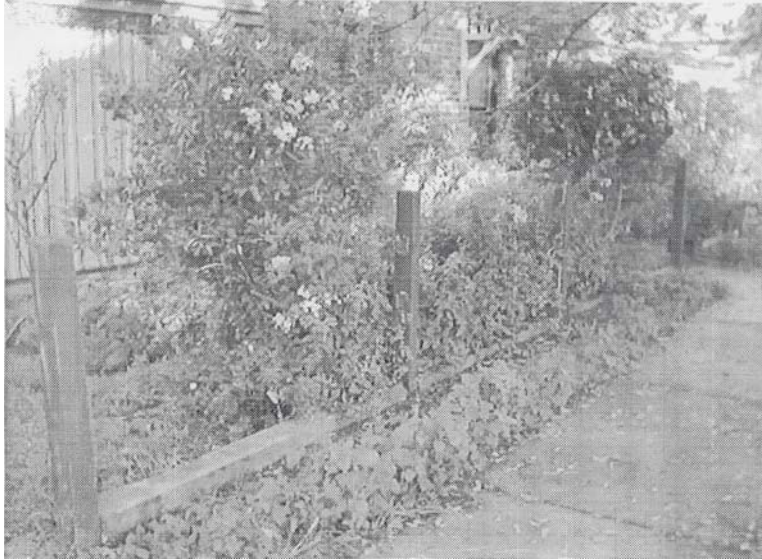
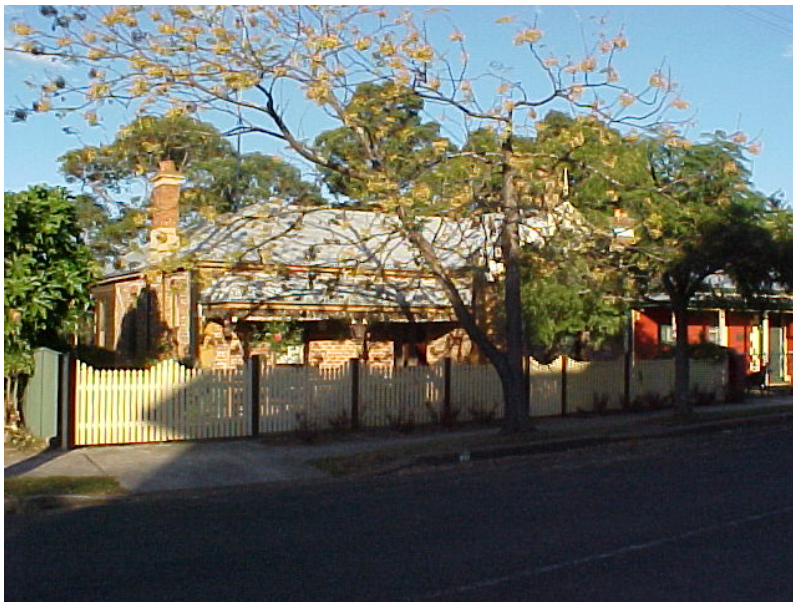
Regent Street, Maitland

The residence is a fine example of late Victorian style and the previous fencing had almost totally disappeared, although a small amount remaining provided some evidence of the original style of fencing. The fence was reconstructed to match the original form

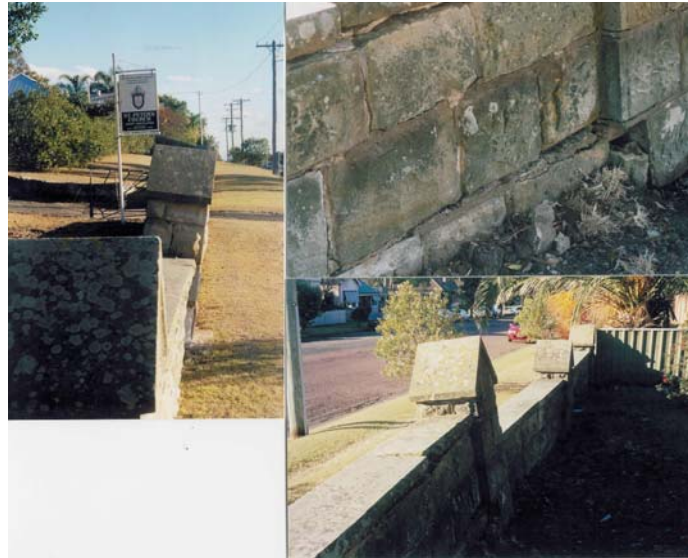
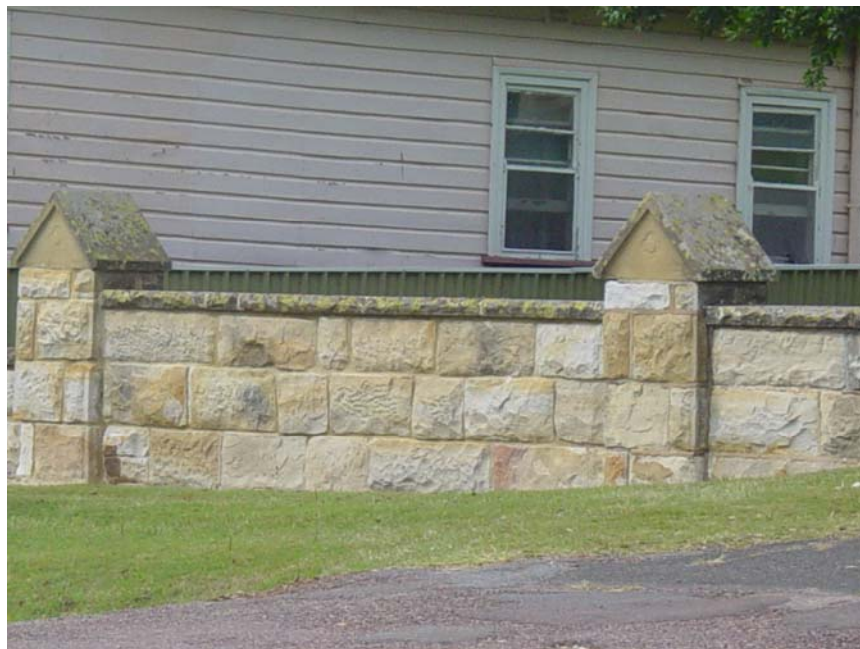
St Peters Anglican Church

Tree roots were causing the destabilisation of this masonry fence, and root barriers were required to be installed prior to the reconstruction of the fence.

Damaging cement mortar had to be cleaned from the joints which was replaced by a traditional lime based mortar.

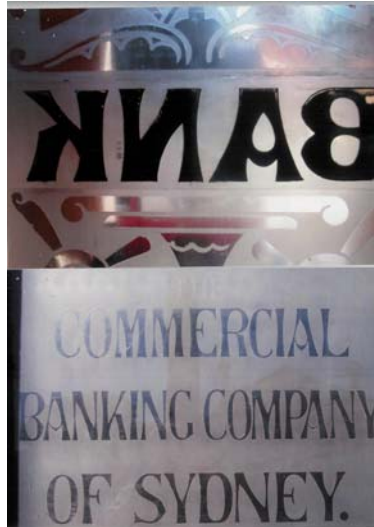
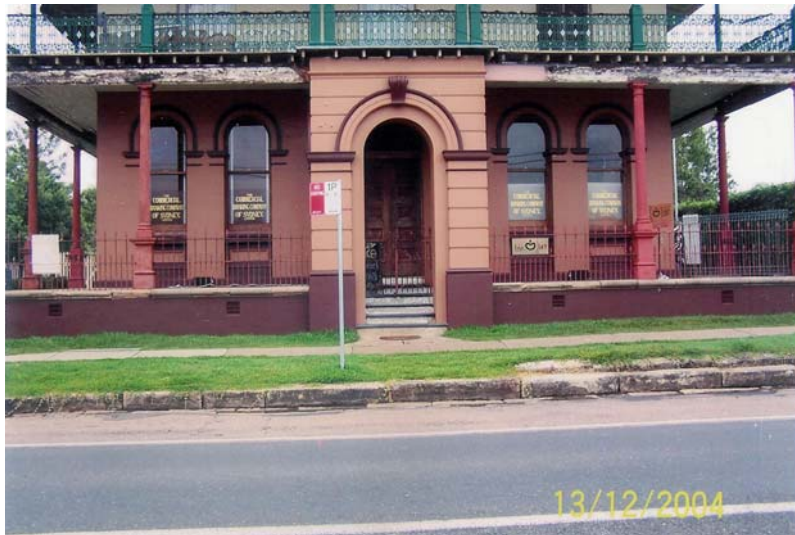
Former CBC Bank, Morpeth

The former CBC Bank in Swan Street, Morpeth is of considerable heritage value having architectural, historical and landmark significance. The crucial component of this project was ensuring traditional techniques were applied in undertaking the work. A method dating to 1899 was researched and details were provided to a tradesman who was familiar with the technique.

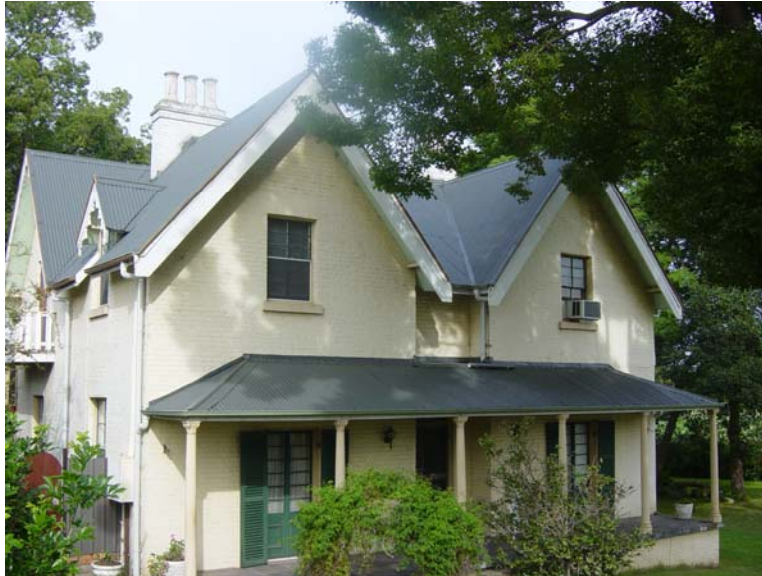
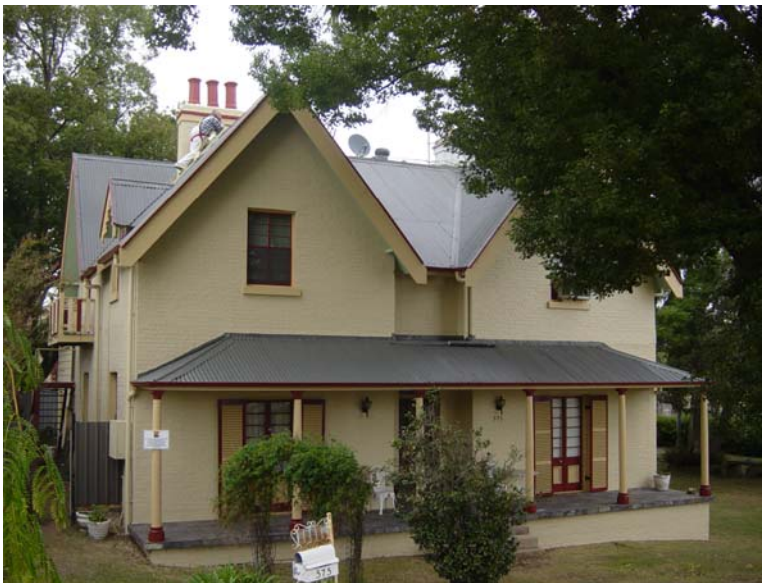
Central Maitland

This is only dwelling in Maitland of the Victorian Gothic style, and which was designed by WH Pender. The original roof was slate, which has been replaced with galvonised iron. The roof was coloured green prior to this project which has used a slate grey colour.

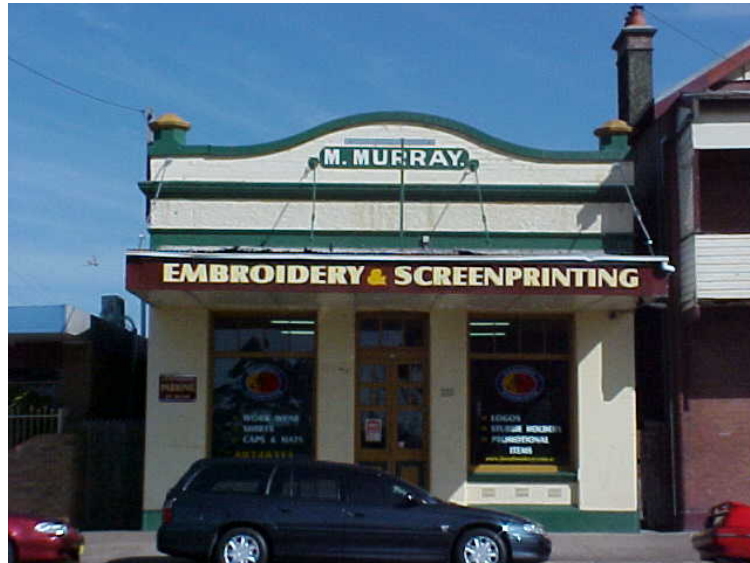
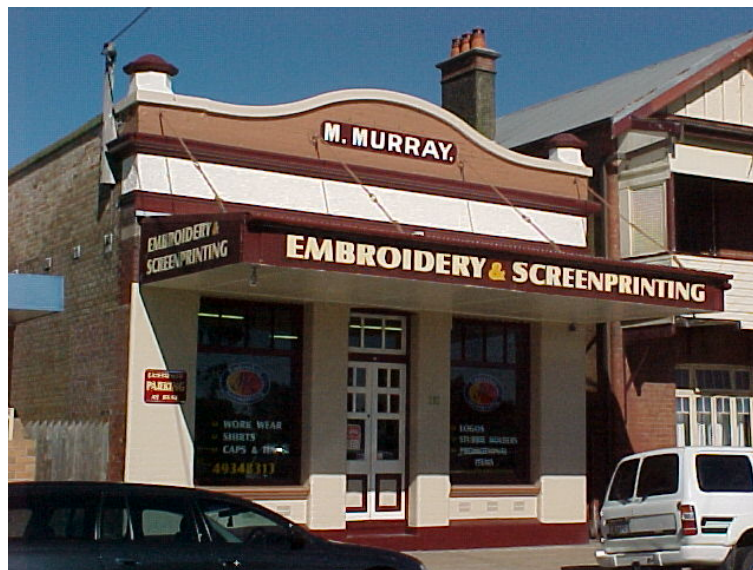
The repainting of commercial premises within Conservation Areas such as this site in High Street, Maitland are generally given a high priority in the funding rounds given their high profile and high impact locations.

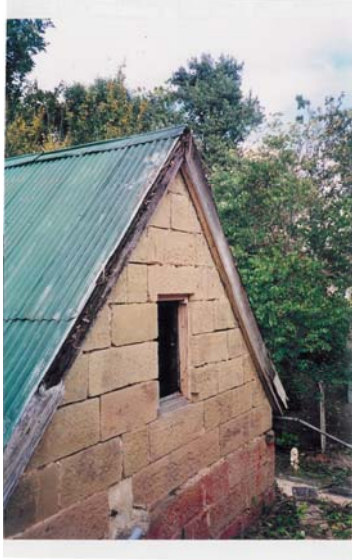
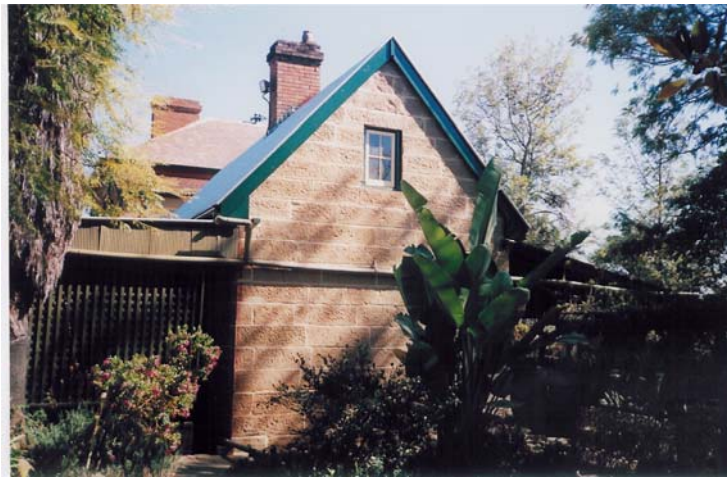
Lochinvar

This building dates to 1840, being the original home of Joseph Clift an early land holder in the Maitland region. The subject cottage served as the original residence on the site until the residence 'Clifton' was built in approximately 1849. While the structure was generally sound, the roof timbers had been damaged by white ants, and the iron roofing had failed causing rain entry. Fabric conservation work including repointing, carpentry repairs and reroofing was required.
