Contamination Assessment

Wyndella Road,
Lochinvar, NSW

NEW22P-0012-AA.rev1
22 February 2023

Document Control					
Report Title		Detailed Contamination Assessment			
Document ID		NEW22P-0012-AA			
Project		Contamination Assessment Wyndella Road, Lochinvar, NSW			
Rev	Date	Revision details/status	Prepared by	Author	Reviewer
0	25 November 2022	Original	Qualtest	L.Betz	L.Fox
1	22 February 2023	Rev 1 – Update Section 11 and Figures only	Qualtest	L.Betz	-

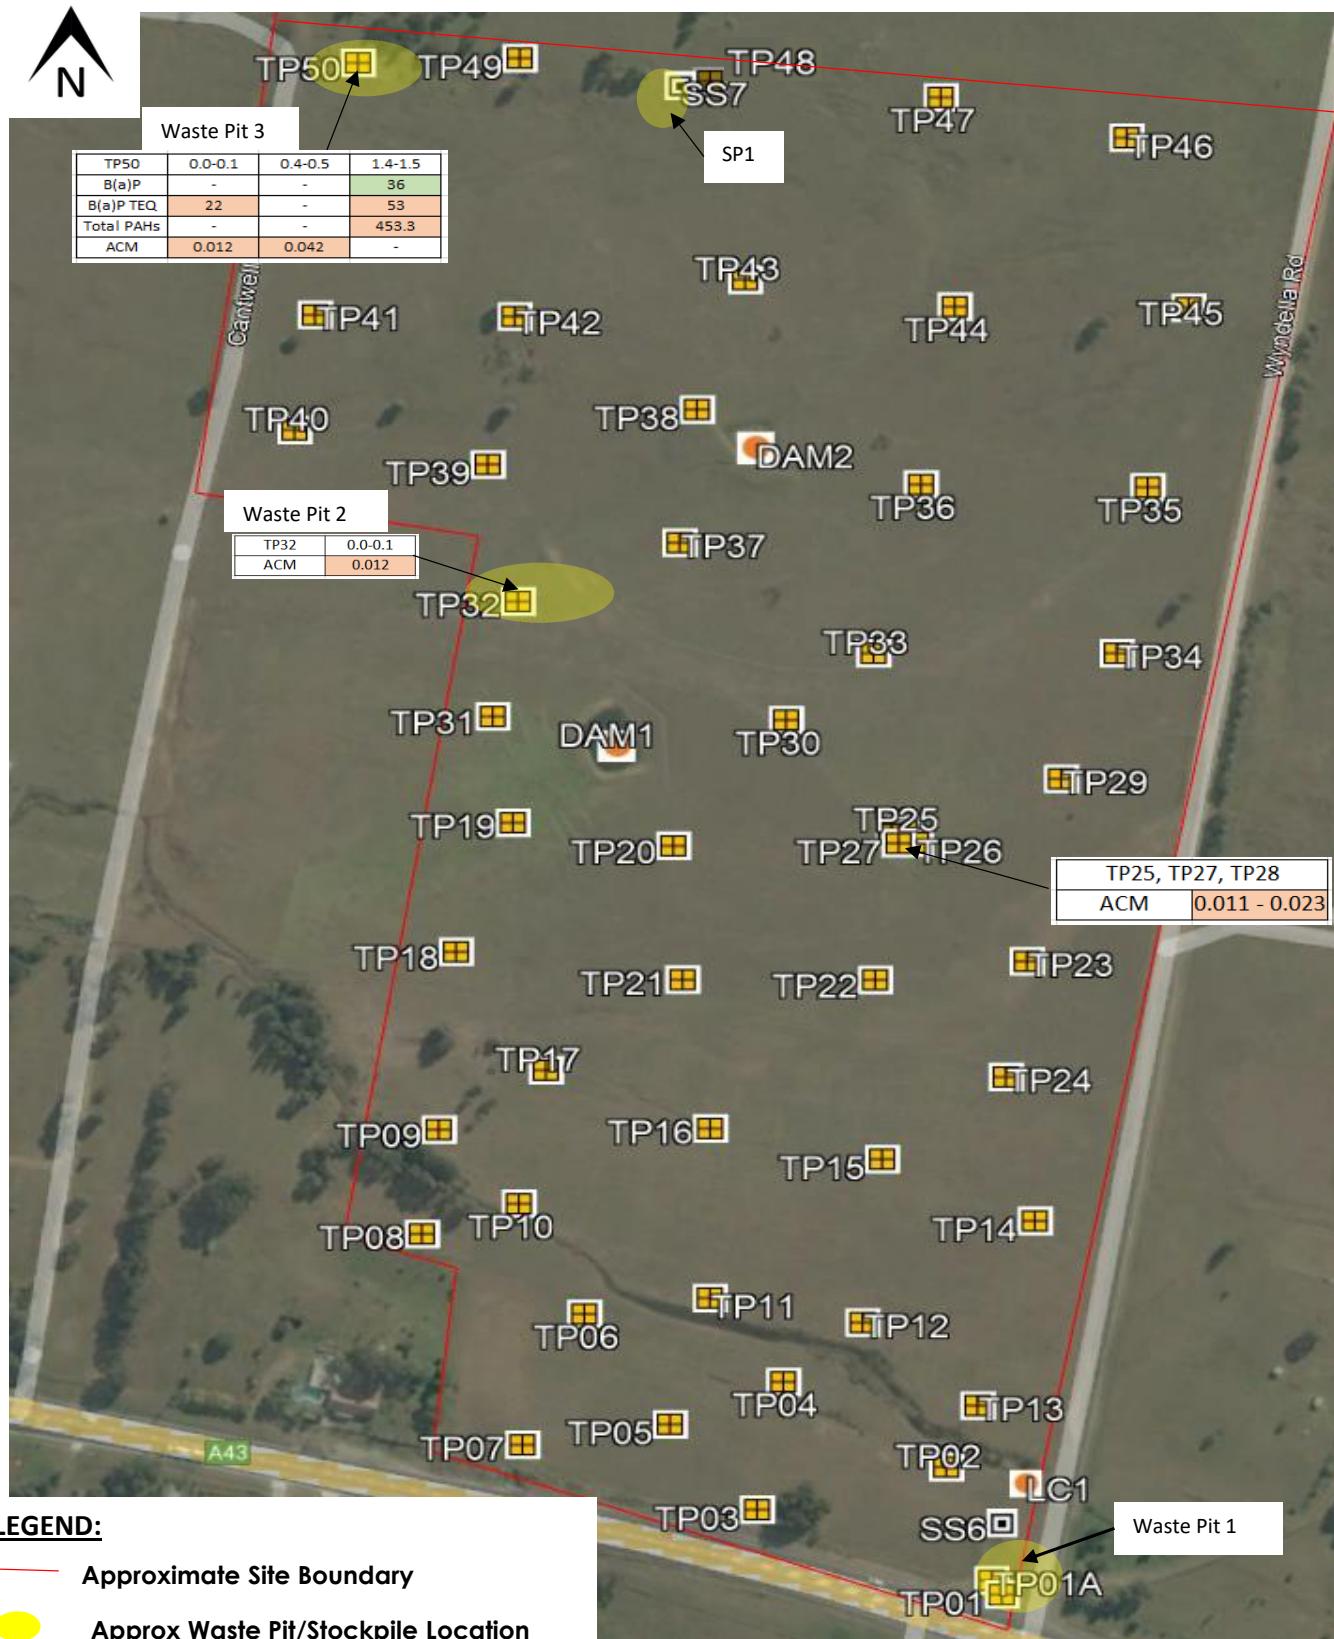
Qualtest LABORATORY (NSW) PTY LTD	Client: LOCHINVAR DEVELOPMENTS PTY LTD	Drawing No: FIGURE 3C
Project:	CONTAMINATION ASSESSMENT	Project No: NEW22P-0012-AA
Location:	898 NEW ENGLAND HIGHWAY, LOCHINVAR	Scale: AS SHOWN
Title:	SAMPLING EXCEEDANCE PLAN	Date: 22/02/2023

- ACM above human health criteria and zinc above ecological criteria in surface soils surrounding the barn in the south eastern portion of the site;
- ACM above the adopted human health criteria in Waste Pit 2 and ACM and PAHs above human health and ecological criteria in Waste Pit 3; and
- Anthropogenic materials observed in Waste Pit 1 to Waste Pit 3 and Stockpile 1 will also require removal/management for aesthetic reasons.

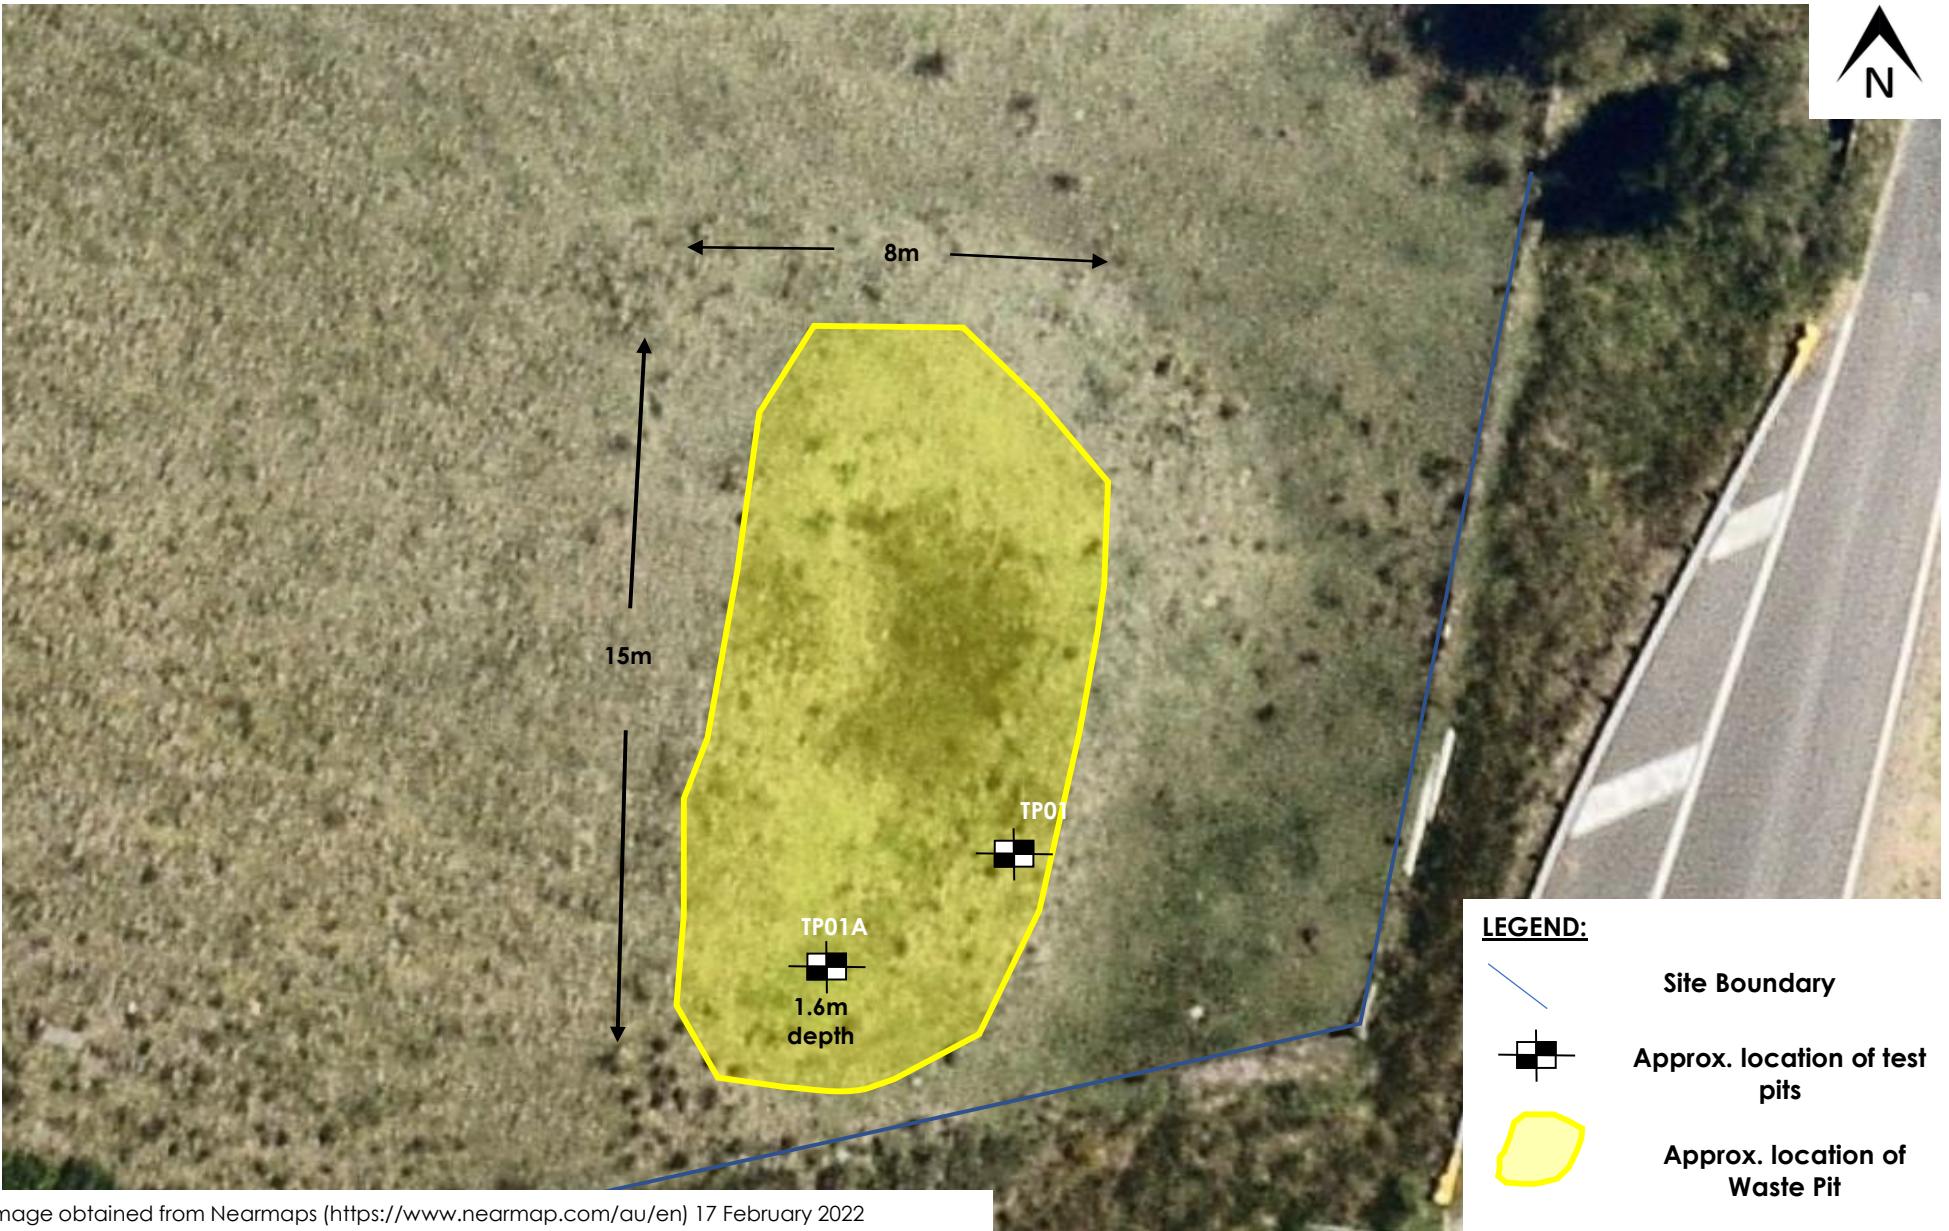
Client:	LOCHINVAR DEVELOPMENTS PTY LTD	Drawing No:	FIGURE 4A
Project:	DUE DILIGENCE ASSESSMENT	Project No:	NEW22P-0012-AA
Location:	898 NEW ENGLAND HIGHWAY, LOCHINVAR	Scale:	N.T.S.
Title:	WASTE PIT 1 - TP01/TP01A	Date:	17/02/2022

Location	Estimated Volume (m³)*	Description	Identified Contamination above HILs/HSLs/ESLs/EILs	Preliminary Waste Classification
Waste Pit 1 (TP01/ TP01A)	190	Fill: Gravelly Clay/Sandy Clay, brown to dark brown and grey/brown with some orange/brown. Anthropogenic materials included concrete, bricks, terracotta pipe, wood and asbestos containing material (ACM).	Soil sample results were reported below adopted criteria. Due to the volume of material observed, additional sampling of Waste Pit 1 is recommended. Anthropogenic material will require removal/management for aesthetic reasons.	GSW – Special Waste Asbestos
Waste Pit 2 (TP32)	90	Fill: Sandy Gravelly Clay, dark brown. Anthropogenic materials included steel, concrete, bricks, plastic and ACM.	ACM was detected above the adopted HIL criteria and will require remediation/management. Due to the volume of material observed, additional sampling of Waste Pit 2 is also recommended. Anthropogenic material will require removal/ management for aesthetic reasons.	GSW – Special Waste Asbestos

- Due to the volume of material observed in the waste pits, and the low sampling density additional soil sampling for the waste pits is recommended. This additional assessment can be included in the Remediation Action Plan for the site (see bullet point below).
- Preparation of a Remediation Action Plan (RAP) will be required to outline the remediation for the soil contamination identified.
- Preparation of a Contaminated Land Management Plan for use during earthworks and construction of the development, which will include:
 - Guidance to the workers on identifying potentially contaminating materials such as slag impacted soil, asbestos containing material and,
 - Unexpected Finds Procedure (UFP); and
 - Procedures for handling, management and disposal/re-use of contaminated soil and surface water, if encountered.

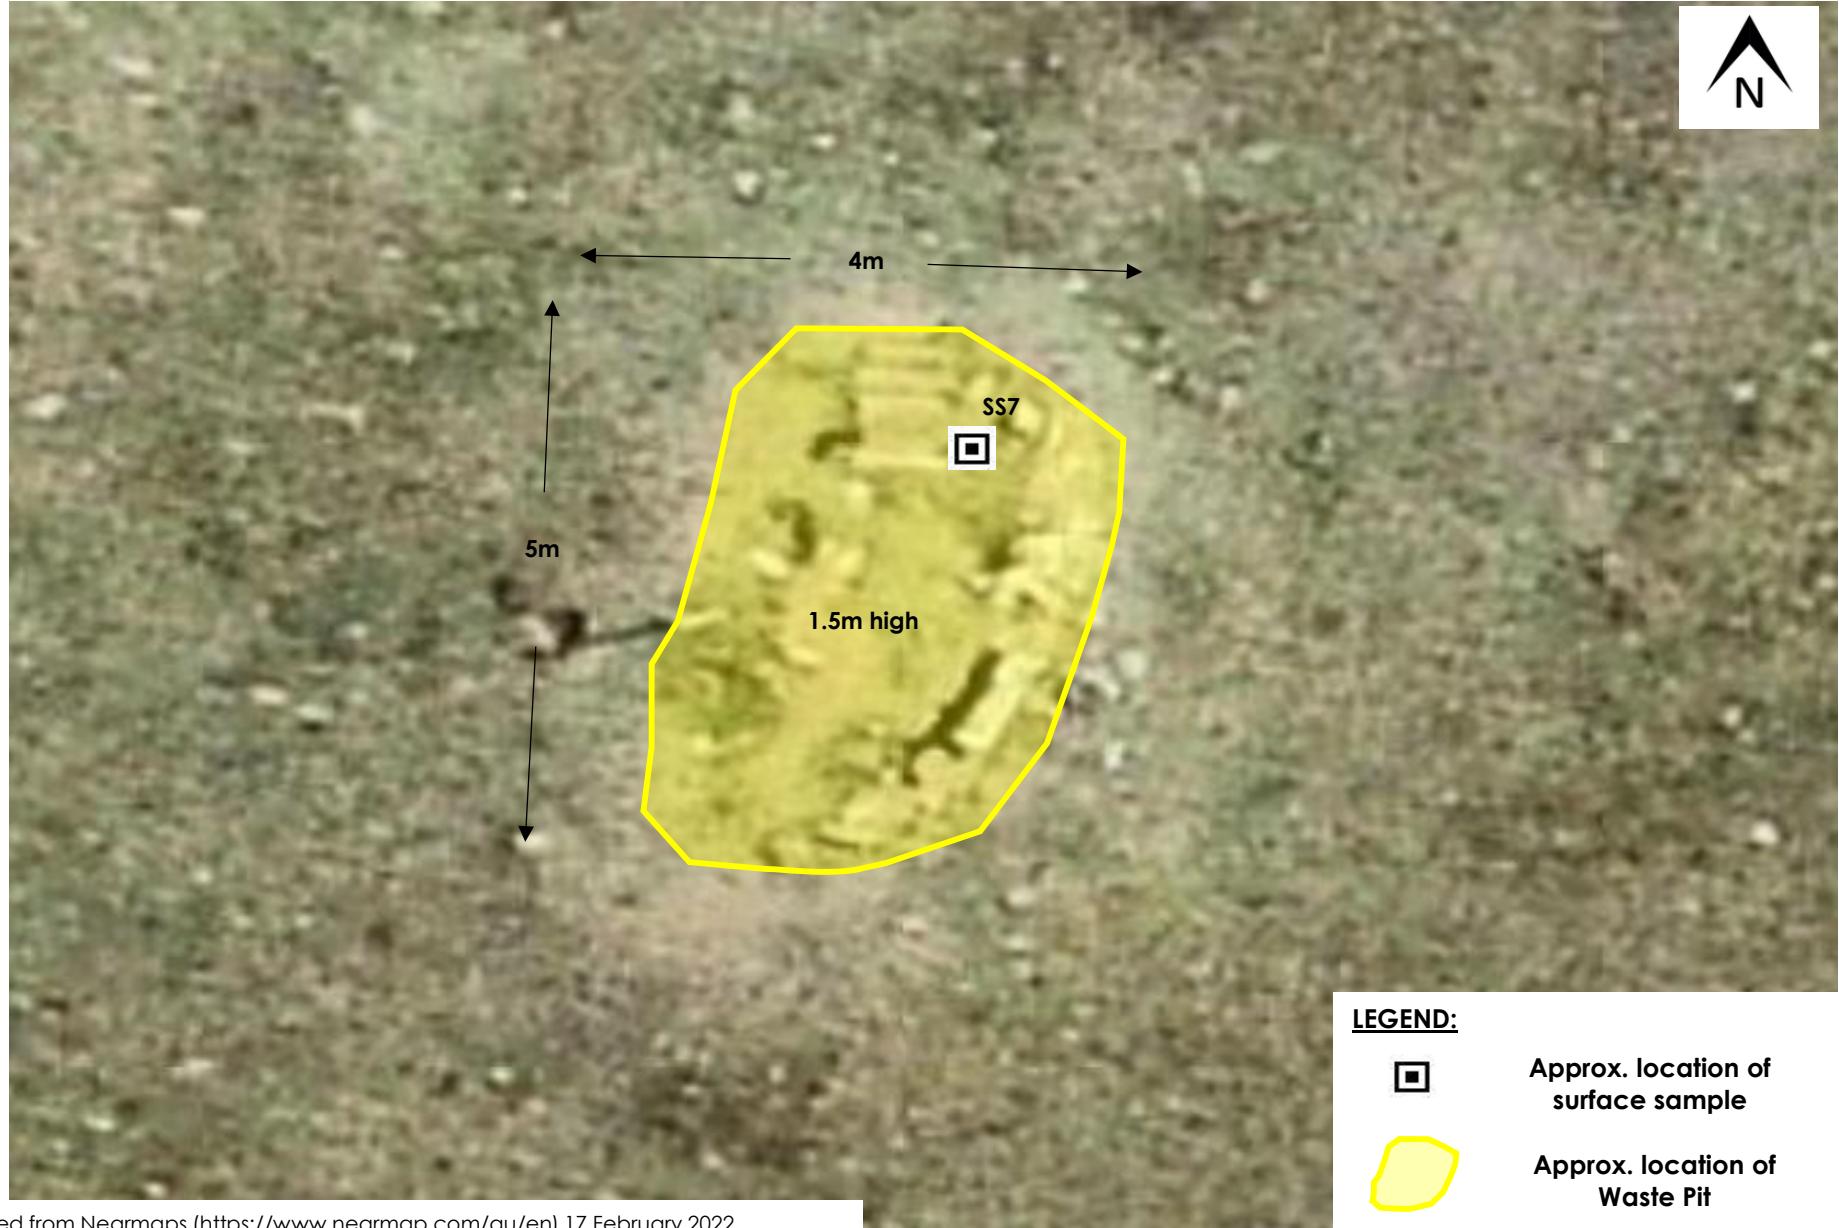
Client:	LOCHINVAR DEVELOPMENTS PTY LTD	Drawing No:	FIGURE 4C
Project:	DUE DILIGENCE ASSESSMENT	Project No:	NEW22P-0012-AA
Location:	898 NEW ENGLAND HIGHWAY, LOCHINVAR	Scale:	N.T.S.
Title:	STOCKPILE 1	Date:	17/02/2022

- A stockpile (SP1) about 30m³ containing some concrete stairs, large concrete blocks and concrete bricks was observed in the northern portion of the site and area of potential fill was also observed to the west of SP1 (see photograph 5).

Location	Estimated Volume (m ³)*	Description	Identified Contamination above HILs/HSLs/ESLs/EILs	Preliminary Waste Classification
			<p>ACM was detected above the adopted HIL Criteria.</p> <p>Due to the volume of material observed, additional sampling of Waste Pit 3 is also recommended.</p> <p>Anthropogenic material will require removal/ management for aesthetic reasons.</p>	<p>sampling carried out to try and reduce the classification to RSW</p>
stockpile 1 (SS7)	30	The waste material in Stockpile 1 was mostly concrete. No ACM was observed on the surface of the stockpile.	Anthropogenic material will require removal/ management for aesthetic reasons.	Preclassifies as GSW. Concrete may be able to go to recycler.

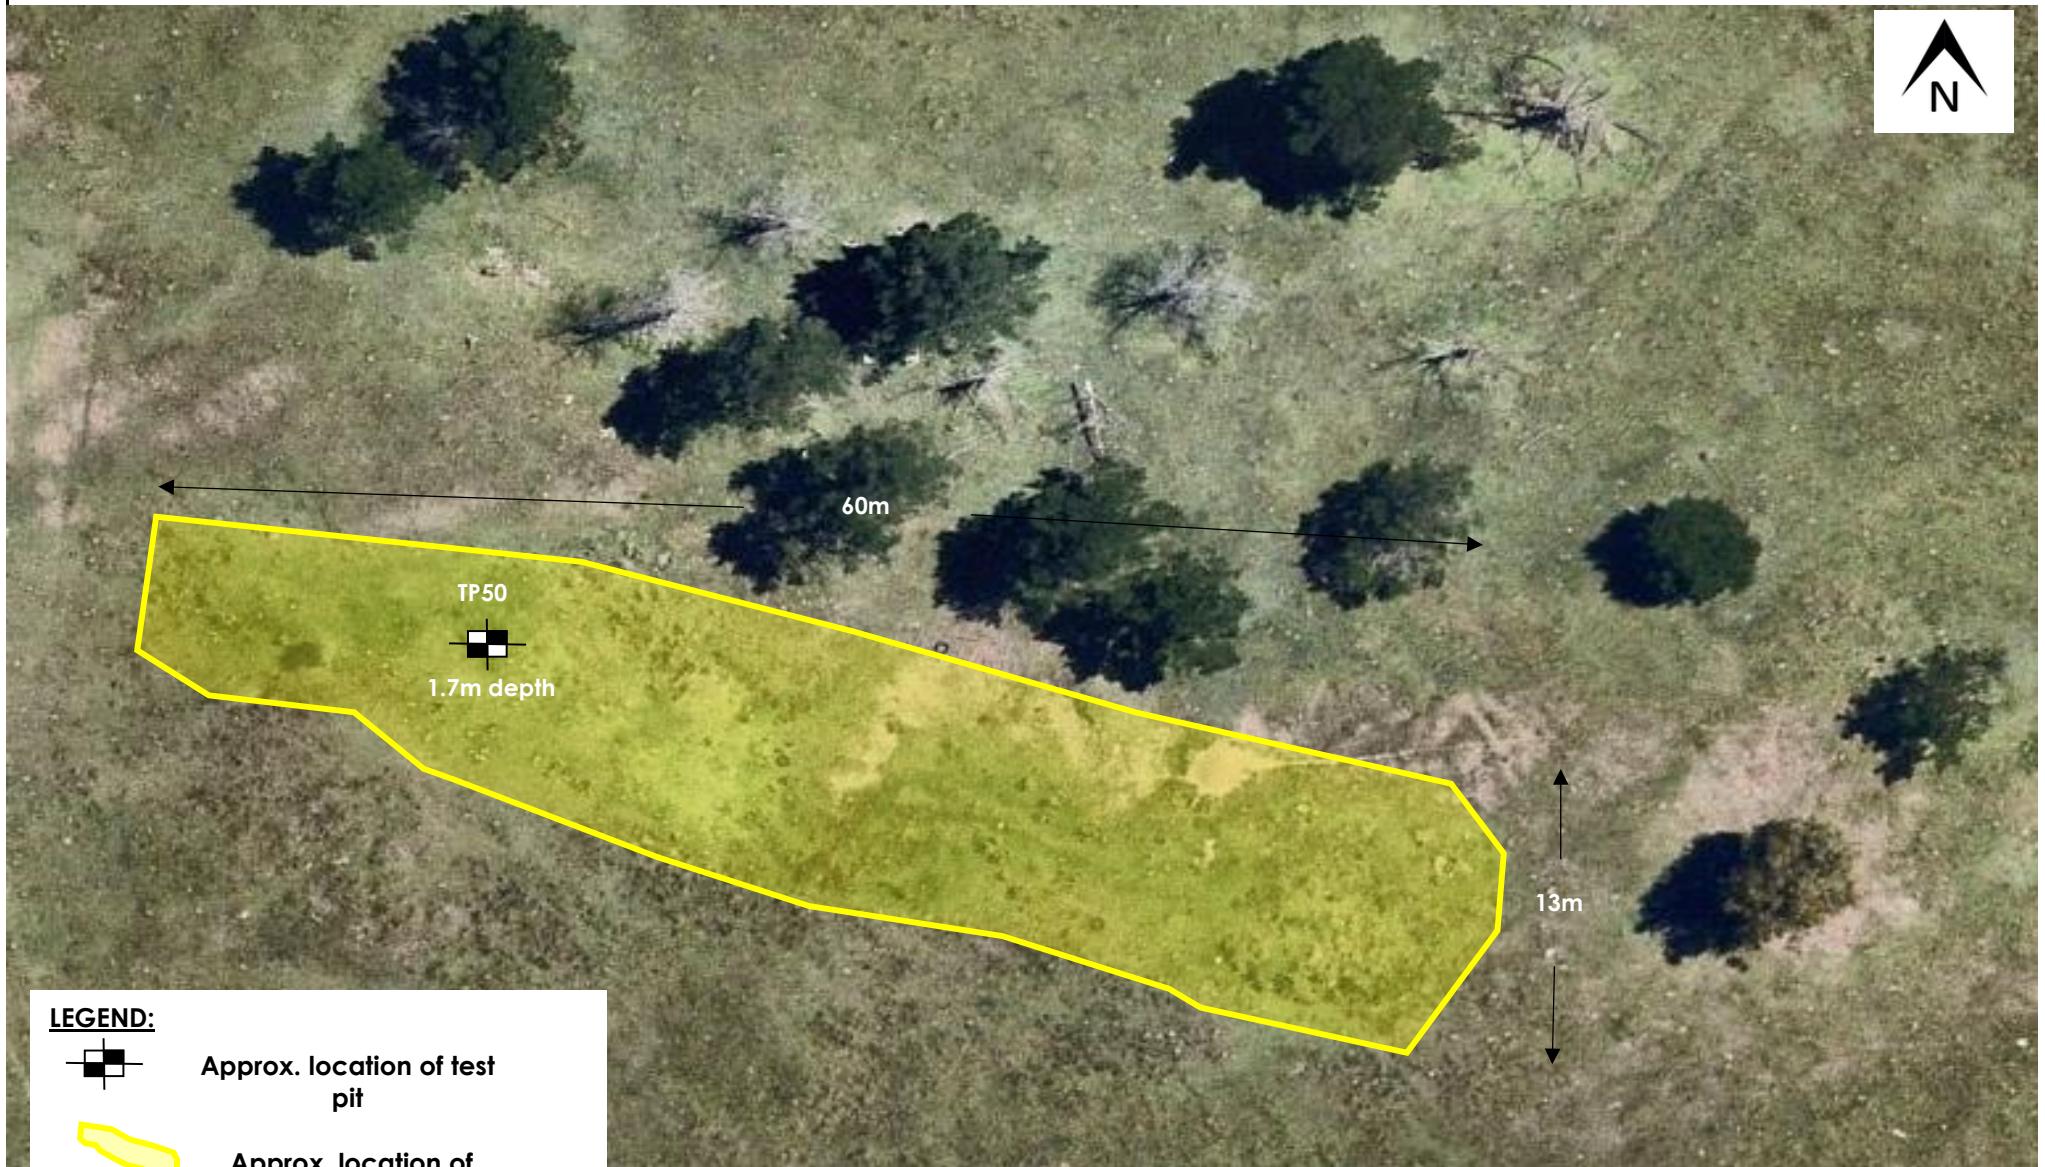
Client:	LOCHINVAR DEVELOPMENTS PTY LTD	Drawing No:	FIGURE 4D
Project:	DUE DILIGENCE ASSESSMENT	Project No:	NEW22P-0012-AA
Location:	898 NEW ENGLAND HIGHWAY, LOCHINVAR	Scale:	N.T.S.
Title:	WASTE PIT 3 - TP50	Date:	17/02/2022

Waste pit 3 (TP50)	1170	Fill: Sandy Gravelly Clay, dark, grey/brown. Anthropogenic materials included steel, concrete, bricks, asphalt, plastic and ACM.	Concentrations of benzo(a)pyrene, benzo(a)pyrene TEQ and total PAHs were reported above the adopted EIL and/or HIL criteria and will require remediation/management.	Currently classifies as Hazardous Waste – Special Waste Asbestos. It is recommended that leachability and additional

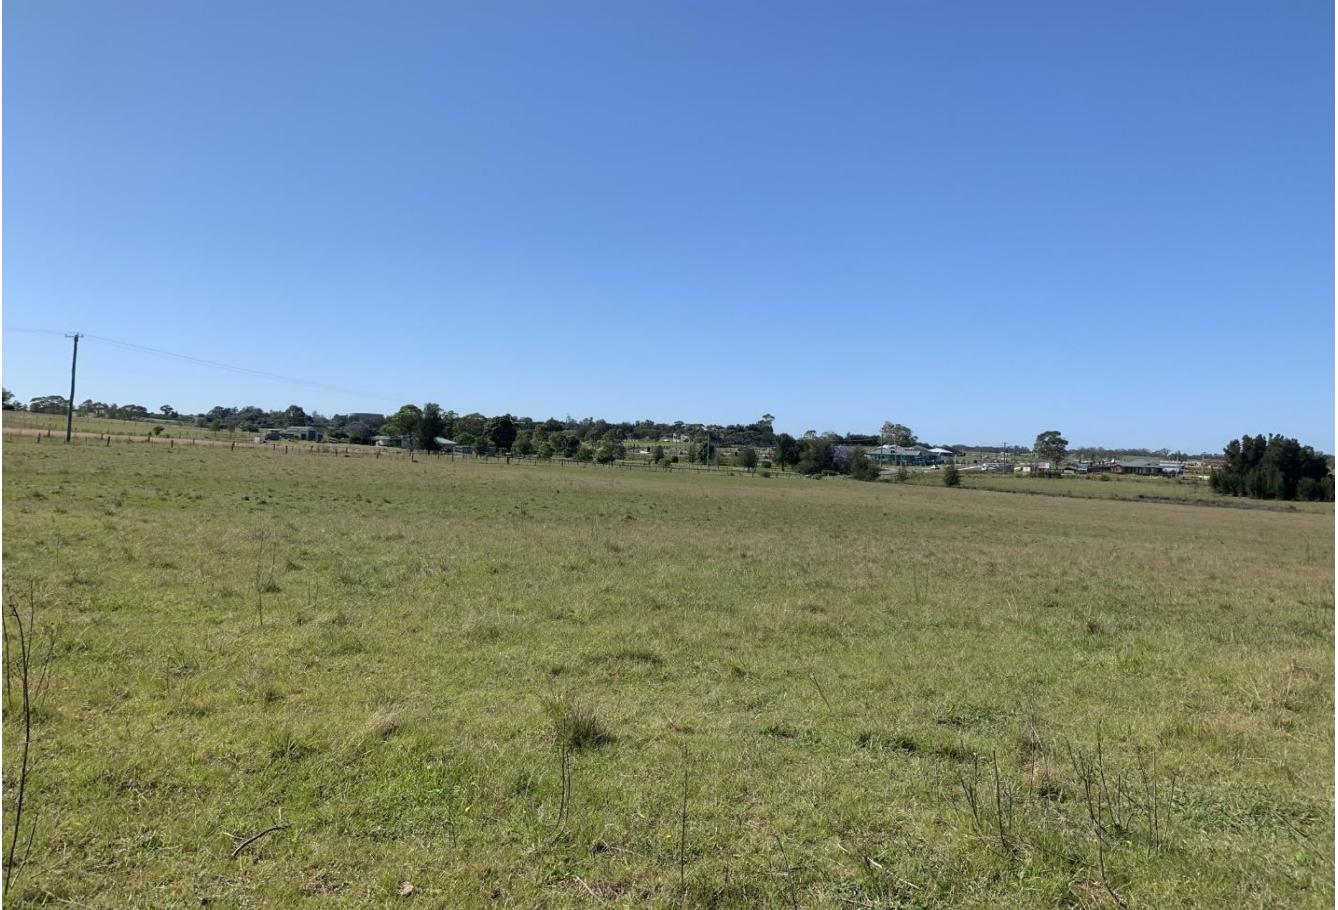
- The site consisted of mostly cleared grassland, with land used for stock (cattle) grazing. Several small to medium sized trees were observed in the northern portion (see photograph 1).

Photograph 1 - Showing general site conditions, facing south, from the northern portion of the site.

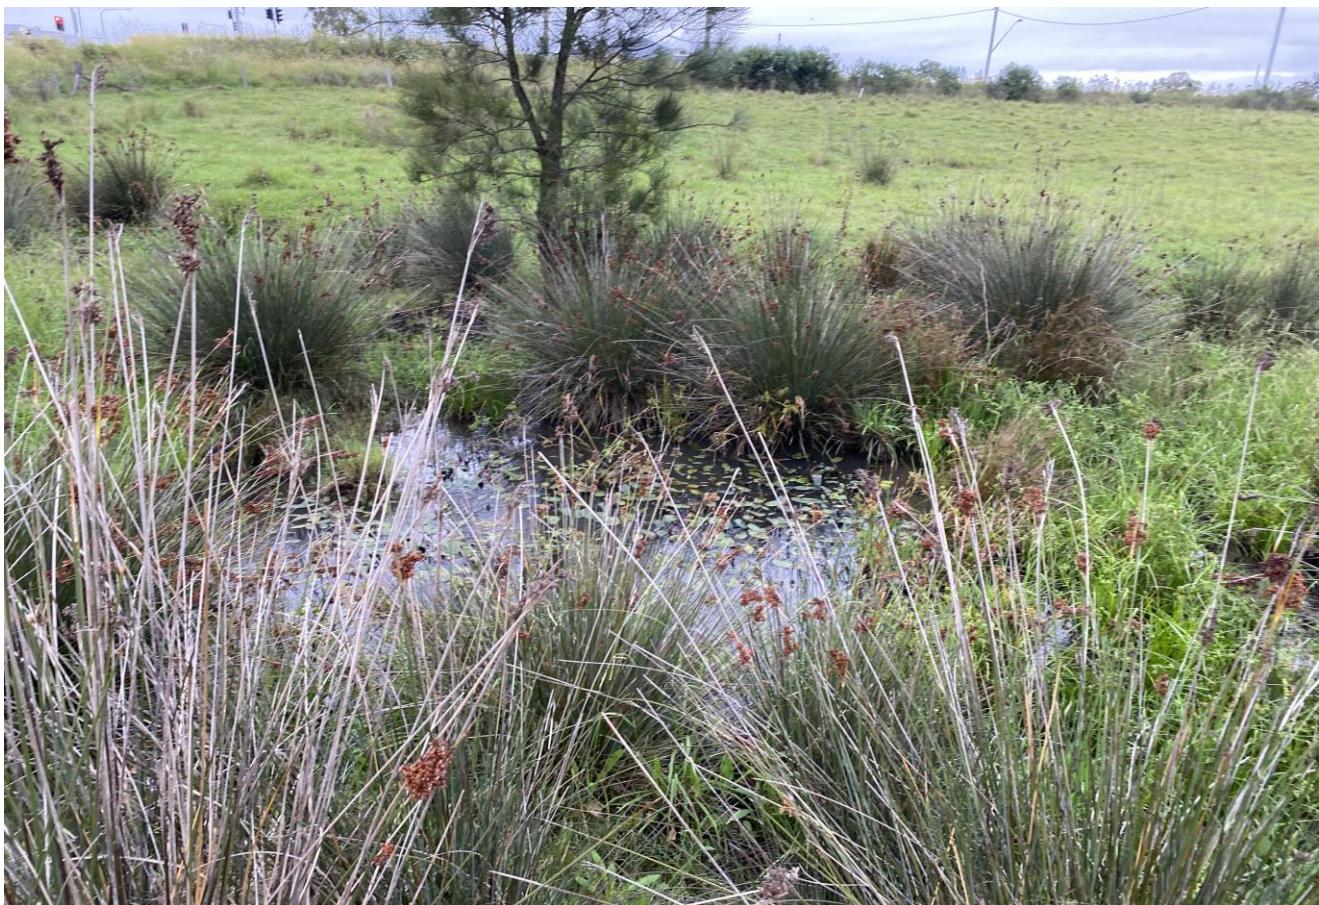
- Lochinvar Creek was observed running in an approximate east-west direction in the southern portion of the site. Lochinvar Creek was observed to be well vegetated. Water within Lochinvar Creek was observed to be mostly stagnant (see photographs 2 and 3).

Photograph 2 - Showing Lochinvar Creek, located in the south-eastern corner of the site.

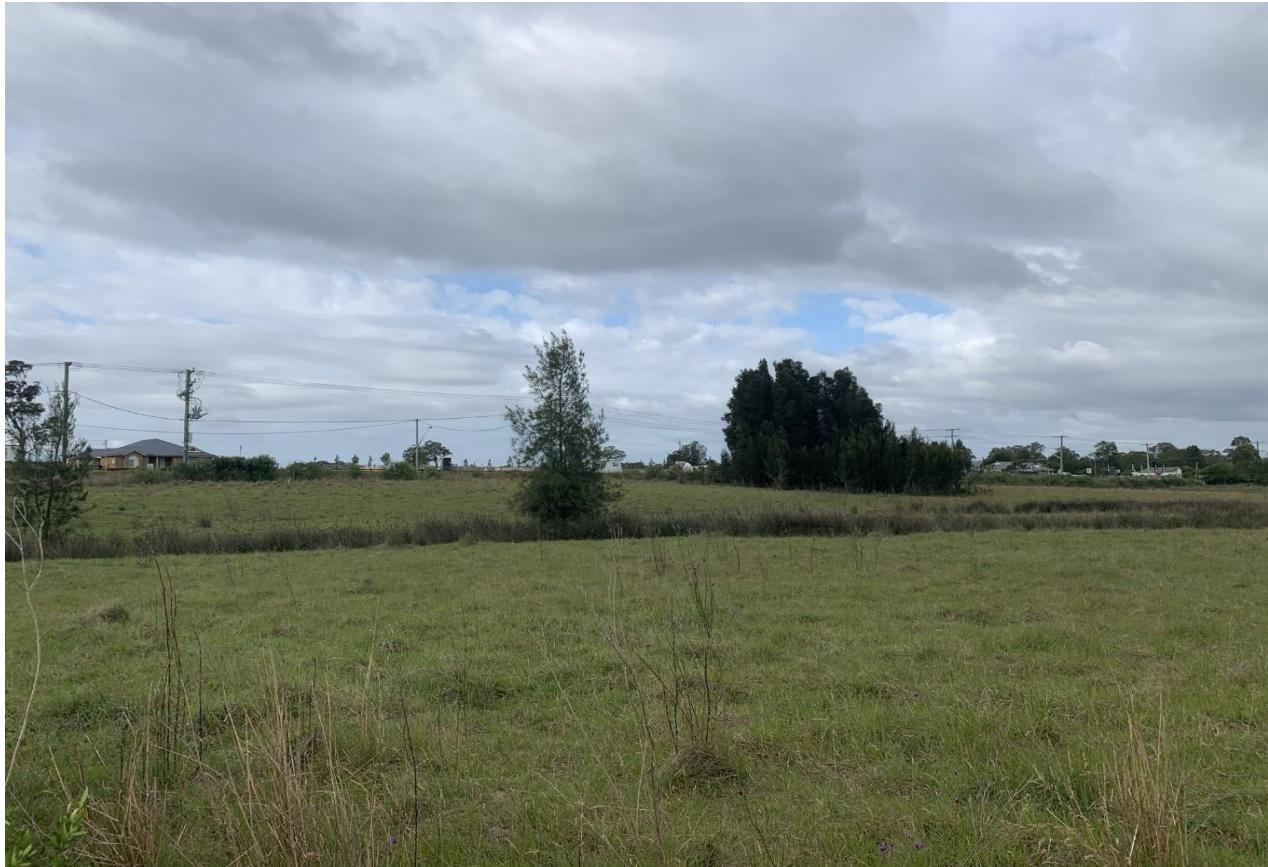
Photograph 3 - Showing Lochinvar Creek in southern portion of site.

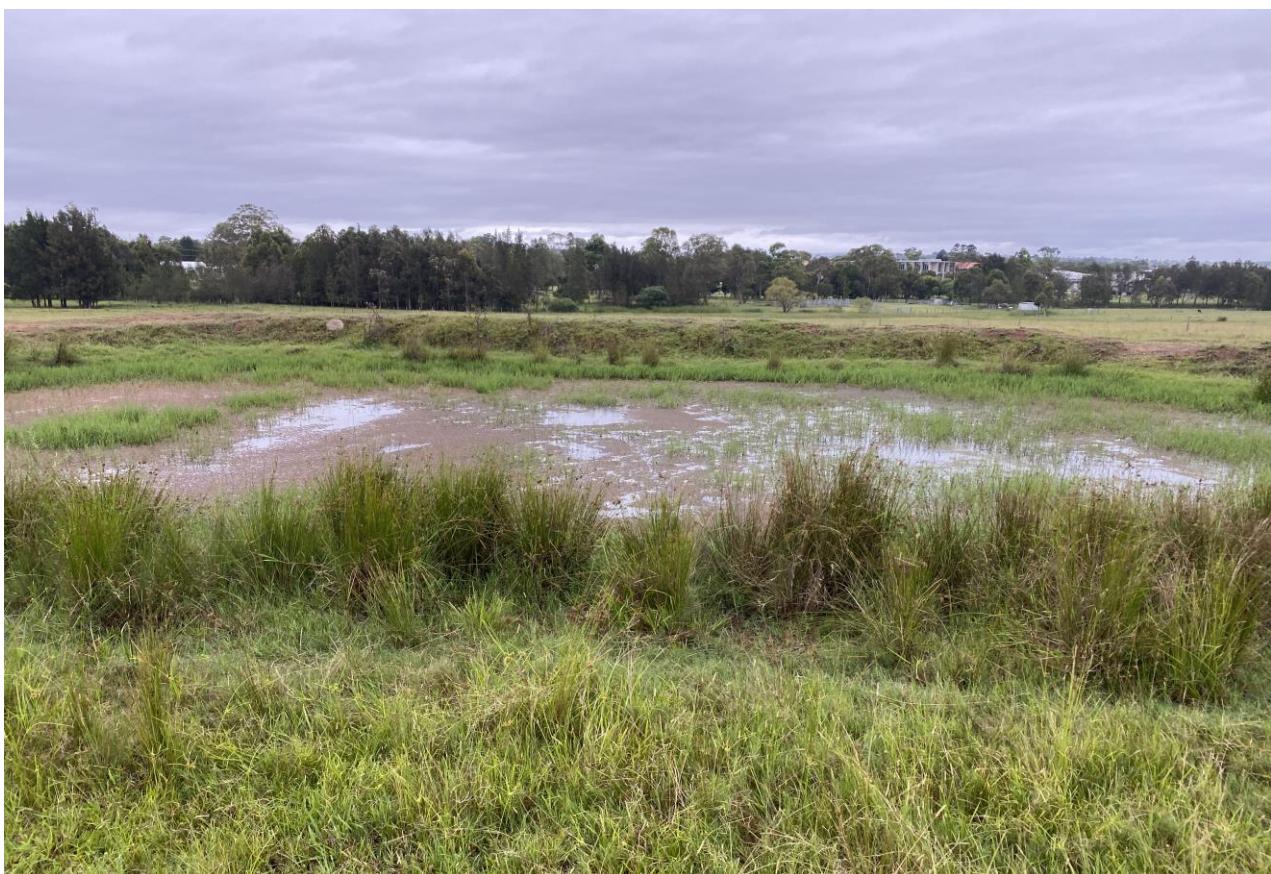
- Two dams were observed in the northern/central portion of the site. The dam walls were observed to have been constructed of fill materials, most likely sourced from the dam during excavation. Trace amounts of concrete was observed at the surface of the fill. Several black poly pipes were observed coming from the dam walls. The dams water overflows would be expected to drain to the south (see photograph 4).

Photograph 4 - Showing Dam located in the central northern portion of the site

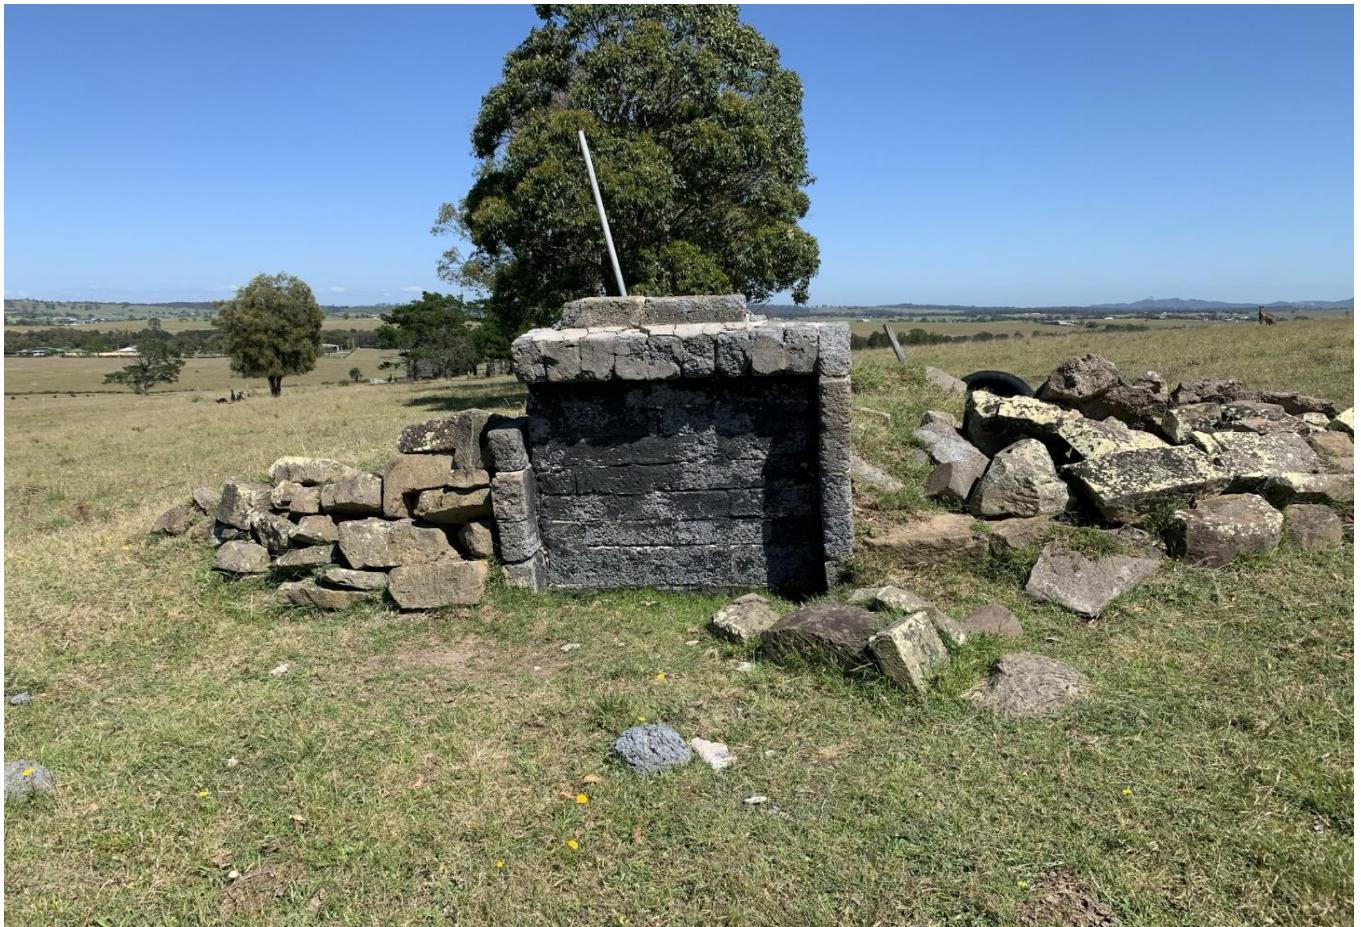
Photograph 5 - Showing Stockpile (SP1) of house rubble in central portion of site.

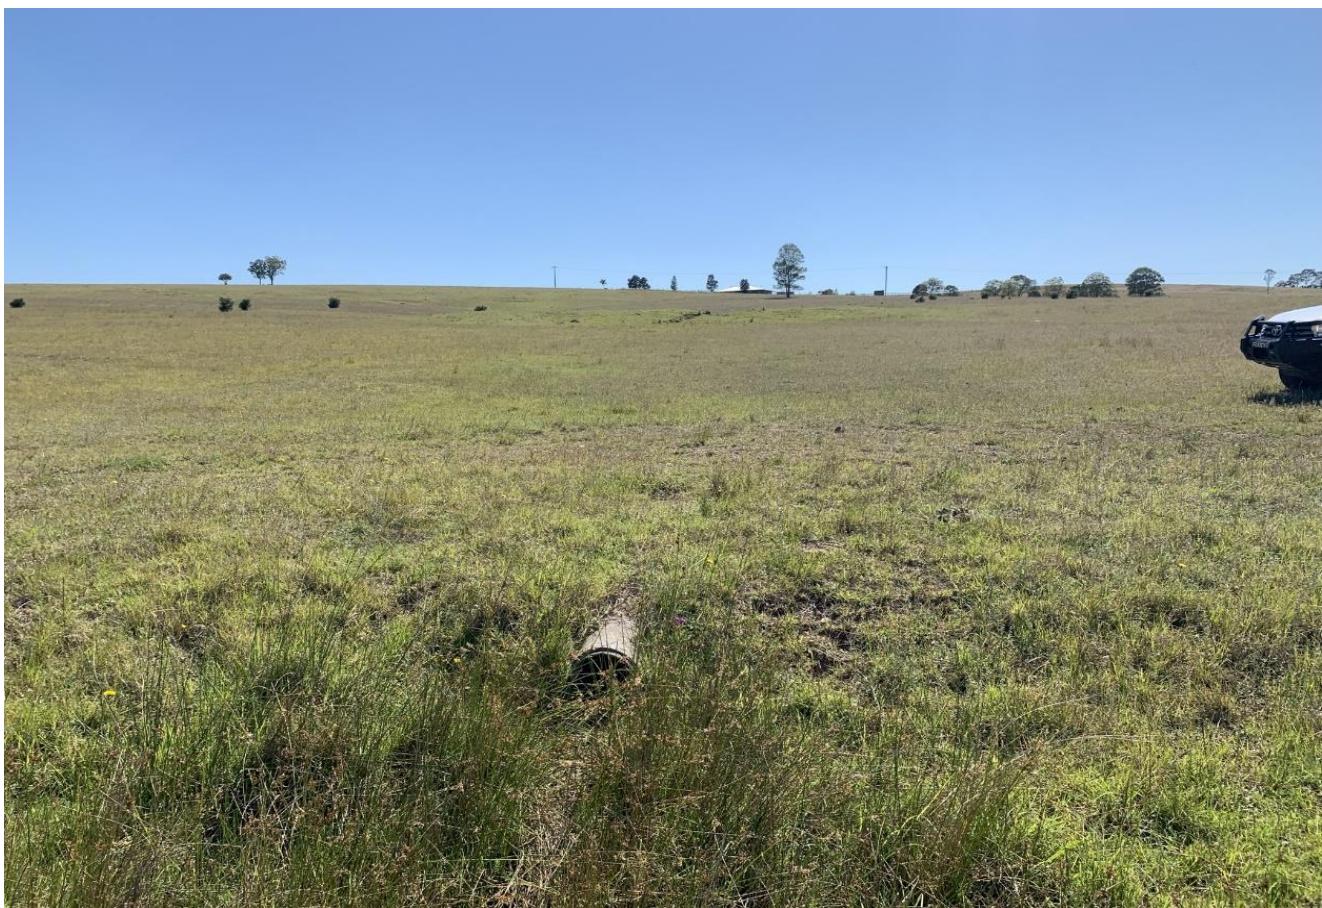
- An exposed metal and concrete drainage pipe was observed along the central western boundary of the site. Some concrete, bricks, tiles were observed in fill covering the exposed pipe (see photograph 6).

Photograph 6 - Showing exposed pipe in fill.

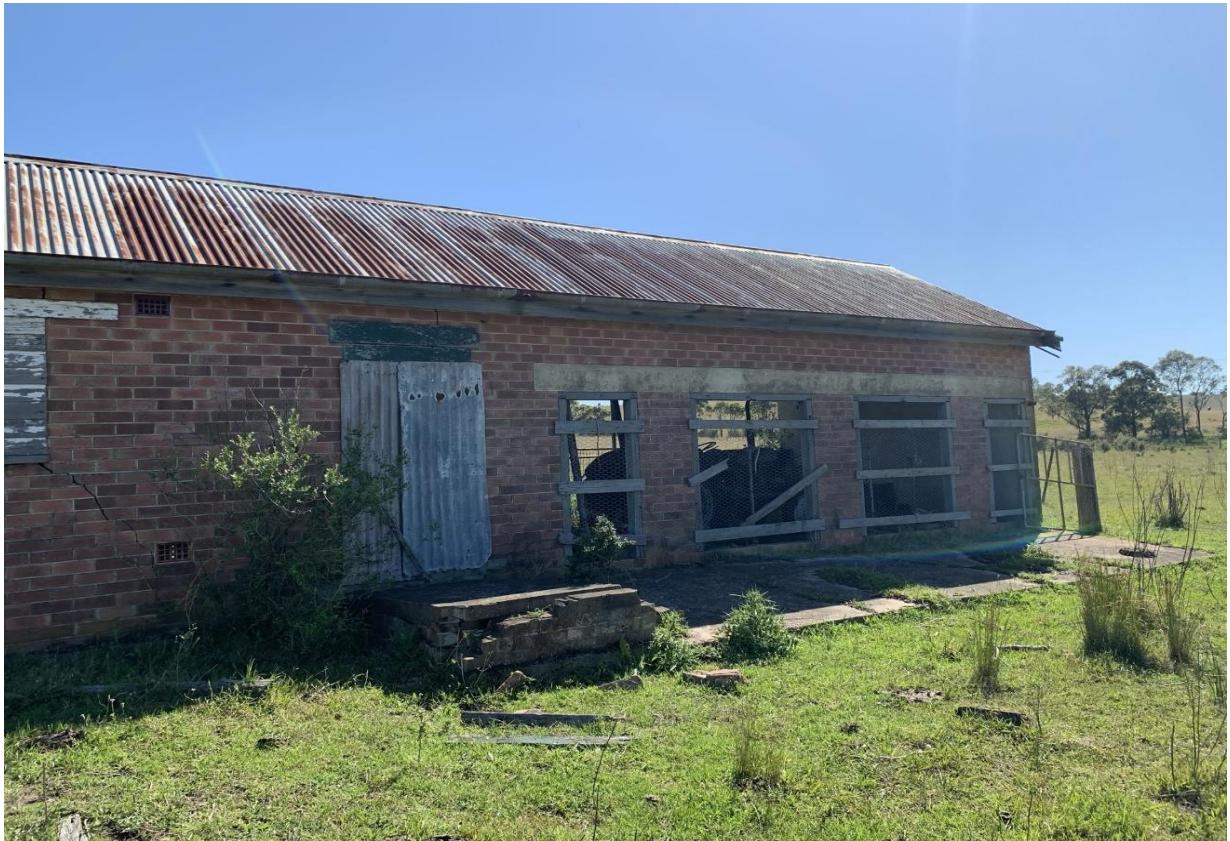
- A barn constructed of brick, metal clad roofing and concrete floor was observed in the central portion of the site. Some possible asbestos containing materials (ACM) were observed in parts of the roofing and on the ground surface. A tractor, hay, some general waste including old fuel drums (2.5L-5L) and wooden pallets were observed on the concrete flooring. The concrete flooring was observed to be in a relatively good condition with minor staining and cracks (see photographs 7 to 10).

Photograph 7 - Showing outside of brick and metal clad barn.

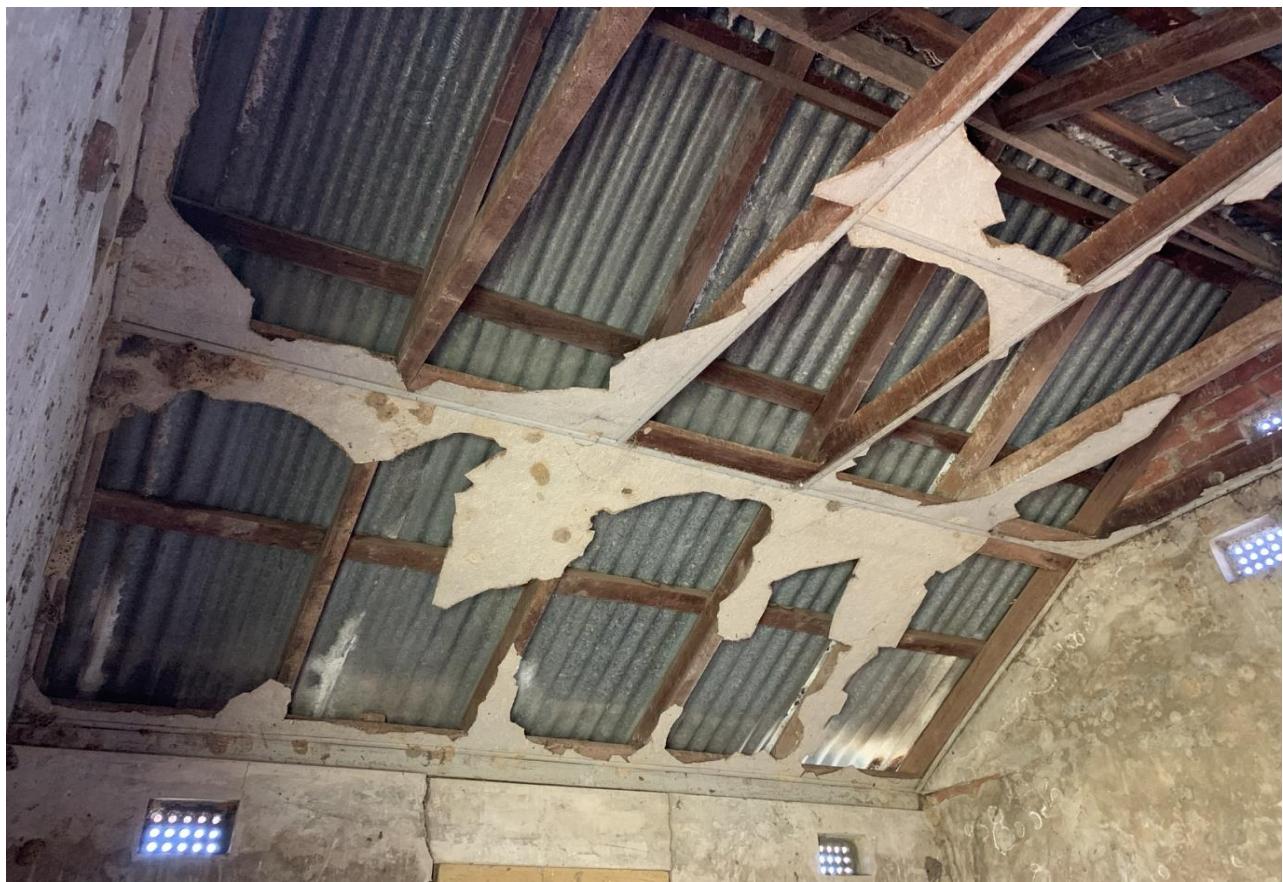
Photograph 8 - Showing possible asbestos containing roof sheeting.

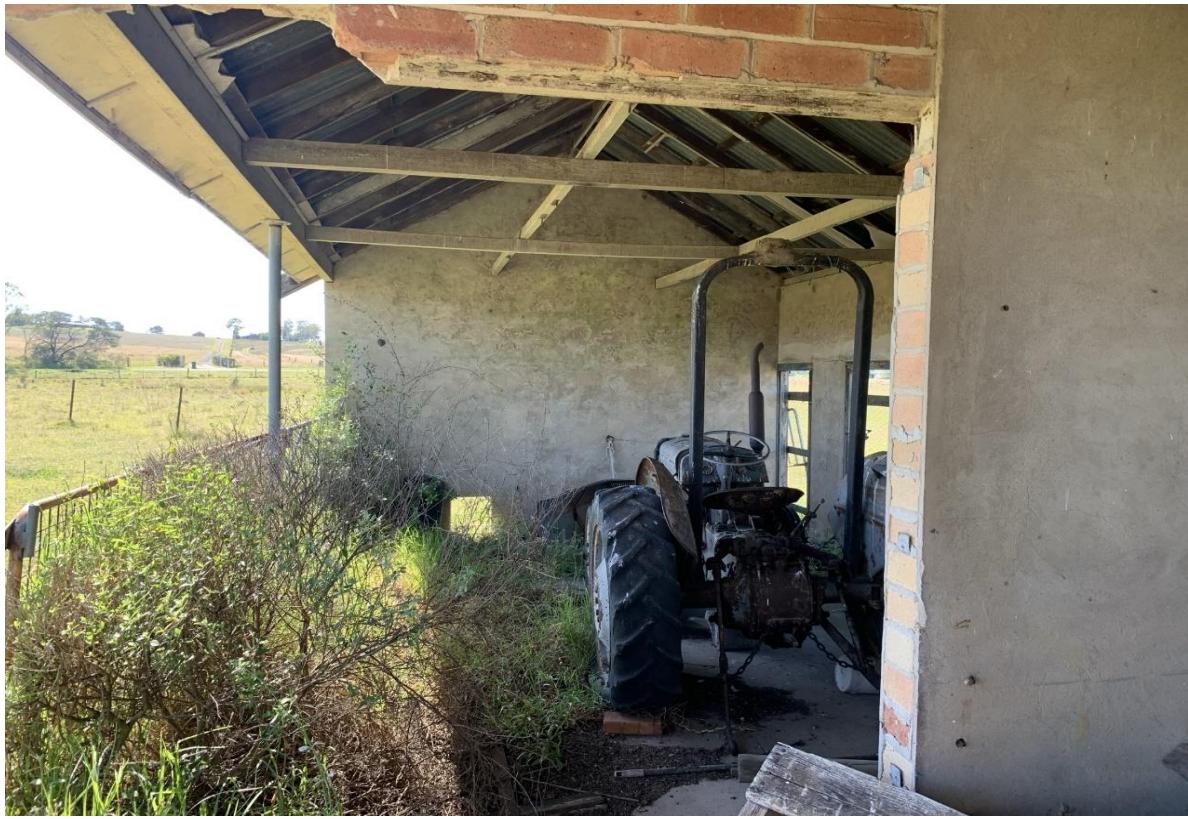
Photograph 9 - Showing tractor on concrete flooring and overgrown weeds.

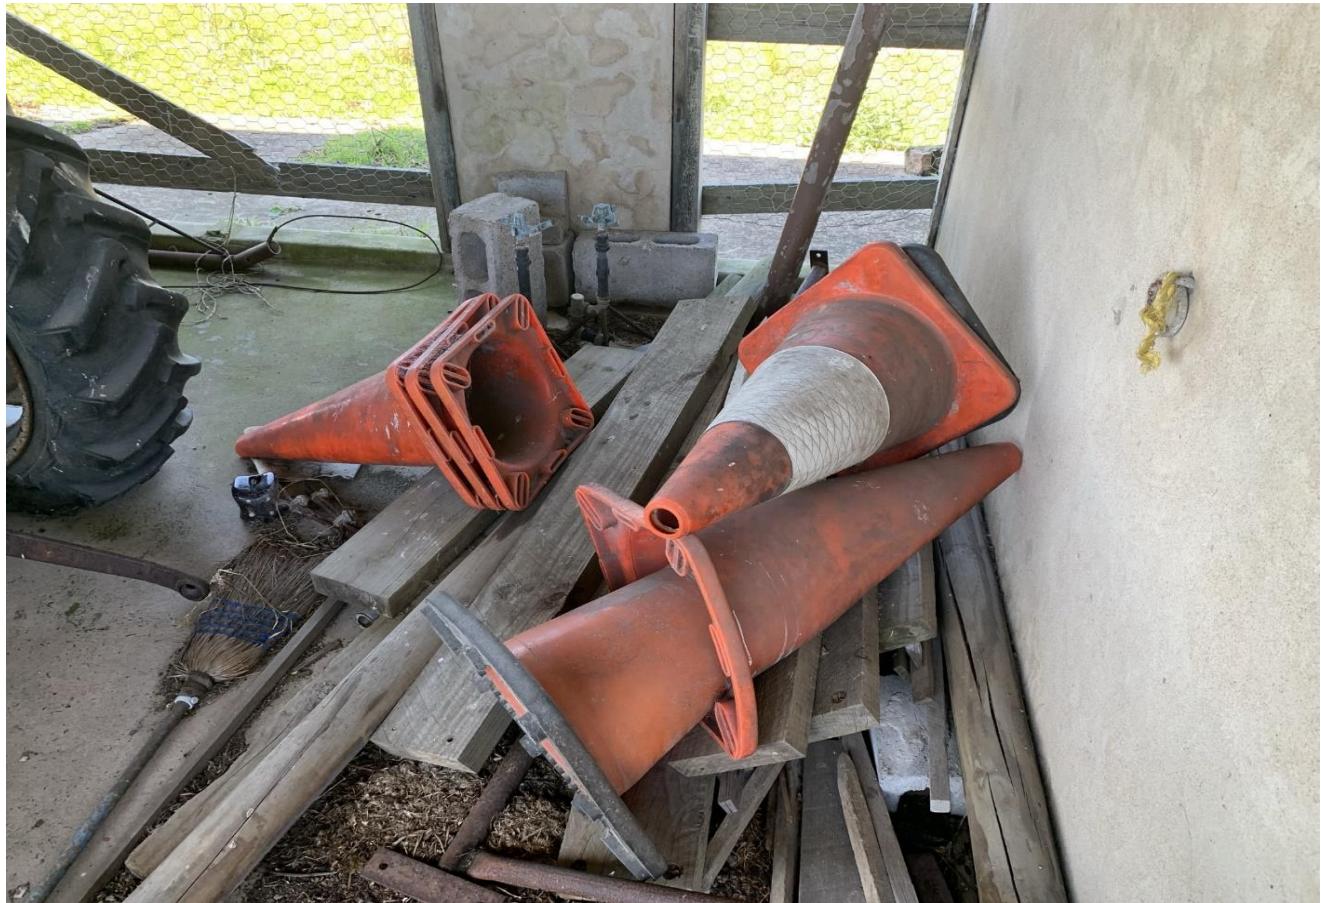
Photograph 10 - Showing wood and waste materials in barn.
