Report on  
Geotechnical Investigation

Proposed  
Synthetic Bowling Greens

Prepared for  
Maitland City Bowls Sports and Recreation

Project 39498.06  
March 2015

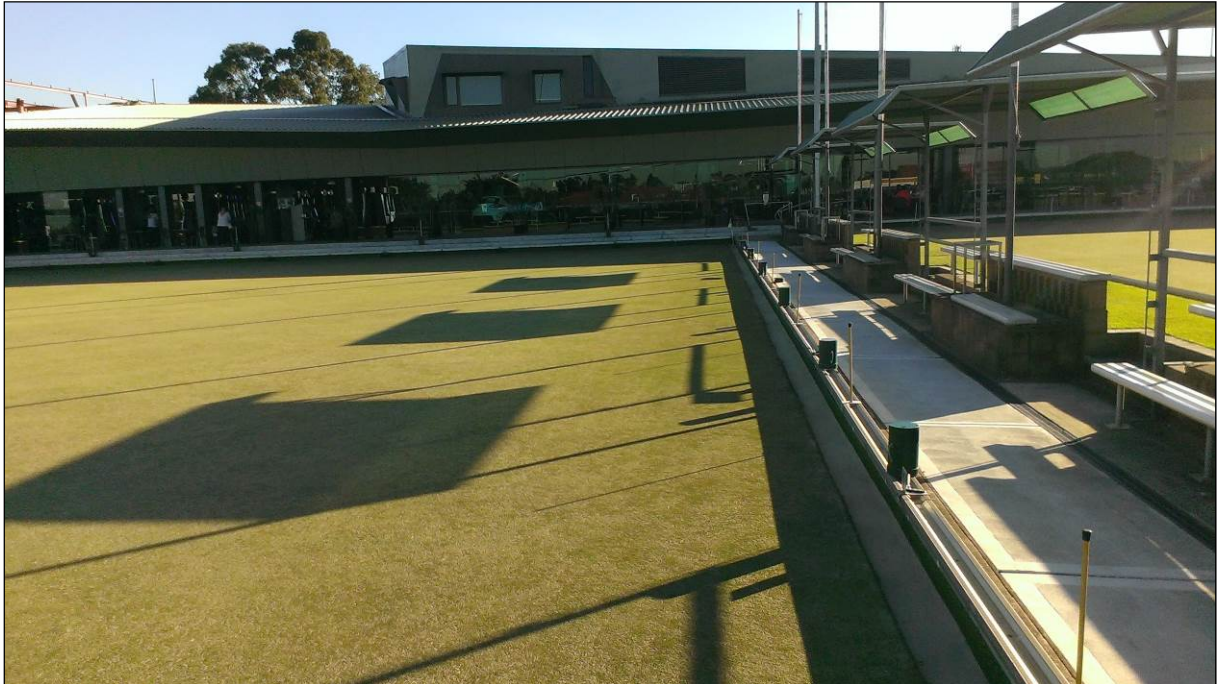
**Figure 1: Bowling Green No. 1 and No. 2 looking west**

The proposed synthetic bowling greens (about 37 m x 37 m in dimension for each green) are to be constructed in the location of the existing green No. 1 and No. 2 as shown on the attached Drawing 1. The site is shown in Figures 1 to 3 below.

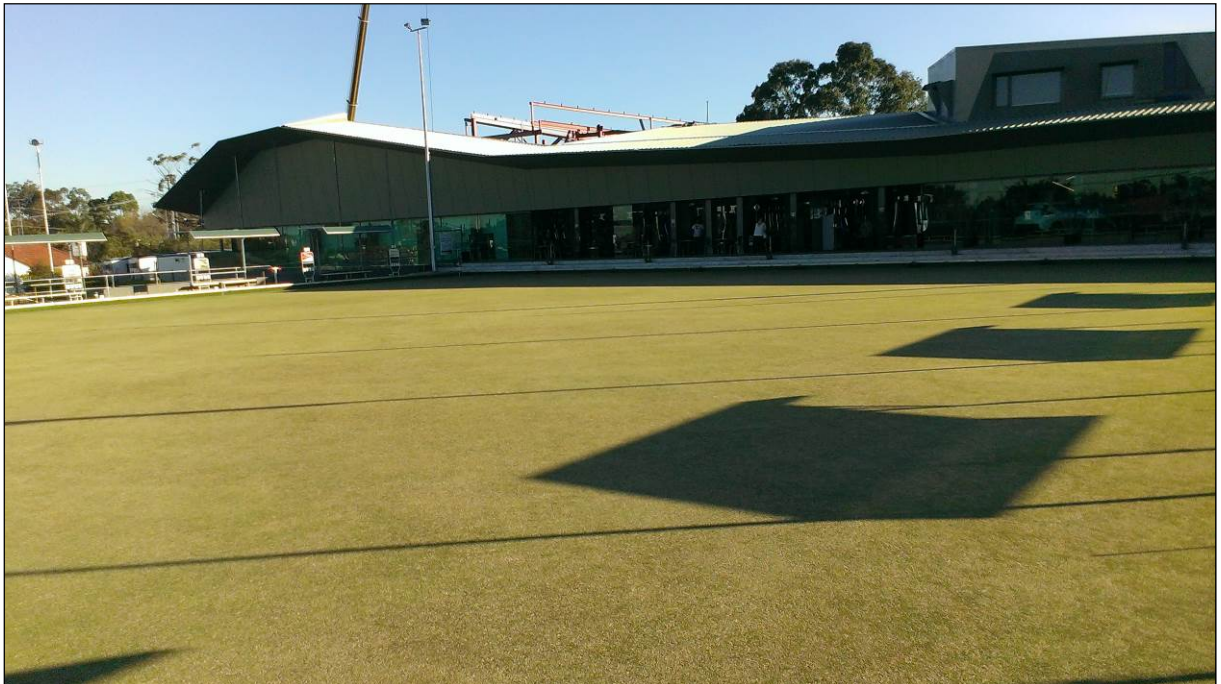
**Figure 2: Bowling Green No. 2 looking south west**

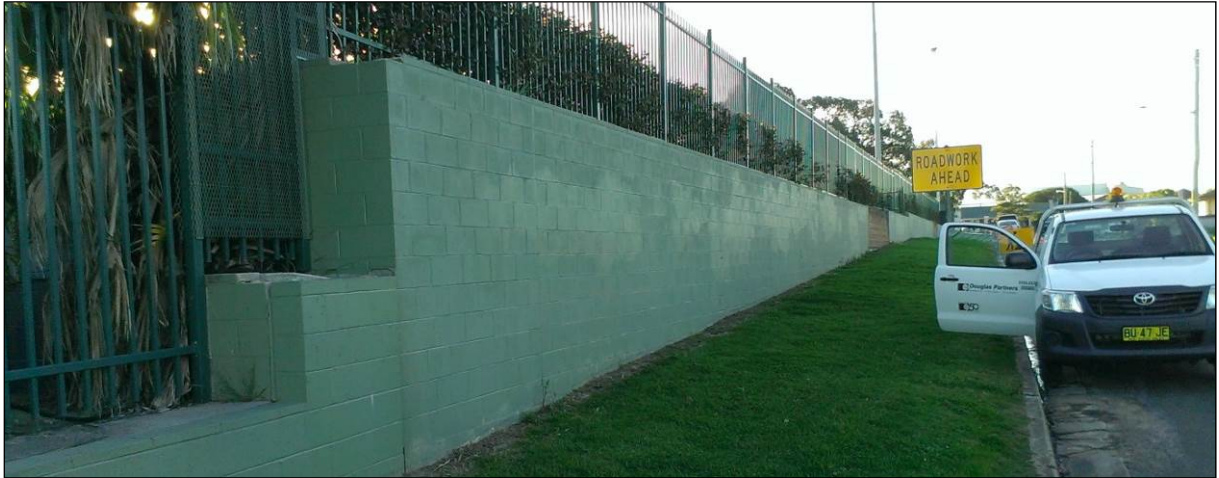
**Figure 3: Looking north along western retaining wall**

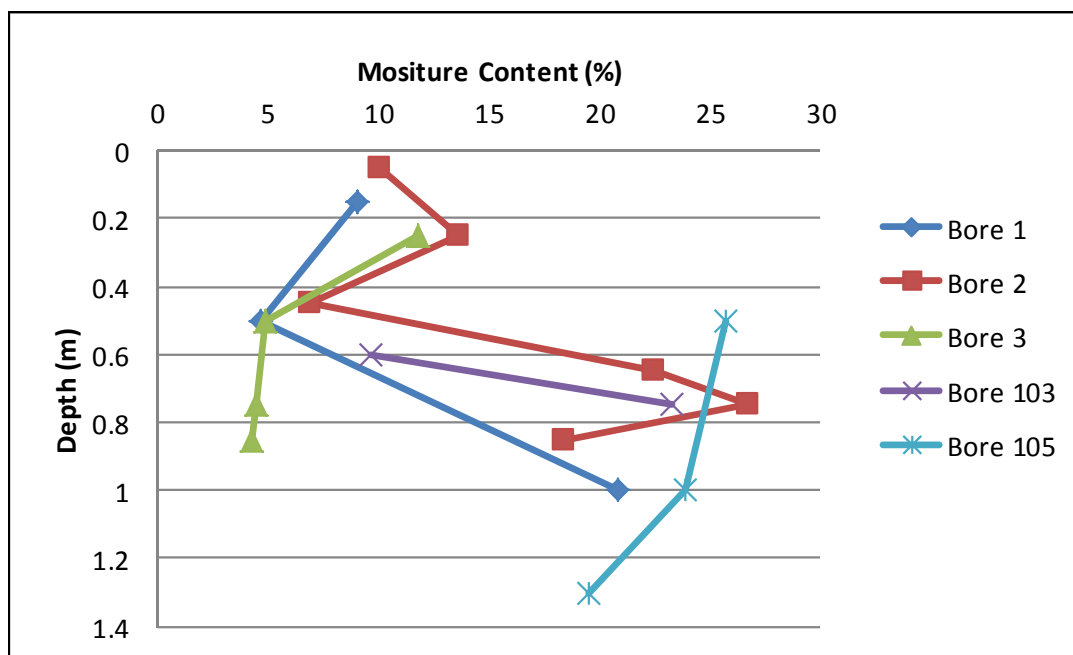
Moisture content tests were undertaken on samples collected from the bores to assess the variation in moisture profiles within the bores and across the site. Detailed laboratory test results are attached and are graphically represented in Figure 4 below.

**Figure 4: Moisture content variation with depth**

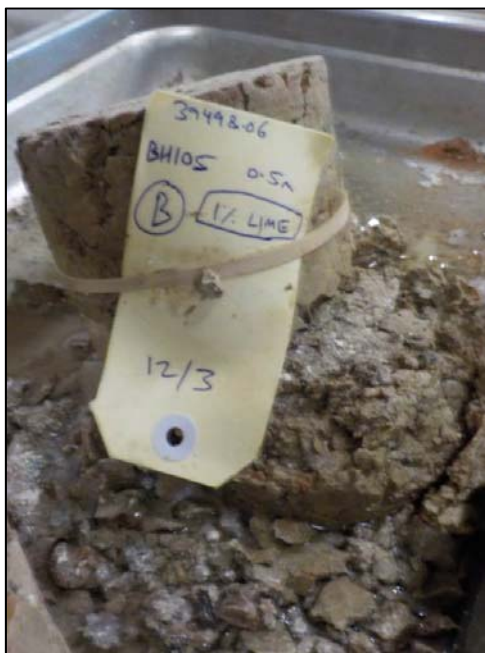
Figures 5 to 11 show examples of the samples after lime stabilisation.

**Figure 5: Bore 105/0.5 m 1% Lime – Sample B**

- Stabilisation of the clay / clay filling with at the rates of lime tested was not successful and the treated material was still sensitive to changes in moisture. The results suggest that the clay soils at this site would require a significantly higher proportion of lime to be effective;

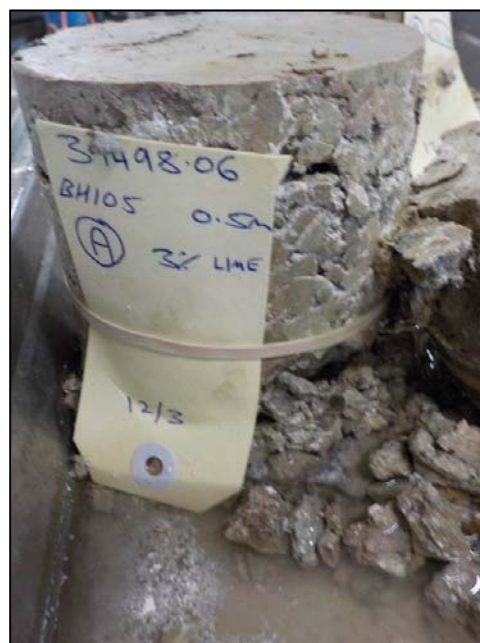
**Figure 6: Bore 105/0.5 m 3% Lime – Sample A**

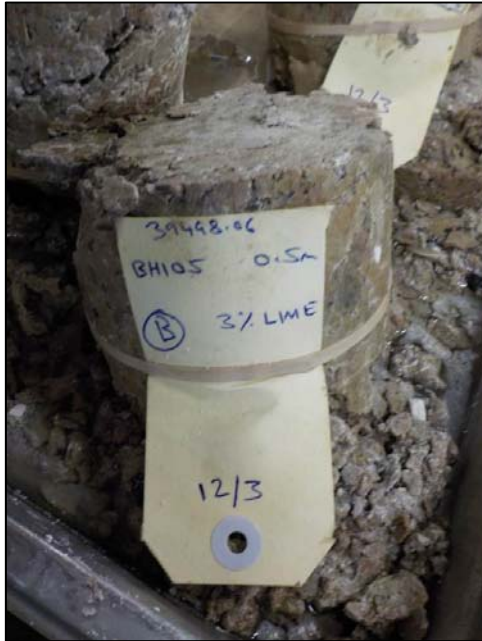
**Figure 7: Bore 105/0.5 m 3% Lime – Sample B**

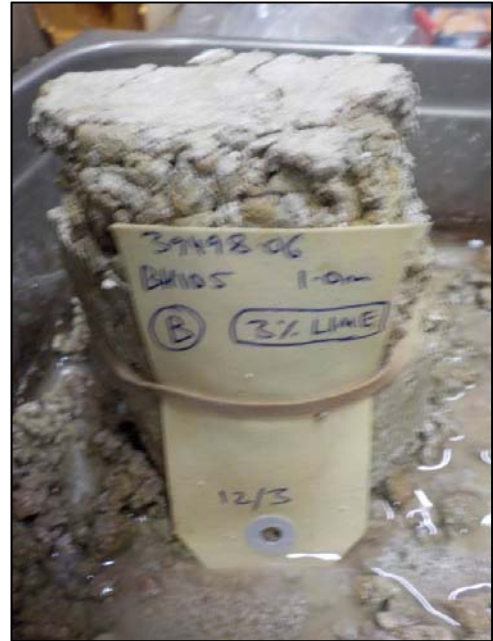
**Figure 8: Bore 105/1.0 m 3% Lime – Sample B**

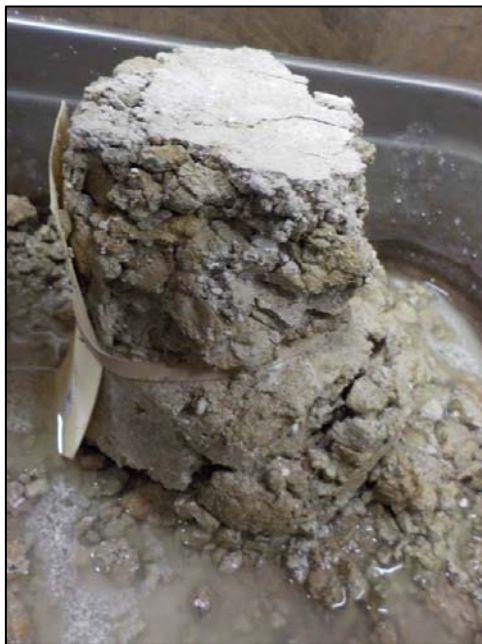
**Figure 9: Bore 105/1.0 m 3% Lime – Sample B**

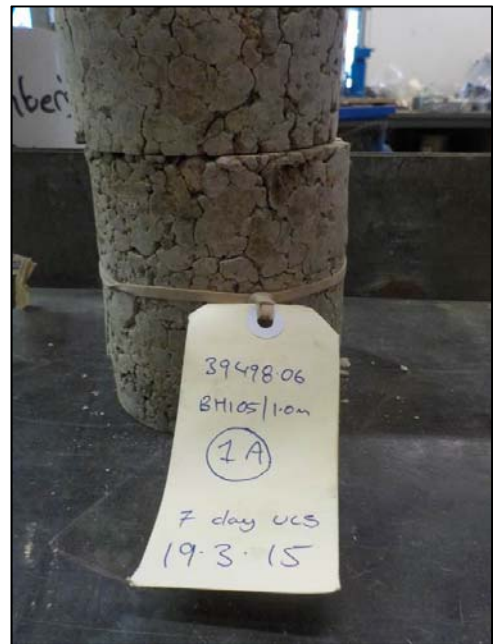
**Figure 10: Bore 105/1.0 m 3% Lime – Sample 1A (un-soaked prior to testing)**
