Document Register/Issue: B2413-DI-04

Melville Ford Bridge Over The Hunter River

MELVILLE FORD BRIDGE OVER THE HUNTER RIVER ON MELVILLE FORD ROAD AT 4.21km NORTH OF HW9

Melville Ford Bridge Upgrade

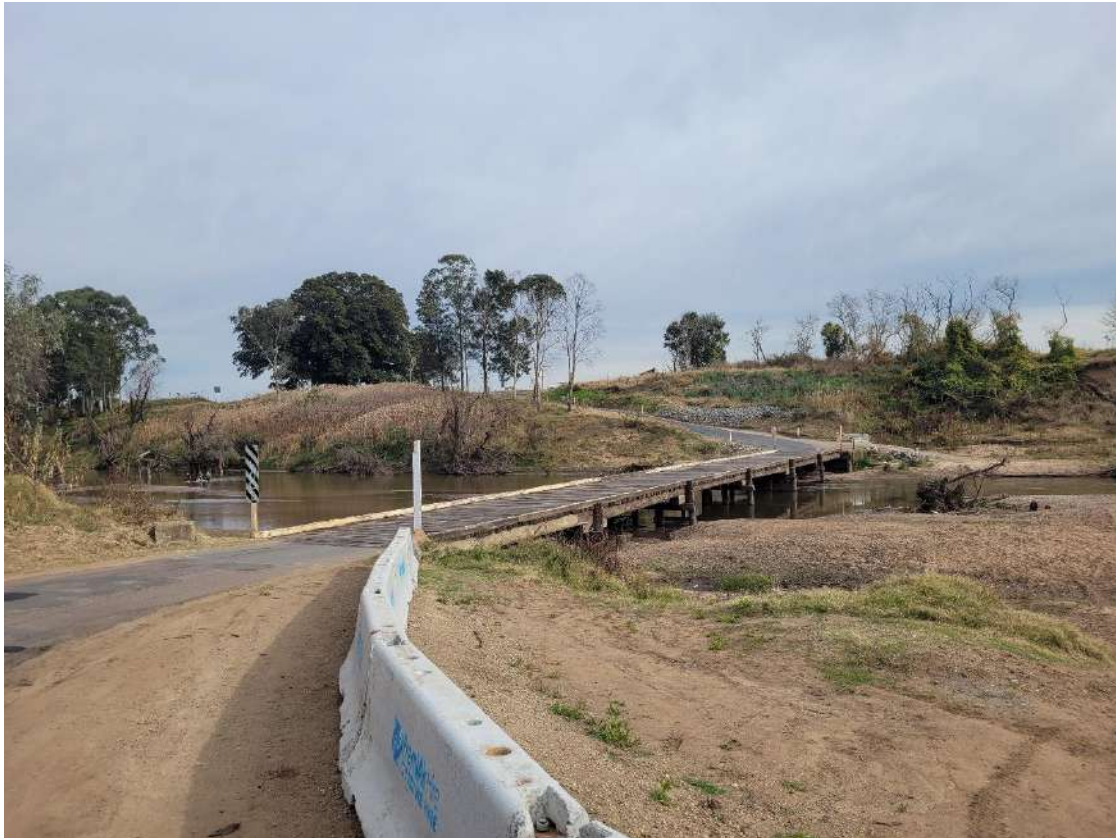
Plate 2-1. Existing timber bridge, view from the east on Aberglasslyn Road.

The existing bridge is a single-lane, six span, timber girder bridge which is 62 metres long (**Plate 1-1**). The low-lying, timber bridge is regularly inundated during flood events, requiring repairs and ongoing maintenance. Overtopping of the bridge of several metres occurs in moderate to large flooding events on the Hunter River. The local community have voiced their desire for a higher, safer, and more modern crossing at the Melville Ford Bridge location for many years.
