Gissing's Distributors

STATEMENT of HERITAGE IMPACT

73 Bulwer Street
Lot 1 DP1038953
Maitland NSW 2320

Statement of heritage impact for change of use, alterations and additions to the former Gissing's Distributors warehouse.

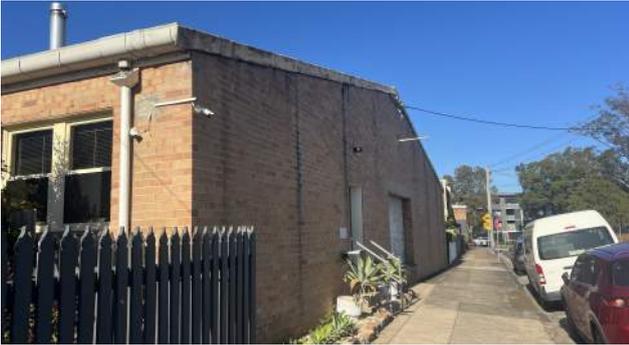
Figure 22
View of the Bulwer Street frontage with a portion of the boundary lined by a low-lying gravel planting bed with bush rock edging. Note the combination of fencing to neighbouring properties with sections of timber pickets and Colorbond.

The subject site is oriented north-west fronting Bulwer Street with secondary frontage to Napoleon Lane. The main entrance is defined by concrete steps flanked by low-lying garden beds, adjoined by a concrete crossover formerly servicing the original textiles warehouse. Side and rear boundaries are bordered by a combination of timber paling and corrugated metal fencing with pedestrian access provisioned via wire mesh and timber gates to the northern and western corners of the site. Due to the extent of contemporary alterations, there is little surviving evidence of early landscaped features, with the rear yard incorporating a paved patio intersected by a ramp-way and areas of turf. Vehicular access is provided from Napoleon Lane via a concrete driveway with a light-weight steel framed carport partially enclosed by timber lattice.

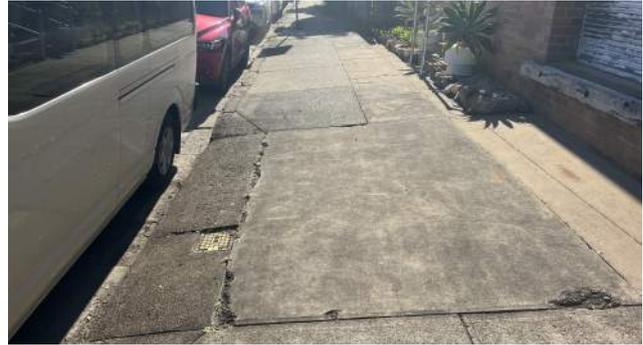
Figure 23
Former concrete driveway with exposed aggregate crossover servicing unloading of goods to the Gissing's warehouse. Sandstone kerb and gutter evident beyond.

- a) The existing concrete driveway, crossover and sandstone kerb/guttering to Bulwer Street is conserved.
- b) Documentary evidence confirms the site was historically devoid of significant plantings and landscaped features. As such the proposal to replace extant mass planting areas will not adversely impact the streetscape presentation or setting of the place.
- c) The development proposal allows for integration of new soft landscaping, successfully enhancing the visual qualities of the streetscape. Construction of a planter bed framing the central opening is a particularly positive aspect of the scheme, articulating the historic aperture.

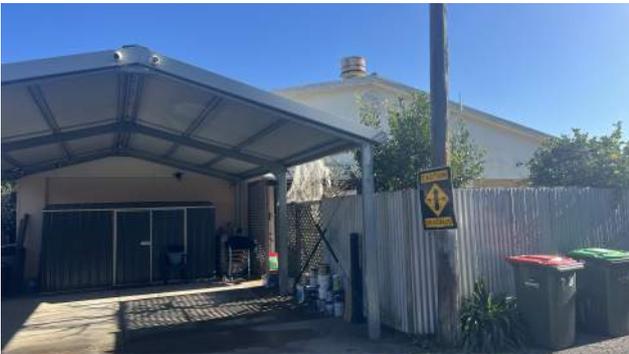
Figure 24
Corrugated metal fencing defining the south-eastern boundary with timber lattice concealing the rear courtyard from Napoleon Lane. Lightweight steel framed carport at left with concrete driveway.

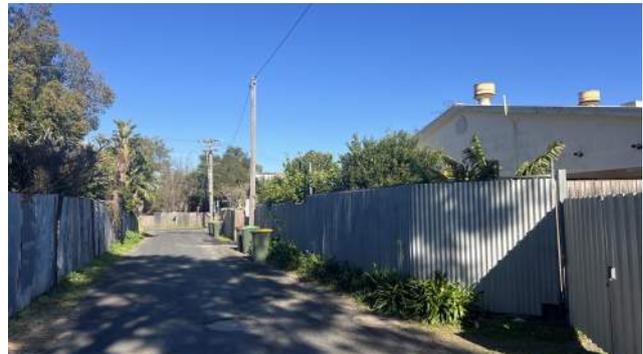
Figure 25
View looking south-west along Napoleon Lane with the subject site at right. Corrugated fencing with agapanthus borders the laneway with timber palings defining the north-eastern boundary.

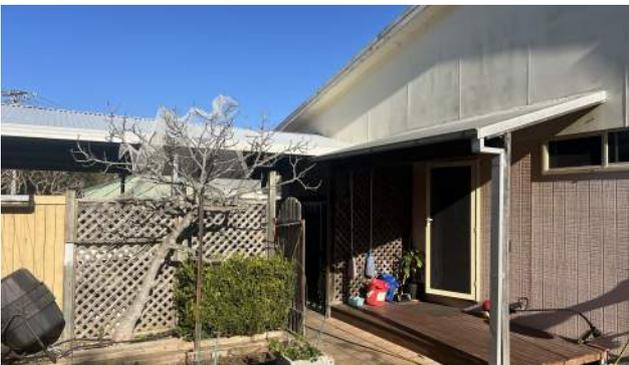
Figure 26
Rear paved courtyard with timber framed awning over decking to the laundry entrance. Deck, awning and entry door nominated for demolition.

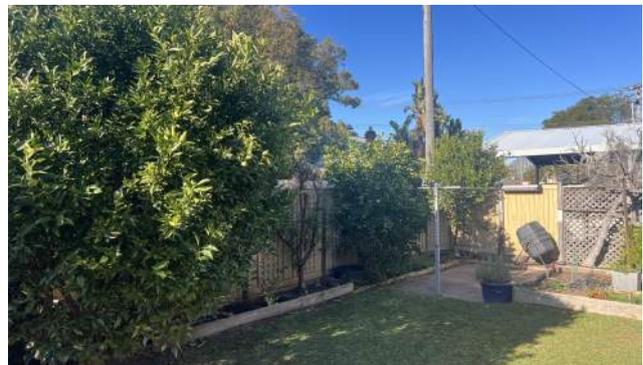
Figure 27
Established tree plantings lining the rear and side boundaries with pine sleepers, areas of turf and paving.

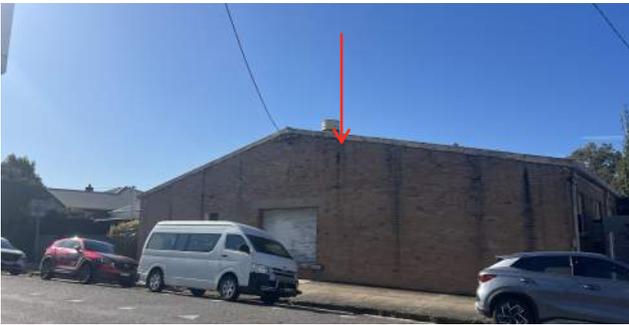
Figure 28

Front façade of the existing dwelling highlighting the simple gabled form, blonde face brick, central roller door opening.

The historic warehouse structure employs a simple gabled form of masonry construction with asbestos clad roof and gutter. The prominent Bulwer Street facade is characterised by face blonde brickwork with a central roller door opening, masonry lintel and timber bumper. An elevated tiled entrance alcove is located to the north-eastern corner of the site, incorporating a combination of vinyl weatherboard and painted brick walls with solid core timber double doors and aluminium security screen. Timber framed sash windows retrofitted with metal security mesh line the eastern and western elevations whilst a series of sliding doors to the southern facade provide access to the paved courtyard. The southern portion of the building has been subject to extensive alterations with the introduction of a glass brick opening, faux PVC weatherboards and fibre cement sheeting to the gable end. A secondary entry flanked by a light-weight timber awning adjoins the lean-to car port accessible from Napoleon Lane.

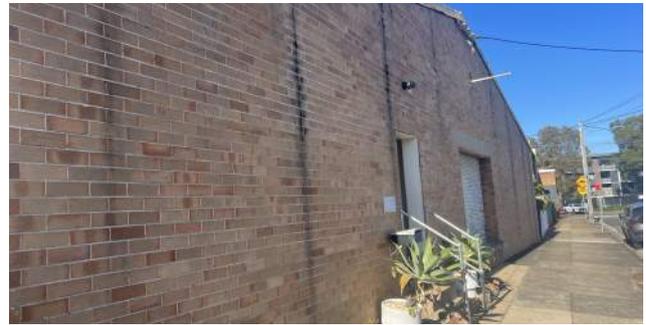
Figure 29

Detailed view of the face brick exterior fronting Bulwer Street with the central entrance at right. Note the areas of organic growth to locations of compromised drainage.

The collective structure presents in fair condition with surface staining to areas associated with compromised metal barge capping. Timber fascia boards are similarly in a state of disrepair.

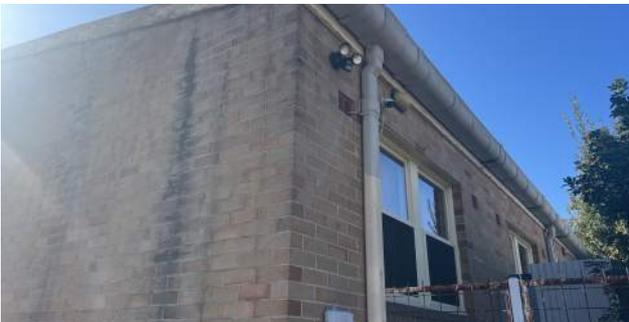
Figure 30

Detailed view of the north-eastern corner of the dwelling highlighting the timber sash window nominated for demolition. Note the unsympathetic fence panel at right.

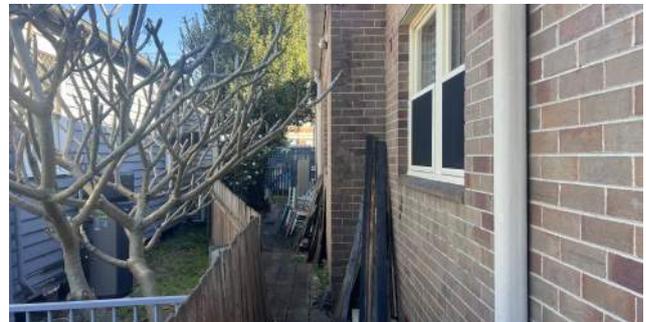
Figure 31

View looking north-east along the side boundary highlighting the blonde face brick facade, and timber windows. A paved pathway extends the length of the boundary connecting to Bulwer Street.

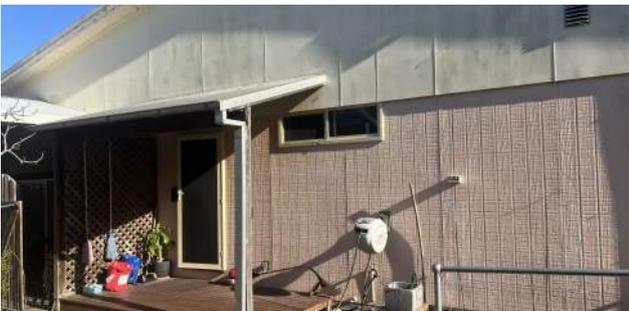
Figure 32

Southern facade clad in vinyl weatherboards with cement sheeting to the gable end.

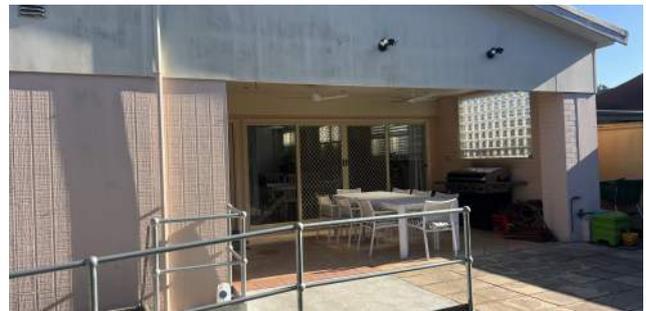
Figure 33

View of the partially enclosed patio addressing the rear yard with contemporary aluminium fenestration, cement ceiling lining and glass block infilled opening.

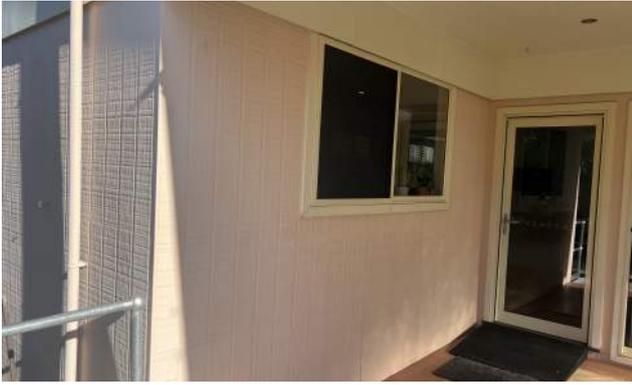
Figure 34

Aluminium windows and doors to the kitchen and living space forming part of the c2000s alterations.

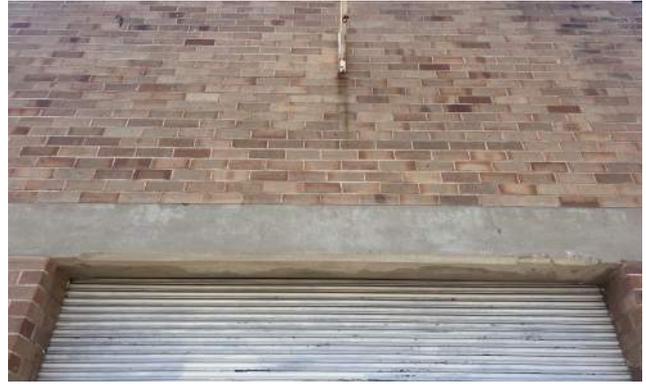
Figure 35

Detailed view of the masonry lintel over the central roller door opening with remnant fixings above likely used in connection with the Gissing's factory operations.

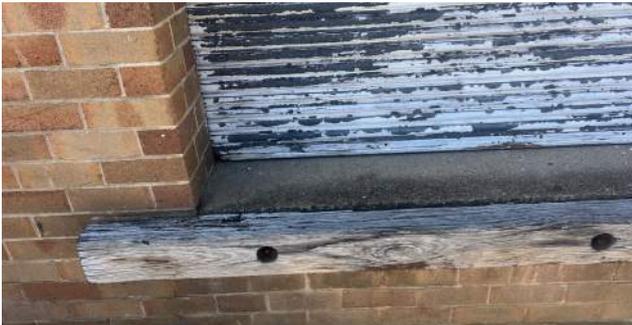
Figure 36

Detailed view of the extant timber bumper mounted to the central Bulwer Street opening.

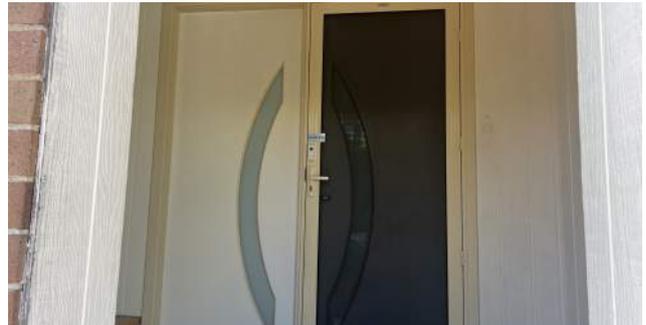
Figure 37

Solid core timber entrance doors to the Bulwer Street vestibule with aluminium security screen. Vinyl cladding fixed to the entrance reveal.

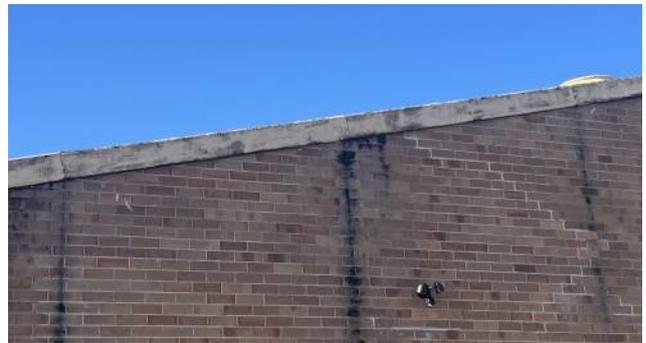
Figure 39

Detailed view of the northern gable end illustrating the deteriorated condition of the metal barge capping, areas of organic growth and sections of re-pointed brickwork.

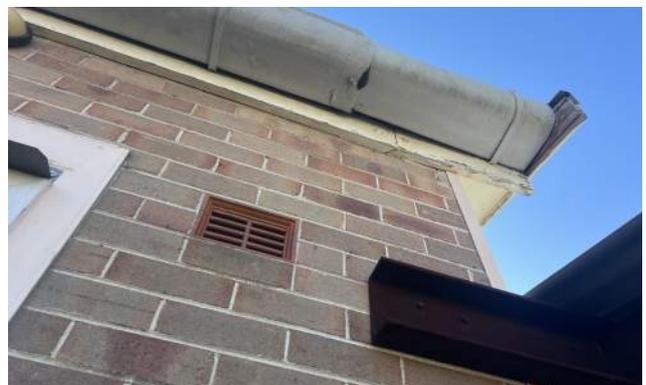
Figure 41

Detailed view of face brickwork, timber fascia board, asbestos gutter and single clay wall vent.

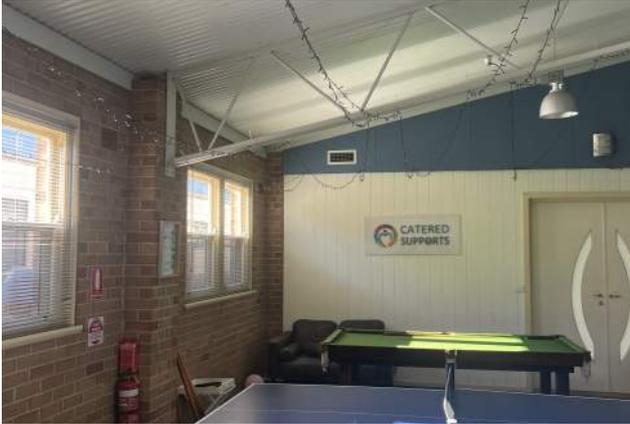
Figure 42

Internal view of the main foyer space with original sections of brickwork, exposed truss, corrugated sheet lining and timber sash windows.

The internal spatial arrangement of the warehouse comprises a central entrance foyer adjoined by an open-planned living/dining and kitchen space fronting an outdoor patio. A series of bedrooms, offices, toilet and laundry are contained to the western portion of the dwelling connected via a central corridor and separate living area. Adapted for residential usage in the early 2000s, much of the fabric identified does not date to the original construction period of the warehouse and is of deemed of little significance.

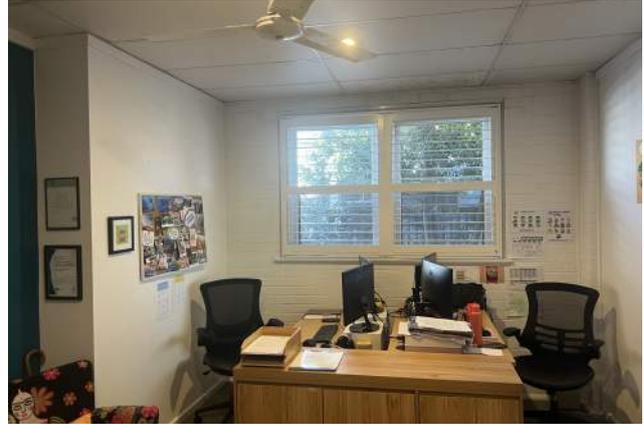
Figure 43

Typical office interiors with a combination of painted brick and plasterboard walls with contemporary suspended ceiling tiles and venetian shutters.

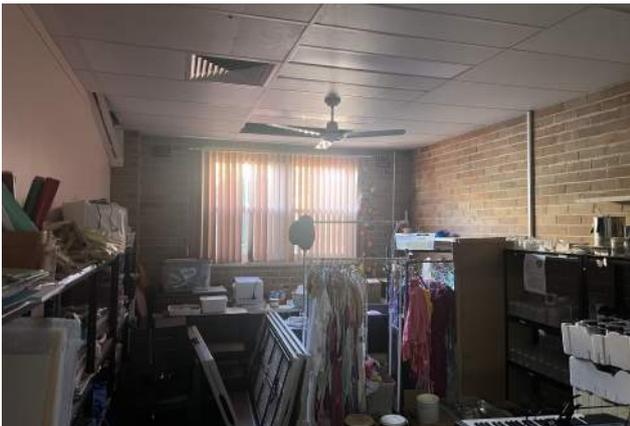
Figure 44

General view of the store room with exposed brickwork, suspended ceiling tiles with modern cornice at left.

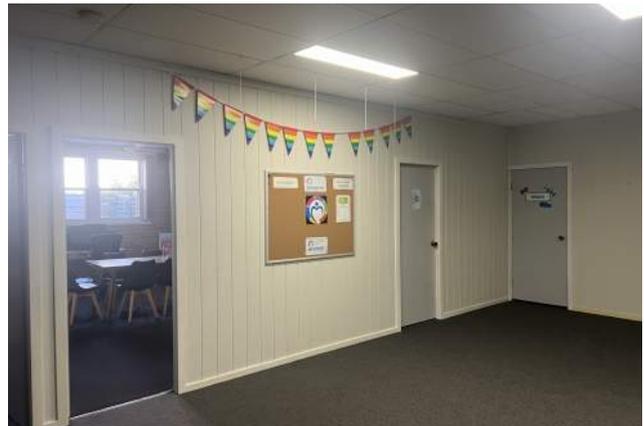
Figure 45

Secondary living area with suspended ceiling, linear vinyl cladding, modern architraves and hinged solid core doors.

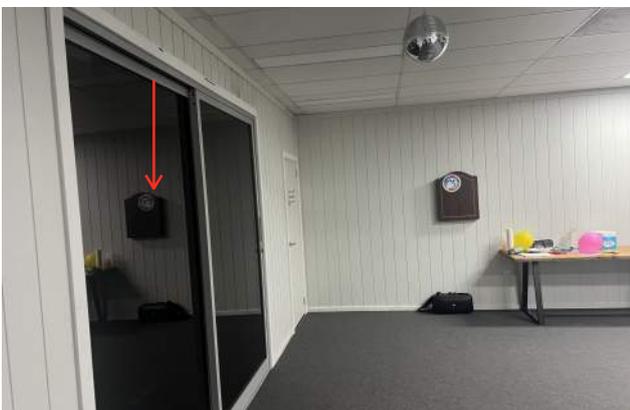
Figure 46

Internal view of the secondary living space with sliding glass doors concealing the original central roller door opening indicated at left.

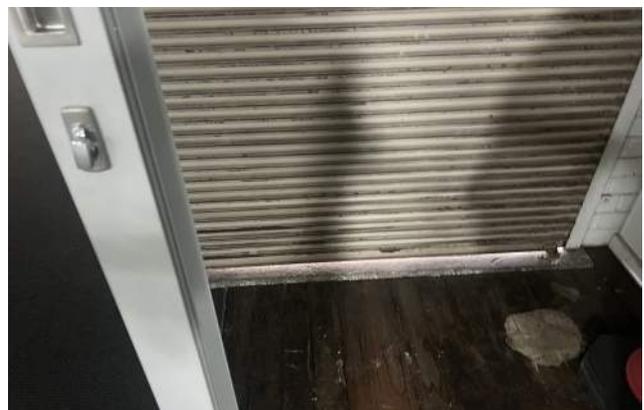
Figure 47

Sections of original floor timbers lining the Bulwer Street roller door opening. This fabric is nominated for reuse as part of the central planter bed.

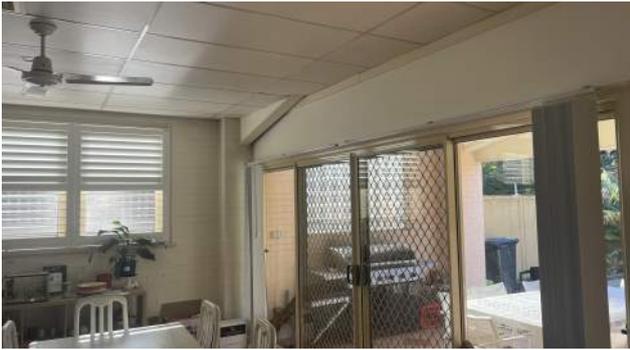
Figure 48
General internal view of the main living area with painted brickwork, ceiling tiles and aluminium sliding doors.

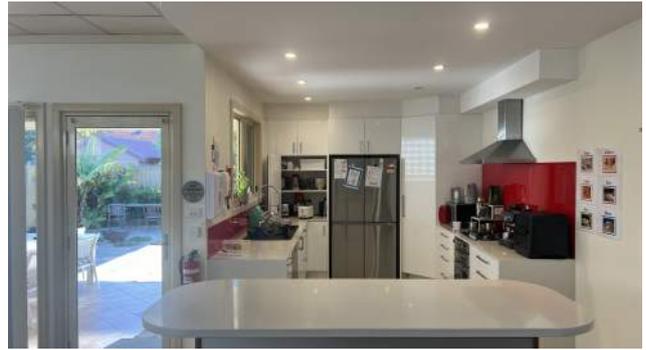
Figure 49
Contemporary kitchen adjoining the open planned living/dining space with aluminium glazed doors connecting to the rear patio and courtyard.

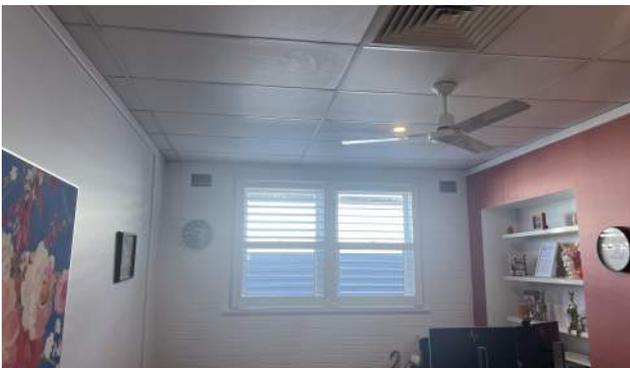
Figure 52
Typical office with plasterboard wall partitions, suspended ceiling and painted brickwork.

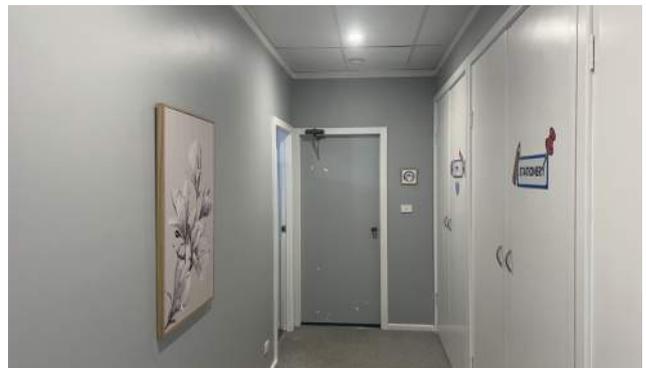
Figure 53
Central hallway looking north with the entrance to Room 3 beyond at left. Note the carpet flooring, plasterboard walls, joinery, doors, architraves, ceiling, skirting and cornice form part of the later residential works.

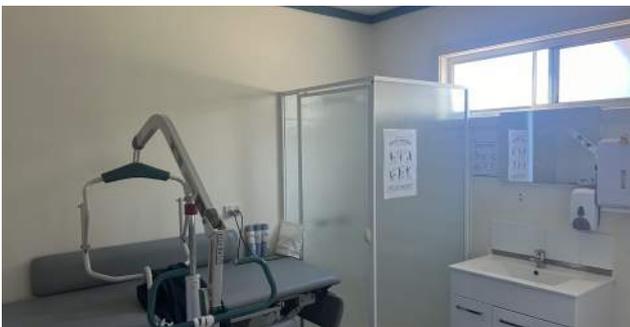
Figure 54
Internal view of the common bathroom with no significant fabric of note.

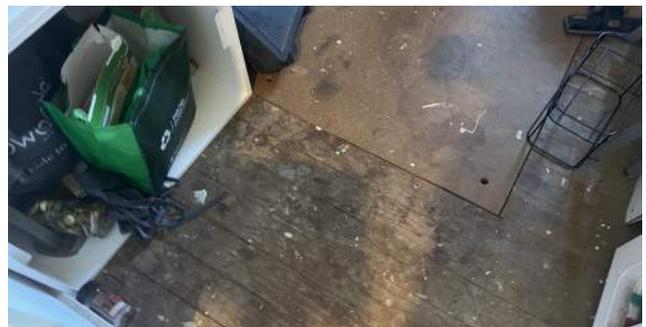
Figure 55
Areas of original timber floor boards to the store room.

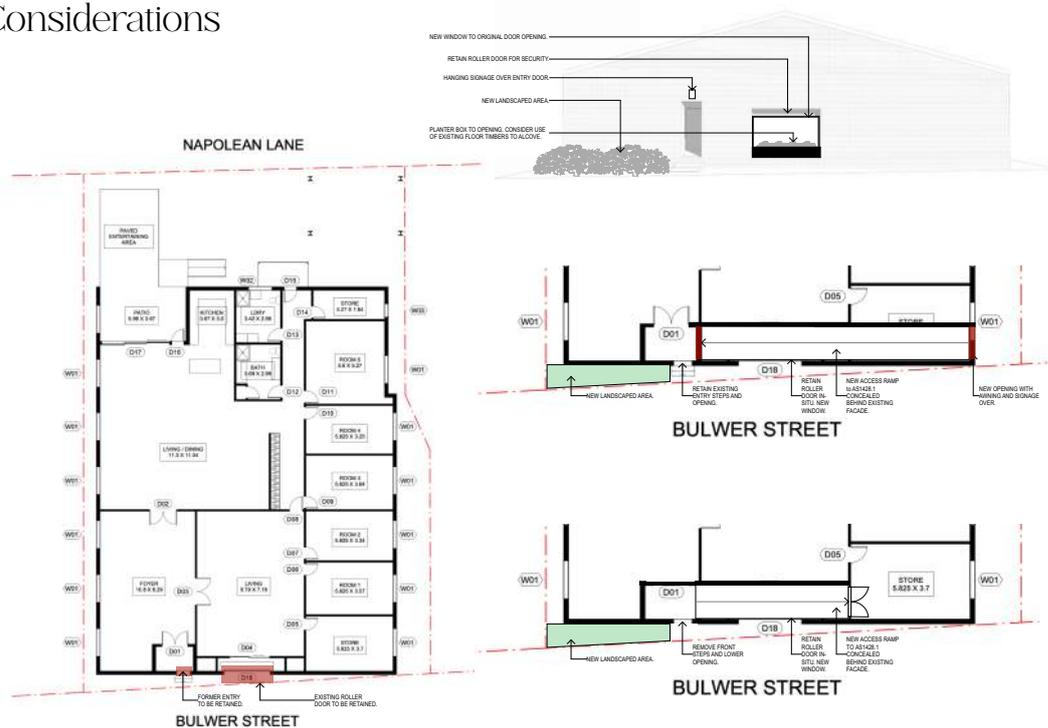
Figure 56 Preliminary heritage considerations: ramp concepts, A001, 23 July 2024. source: Heritas in consultation with Hoover Group.

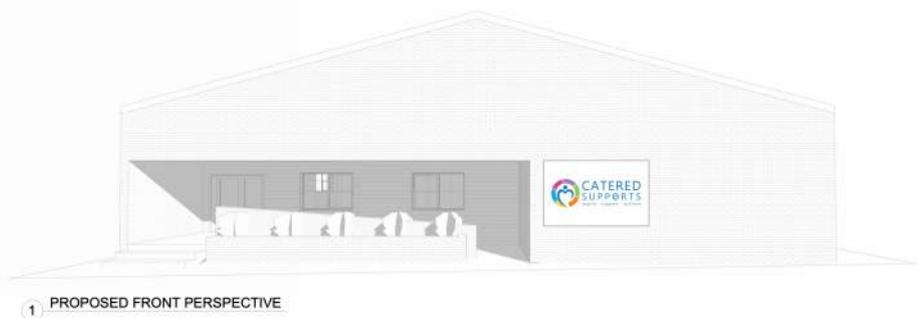
Figure 57 Bulwer Street elevation initial design concept, proposed perspectives, DA08, 11 July 2024. source: Hoover Group, CATERED-202401.

The development proposal comprises alterations and additions to the existing residence accommodating a commercial disability day centre. Partial demolition of the south-western facade allows for introduction of a new primary entrance connecting to an accessible ramp-way with retention of the significant warehouse presentation and central roller door to Bulwer Street. Internal modifications are limited to areas of previously disturbed fabric with the introduction of new male and female ambulant amenities and bathroom. A number of extant solid hinged doors are nominated for replacement with widening of openings to meet accessibility requirements. The general internal configuration of the existing residence is conserved with an open planned living/dining space adjoined by a series of individual office spaces and central common room. New areas of soft landscaping are provisioned throughout with mass planting beds bordering the rear entertaining area and carport. Additional paved parking areas are nominated to Napoleon Lane.

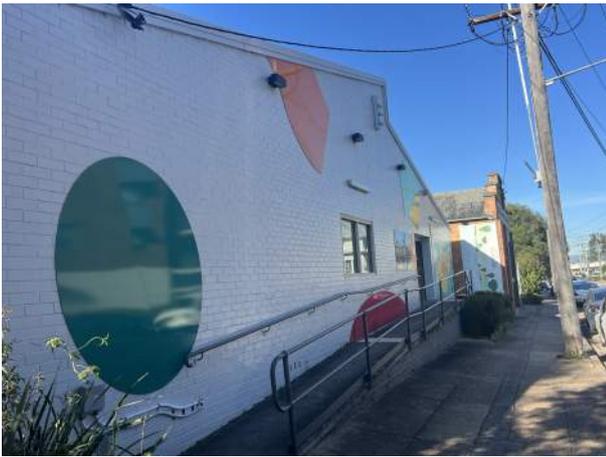
Figure 60

Warehouse at 73 Elgin Street servicing Headspace Maitland with recent paint finish, mural and ramp.

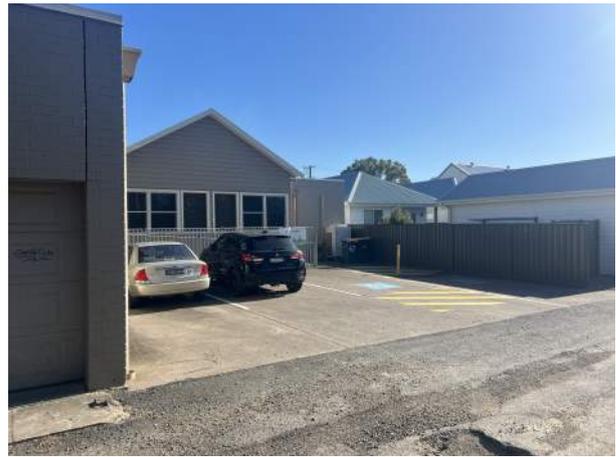
Figure 61

Single storey cottage adapted as a rehabilitation centre to 67 Bulwer Street with vehicle parking accessible from Napoleon Lane.
