## Waterfront Land Assessment Report

**20 & 20A Cantwell Road and 60 New England Highway,  
Lochinvar, NSW**

**AEP Ref: 4951**

**Revision: 03**

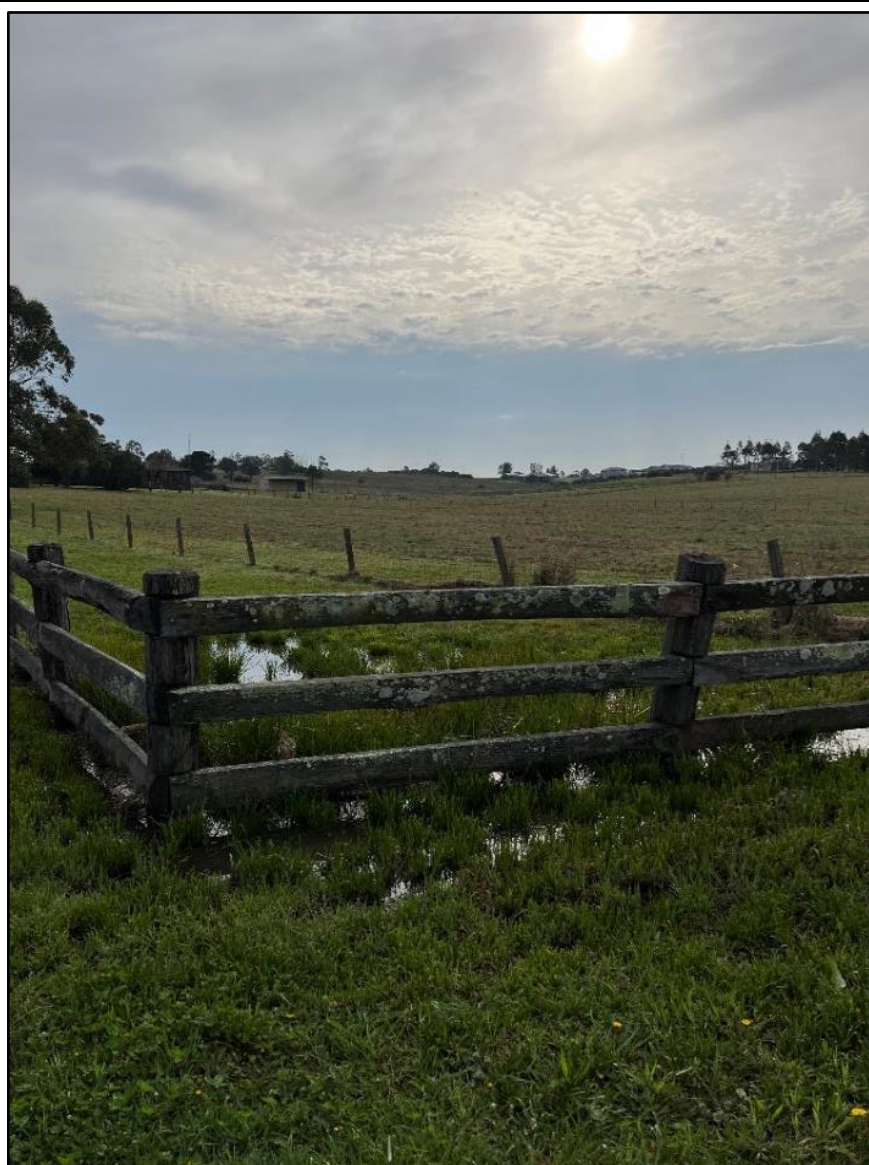
Survey Point 2.1 - mapped upstream

Task – Waterland Tool (2020)	Assessment	Comments (provide evidence)	Figures
Bank Vegetation (Toe to top of high Bank)	No native vegetation Present		
Riparian Vegetation (high bank to 40m)	None Present		
Controlled Activity Approval Required (Y / N)	N/A	WFL does not occur at this survey point.	-
Comments	Segment 2 is mapped as a 1 <sup>st</sup> order stream. No WFL features, such as a defined bed and bank, or a change in vegetation indicating a wetland were identified. A farm dam is visible on aerial photography north east of Survey Point 2.1, and likely historical land use for agriculture has altered the surface hydrology and geomorphology of the mapped hydroline. Survey Point 2.1 does not constitute waterfront land.

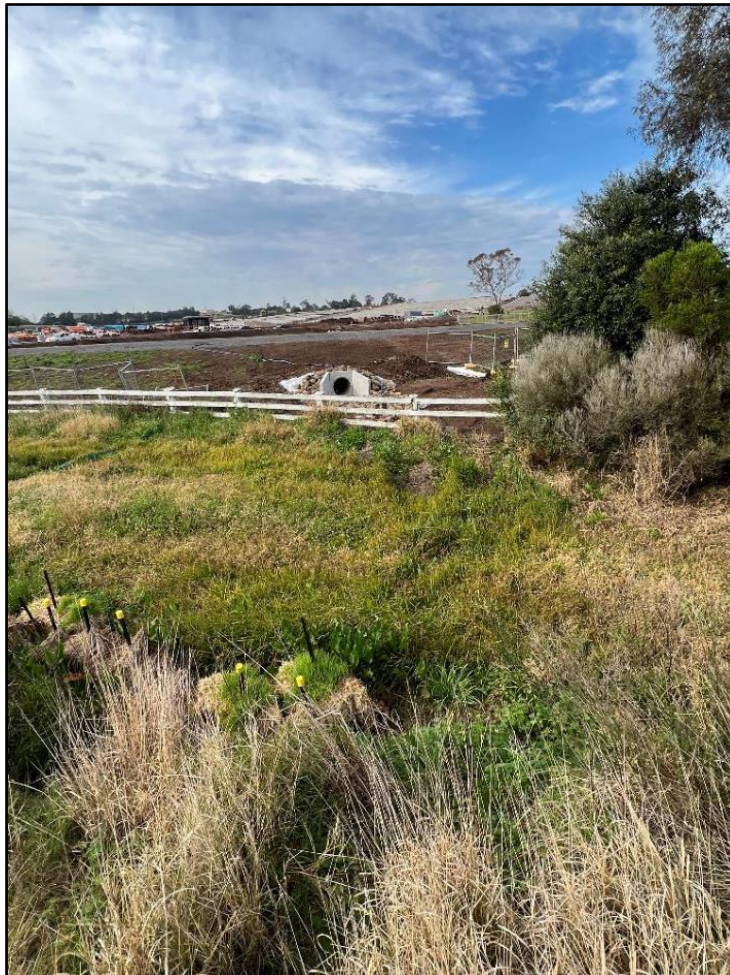
**Survey Point 3.1 mapped upstream**

Task – Waterland Tool (2020)	Assessment	Comments (provide evidence)	Figures
Bank Vegetation (Toe to top of high Bank)	No native vegetation Present		
Riparian Vegetation (high bank to 40m)	None Present		
Controlled Activity Approval Required (Y / N)	N/A	WFL does not occur at this survey point.	-
Comments	<p>Segment 3 is mapped as a 1<sup>st</sup> order stream. A roadside swale along the NEH and recently constructed detention Basin for a subdivision development on the southern side of the NEH have likely altered the hydrological and geomorphological characteristics of the landscape.</p> <p>The inspection showed stormwater infrastructure through an urban environment (swales, culverts and detention basin). No WFL features, such as a defined bed and bank or a change in vegetation indicating a wetland were identified.</p> <p>Survey Point 3.1 does not constitute waterfront land.</p>

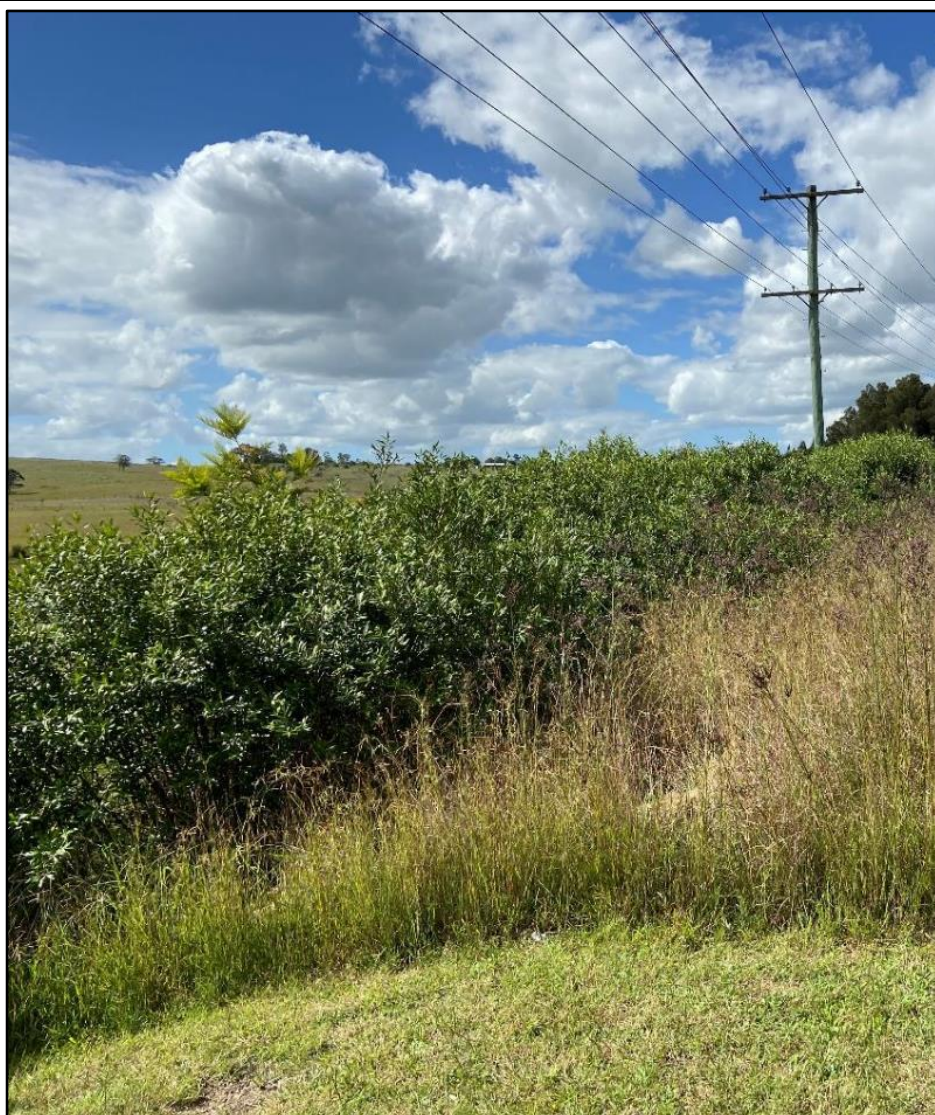
Survey Point 4.1 – mapped upstream

Task – Waterland Tool (2020)	Assessment	Comments (provide evidence)	Figures
Bank Vegetation (Toe to top of high Bank)	No native vegetation Present		
Riparian Vegetation (high bank to 40m)	None Present		
Controlled Activity Approval Required (Y / N)	N/A	WFL does not occur at this survey point.	-
Comments	<p>Segment 4 is mapped as a 2<sup>nd</sup> order stream and the location is now occupied by a swale along the NEH. Urban development has altered the hydrological and geomorphological characteristics of the landscape.</p> <p>The previously mapped hydroline is not present. The inspection showed stormwater infrastructure through an urban environment. No WFL features, such as a defined bed and bank or a change in vegetation indicating a wetland were identified.</p> <p>Survey Point 4.1 does not constitute waterfront land.</p>

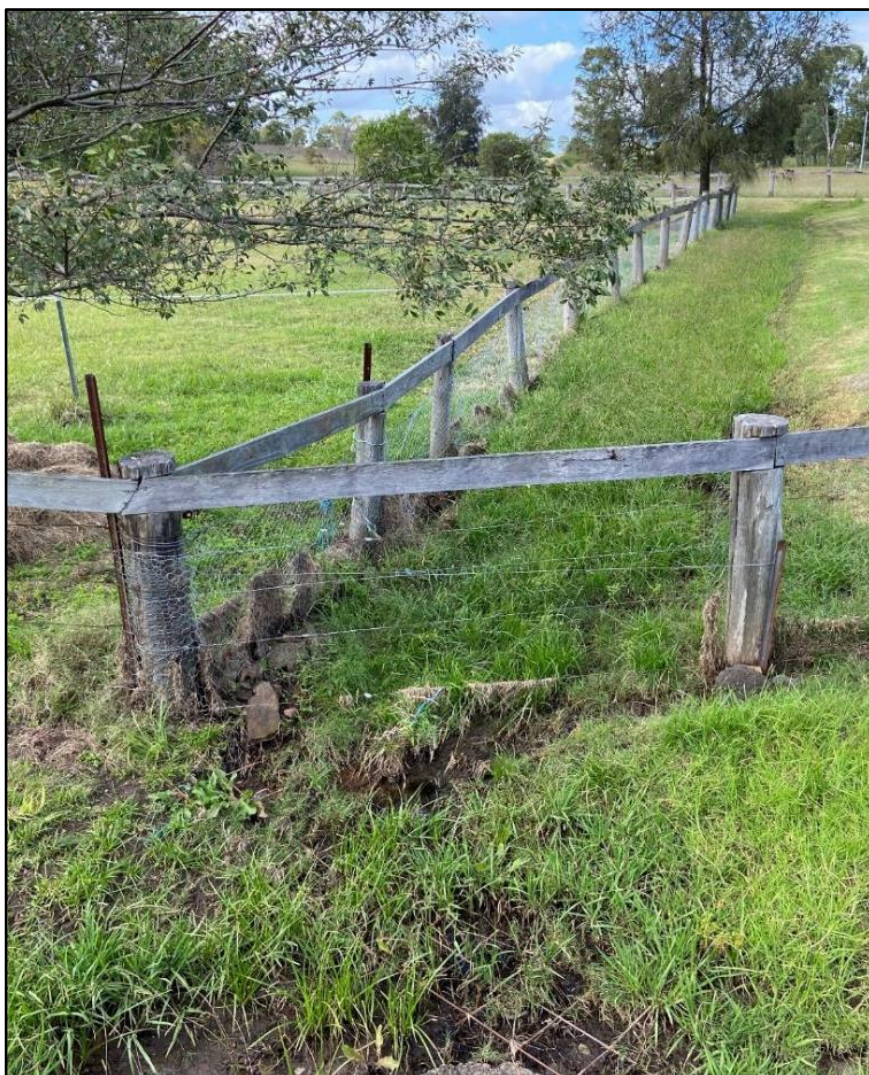
Survey Point 5.1 – mapped upstream

Task – Waterland Tool (2020)	Assessment	Comments (provide evidence)	Figures
Bank Vegetation (Toe to top of high Bank)	No native vegetation Present		
Riparian Vegetation (high bank to 40m)	None Present		
Controlled Activity Approval Required (Y / N)	N/A	WFL does not occur at this survey point.	-
Comments	<p>Segment 5 is mapped as a 2<sup>nd</sup> order stream. Urban development has altered the hydrological and geomorphological characteristics of the landscape. The adjacent rural property is occupied by a farm dam and dam overflow flows under an internal access road culvert and along a straight drainage channel to an existing culvert under Wyndella Road.</p> <p>The inspection showed farm and stormwater infrastructure through a modified environment. No WFL features, such as a defined bed and bank or a change in vegetation indicating a wetland were observed.</p> <p>Survey Point 5.1 does not constitute waterfront land.</p>

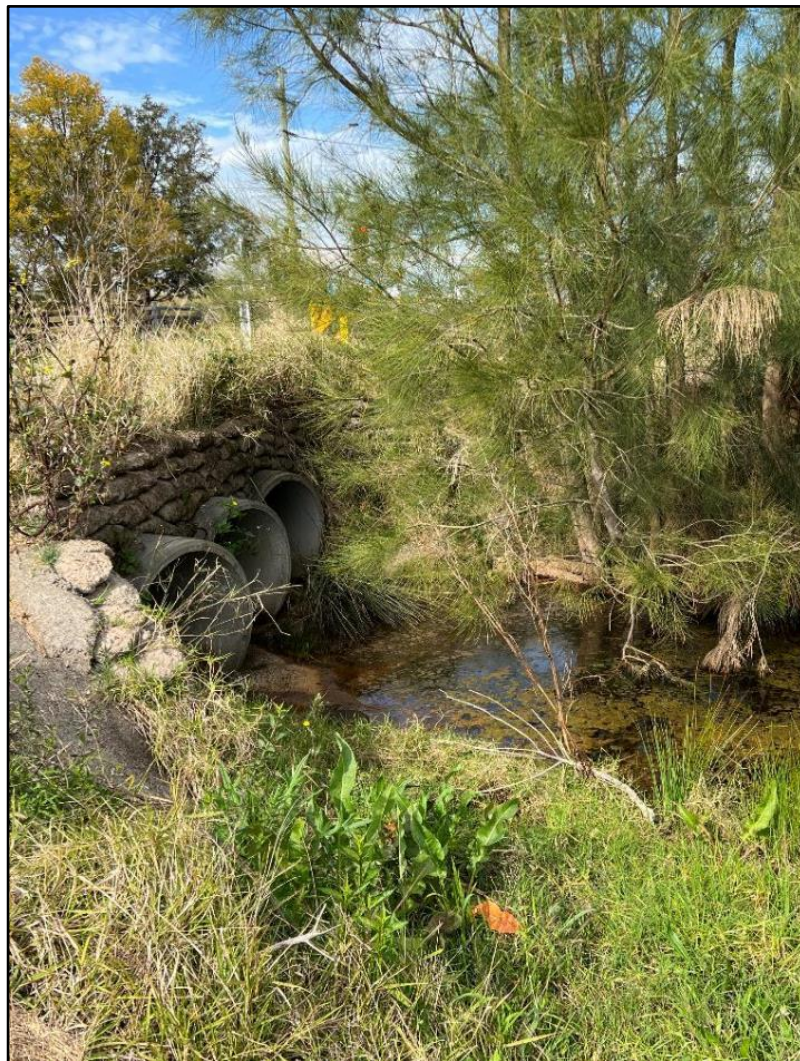
Survey Point 7.1 - upstream

Task – Waterland Tool (2020)	Assessment	Comments (provide evidence)	Figures
Bank Vegetation (Toe to top of high Bank)	<i>Casuarina glauca</i> present		
Riparian Vegetation (high bank to 40m)	<i>Casuarina glauca</i> present		
Controlled Activity Approval Required (Y / N)	Yes	CAA required for works within 40m of the top of banks.	6
Comments	<p>Survey Point 7.1 occurs at a culvert on the western side of Wyndella, Road. Discharge from the culvert has resulted in WFL and includes watercourse features such as a defined bed and bank, pools and a change in vegetation indicating a wetland.</p> <p>Survey Point 7.1 constitutes waterfront land and a CAA is required for works within 40m of the top of bank.</p>

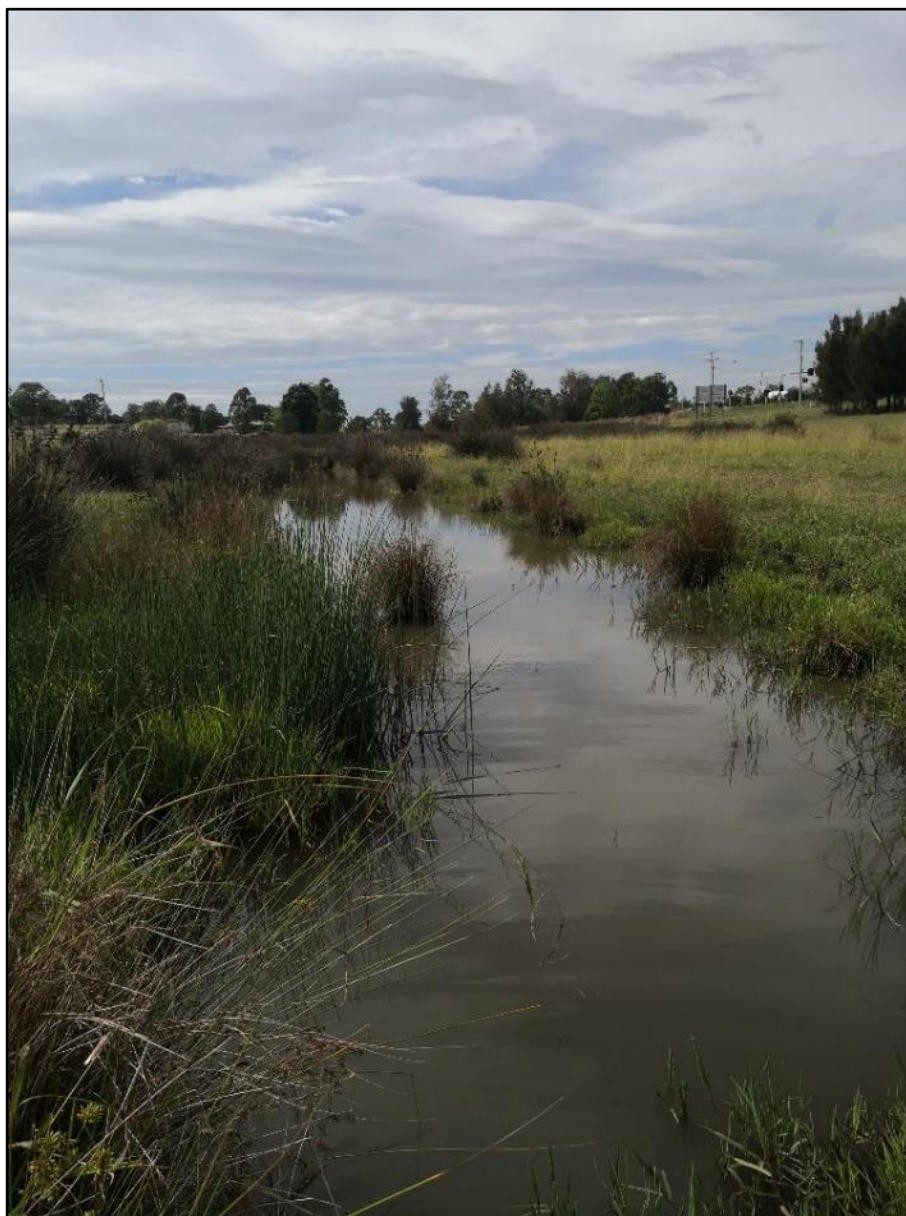
Survey Point 7.2 - upstream

Task – Waterland Tool (2020)	Assessment	Comments (provide evidence)	Figures
Riparian Vegetation (high bank to 40m)	None Present		
Controlled Activity Approval Required (Y / N)	Yes	CAA required for works within 40m of the top of banks.	6
Comments	Watercourse features are present at Survey Point 7.2. Survey Point 7.2 constitutes waterfront land and a CAA is required for works within 40m of the top of bank.

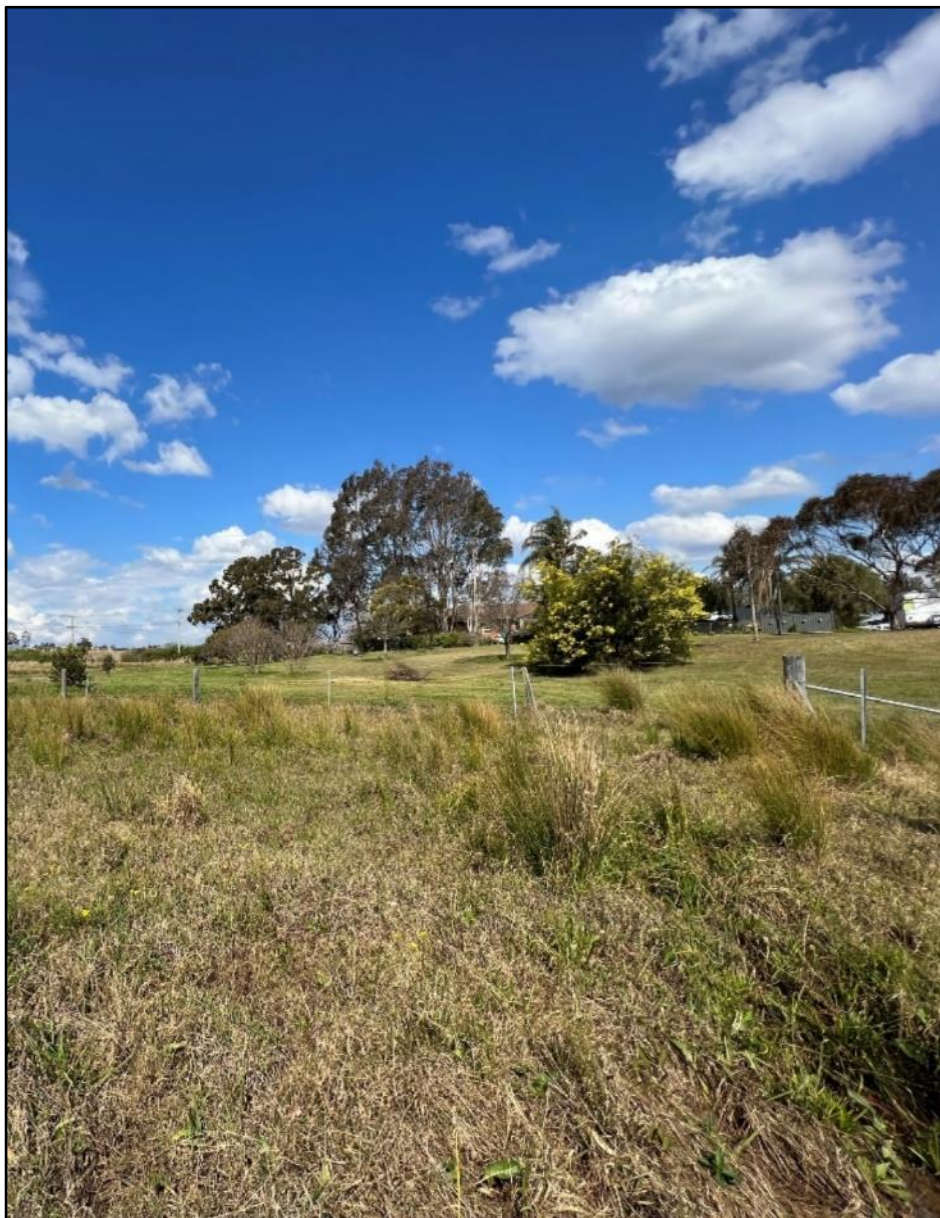
Survey Point 12.2 – mapped upstream

Task – Waterland Tool (2020)	Assessment	Comments (provide evidence)	Figures
Riparian Vegetation (high bank to 40m)	None Present		
Controlled Activity Approval Required (Y / N)	N/A	WFL does not occur at this survey point.	-
Comments	A roadside swale along the NEH and recently constructed detention Basin for a subdivision development on the southern side of the NEH have likely altered the hydrological and geomorphological characteristics of the landscape. No WFL features, such as a defined bed and bank were observed. Inundation due to discharge from the NEH culvert has resulted in sporadic occurrence of <i>Juncus spp.</i> Survey Point 12.2 does not constitute waterfront land.		
Site Photos – Survey Point 12.2

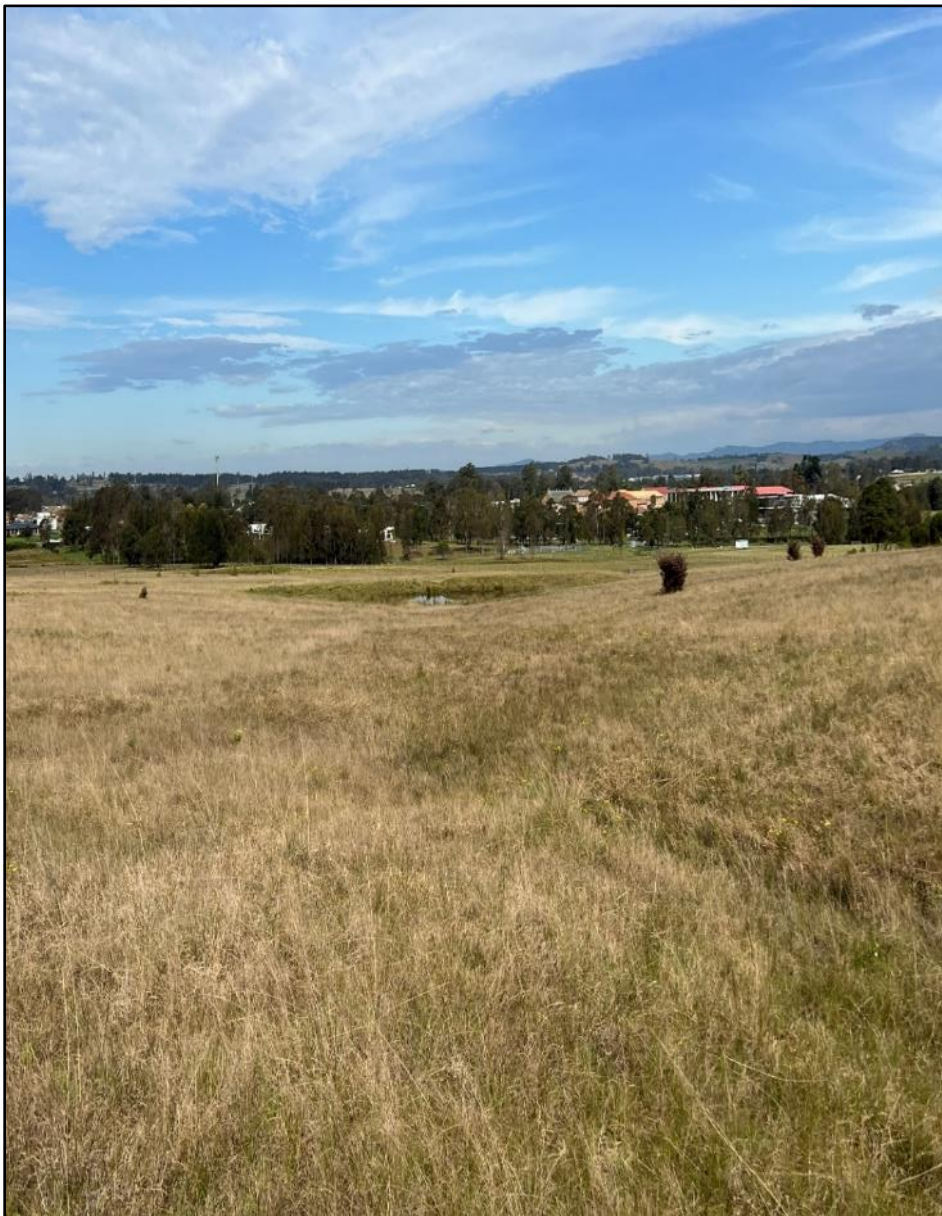
Survey Point 14.1 – mapped downstream

Task – Waterland Tool (2020)	Assessment	Comments (provide evidence)	Figures
Riparian Vegetation (high bank to 40m)	None Present		
Controlled Activity Approval Required (Y / N)	N/A	WFL does not occur at this survey point.	-
Comments	Survey Point 14.1 is occupied by managed grassland. Rural development has likely altered the hydrological and geomorphological characteristics of the landscape through pastoral land use and construction of farm dams and drainage lines. No WFL features, such as a defined bed and bank or a change in vegetation indicating a wetland. Survey Point 14.1 does not constitute waterfront land.		
Site Photos – Survey Point 14.1

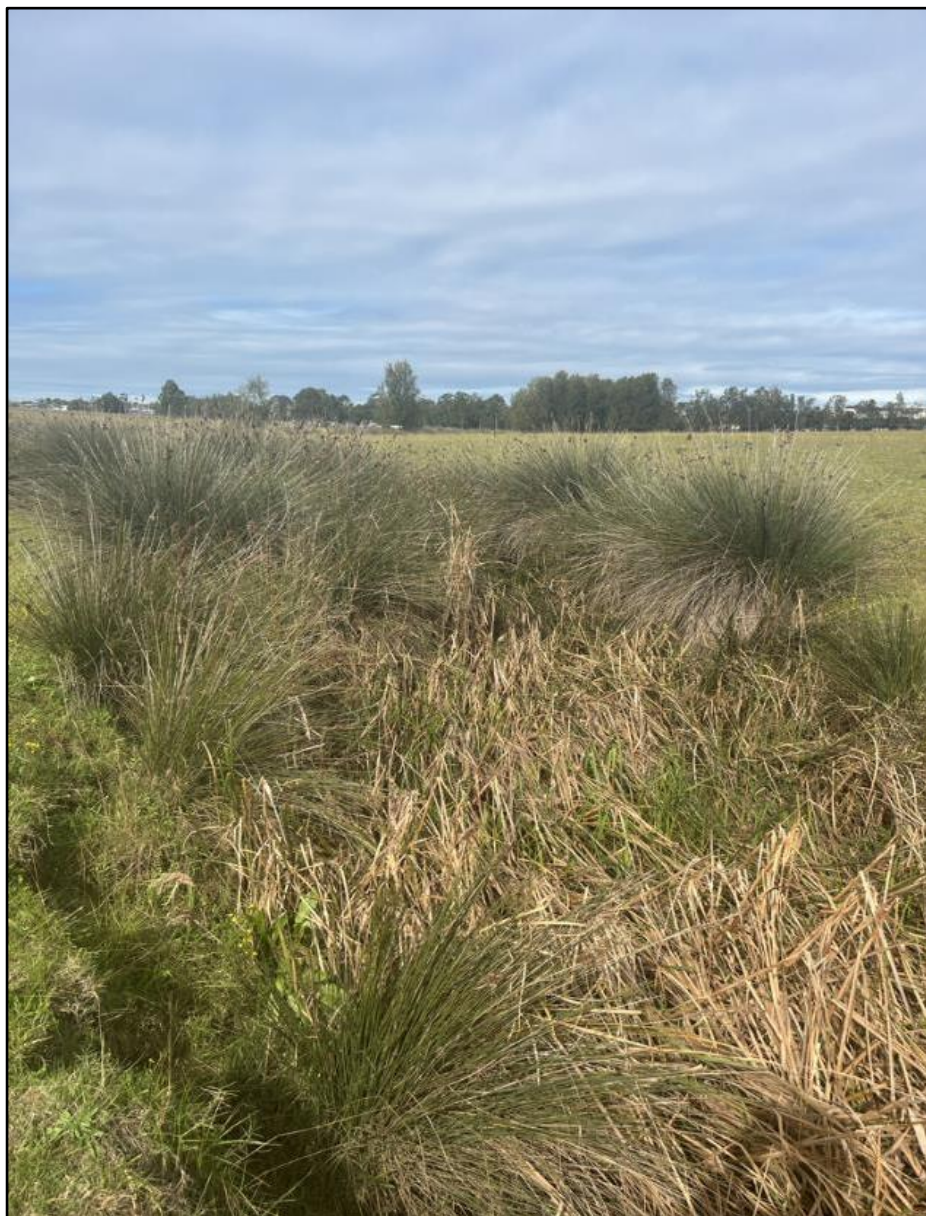
**Survey Point 21.4 - upstream**

Task – Waterland Tool (2020)	Assessment	Comments (provide evidence)	Figures
Riparian Vegetation (high bank to 40m)	None Present		
Controlled Activity Approval Required (Y / N)	Yes	CAA is required for works within 40m of the top of banks.	6
Comments	Watercourse features are present at Survey Point 21.4. Survey Point 21.4 constitutes waterfront land and a CAA is required for works within 40m of the top of bank.		
Site Photos – Survey Point 21.4

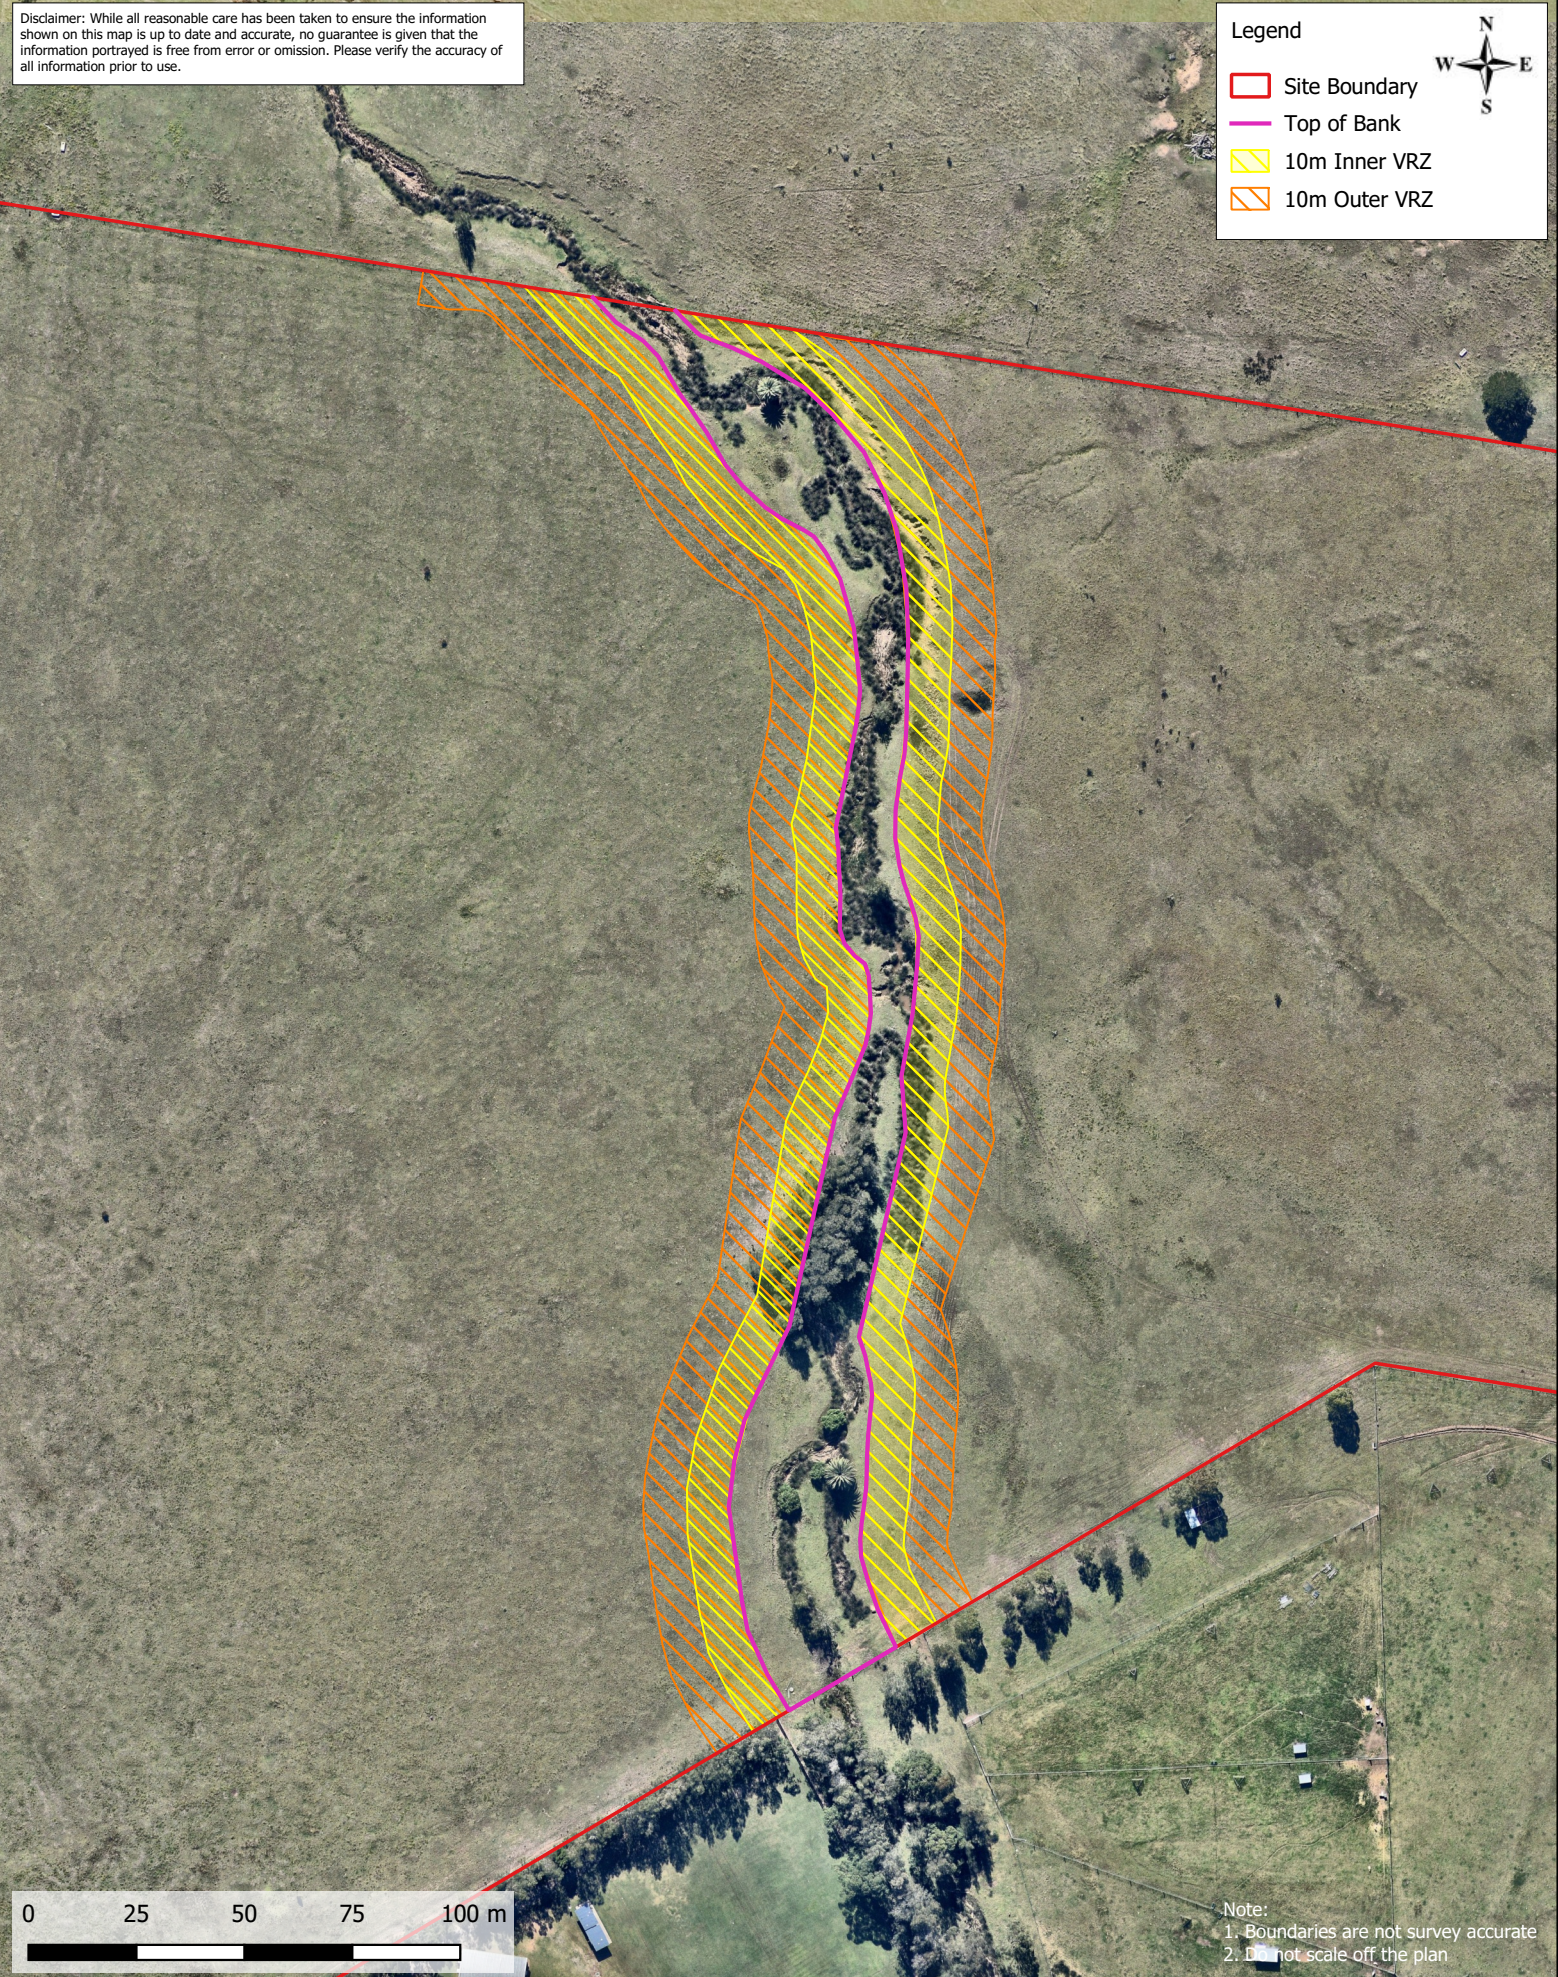
Figure 8 - Vegetated Riparian Zones

The native vegetation within the Waterfront land has been ground-truthed, and contains one (1) Plant Community Type (PCT), in one (1) condition class with the remaining area being non-native and Planted Native. The PCT present within the Waterfront Land is PCT 4023 - *Coastal Valleys Riparian Forest* (0.11ha) in poor condition (refer **Figure 8**).
