PRELIMINARY (ENVIRONMENTAL) SITE INVESTIGATION

PROPOSED CHILD CARE CENTRE

33 STEAM STREET
MAITLAND, NSW

For: BROWN COMMERCIAL BUILDING P/L

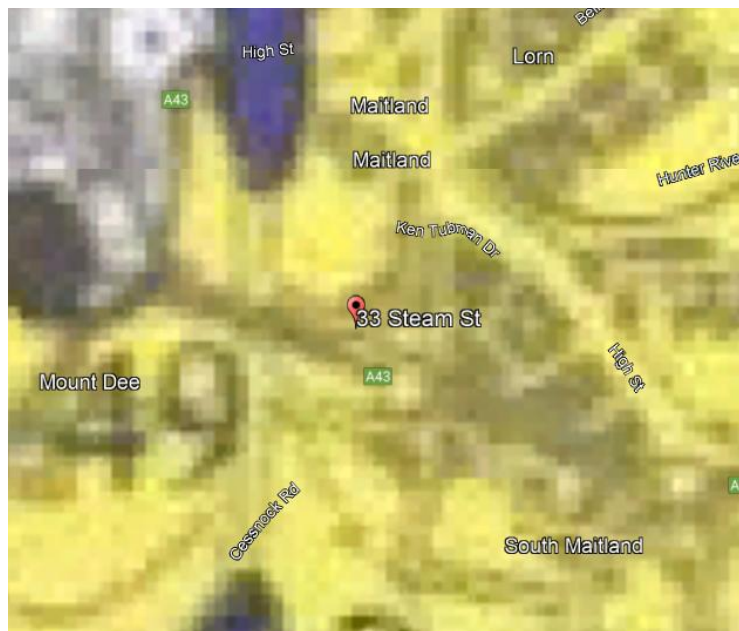
Reference to the 1:250K Newcastle Regional Geology Map S1 56-2 indicates that the site is underlain by Quaternary Alluvial deposits comprising sand, gravel, silt and clay with residual deposits to the south of the site as shown below.

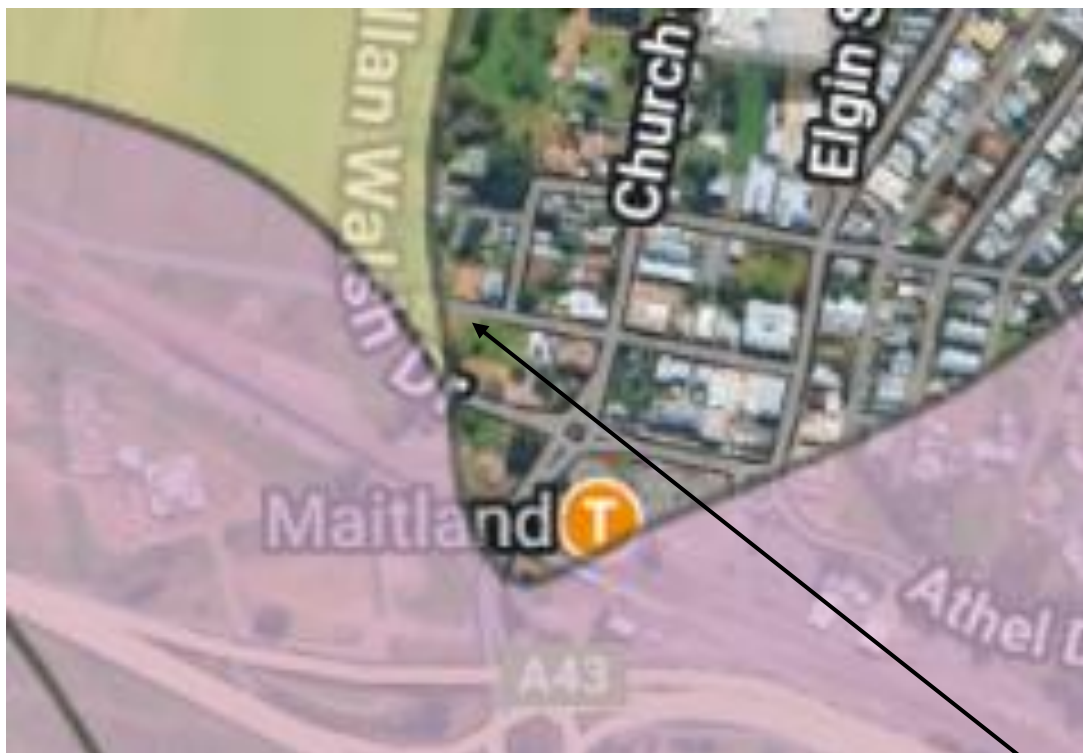
Reference to eSpade indicates that the site is not in an area of known Acid Sulfate Soils as shown below with the possibility of ASS material below 4m depth on the lowest western corner of the site:

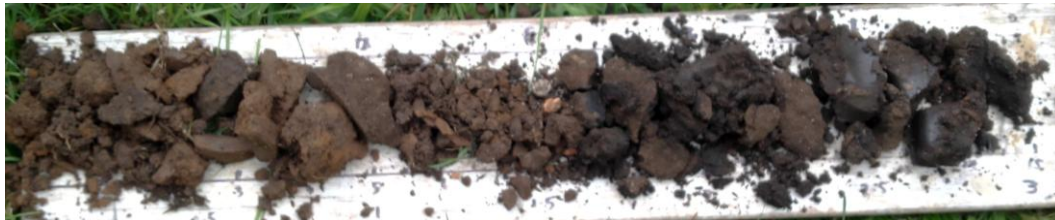
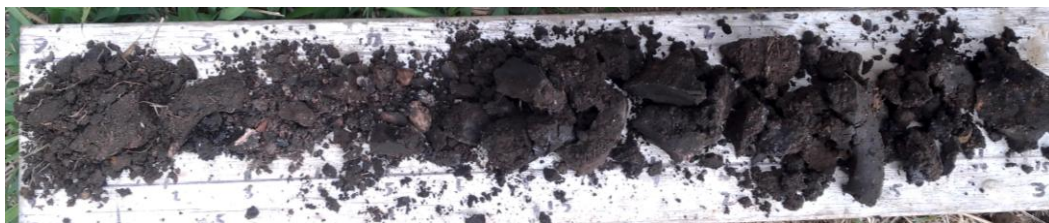
EXAMPLES OF BOREHOLE SPOIL

SOIL UNIT	SOIL TYPE	DESCRIPTION	DEPTH BGL
UNIT 1	FILL	Silty SAND; fine to medium grained, dark brown, low plasticity fines, dry becoming moist, loose, bricks @ various depths and locations	0.5 – 1.5
UNIT 2	ALLUVIUM	Sandy CLAY; low to medium plasticity, dark brown to black, moisture less than or equal to the plastic limit, stiff	0.5 – 3.0 +

Standing groundwater was NOT encountered in the boreholes above termination depth of 3m at the time of assessment. It should be noted that fluctuations in the groundwater levels can occur as a result of seasonal variations, temperature, rainfall and other similar factors, the influence of which may not have been apparent at the time of investigation.

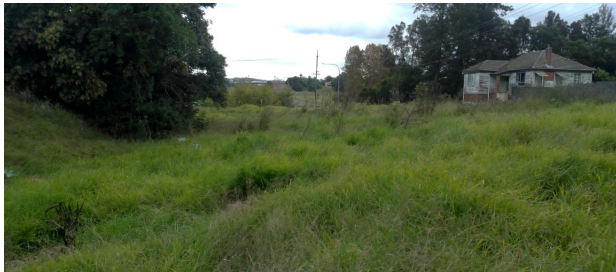
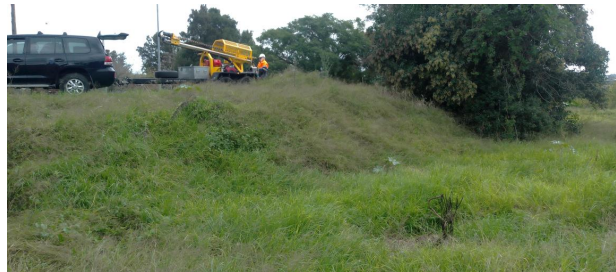
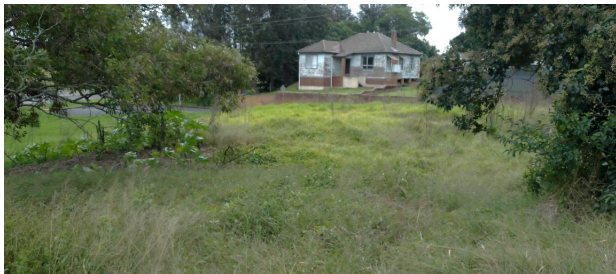
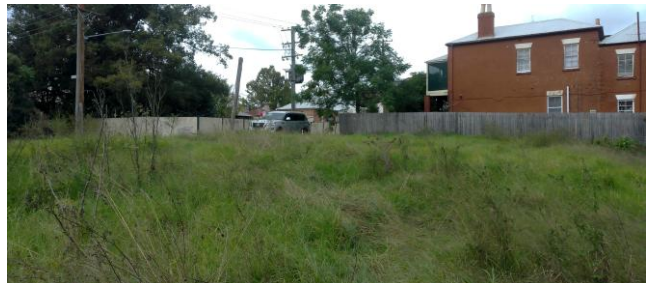
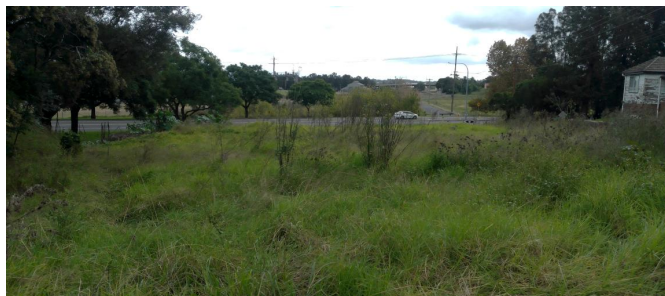
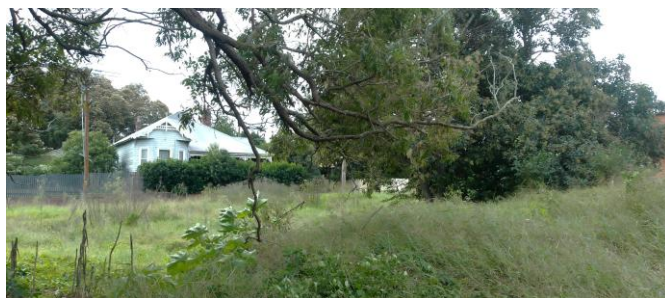
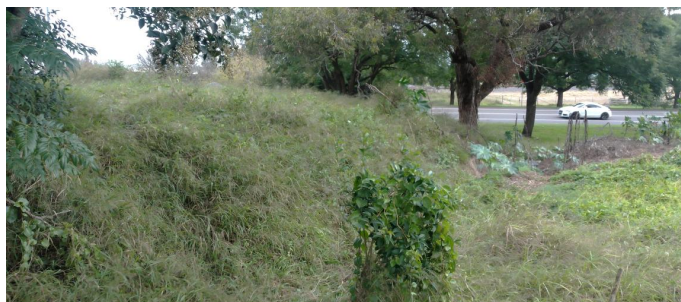
Current Site Use

Currently the site is vacant as seen in the photographs below:

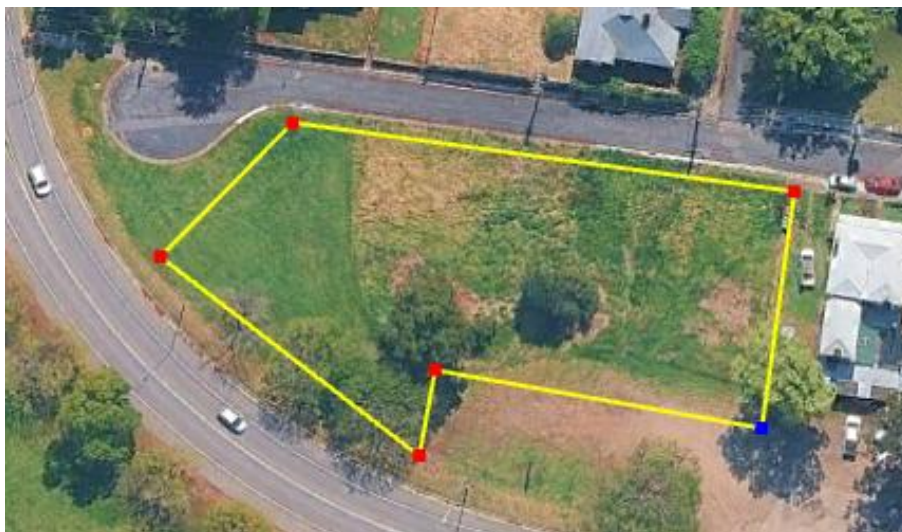
CURRENT SITE SONFIGURATION AT TIME OF ASSESSMENT

2025 Colour	The site in its current configuration	The site remains similar to the previous image.

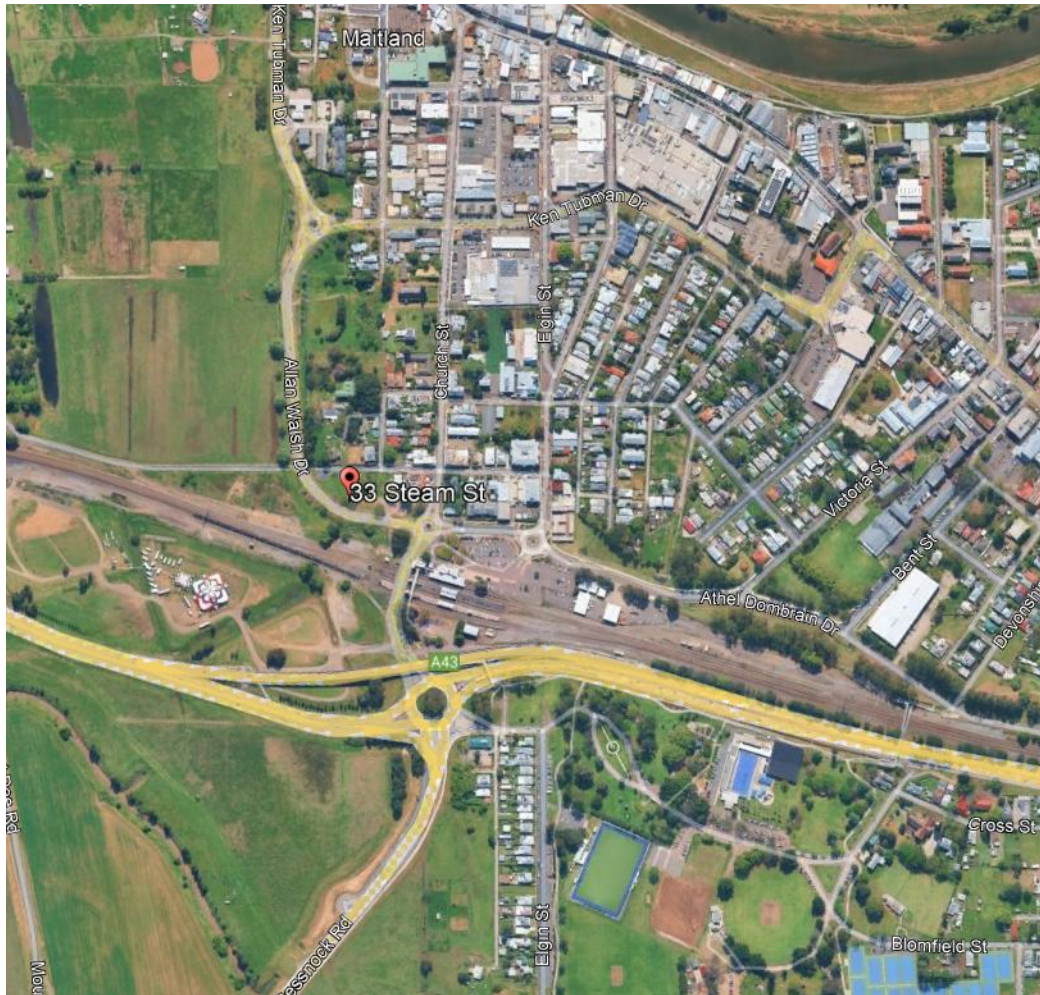
FIGURE 1 – SITE LOCATION

The site is located on the southern side of Steam Street immediately north of Alan Walsh Drive and immediately north west of the roundabout that intersects Alan Walsh Drive and Church Street adjacent to the Maitland Train Station and is about 80m north of the existing rail line in the location as shown on the attached Figure 1.

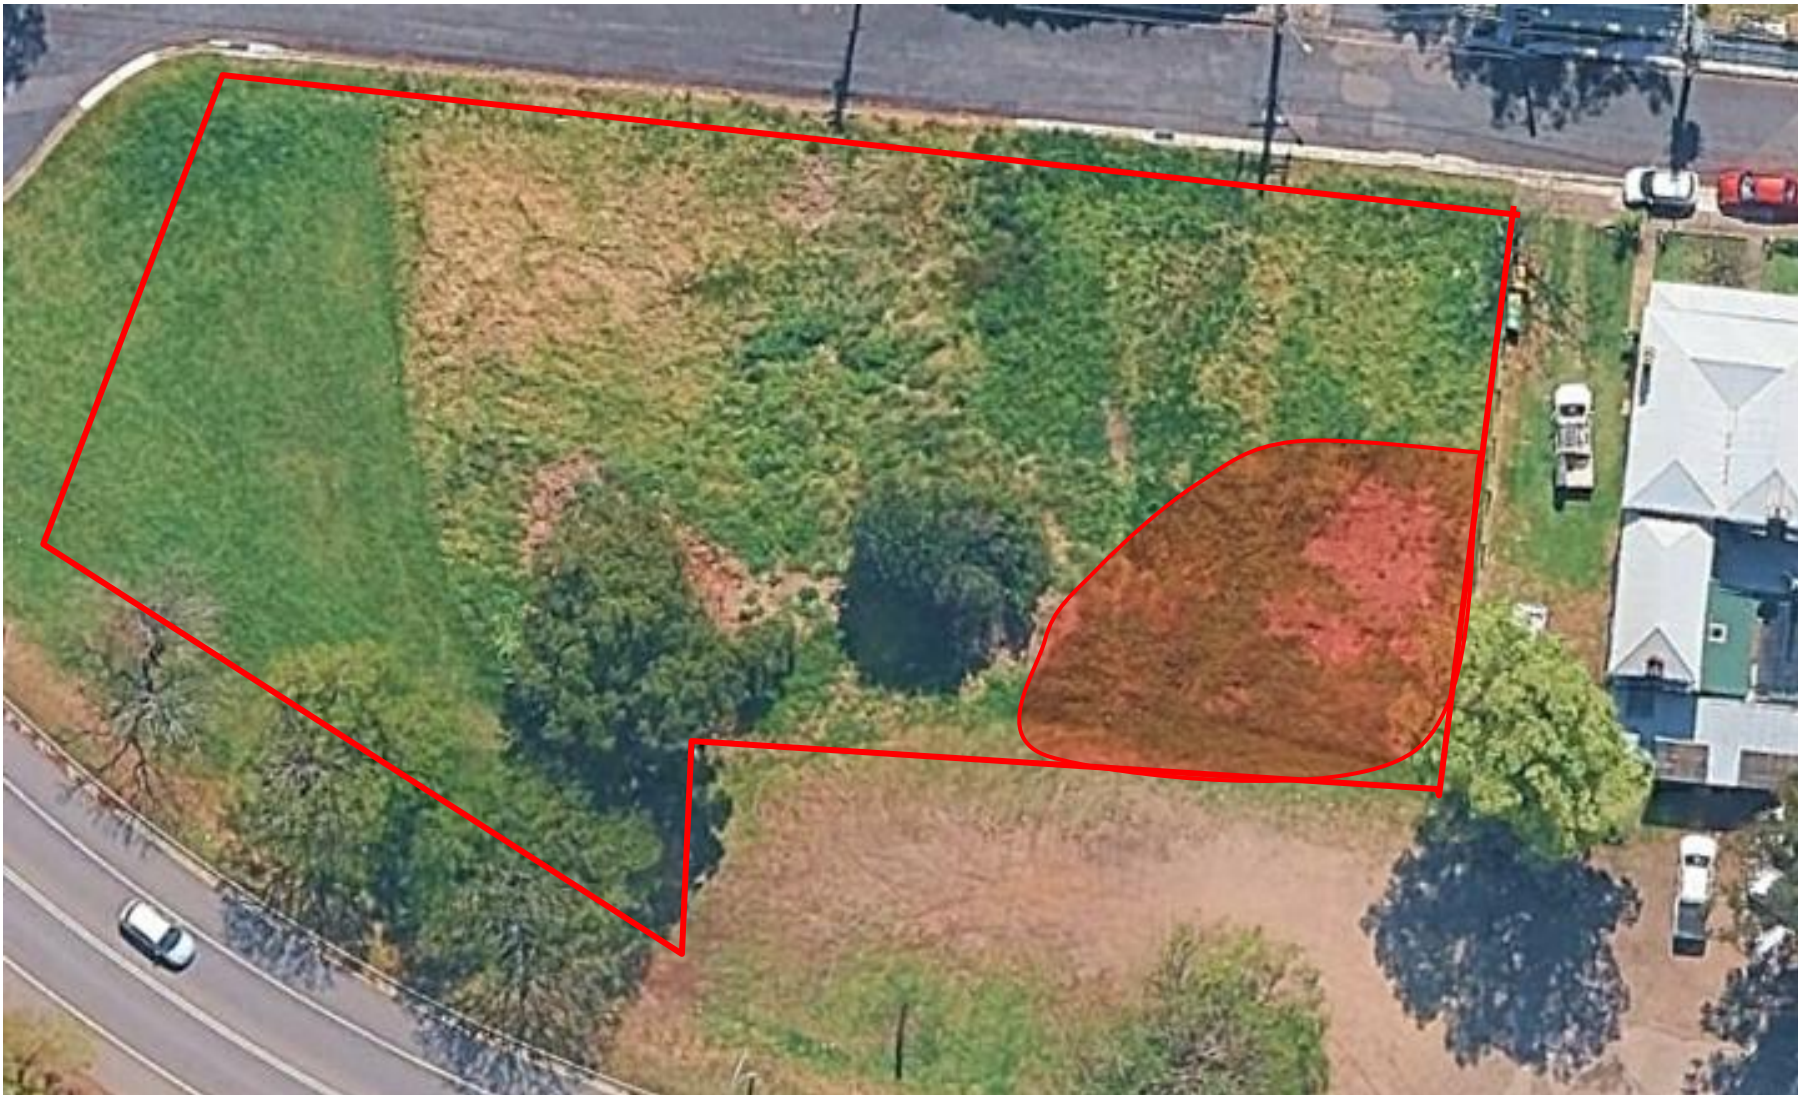
FIGURE 4 – APPROXIMATE AREA REQUIRING FURTHER ASSESSMENT AND DELINEATION

In summary Lead concentrations exceeded Health Investigation Levels (HIL) Threshold Guideline concentrations at one location in the order of 2X and 5X the guideline limit.

It is recommended that further assessment and delineation of the lead impacted area in the south eastern corner of the site be undertaken followed by remediation of this area. A Remedial action Plan (RAP) should be prepared based on the collected data to guide the remediation of this area of the site prior to construction activities by way of offsite removal of contaminated material where elevated Lead concentrations were detected after classification as per the relevant assessment (likely General Solid Waste).
