## **Statement of Heritage Impact**

Demolition of Outbuildings

Alterations and Additions to Residence

‘Riverview’

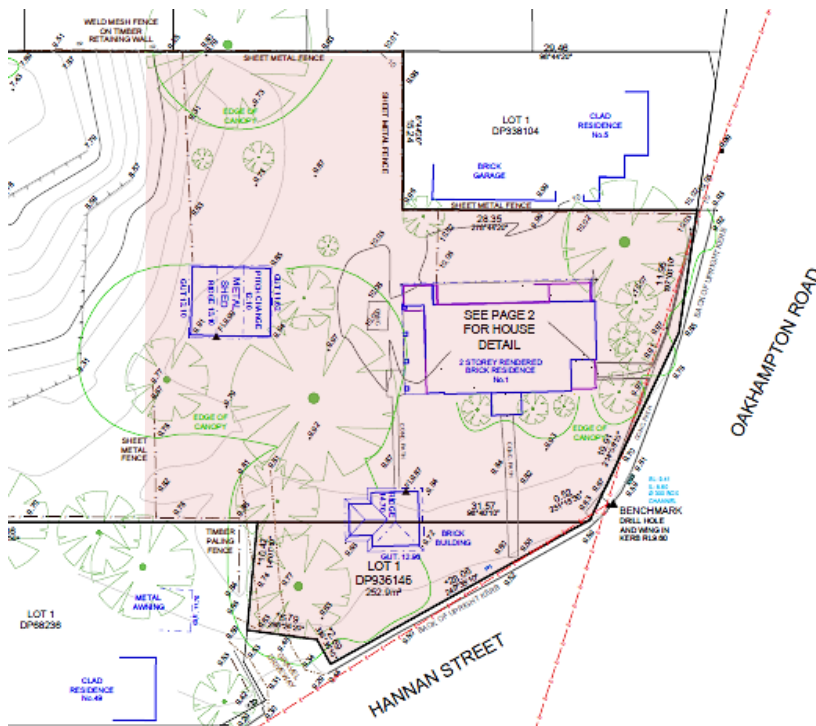
The area of the site of for the proposed works is indicated below, being the shaded part of the site survey drawing:

Image 6: Approximate position on site for the proposed works area (shaded)

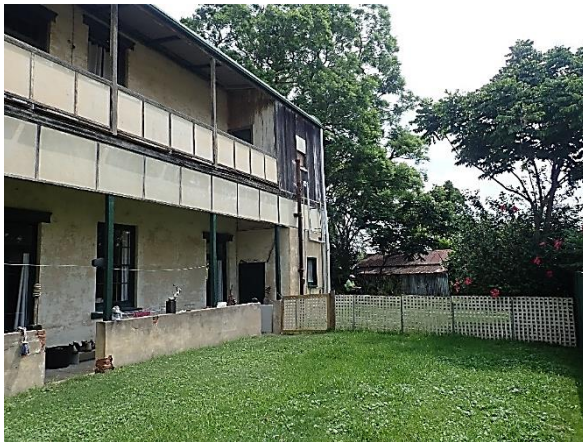
Image 11: north elevation hospital panels  
Source: Placemark 2024

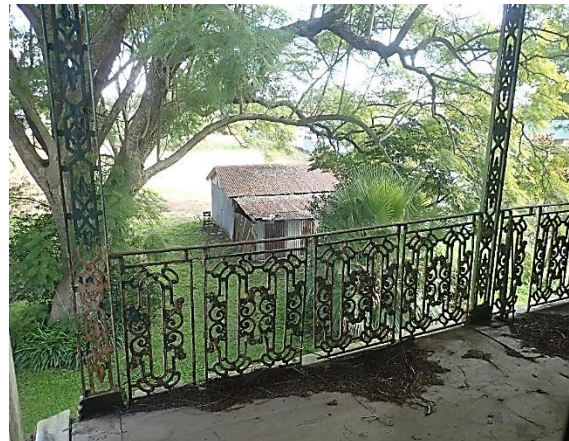
Image 14: west verandah & cast lacework  
Source: Placemark 2024

The four timber columns under the west verandah and associated cast iron columns and balustrade panels are noted 'to be restored'. At the southeast corner Entry new cast iron cast iron columns and lacework as shown to reconstruct the former entry detail, porch and corner verandah above.

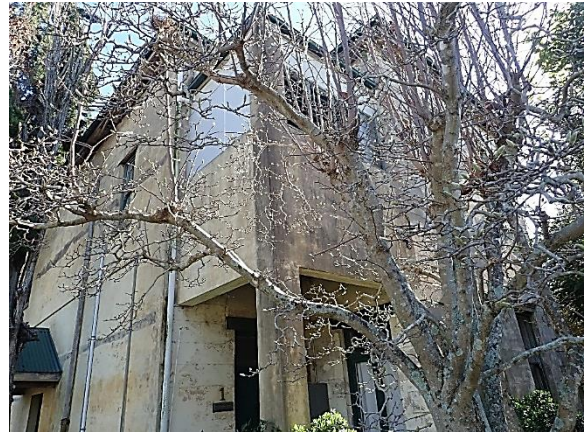
Image 16: enclosed S-E balcony & render  
Source: Placemark 2024

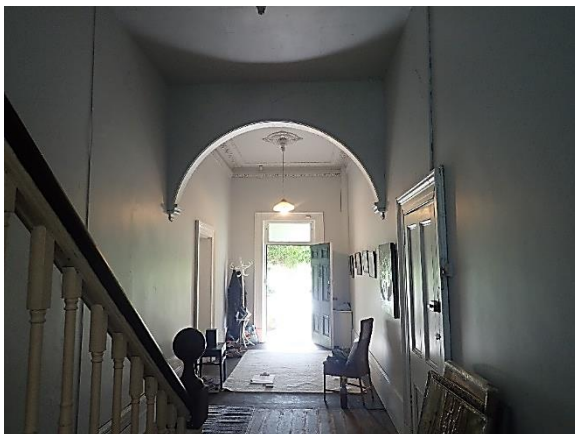
Image 19: Hall. Partition wall removed  
Source: Placemark 2024

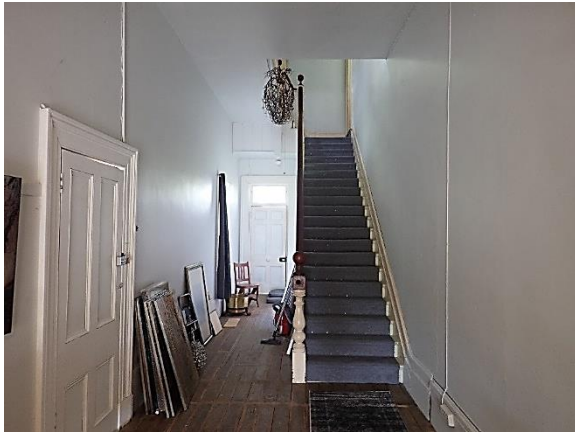
Image 21: Hall, back door & altered stair  
Source: Placemark 2024

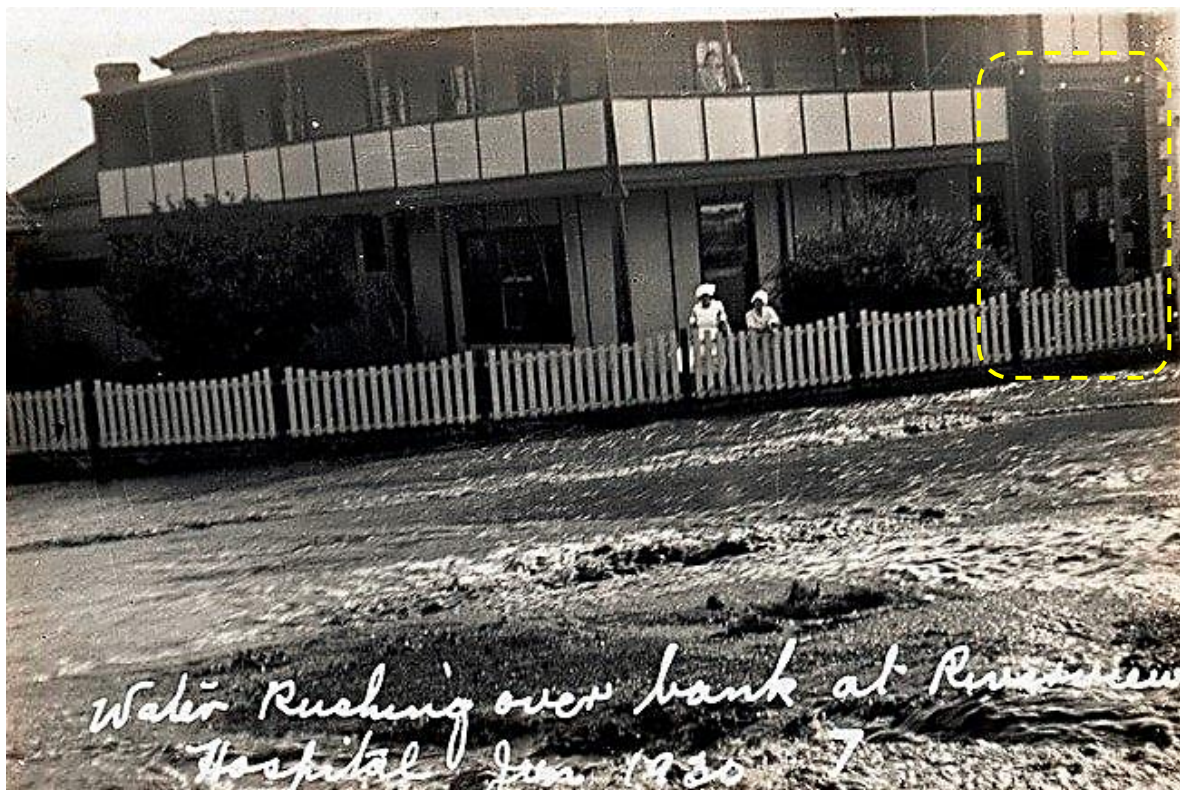
The 1930 photograph below shows the Hospital additions, the battened panels that were used on three elevations, perhaps to give it an overall, institutional appearance? They cover the lacework balustrade. This photo also shows another building behind, to the west.

Image 57: Riverview Private Hospital Maitland Flood 1930. Note entry cast iron column.  
 Source: Maitland Library Collection

The corner of the Theatre building's roof can also be seen in the photo.

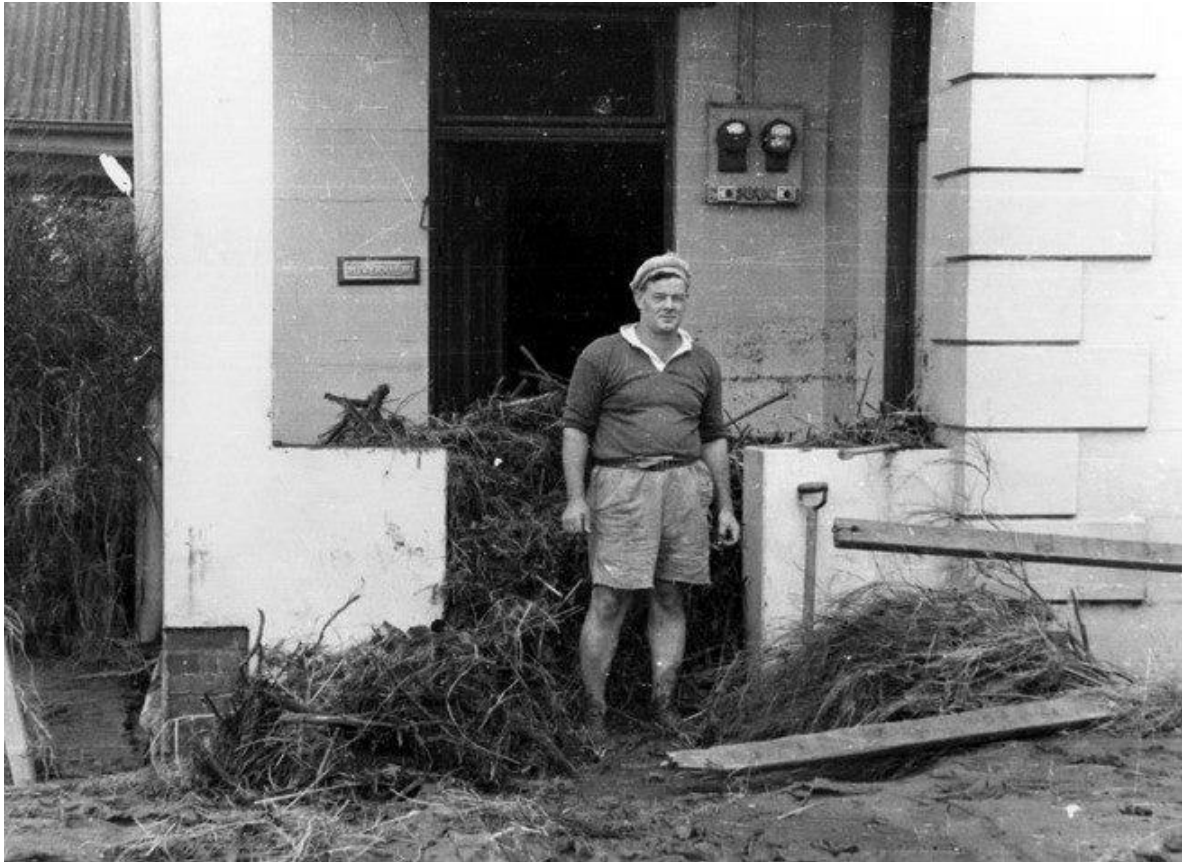
Image 58: Riverview House Maitland Flood 1955. Note cement rendered column.  
Source: Maitland Library Collection. Owner Mr Spruce flood cleans up.

The 1955 photo above shows a missing short garden wall (corner) and shows the numeral 1 with 'Riverview' that are still displayed on this wall. Given the debris, the interior was also flooded, perhaps to just below dado height.

It is likely that after the removal of the hospital's additions an additional skin of cement rendered brickwork, with a side entry were added to the south wall and the cast iron column at the front entry was removed and replaced with rendered brickwork.

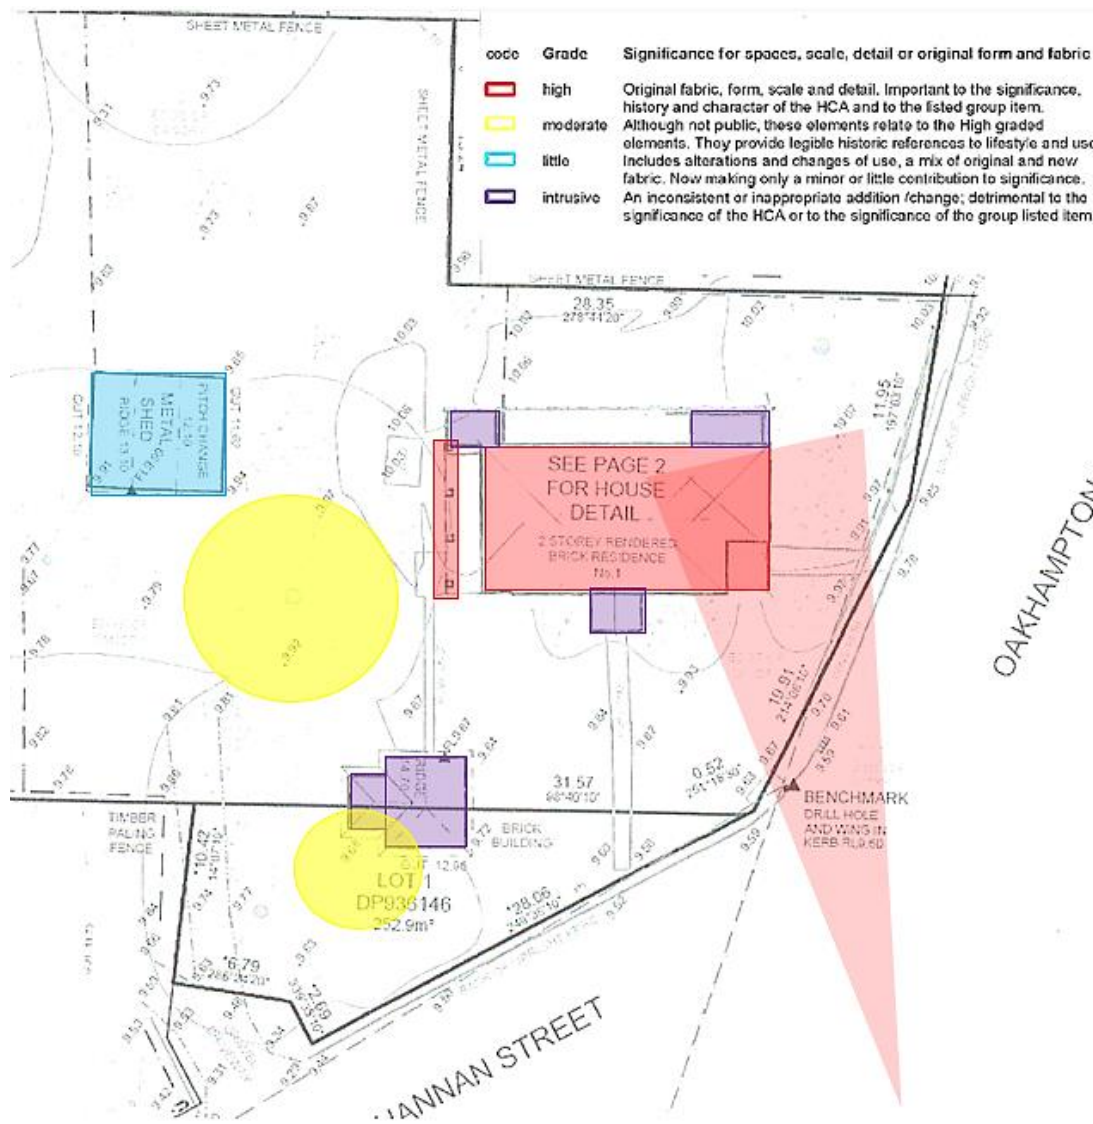
Note the following diagrams below use colours to identify the assessed contribution, for example, the shed- little or none; the two trees – moderate; the infills and additions to the more original form of the building – Intrusive; the 1930's operating theatre- Little to None, Intrusive; the western verandah columns and cast iron lacework- High; the sightline to the S-E corner-High.

Image 60: SITE- Diagram for Grading of Contribution Assessment  
Source: Placemark Consultants

The restoration of the southeast corner would further contribute to the value of the sightline from both the north and south, along Sempill St / Oakhampton Road. Those views take in the chimney, the roof and wall corner quoin details.

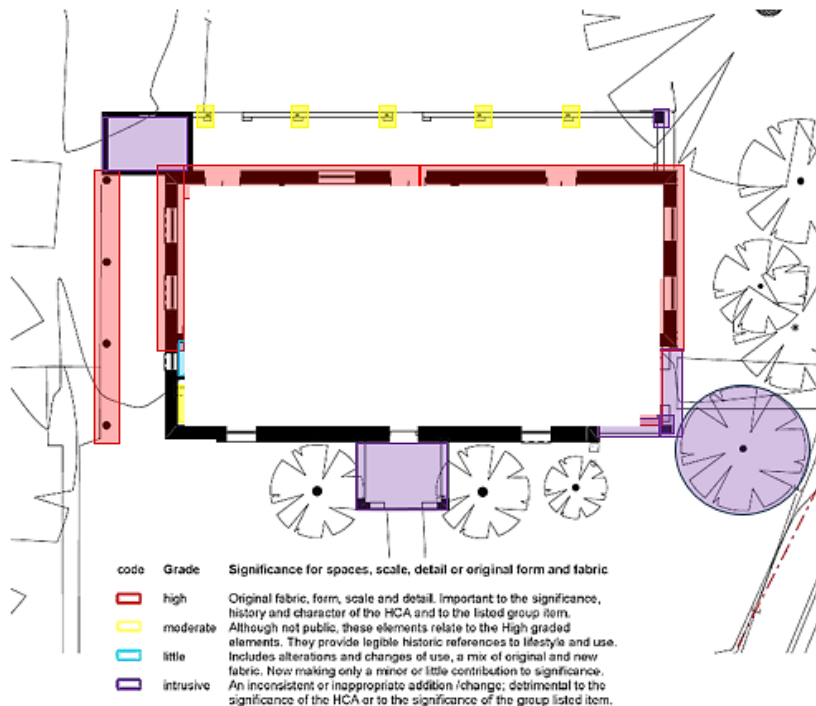
The bathroom infill at the N-W corner – Intrusive; the entry portico at the southern wall- Intrusive; the magnolia- Intrusive [proximity to the building and important sightline]; the brickwork and cement render at the S-E Entry - Intrusive; the Entry, french doors, entry door and name- High; the built form and external walls of the building- High ;the arch in the hallway- High; the N-E front 'good room' - High; the central fire place both sides- High; timber columns supporting west verandah – High; the setout of the posts along the northern verandah at two levels- Moderate; the space of the hall; dining- Moderate; Partition- Intrusive; Stair -Moderate to Little [relocated, altered].

Image 61: HOUSE GROUND FLOOR - Diagram for Grading of Contribution Assessment  
Source: Placemark Consultants

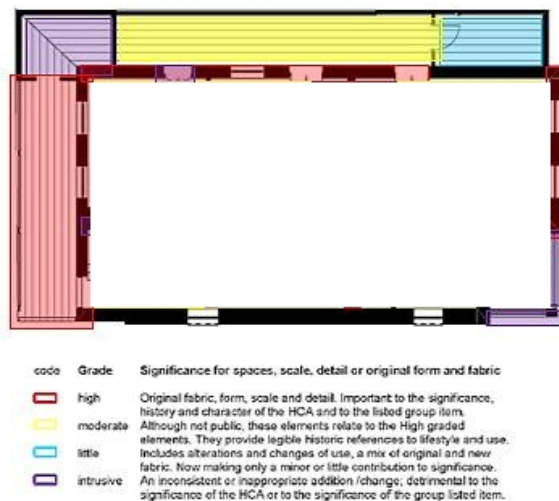
The bathroom infill at the N-W corner – Intrusive; the infill of the S-E porch- Intrusive; the open S-E porch- High; the 2 steps and narrow door opening at the top of the stair- Intrusive; the wide, low door onto the north verandah from the back room- Intrusive; a north verandah (not the hospital panels) – Moderate; Linen store north verandah- Little or None; the stair- Moderate to Little [relocated, altered];the north, east and west external walls- High; the line of the archway below in the void above- High; the spaces- Moderate, note the flat's Kitchen- Intrusive. The south wall has openings closed, new openings and an additional external brick skin which modified the eaves overhang. Some of that wall is coursed in the cement render, some not.

Image 62: HOUSE UPPER FLOOR - Diagram for Grading of Contribution Assessment  
Source: Placemark Consultants

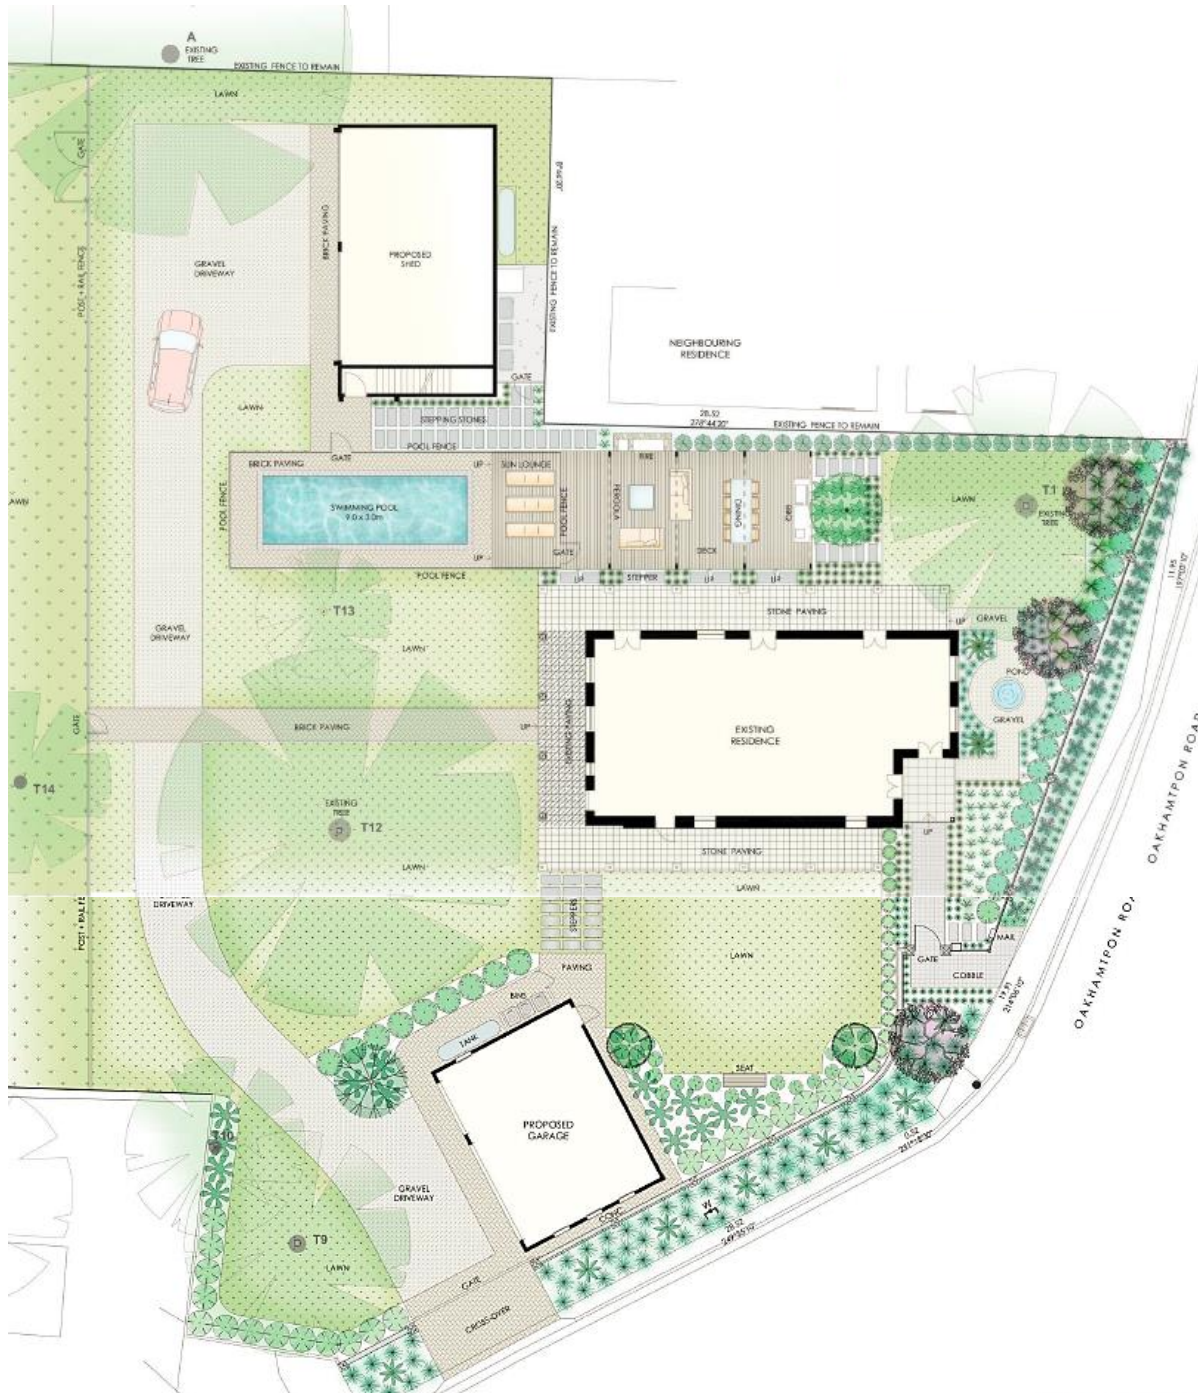
The proposed gardens and landscape design shows an open presentation to the Oakhampton Road in the east (views to the river at ground level are blocked by the levee). A pedestrian entry at the corner provides 'an address', a 'corner' and a transition between a picket fence with formal 'Victorian' influenced gardens and a 'privacy' brick fence with driveway gate at Hannan Street. Gardens are shown outside that fence. Major trees are retained. The space around 'Riverview House' is shown retained and more accessible. Unit paving paths connect the outbuildings and pool with house. A gravel driveway is shown along the back, west side of the site.

Image 64: the setting for 'Riverview House'

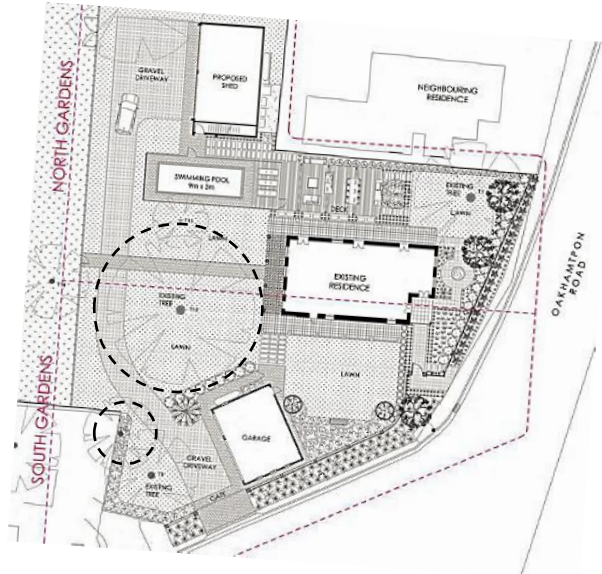
Image 66 : Landscape Site Plan  
Source: Octopus Garden Design DA01 May 2025

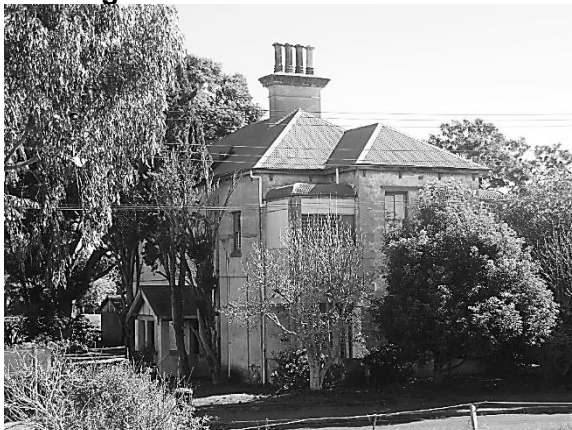
Images 67:Original Entry southeast corner  
Source: Placemark- Viewed from levee bank

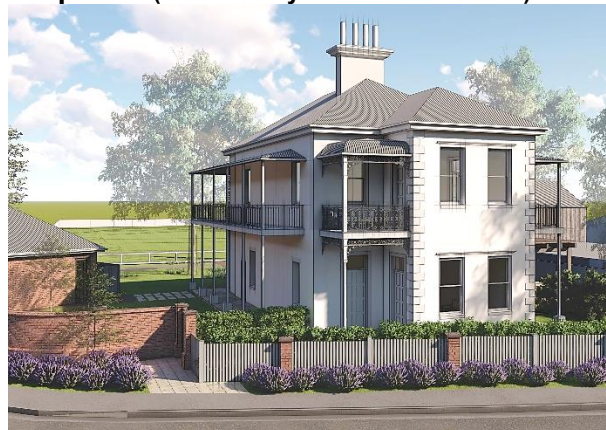
South wall activated. Open corner reinstated.  
Source: Hutch Architecture model

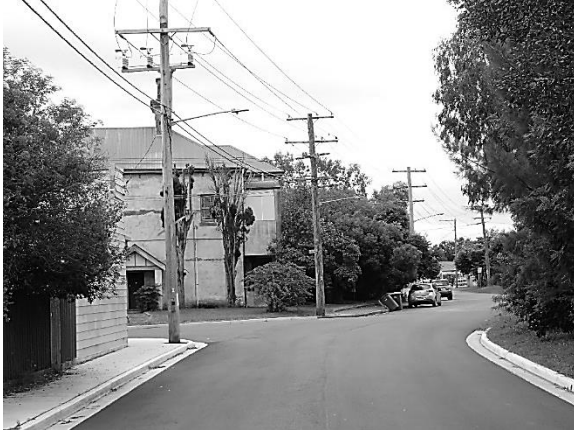
Images 68: Sightline view south elevation  
Source: Placemark- Viewed from Sempill Street

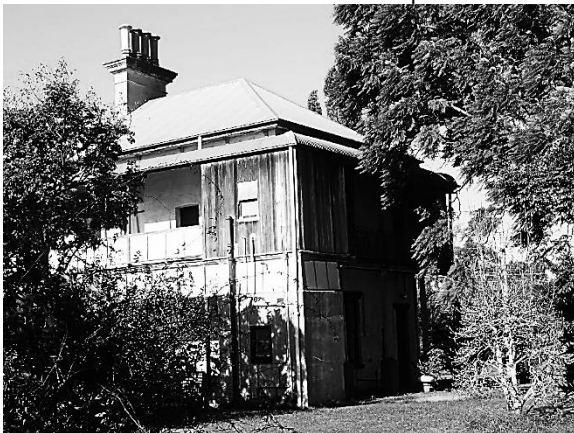
Images 69: Northwest corner & columns  
Source: Placemark- Viewed from back yard

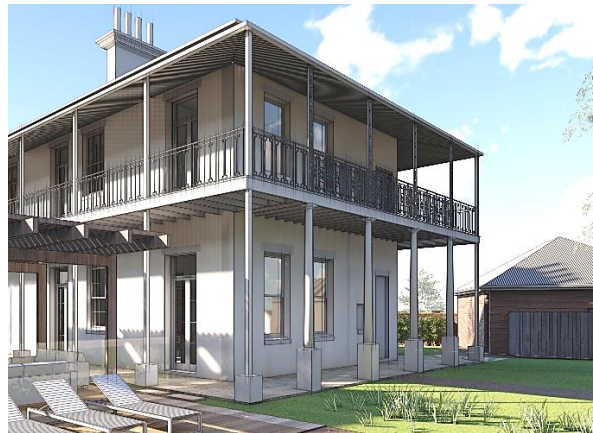
Infill removed. Verandahs re-connected.  
Source: Hutch Architecture model

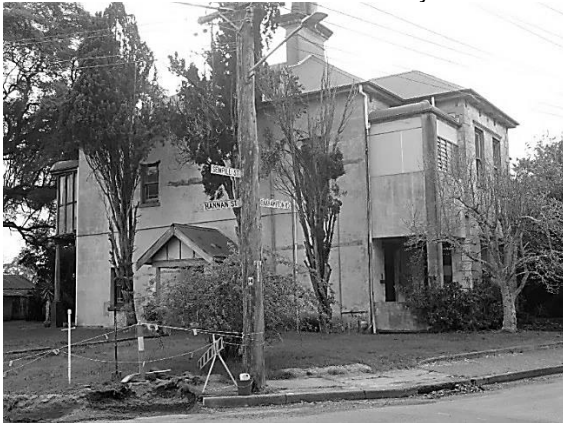
Images 70: Altered south wall & corner  
Source: Placemark- Viewed from corner

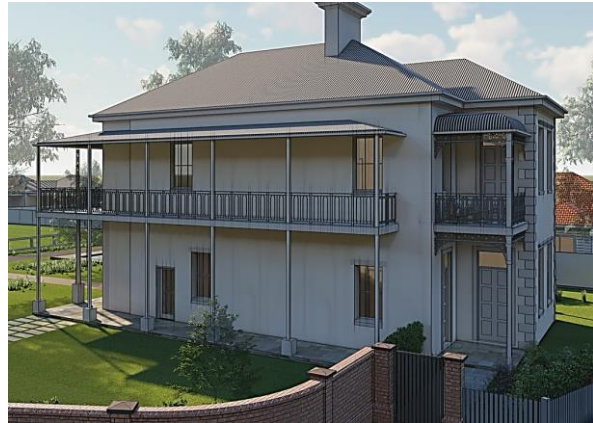
New verandah. Opens the street corner.  
Source: from Hutch Architecture 'fly-around'

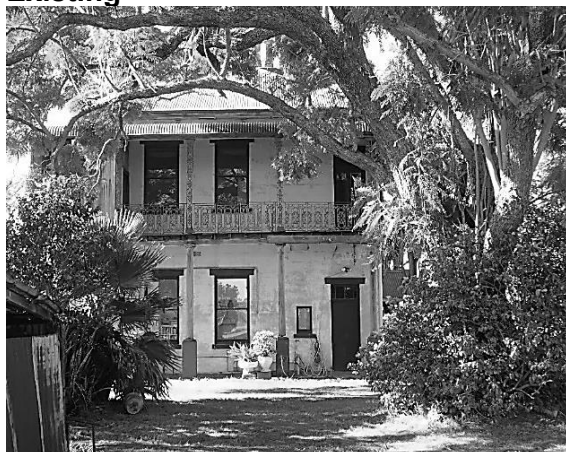
Images 71: Northwest corner & columns  
Source: Placemark- Viewed from levee bank

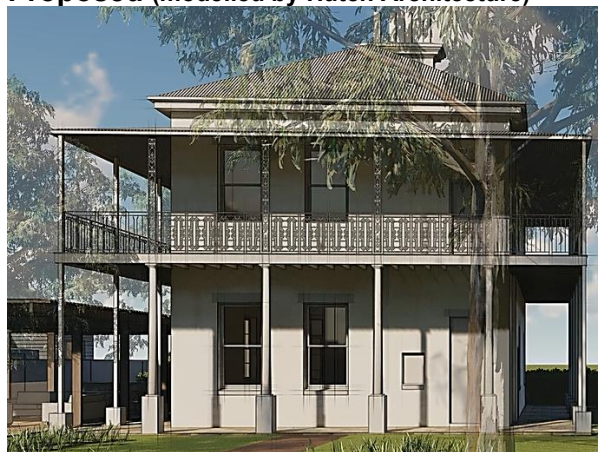
Infill removed. Verandahs re-connected.  
Source: Hutch Architecture 'fly-around'
