## Walka Water Works

Historical Archaeological Assessment

Maitland City Council

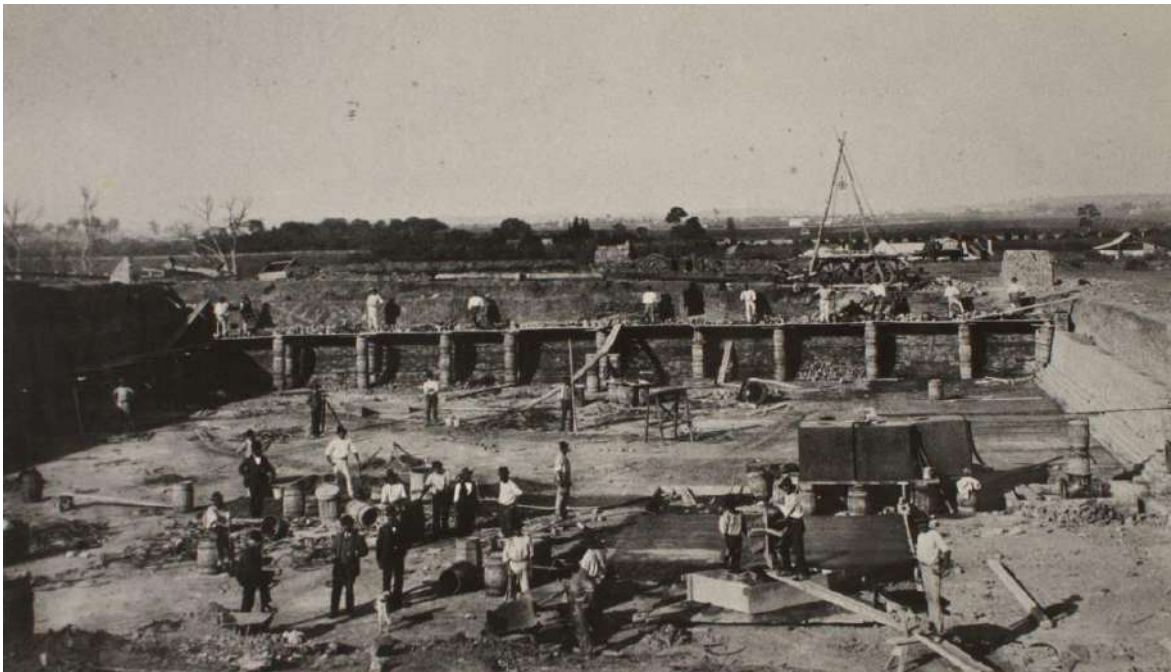
Figure 11: Construction of the setting tank in 1885. Showing the construction methods and materials employed. Photo supplied by Maitland City Council

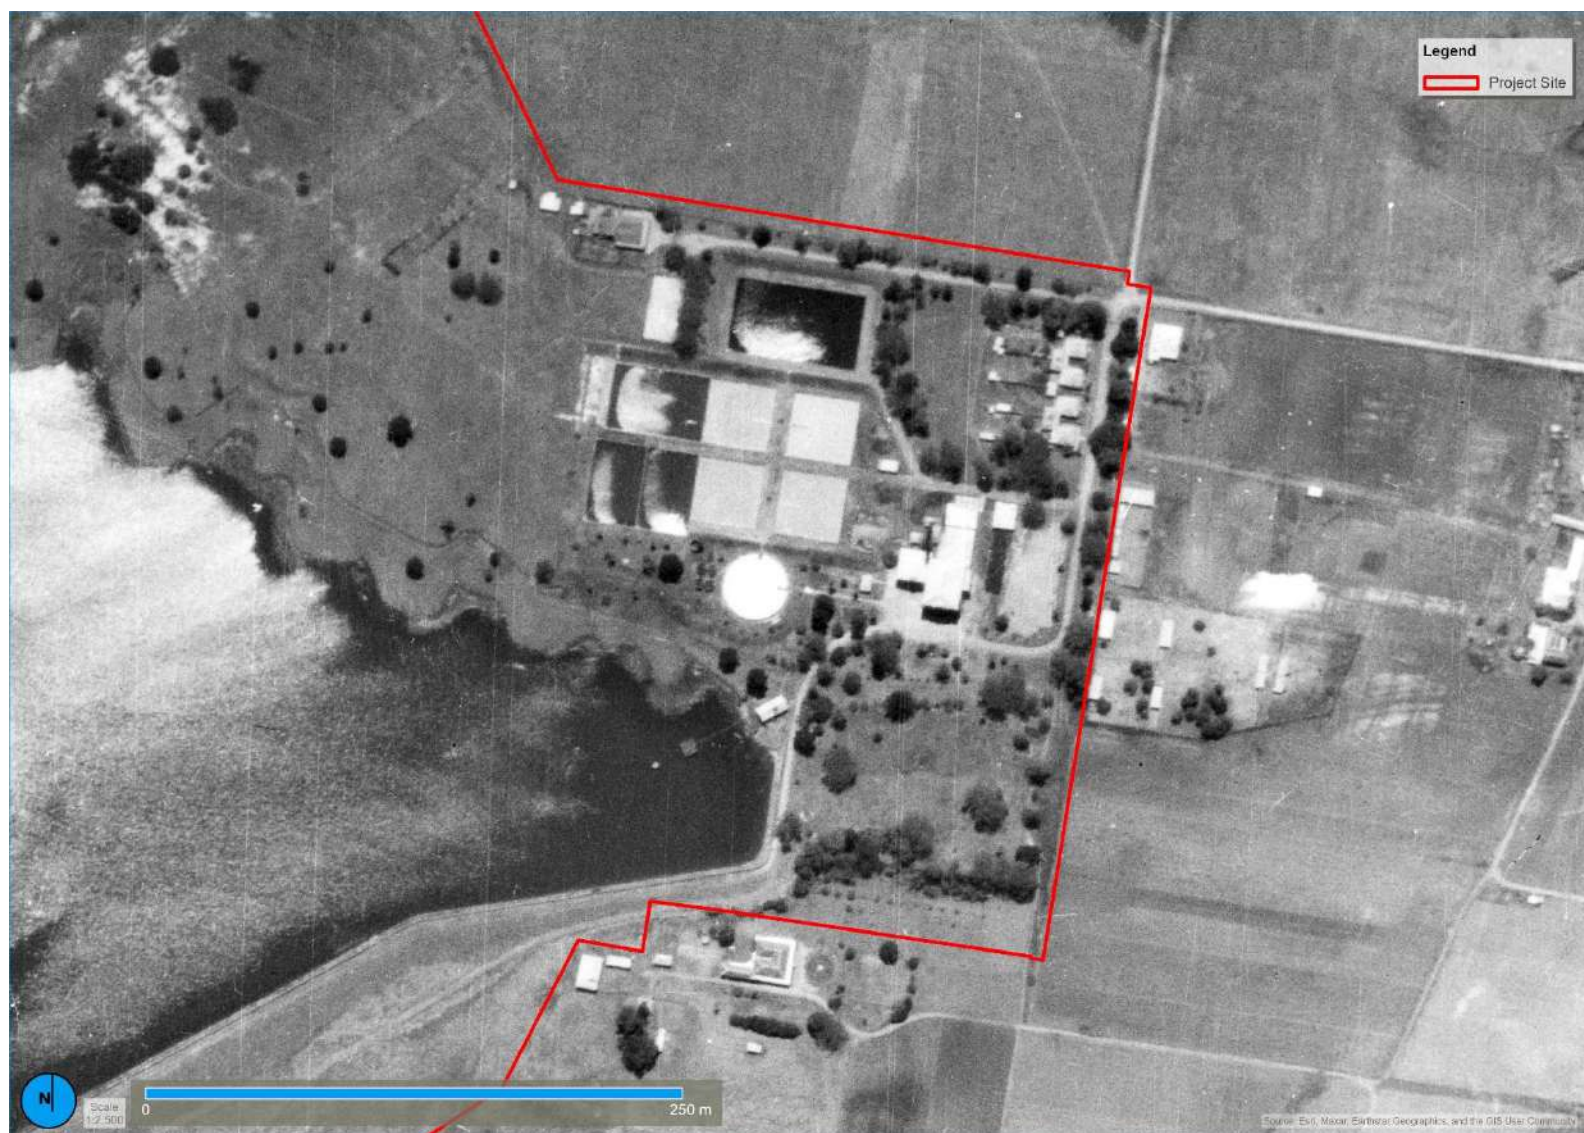
Figure 12: The Project Site in 1938 showing the configuration at the time. Numerous features including the Sand washing plant, change sheds and Pumphouse No 9 are visible. NAA Item ID 12082050, Film MAP2392 Run 10W Frame 12138

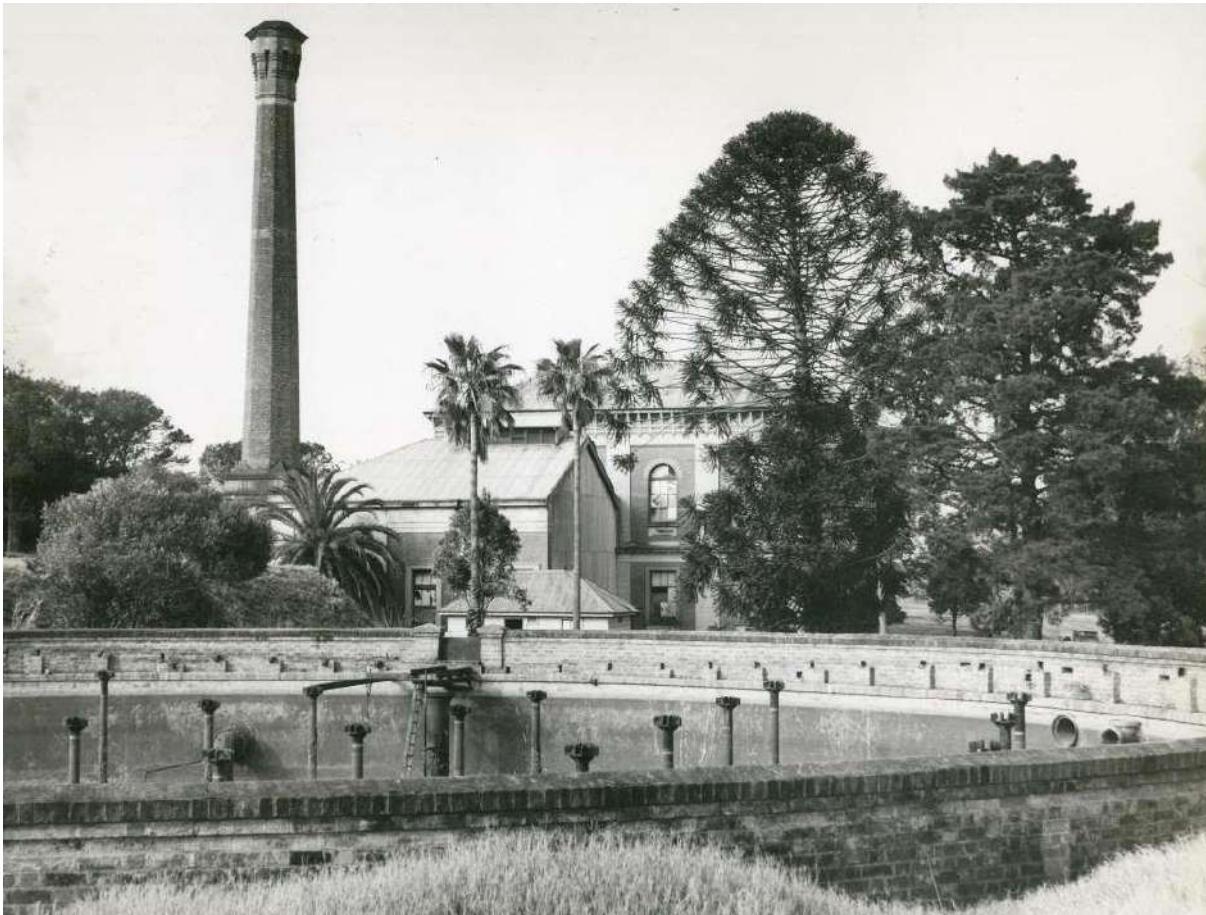
Figure 13: 1947 image of the Cler Water Tank showing the internal roof supports. The roof of the Change Sheds is visible in the background. Photo supplied by MCC

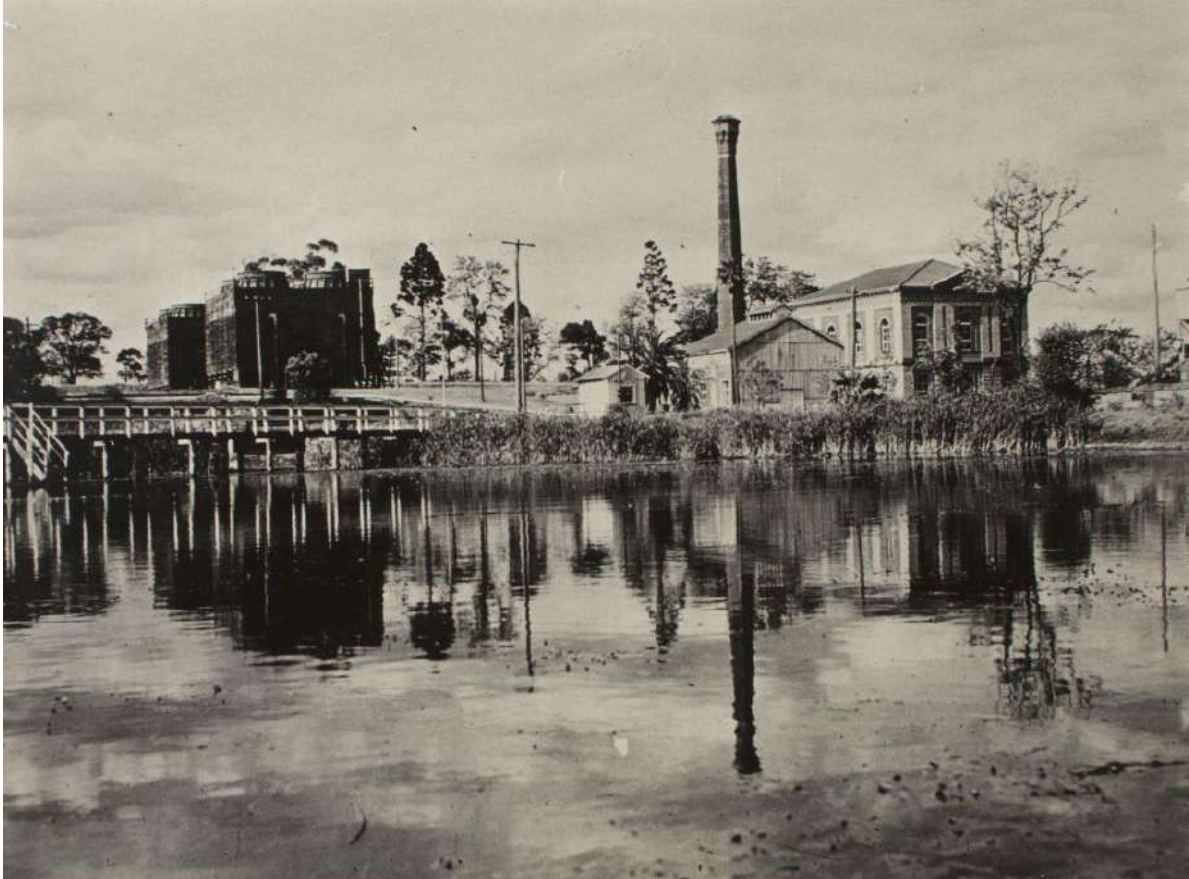
Figure 14: Post-1951 view of the main complex. The cooling towers have been erected over Filter Beds 2 and 4 and Pumphouse No 9 is visible in the foreground. Photo supplied by MCC

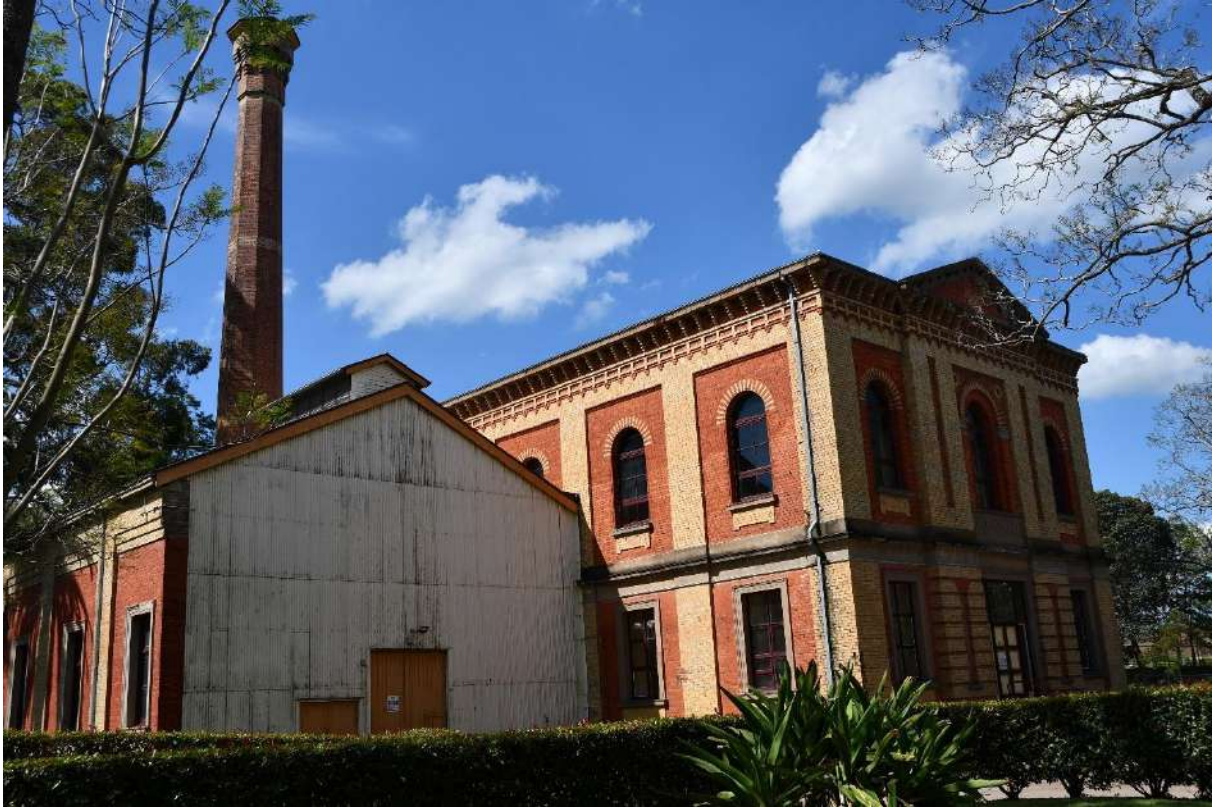
Figure 16: Main Pumphouse (A) and Western Pumphouse (F)

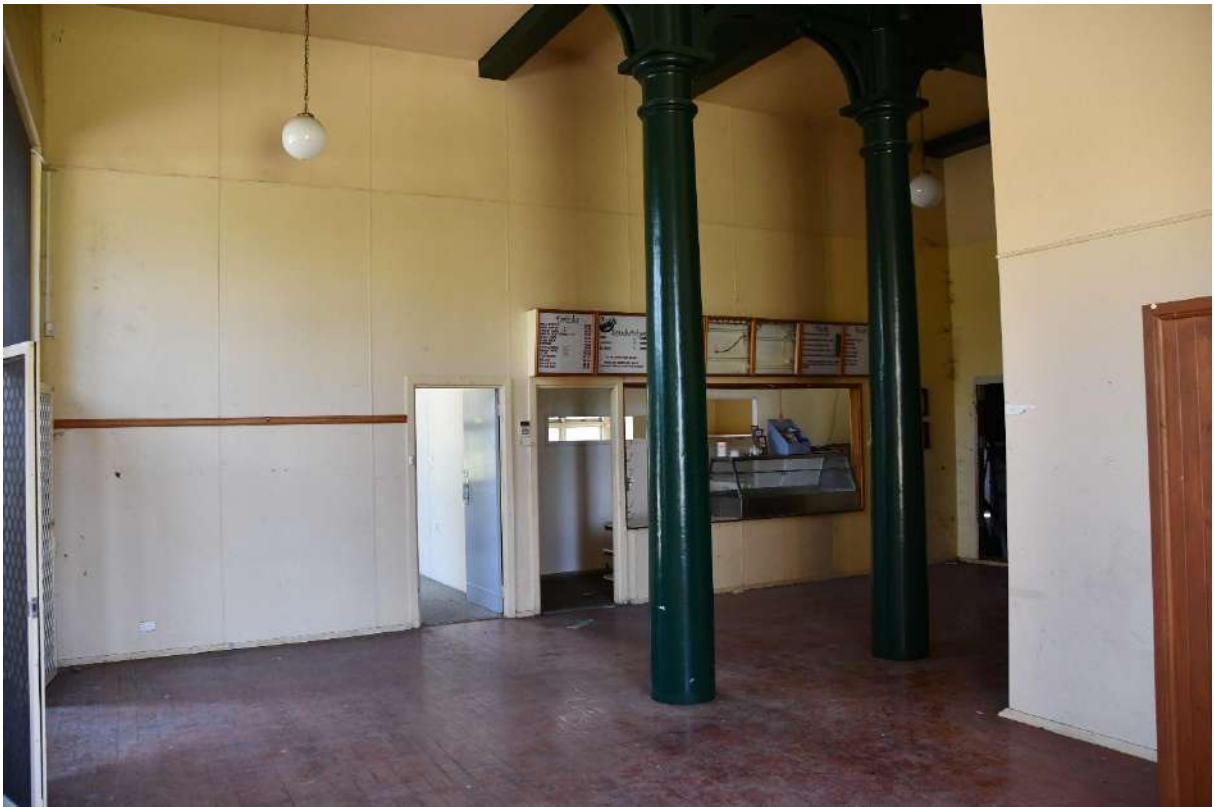
Figure 17: Internal space in Main Pumphouse (A). Note the original columns with 1950s floors and internal divisions in conversion to offices.

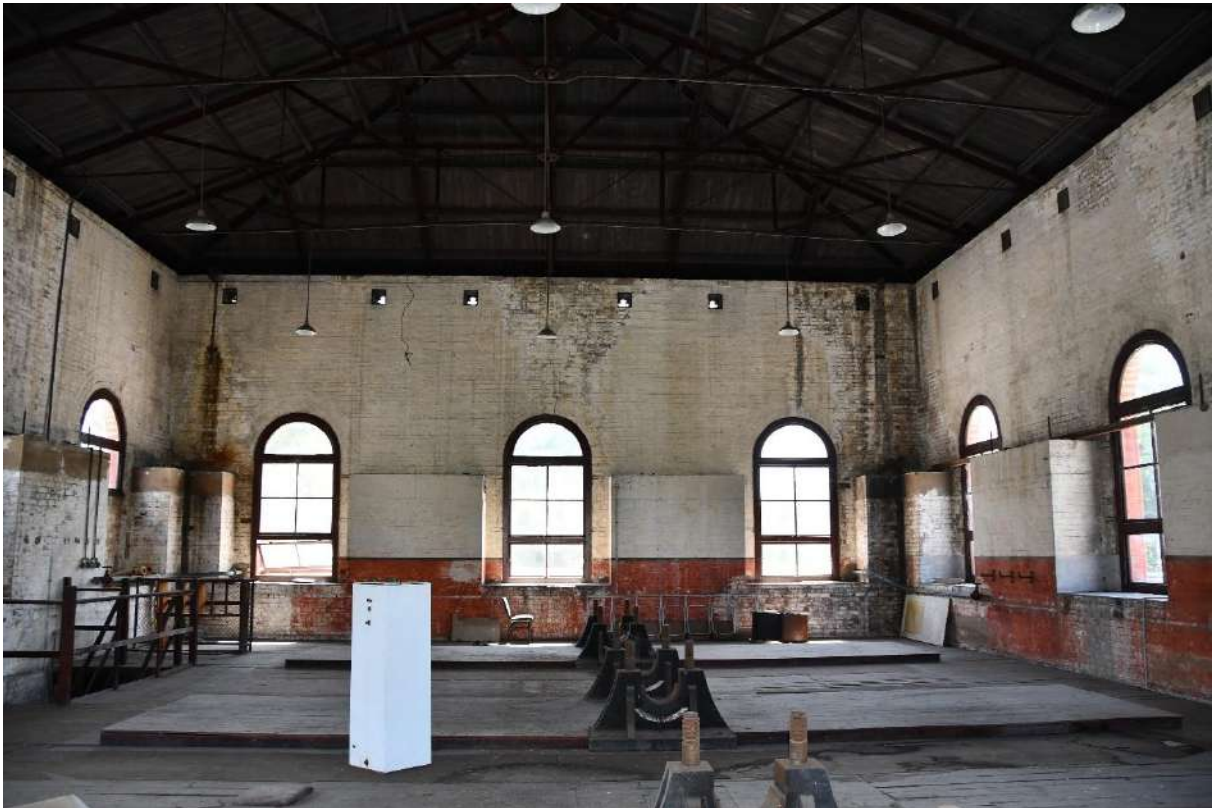
Figure 18: First Floor of Main Pumphouse with original floors and bearing blocks (A)

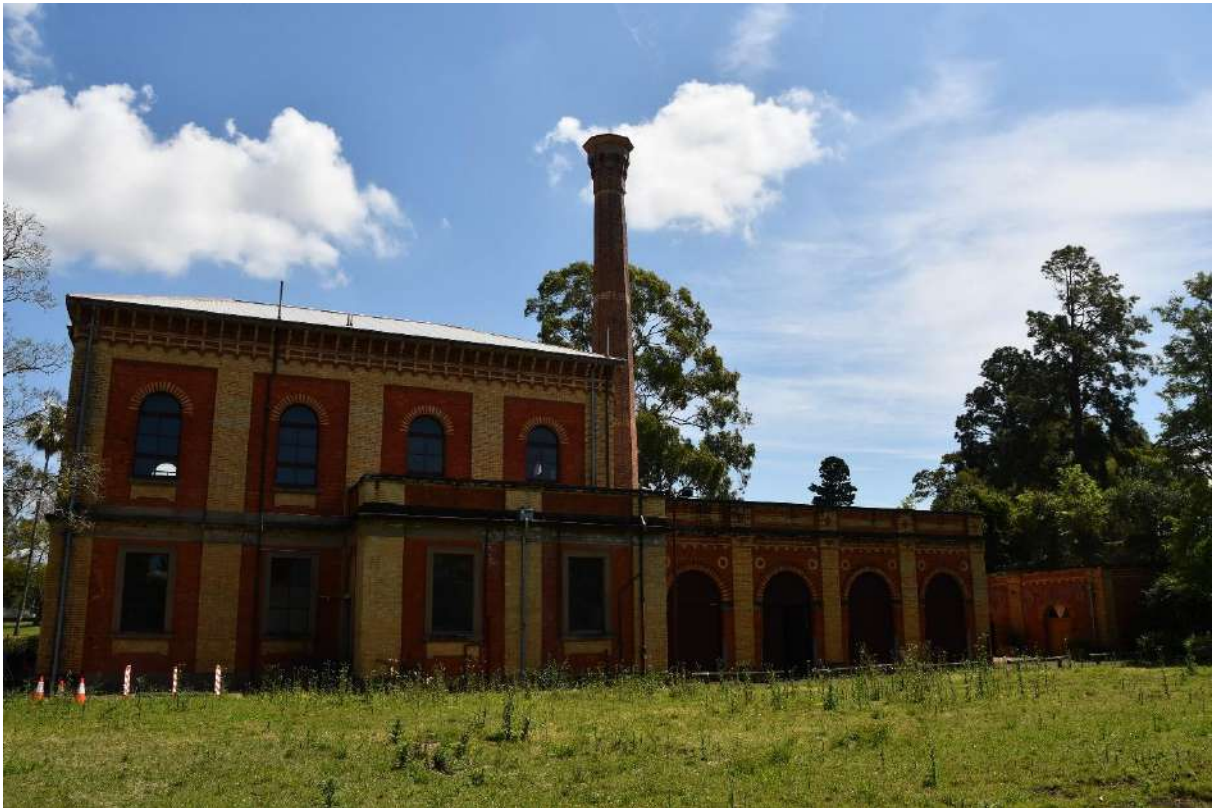
Figure 20: Eastern face of the main building showing the Main Pumphouse (A), Eastern Annexe (D) and Boiler Room (B)

| ID | Item | Date | Description | Integrity | Archaeological potential |
|---|---|---|---|---|---|
| A | Main Pumphouse | Built 1886-1887 | Two storey polychrome brick building with windows, and ~10m deep basement. Single hipped corrugated iron roof. Housed original pumps. Modified in 1950s to offices and later into café/museum (Figure 16, Figure 17, Figure 18, Figure 19, Figure 20) | Original walls, roof and cast iron internal columns remain. Nearly all water related machinery removed aside from first floor bearing blocks. Original timber first floor remains. Power Station floors and internal divisions remain on ground floor along with lighting and other electrical features. Extant 6-pane windows like post 1949 replacing original 9-pane windows. Main entrance stairs later alteration and addition. | Low potential for an infilled basement to contain remains of brick engine beds, engine bearings, flywheels and other associated elements. Medium potential for 19th century features to remain intact below later floors. Externally, high potential for construction trenches, and original outlet and inlet pipes. |

| ID | Item | Date | Description | Integrity | Archaeological potential |
|---|---|---|---|---|---|
| D | Eastern Annexe | Built 1893-1894 | Single storey polychrome brick addition to Main Pump House. Flat roof<br>1950s alteration including southern door and stairs (Figure 20, Figure 23, Figure 24) | External walls and roof remain. Internally all original features removed.<br>Extensive 1950s amenities remain including plumbing and electric features. | Low to nil potential for 19th century features below 1950s floor. |

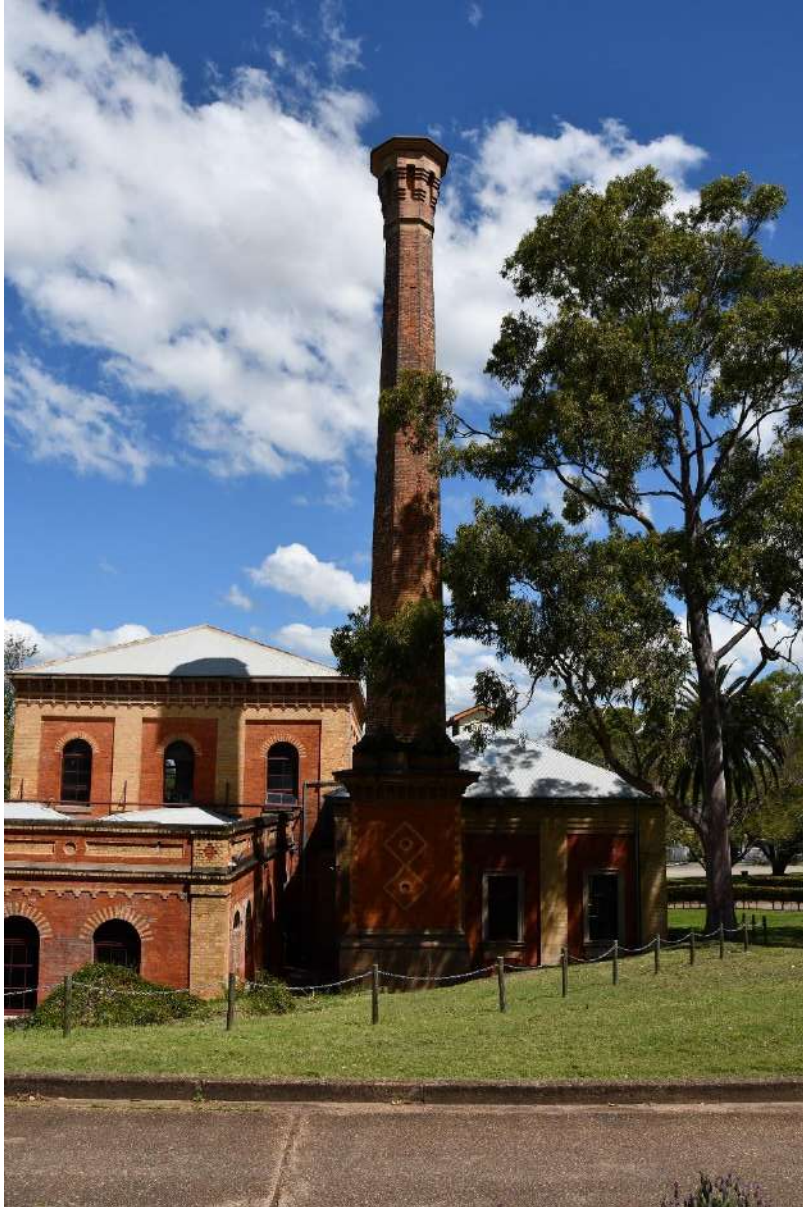
Figure 22: The Chimney (C)

| ID | Item | Date | Description | Integrity | Archaeological potential |
|---|---|---|---|---|---|
| C | Chimney | Built 1886-1887 | 36 metre tall polychrome brick octagonal chimney with finely corbelled top (Figure 22) | Largely extant. Original iron crown replaced in 1990s. | Nil |

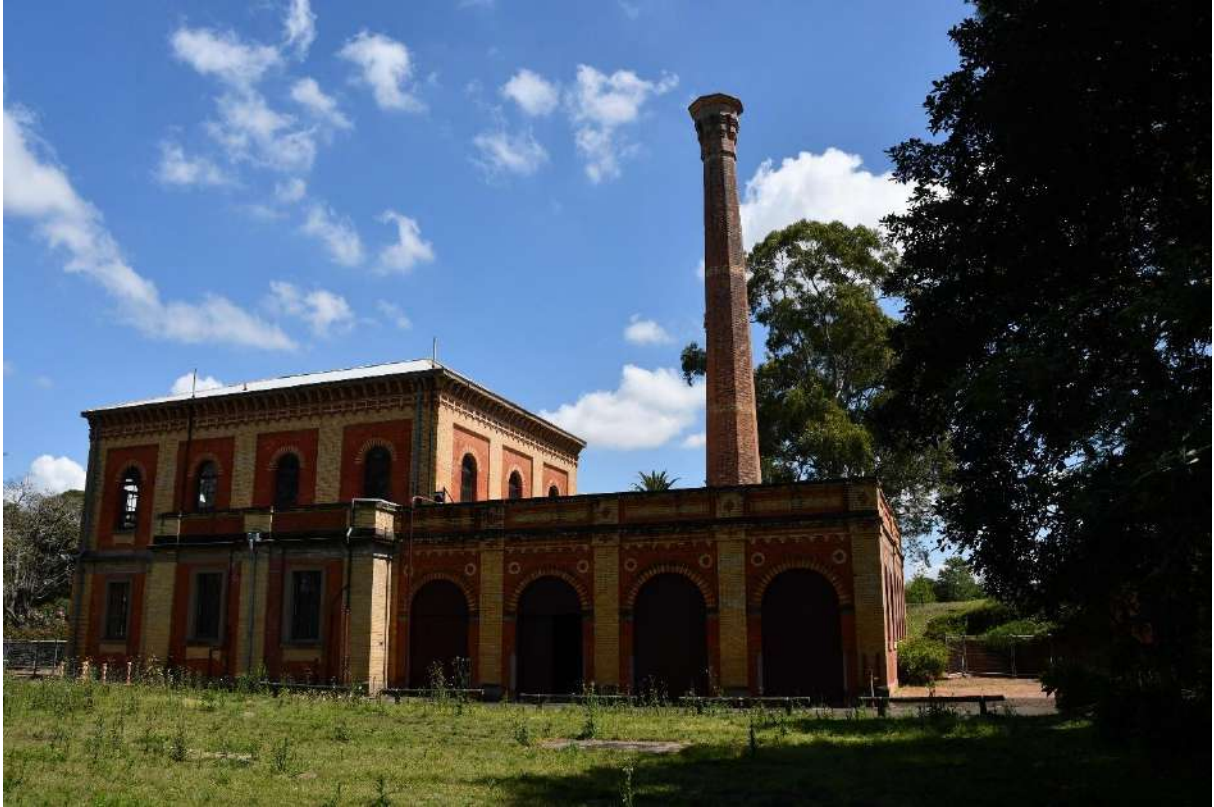
Figure 23: Eastern face showing Boiler Room (B) and Eastern Annex (D)

| ID | Item | Date | Description | Integrity | Archaeological potential |
|---|---|---|---|---|---|
| | | | 1950s (Figure 21, Figure 23) | | |

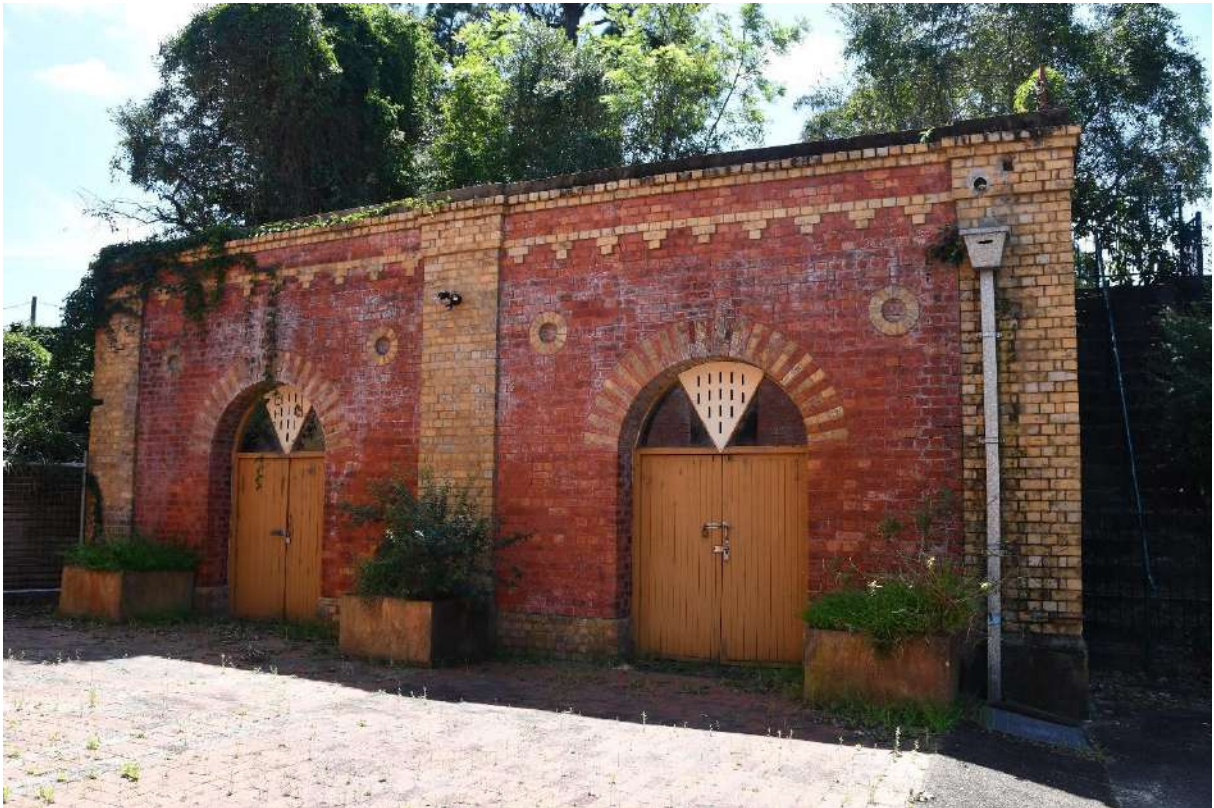
Figure 25: The Workshop / Coal store (E)

| ID | Item | Date | Description | Integrity | Archaeological potential |
|---|---|---|---|---|---|
| E | Coal Store / Workshop | Built 1886-1887 | Single storey polychrome brick structure with flat roof (Figure 25, Figure 26) | Largely extant walls and possible floor. Four cast iron chutes on northern wall remain. Eastern stairs intact but closed off. Possible original fencing on roof. | Low to nil. Limited research potential for investigating chutes to the north and from clearing vegetation. |

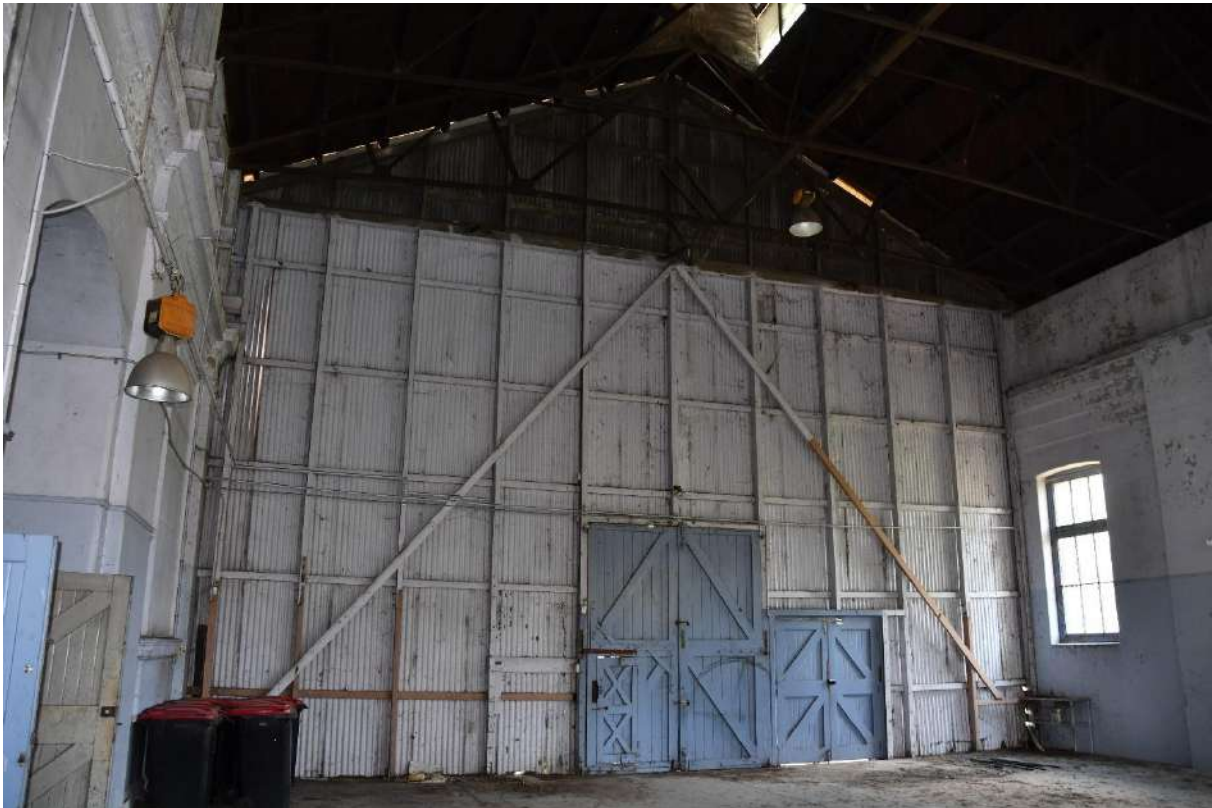
Figure 27: Internal space within the Western Pumphouse (F)

| ID | Item | Date | Description | Integrity | Archaeological potential |
|---|---|---|---|---|---|
| F | Western Pumphouse | Built 1913 | Single storey double height polychrome brick building with basement and corrugated iron monitor roof (Figure 16, Figure 27) | External walls, including timber and corrugated iron southern wall all extant as is the roof. No internal pumping features remain. 1950s concrete floor remains. | Low potential for 19th century features below the 1950s concrete floor. |

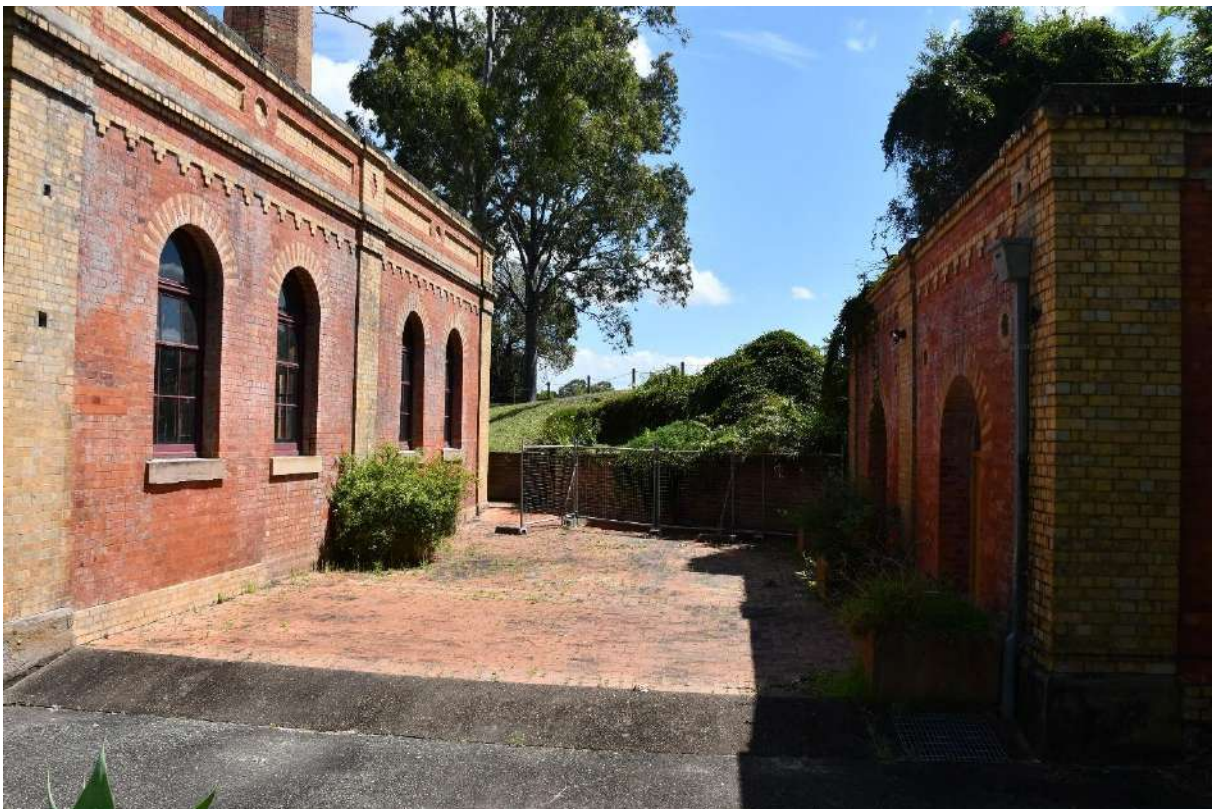
Figure 28: Space where the Boiler Room Addition (G) was located. Note the voids in the northern wall of the Boiler Room that would have supported the roof. The embankment in the background is the location of Pumphouse Number 6 (R)

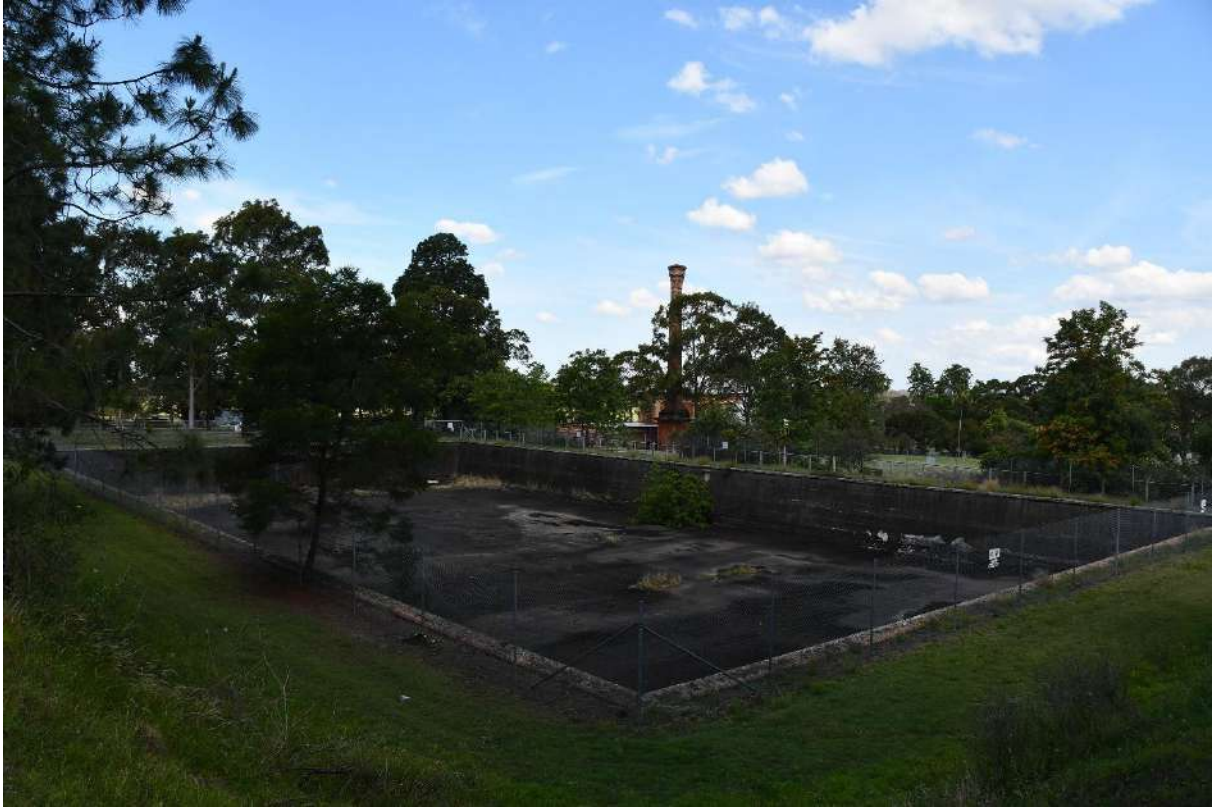
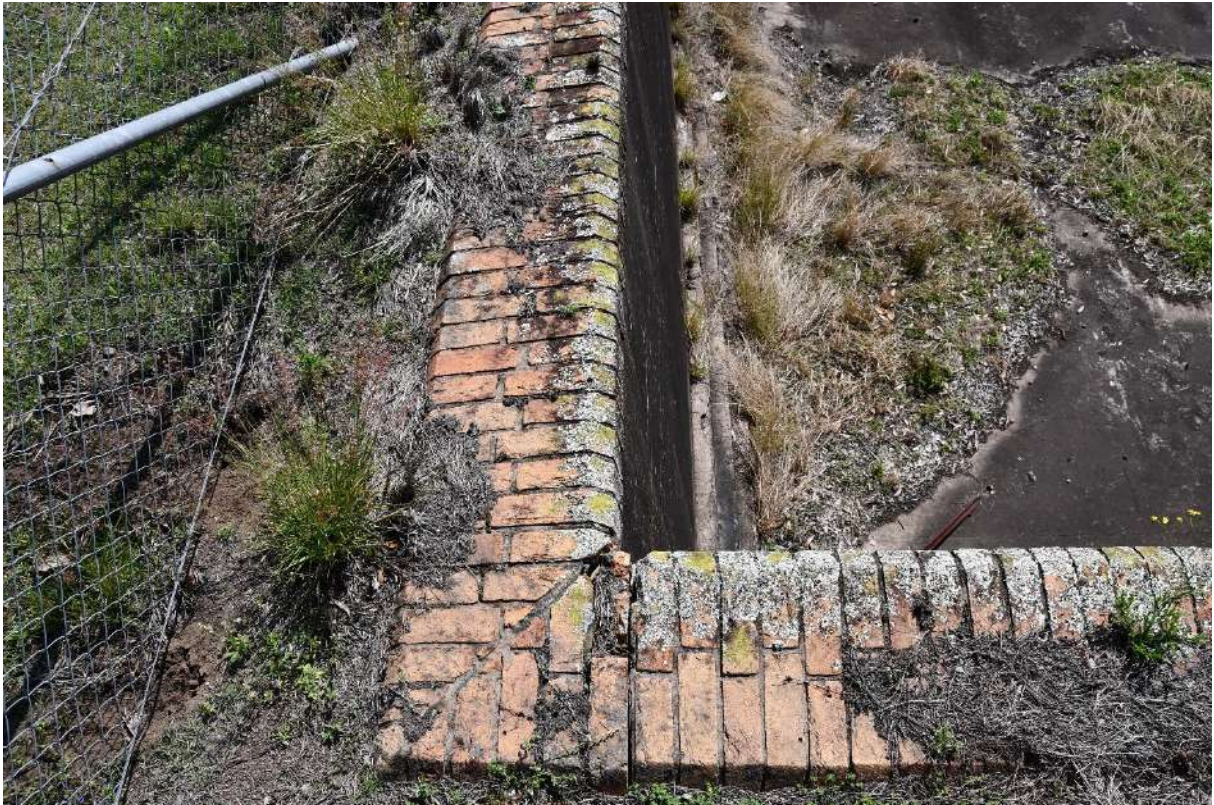
Figure 29: The Settling Tank (H)

Figure 30: Close up of the brick work in the settling tank (H)

| ID | Item | Date | Description | Integrity | Archaeological potential |
|---|---|---|---|---|---|
| H | Settling Tank | Built 1884-1885 | 61 metre long, 35 metre wide rectangular tank at northern end of site. Cement rendered sandstock brick walls and floor (Figure 29, Figure 30) | Well preserved with multiple original features intact including outlet, overflow pipe, and height gauge. Some cracks to surfaces and minimal vegetation within tank. Stairs from Settling Tank to Filter Beds to the south remain. | Nil for new features. Moderate for investigation of extant features. |

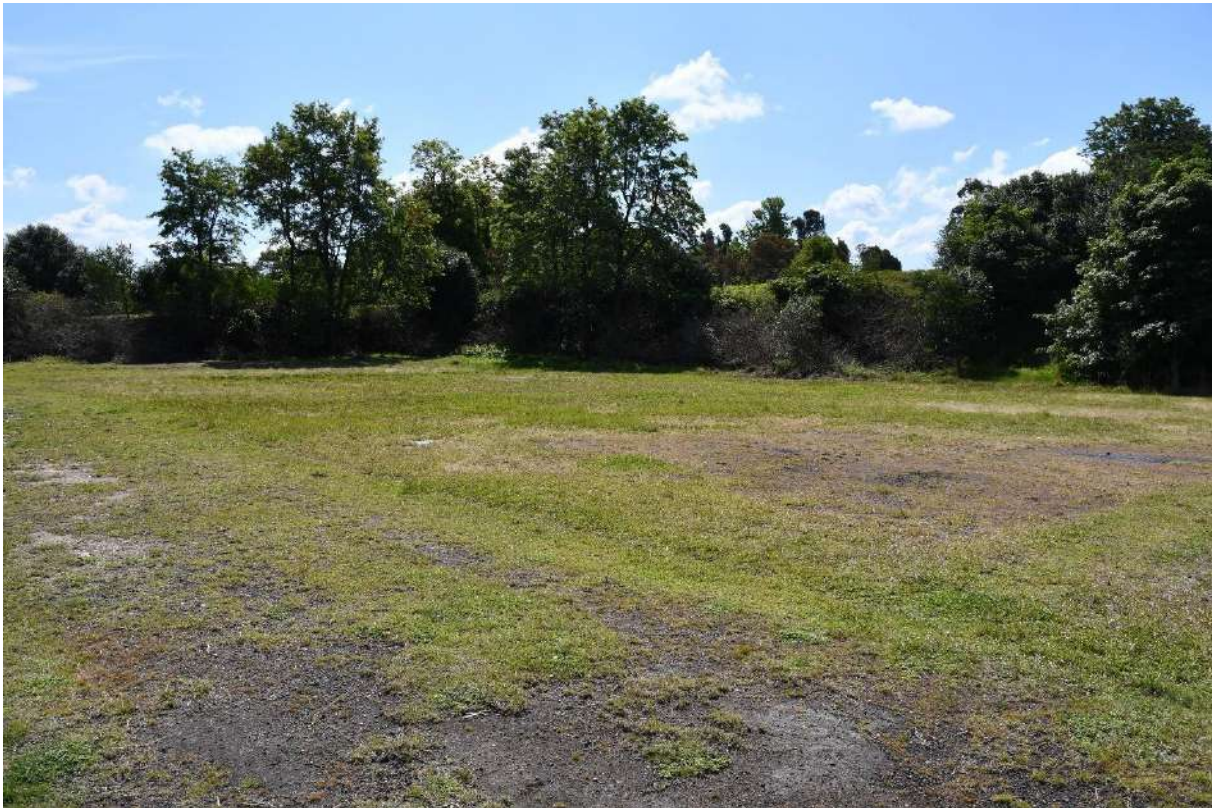
Figure 31: Filter Bed 1 (I-1)

| ID | Item | Date | Description | Integrity | Archaeological potential |
|---|---|---|---|---|---|
| I | Filter Beds 1 - 4 | Built 1884 to 1885 | Four 32 metre x 32 metre rectangular structures built in a grid along a north-south aligned central pipe. Built from sandstock brick with cement rendered base (Figure 31, Figure 32, Figure 33, Figure 34) | Bed 1 backfilled, likely largely intact.<br>Bed 2 empty with moderate levels of vegetation some pipework and features present. Modified during 1950s.<br>Bed 3 backfilled, likely largely intact.<br>Bed 4 backfilled, Modified during 1950s. Some features visible on surface. | Moderate to high. All beds are likely to retain evidence of original features such as pipework, inlets, floats and other mechanical and technological evidence of functionality. Beds 2 and 4 are likely to have evidence of changing purposes during the 1950s. |

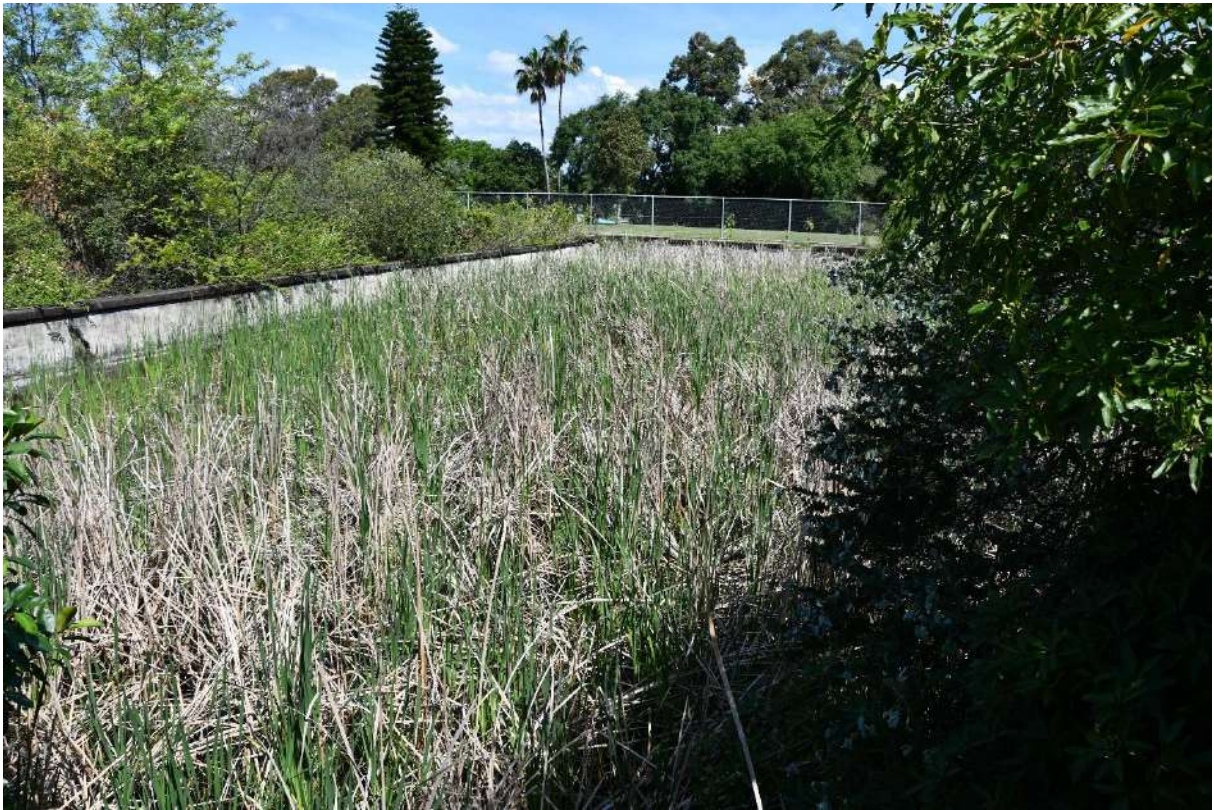
Figure 35: Filter Bed 5 & 6 (J-5 and J-6)

| ID | Item | Date | Description | Integrity | Archaeological potential |
|---|---|---|---|---|---|
| J | Filter Bed 5 & 6 | Built 1907-1908 | Two 39 metre long, 25 metre wide rectangular structures built as an adjoining pair with precast concrete walls and possibly base (Figure 35) | Both beds still extant. Large volume of vegetation. Some cracking and separation of concrete elements. | Moderate to high. Beds are likely to retain evidence of original features such as pipework, inlets, floats and other mechanical and technological evidence of functionality. Both likely to have evidence of modification during 1950s |

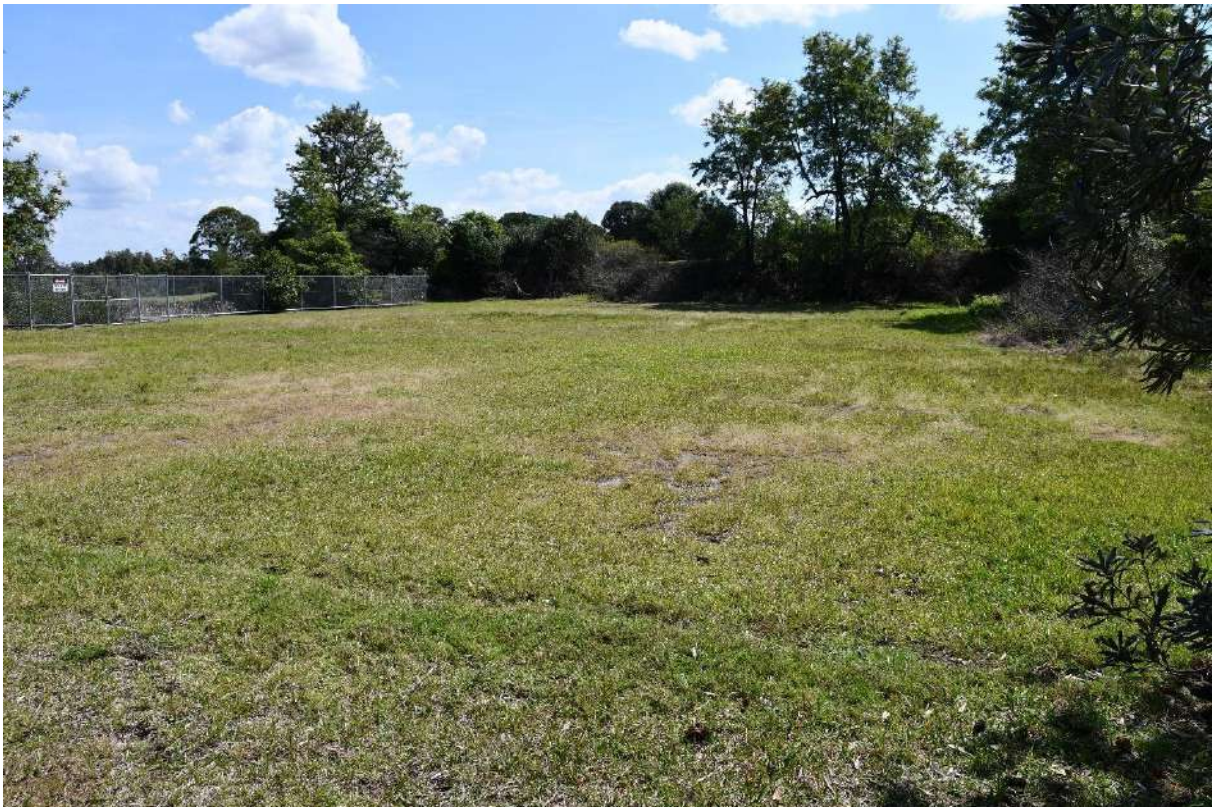
Figure 36: Filter Bed 7 (K-7)

| ID | Item | Date | Description | Integrity | Archaeological potential |
|---|---|---|---|---|---|
| K | Filter Bed 7 | Built 1912-1913 | 47 metre long, 31 metre wide rectangular structure north of Filter Bed 5 and 6. Built with precast concrete walls and possibly base (Figure 36) | Backfilled, likely largely intact. | Moderate to high. Likely retains some evidence of original features such as pipework, inlets, floats and other mechanical and technological evidence of functionality. |

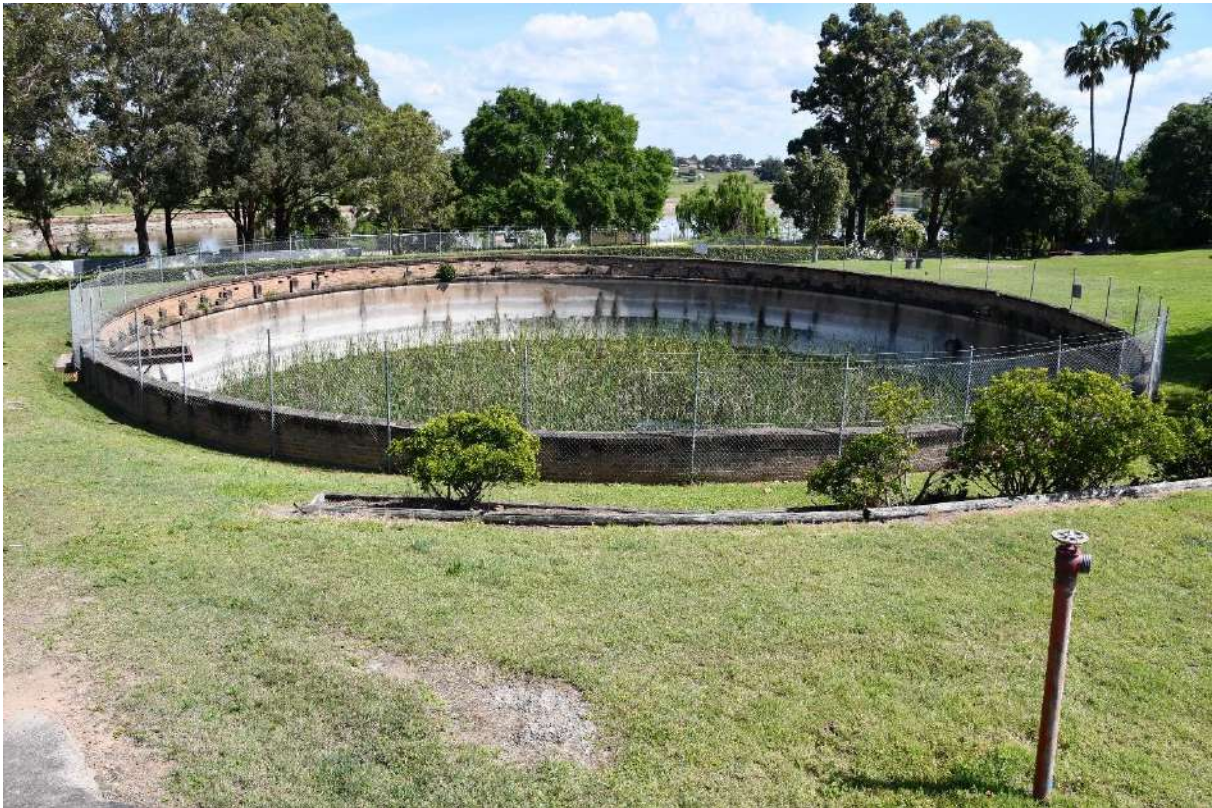
Figure 37: Clear Water Tank (L)

| ID | Item | Date | Description | Integrity | Archaeological potential |
|---|---|---|---|---|---|
| L | Clear Water Tank | Built 1884-1885 | Circular 31 metre wide tank built from dry pressed brick. Lower courses cement rendered (Figure 37) | Original roof, including supports all removed. Otherwise in good condition with a number of original pipe features. Base obscured by vegetation. | Nil for new features. Moderate for investigation of extant features. |
