## Walka Water Works

Historical Archaeological Assessment

Maitland City Council

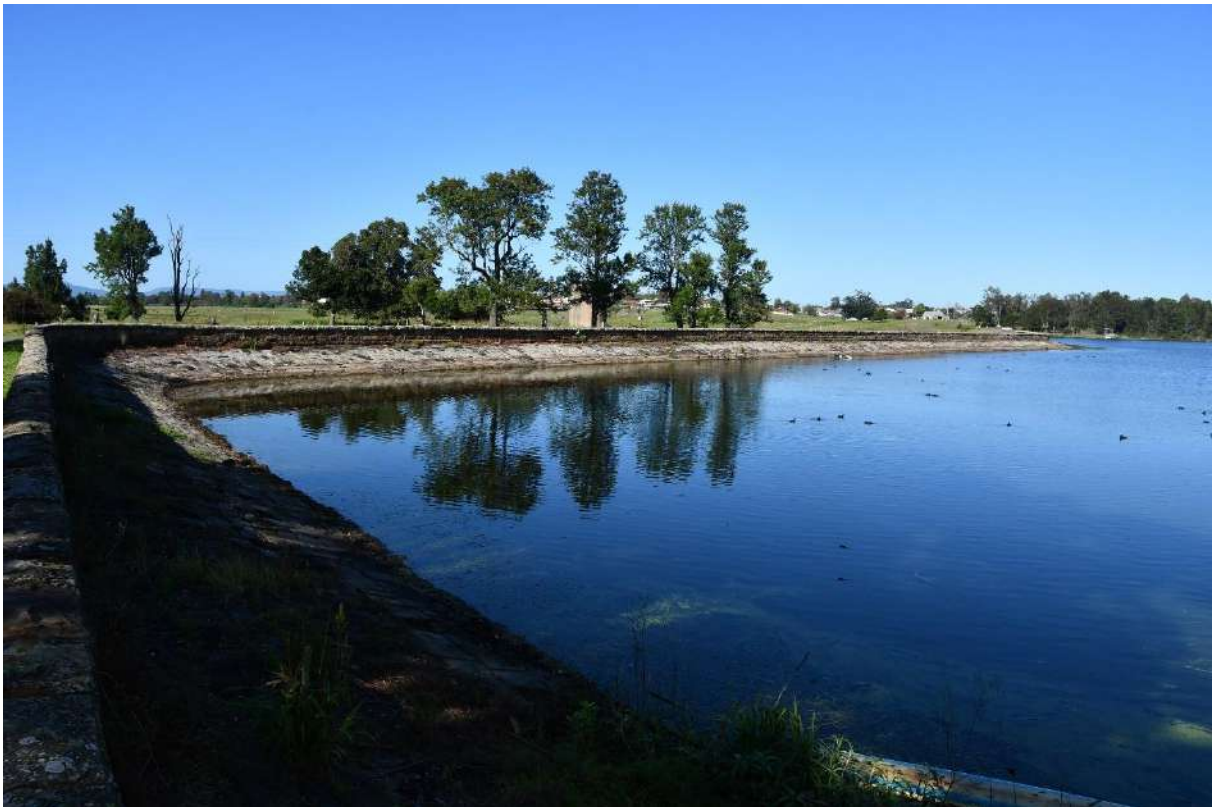
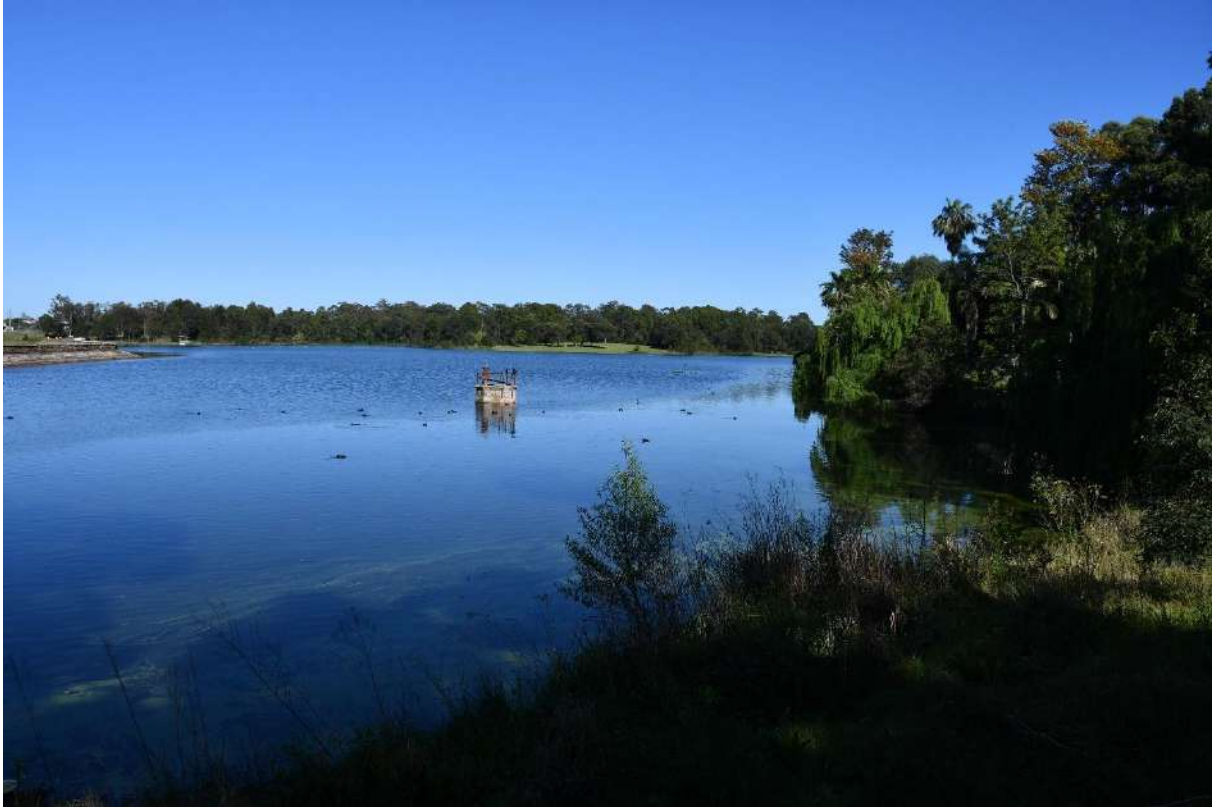
Figure 38: Reservoir Wall (M)

Figure 39: Outlet tower (M)

| ID | Item | Date | Description | Integrity | Archaeological potential |
|---|---|---|---|---|---|
| M | Reservoir & Outlet Tower | Built 1884-1885 | 540 meter long embankment, lined with moderately well hewn sandstone blocks. Outlet tower is circular brick structure with iron fencing and features (Figure 38, Figure 39) | Embankment wall in good condition with sandstone largely intact. Upper surface utilised as roadway. Outlet tower appears in moderate condition although not visited. | Low. Embankment is standardised structure with well understood construction method consisting of upcast from reservoir excavation. |

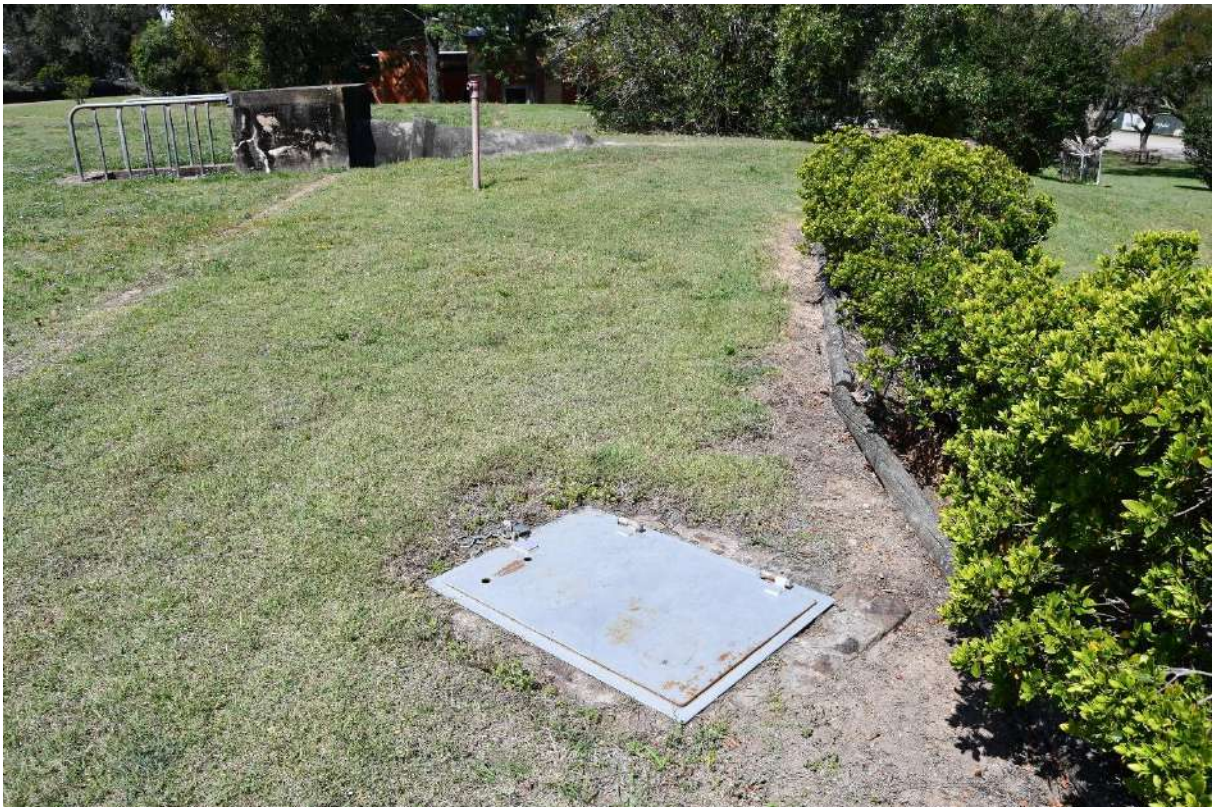
Figure 40: Examples of the Pipe Access Pits (N)

| ID | Item | Date | Description | Integrity | Archaeological potential |
|---|---|---|---|---|---|
| N | Pipes, Pits and Tunnels | From 1883 onwards | Expansive pipe network across the site comprised of cast iron and steel pipes and various access points. Includes pipes laid for the Power Station (Figure 40, Figure 41) | Believed to be largely intact comprehensive network. Access points are visible across the site. | High. Numerous examples of pipes are likely present across the site, in addition to tunnels, culverts and access points. Critical to understanding technological aspects of the site. |

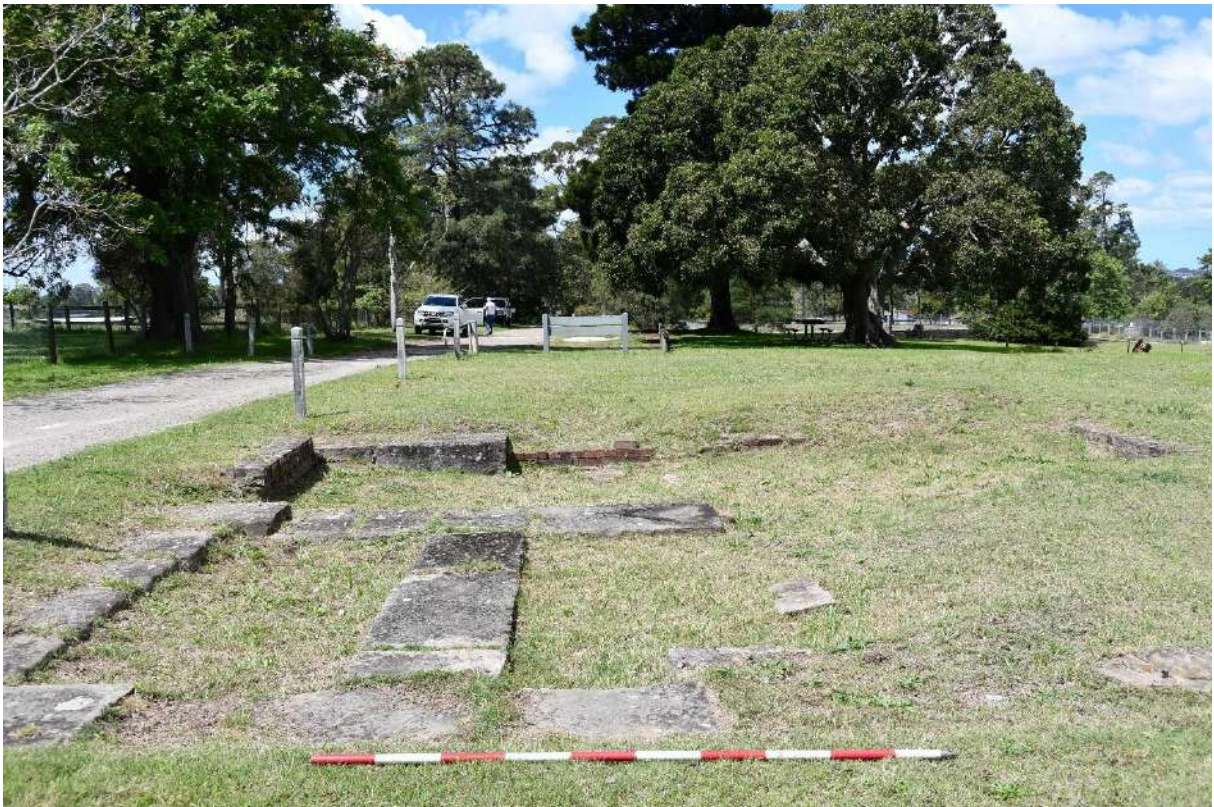
Figure 42: Exposed footings of the Chief Engineer's Cottage (O-1)

| ID | Item | Date | Description | Integrity | Archaeological potential |
|---|---|---|---|---|---|
| O | Chief Engineers Cottage & Garden | Built 1882<br>Demolished 1975 | Large cottage with associated outbuilding. Foundations visible on surface. Garden features visible to the south on aerial imagery (Figure 42) | Substantial footings remain with large sandstone blocks and sections of brickwork. | High. Potential for further footings, associated postholes, paths and garden beds in direct association with the cottage. Also potential for wells, cesspits, rubbish pits and other domestic features. Moderate for garden features likely located to the south including potential well. |

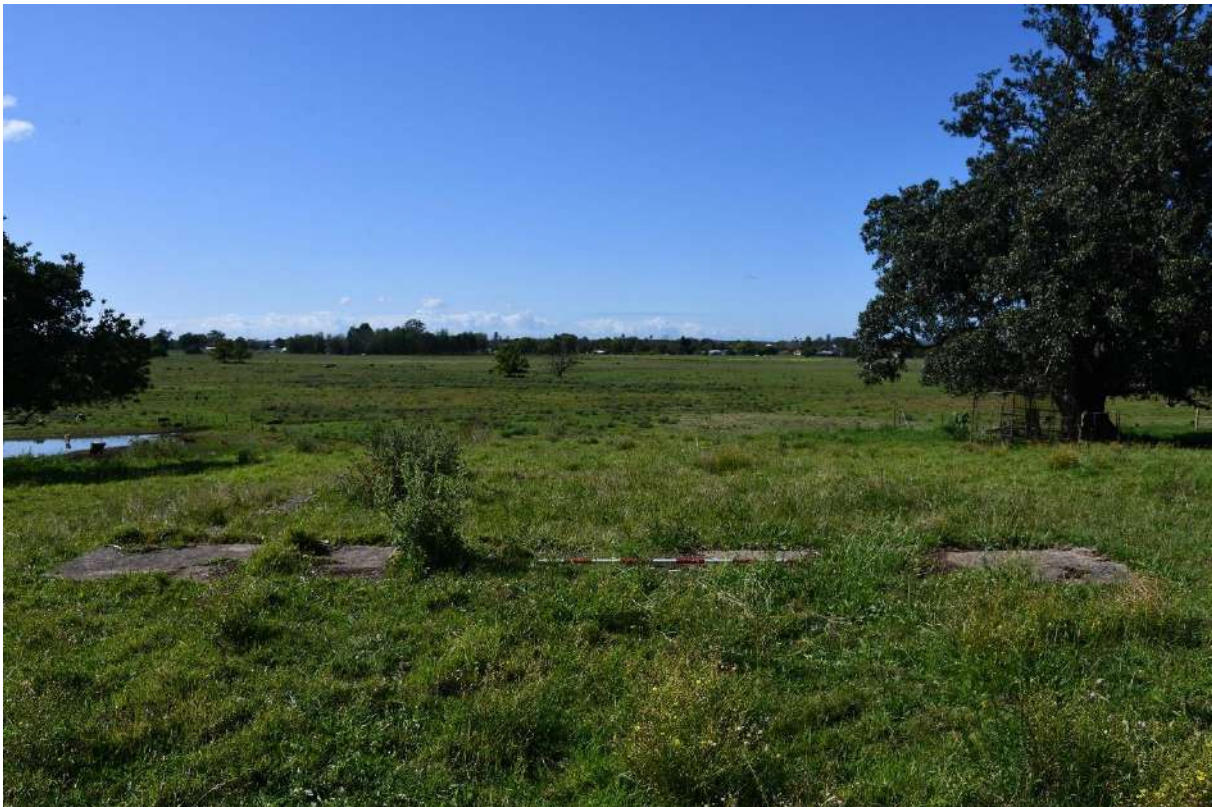
Figure 44: Footings of the Second Engineer's Cottage (Q)

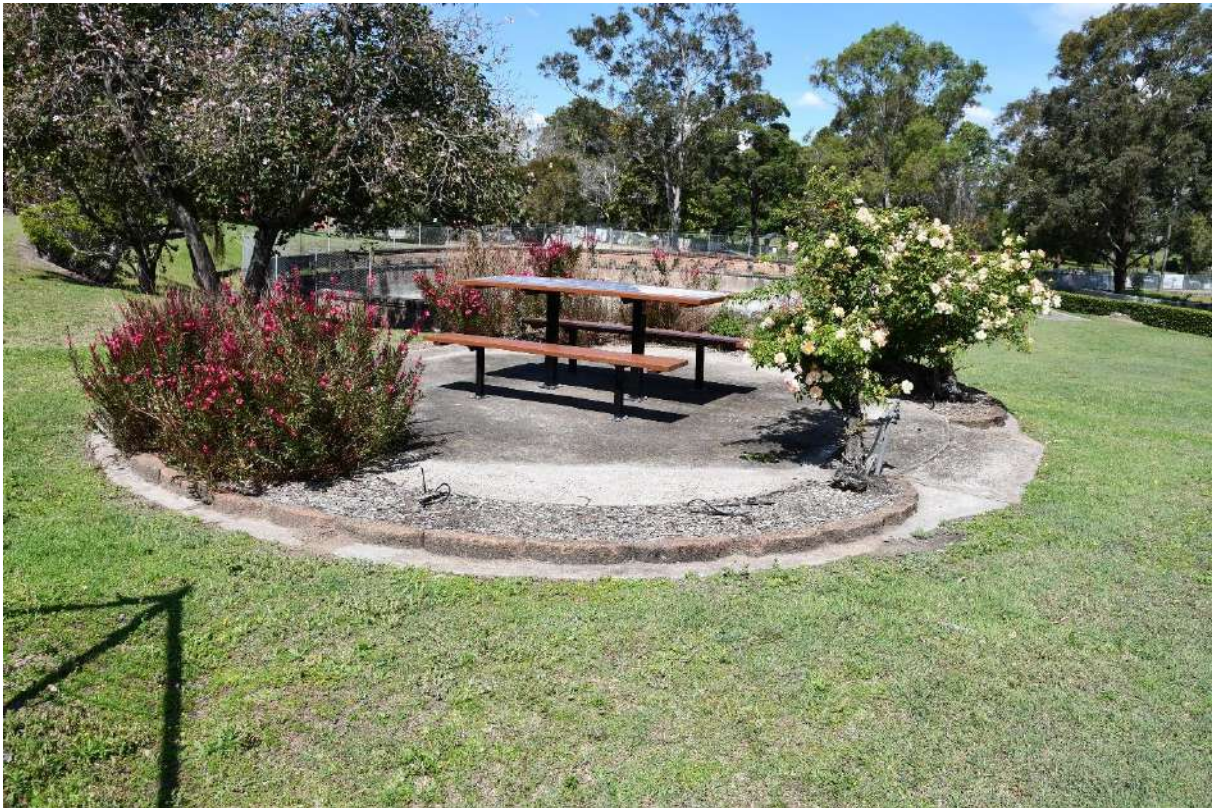
Figure 45: Location of the Rapid Filter Bases. It appears the base has been repurposed for use as a garden (S)

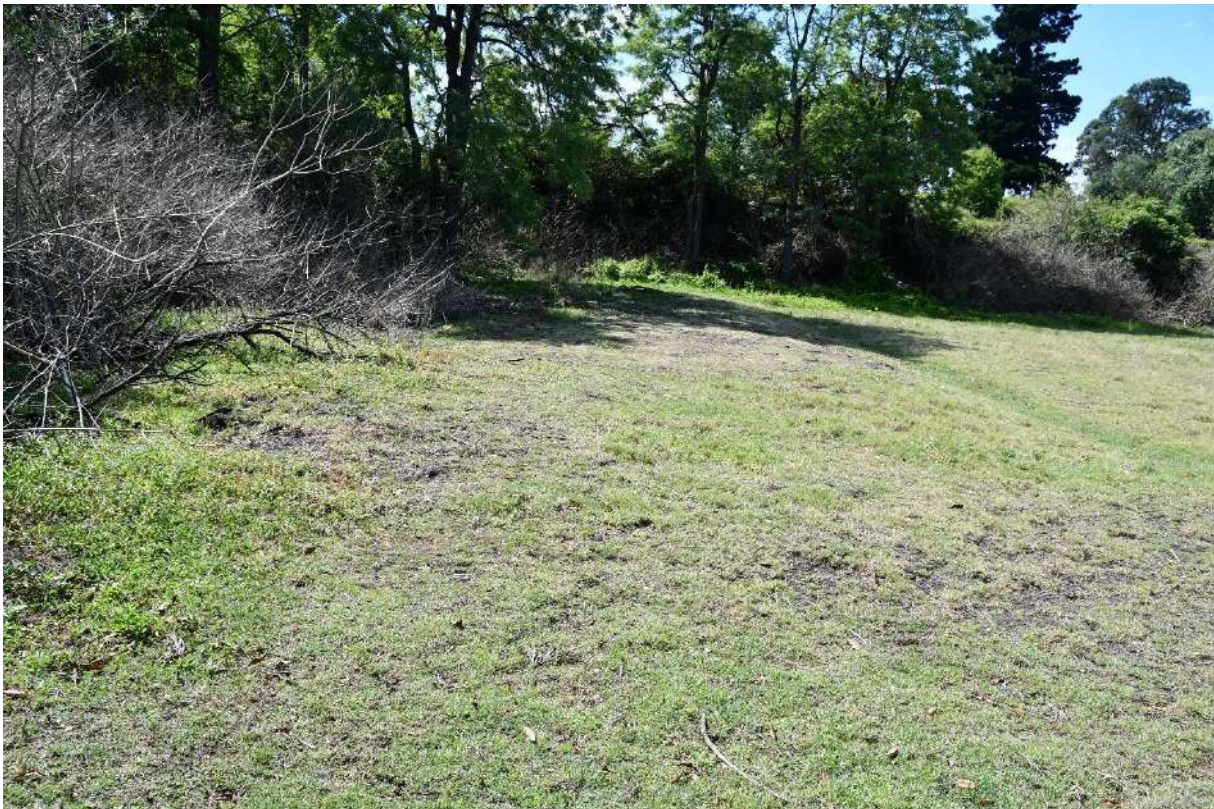
Figure 48: Location of Western Sand washing Plant. Note the promontory indicating a subsurface feature (U)

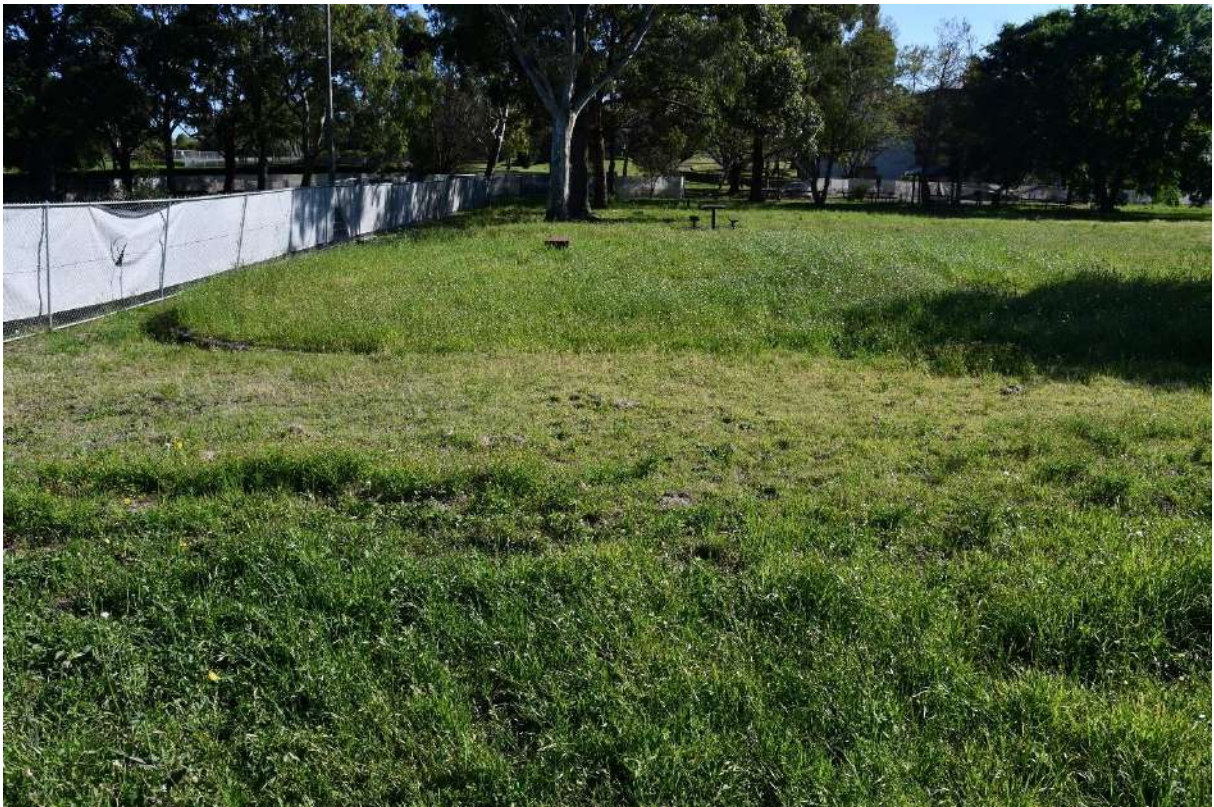
Figure 50: Location of the Power Station with kerbing visible (W)

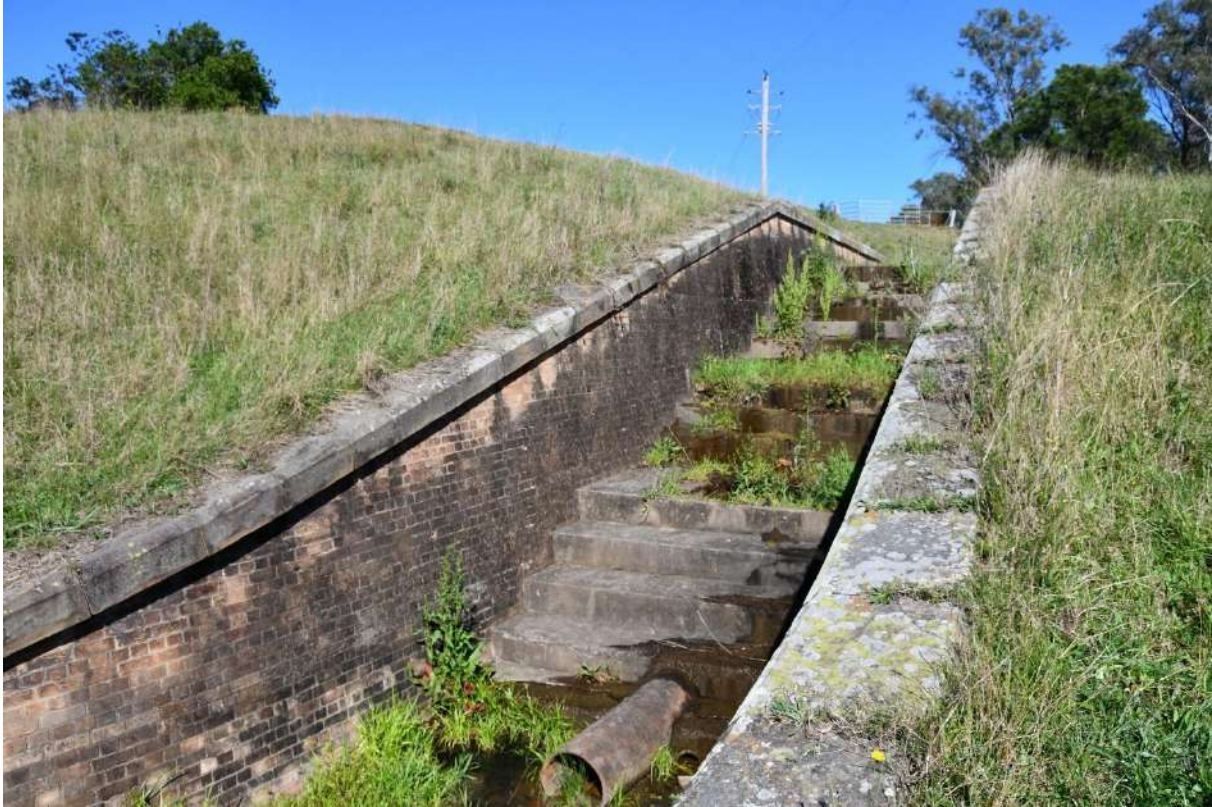
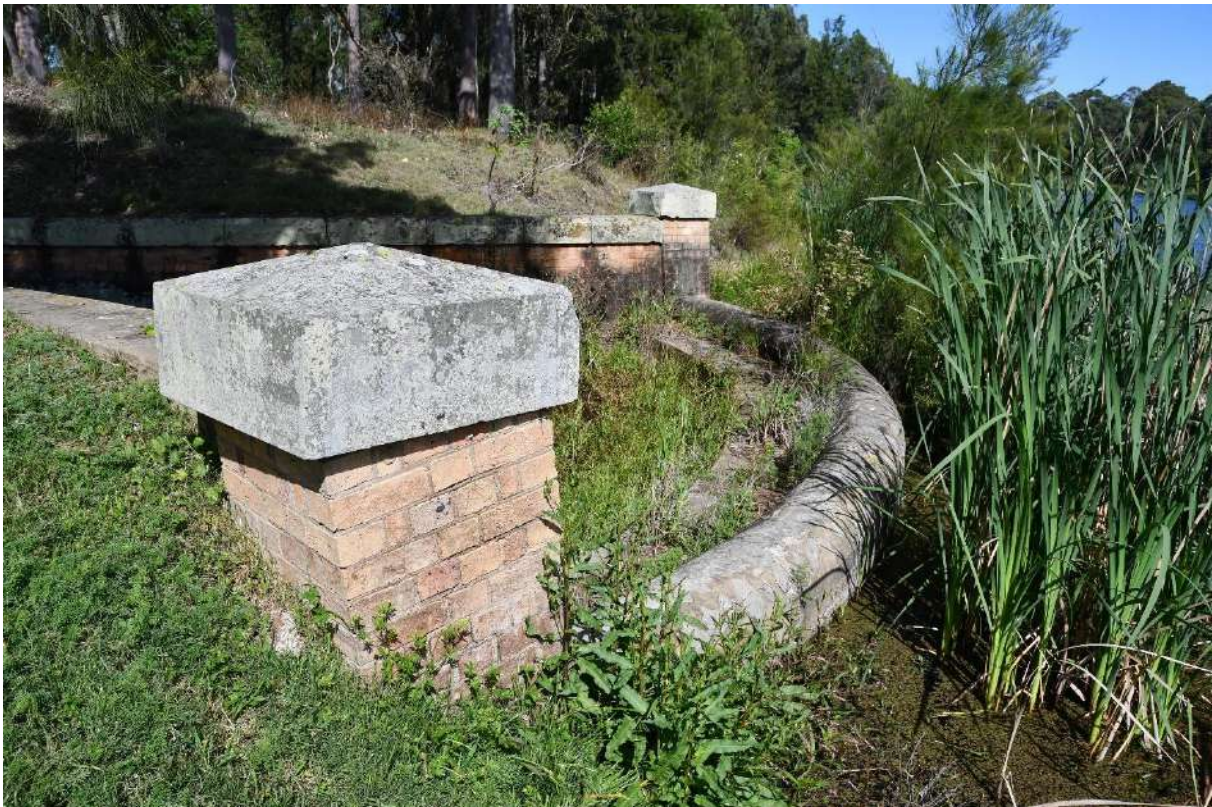
Figure 51: Middle section of the Byewash (X)

Figure 52: Inlet of the Byewash at the Reservoir (X)

| ID | Item | Date | Description | Integrity | Archaeological potential |
|---|---|---|---|---|---|
| X | Byewash | Built 1884 - 1885 | Northwest to southeast flowing brick channel with d rendered base leading to cobbled section to southeast. Northwest section features well-constructed rounded inlet. All brick walls buttressed and capped with sandstone (Figure 51, Figure 52) | Very high. Recently cleared and in very good condition. Some cracking evident. | Low. Recent clearance has likely removed most archaeological evidence. |

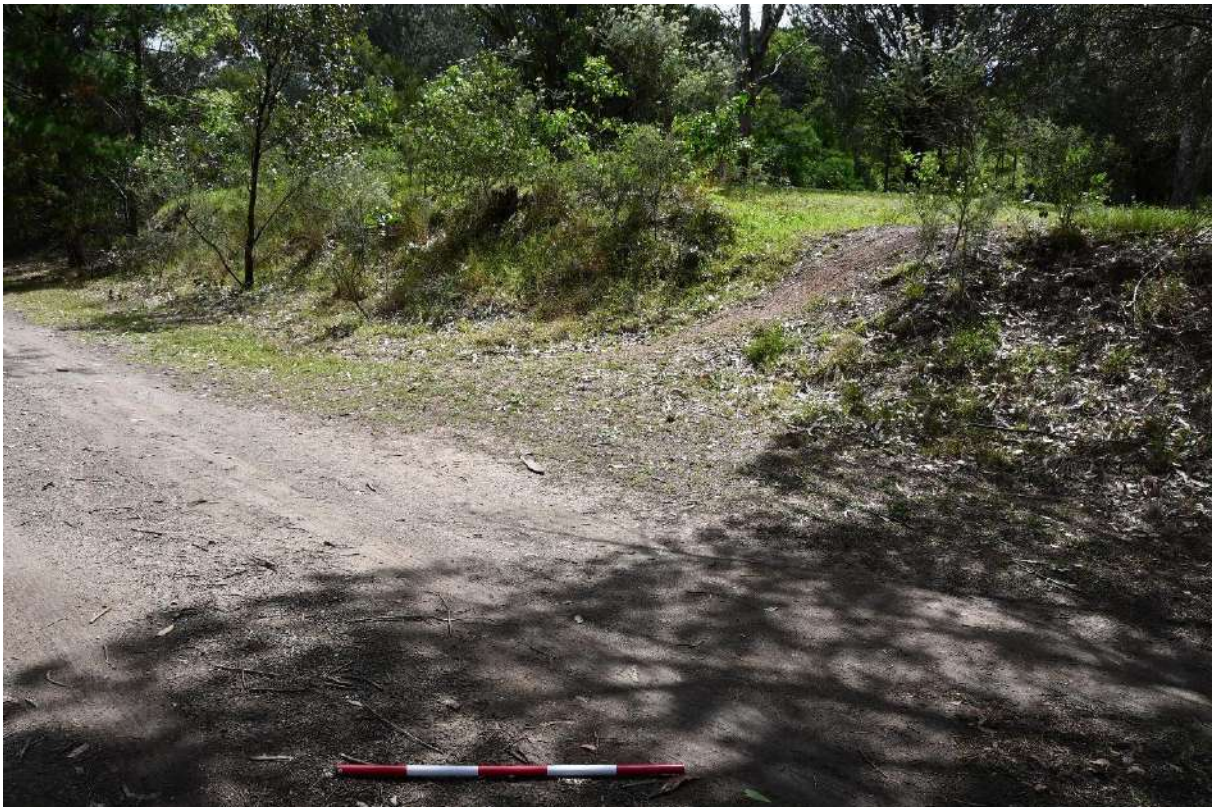
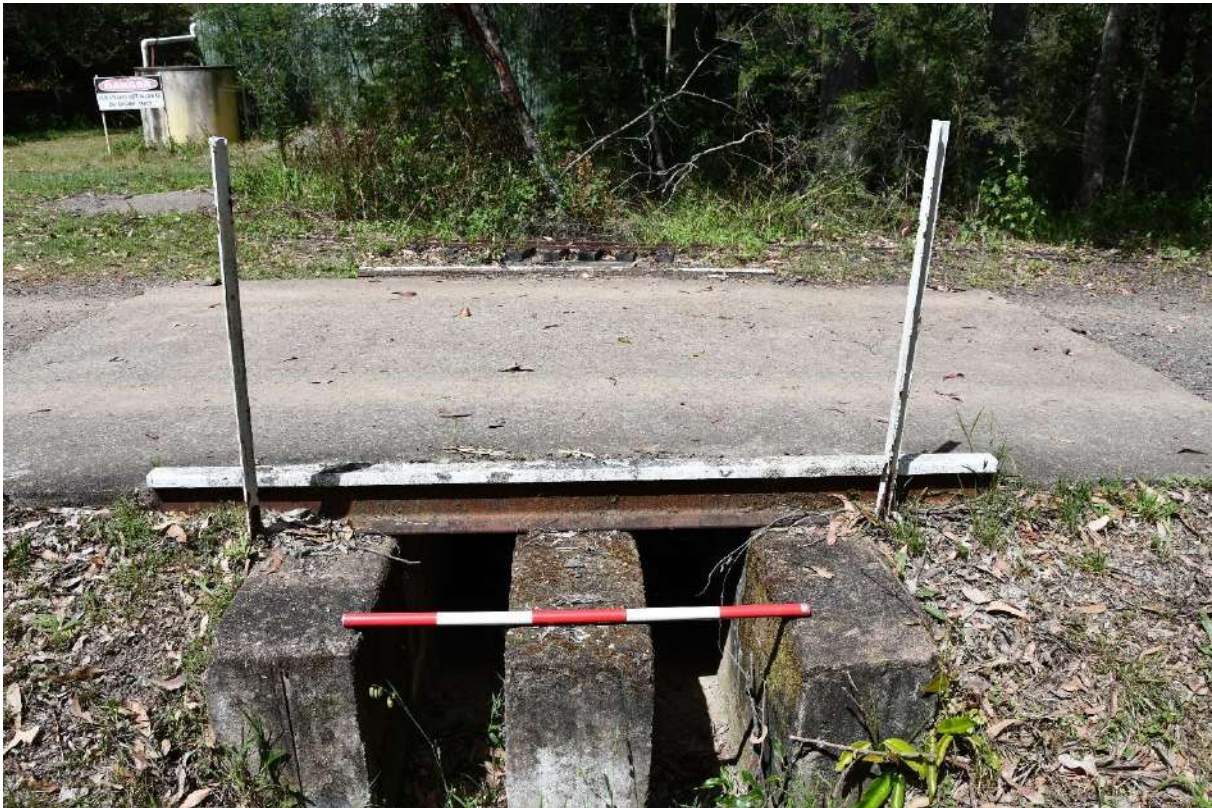
Figure 54: Example of one of the railway cuttings (Z)

Figure 55: Example of one of the small railway bridges with repurposed track (Z)

| ID | Item | Date | Description | Integrity | Archaeological potential |
|---|---|---|---|---|---|
| Z | Railway cutting & tracks | 1951 | 1.1 kilometre long railway cutting, featuring multiple areas of cut ground, small concrete bridges embankments (Figure 54, Figure 55) | Varies along route. Tracks are clearly visible south of the Main Pumphouse within existing road and continuing in GPR survey (Appendix a). Multiple concrete bridges in good condition along route but tracks appear to have been repurposed to contain road. | Low to moderate. Potential for railway infrastructure along entire route including bridges, tracks, signals etc. |
