Proposed Residential
Subdivision – Addendum
Contamination
Assessment

Lochinvar Ridge
Stages 16 to 21 -
70 Christopher Road,
Lochinvar NSW

NEW17P-0034C-AA
4 December 2024

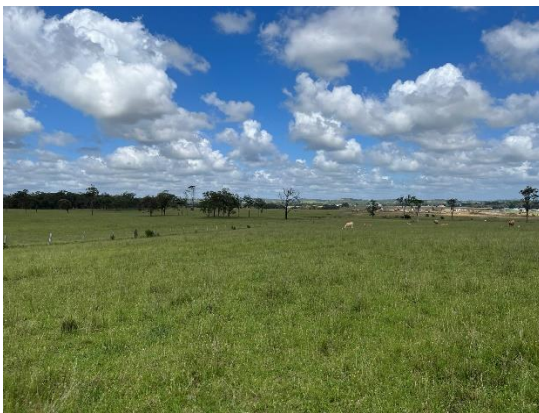
- The eastern portion of the site was observed to comprise grazing farmland, generally sloping west to north west towards two onsite ponds. Pond 1 was observed along the north eastern boundary of the site and appeared to be used for stock watering. Pond 4 was observed south of Pond 1 and appeared to be partly covered in reeds/vegetation.

Looking south west from eastern portion of the site

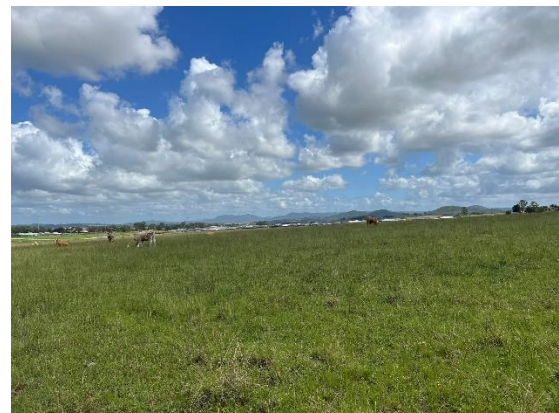
Looking north west from eastern portion of the site

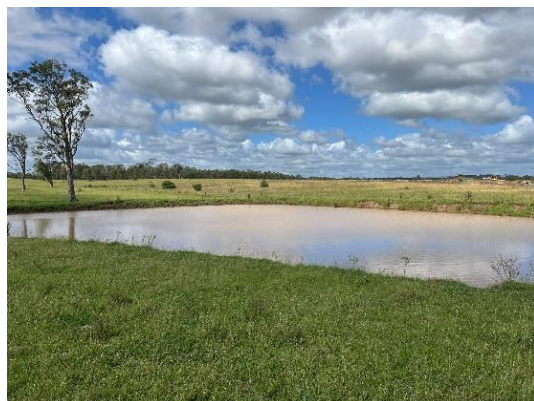
Pond 1 located in the north eastern portion of the site

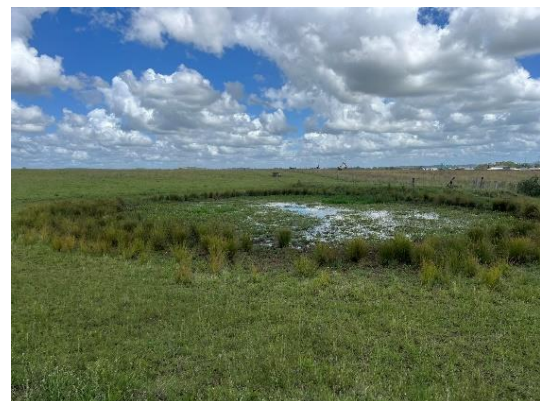
Pond 4 located south of Pond 1 in the central eastern portion of the site

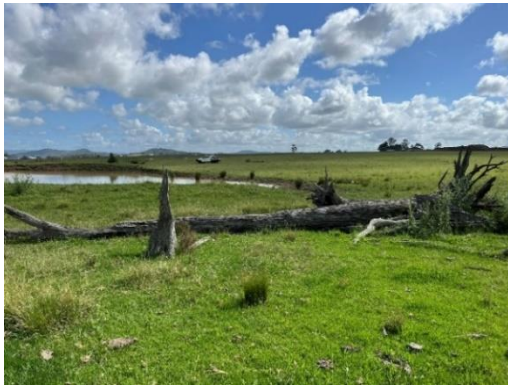
- A number of trees (including fallen trees) were observed throughout the eastern portion of the site.

Fallen tree observed south of Pond 1

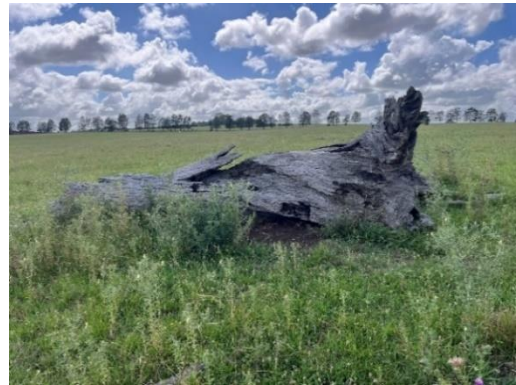
Fallen tree observed east of Pond 1

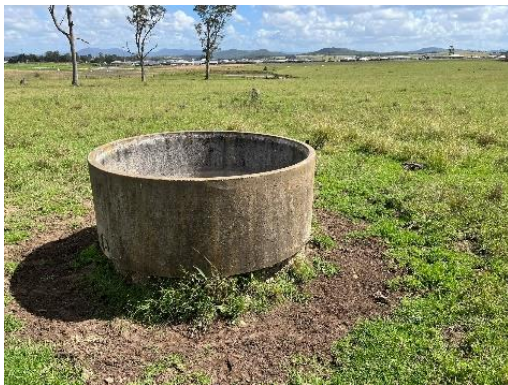
- An unused concrete water trough and steel water trough was observed east of Pond 4. Some concrete, asphalt and brick were observed around the concrete trough.

Concrete trough east of Pond 4

- A *Construction Environmental Management Plan (CEMP)* is implemented, prior to earthworks commencing, in order to appropriately manage the on-site and off-site disposal

of soil, sediment and water." The CEMP will also be required to manage anthropogenic materials observed across the site.

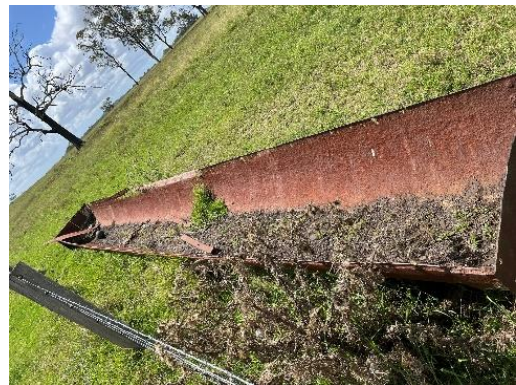
Rusted steel trough

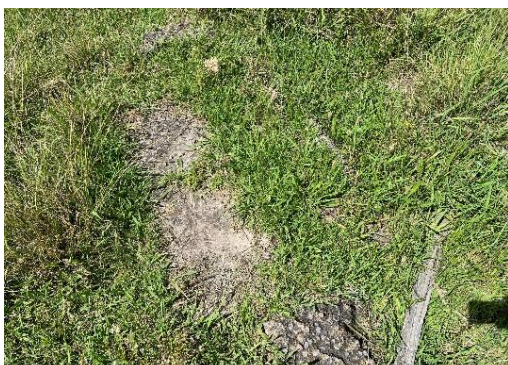
Concrete and asphalt north of trough

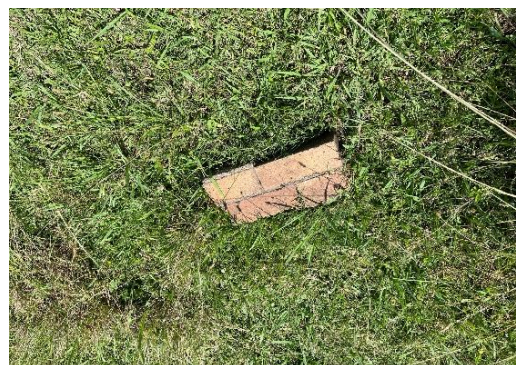
Brick fragments north of trough

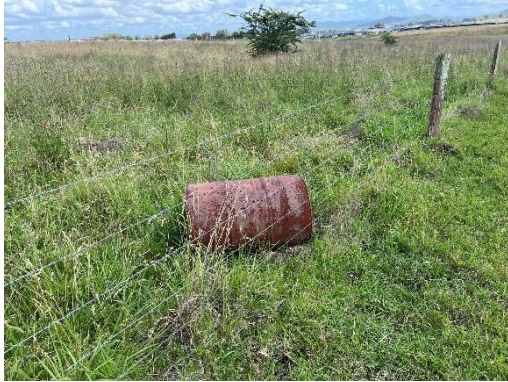
- A 44-gallon drum was observed just south west of Pond 1 sitting adjacent to a fence line.

Empty 44 Gallon Drum

Qualtest also recommends that an Unexpected Finds Procedure be included in the CEMP for the site.

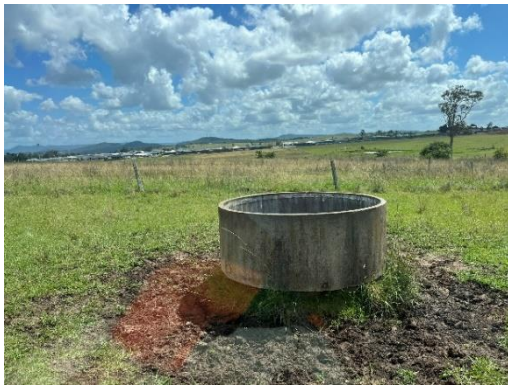
- The central portion of the site was observed to comprise grazing farmland with some trees (including some fallen), particularly in the south eastern portion of the site. The central northern portion was fenced from farmland and did not hold livestock. A concrete water trough was observed west of Pond 1 and former power poles were stored in the south western corner of the site.

Concrete trough west of Pond 4

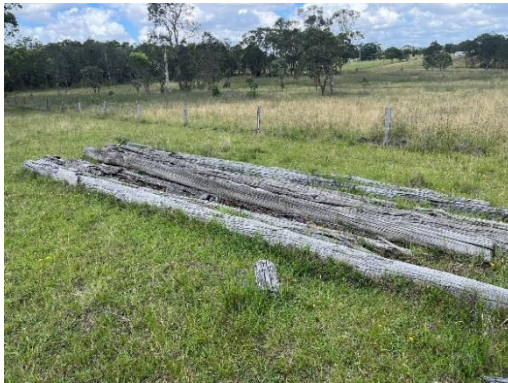
Power poles in south western corner
