# HUNTER RIVER BRANXTON TO GREEN ROCKS FLOOD STUDY

## HUNTER RIVER: BRANXTON TO GREEN ROCKS FLOOD STUDY

SEPTEMBER, 2010

<b>Project</b> Hunter River: Branxton To Green Rocks Flood Study		<b>Project Number</b> 27036	
<b>Client</b> Maitland City Council		<b>Client's Representative</b> Mr Chris McGrath	
<b>Authors</b> R W Dewar R Hardwick-Jones		<b>Prepared by</b>	
<b>Date</b> 23 September 2010		<b>Verified by</b>	
Revision	Description		Date
3	3 <sup>rd</sup> Draft Report		July 2010
2	2 <sup>nd</sup> Draft Report		March 2010
1	Preliminary Draft Report		October 2009

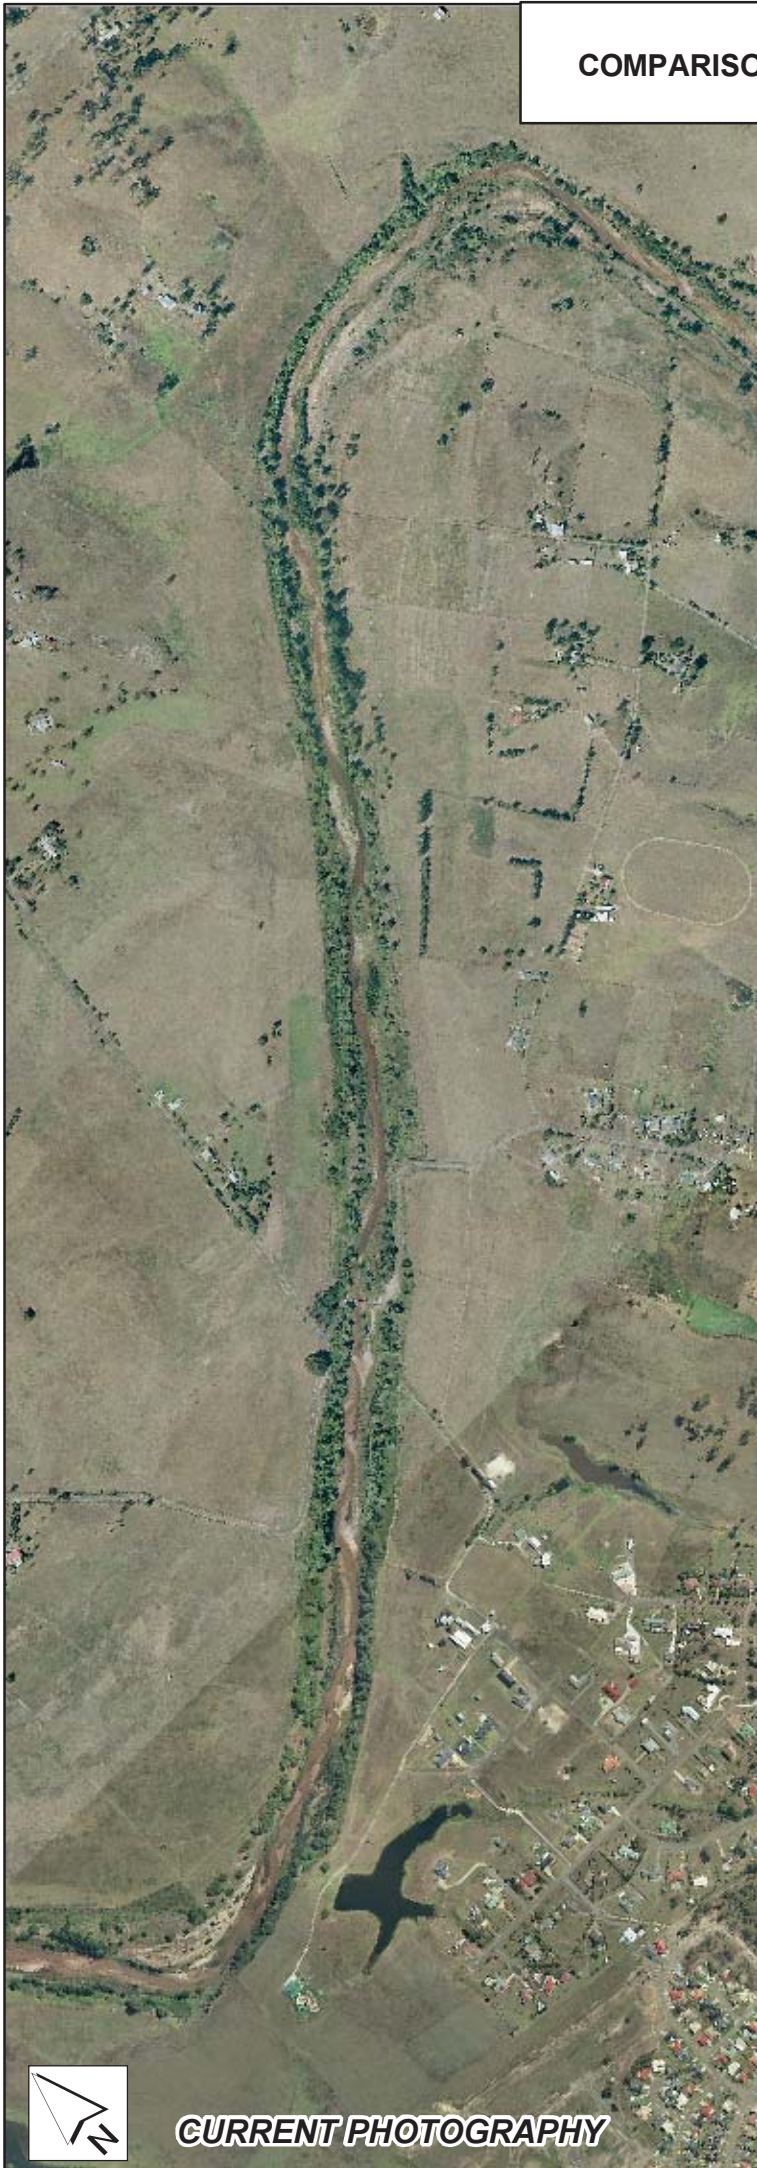
COMPARISON OF 1974 & CURRENT STREAMBANK VEGETATION  
ZONE A

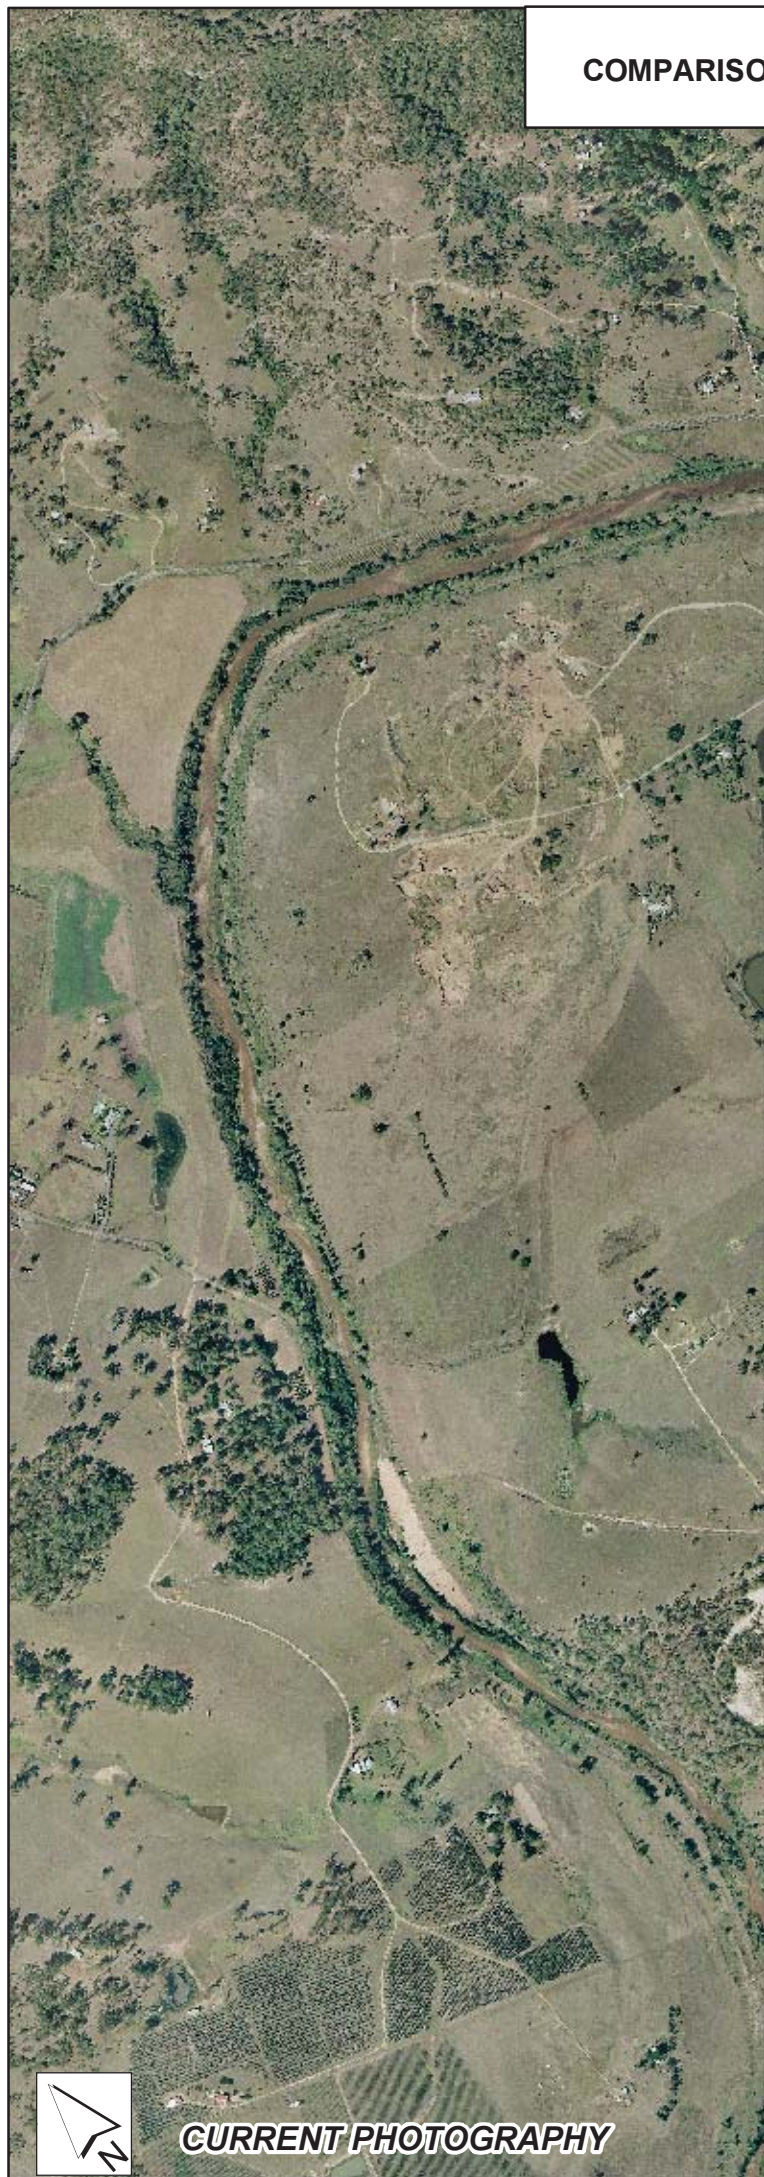
COMPARISON OF 1974 & CURRENT STREAMBANK VEGETATION  
ZONE B

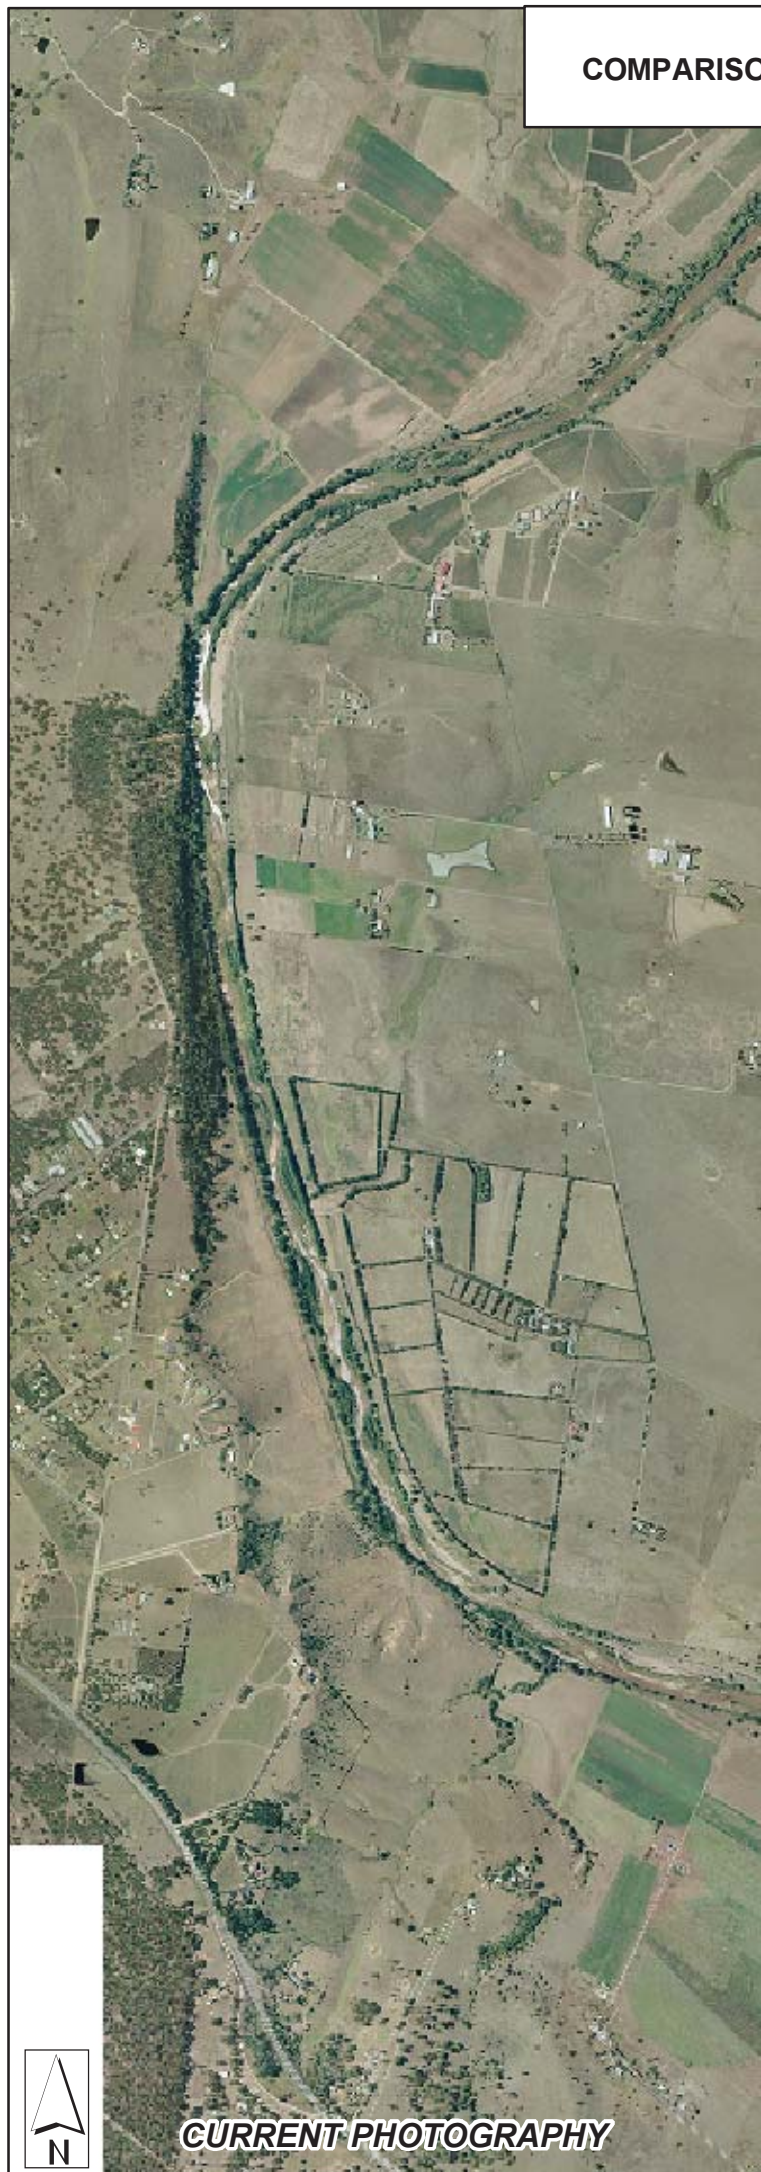
COMPARISON OF 1974 & CURRENT STREAMBANK VEGETATION  
ZONE C

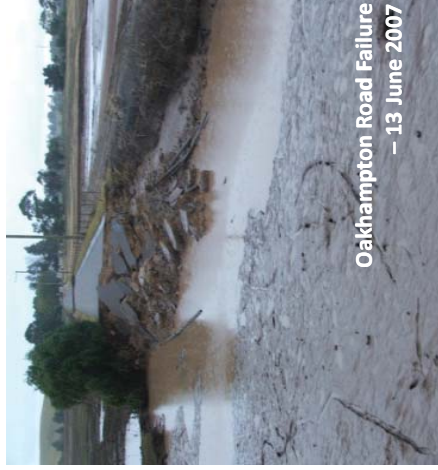
Oakhampton Road Failure  
- 13 June 2007

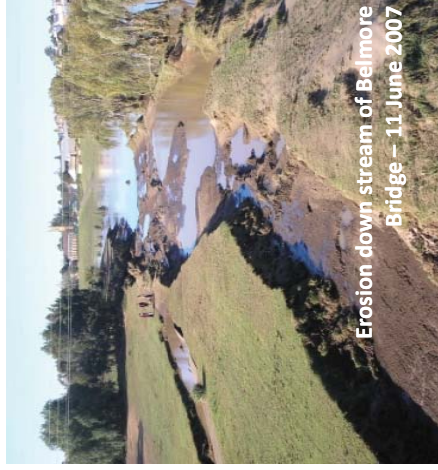
Erosion down stream of Belmore  
Bridge - 11 June 2007
