Report on  
Detailed Site Investigation

Proposed Administration Building  
High Street Maitland

Prepared for  
Maitland City Council

Project 49797.01  
October 2018

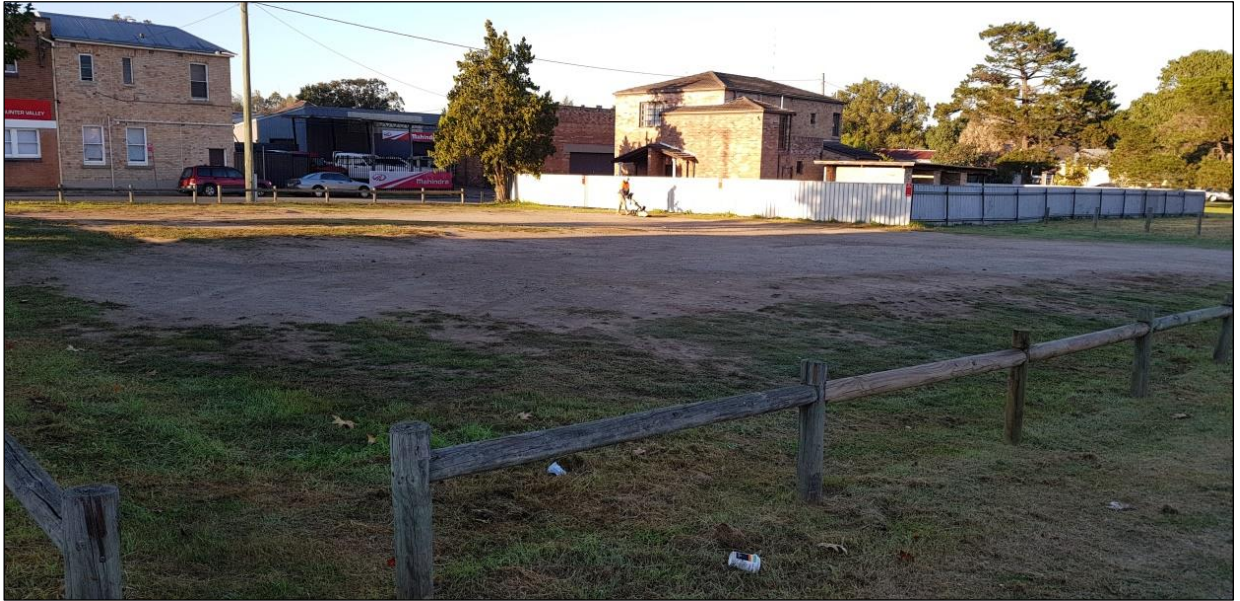
- Unpaved vacant area in the north-eastern portion of the site, understood to be used as a parking area by MCC (Figure 3);
- Grassed area in the south-eastern portion of the site (Figure 4);

**Figure 3: Unpaved car park area in the north-eastern portion of the site, looking south-east**

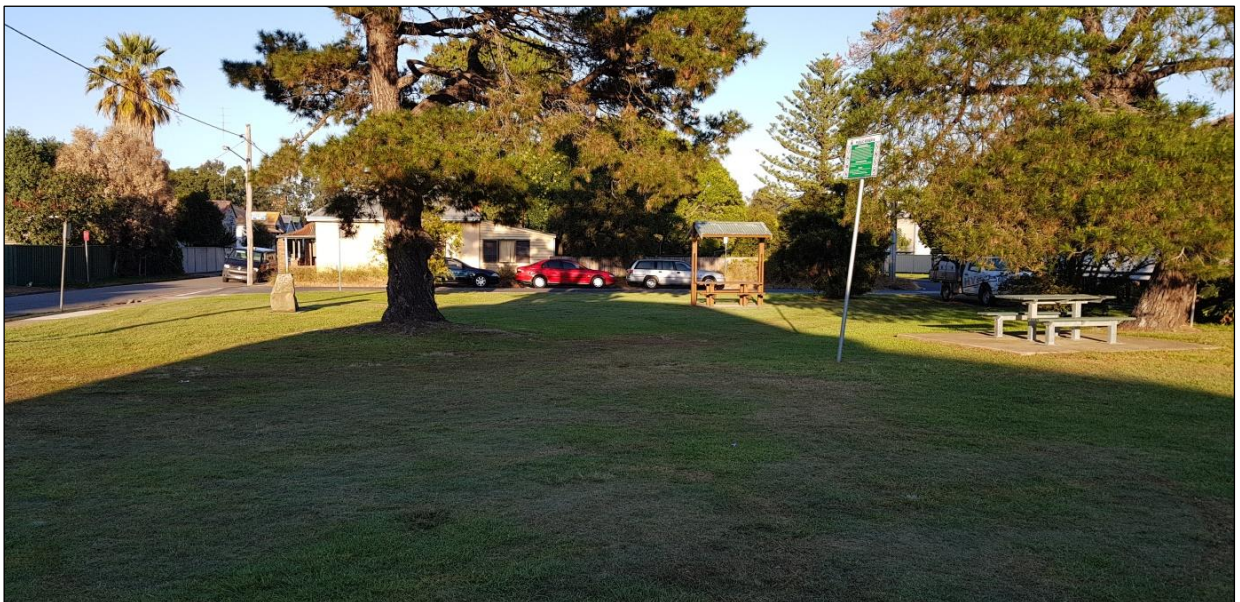
**Figure 4: Grassed area in the south-eastern portion of the site, looking south**

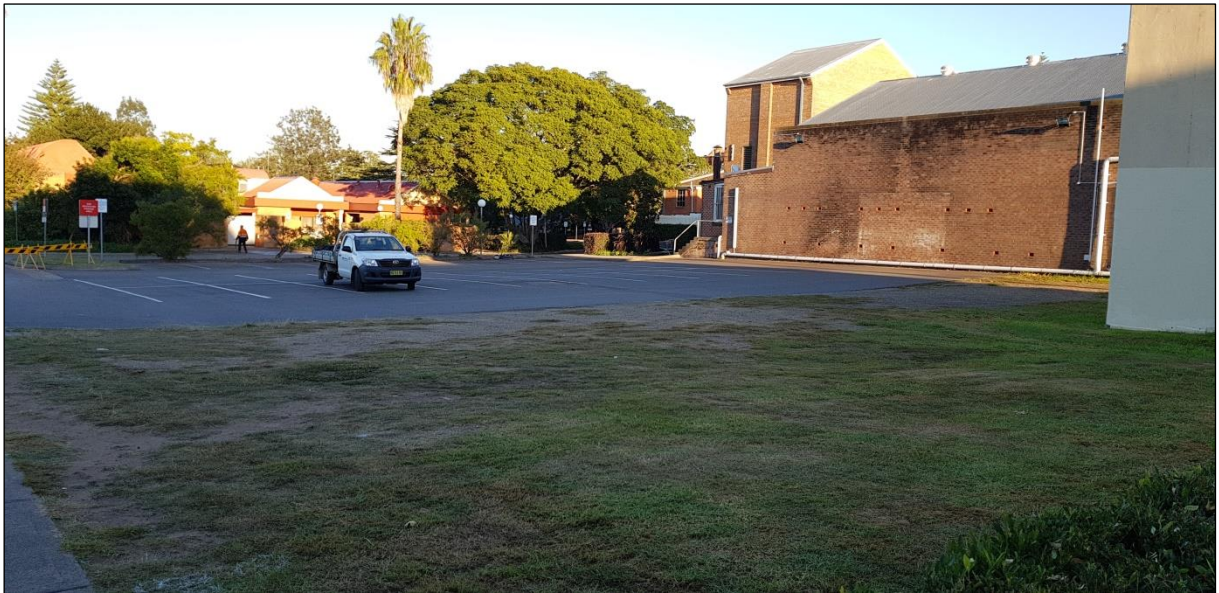
- Grassed vacant area in the north-western portion of the site, adjacent to the historical commercial structure (Figure 5);
- Asphalt-paved car parking areas in the western portion of the site (Figure 6);

**Figure 5: Grassed area and former shop (far right of figure) in the north-western portion of the site, looking south-west**

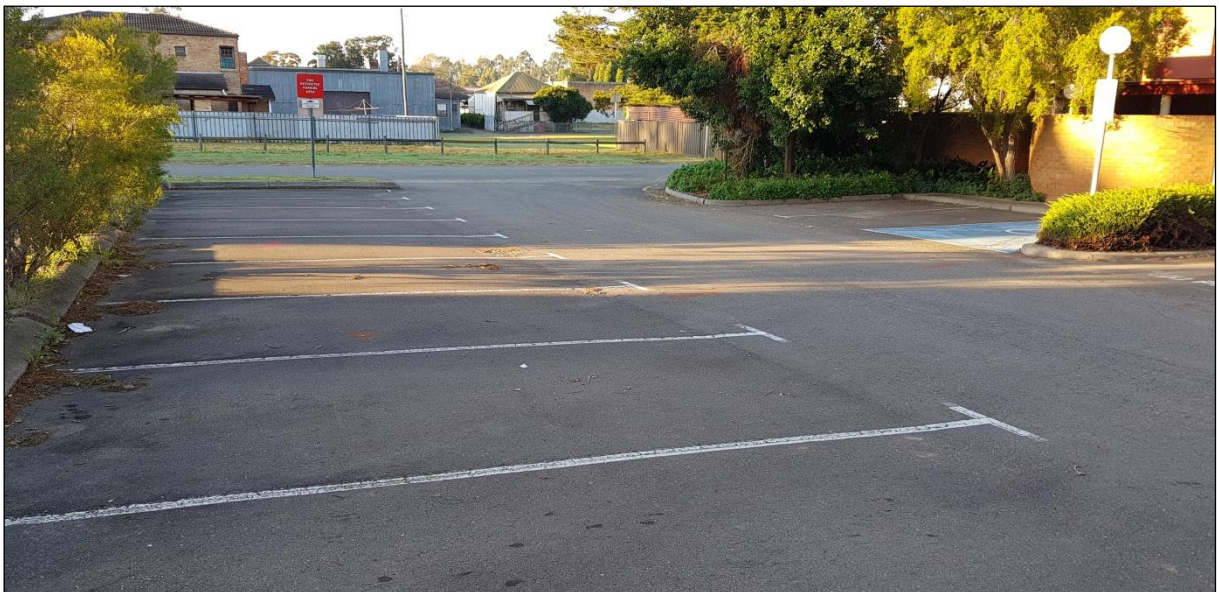
**Figure 6: Asphalt car park in the western portion of the site, looking east**
