## Arboricultural Impact Assessment

Proposed Residential Sub-division  
36 Sanctuary Drive, Lochinvar 2321  
Lot 1 DP1309170

**AEP Ref: 5553**

**May 2025**

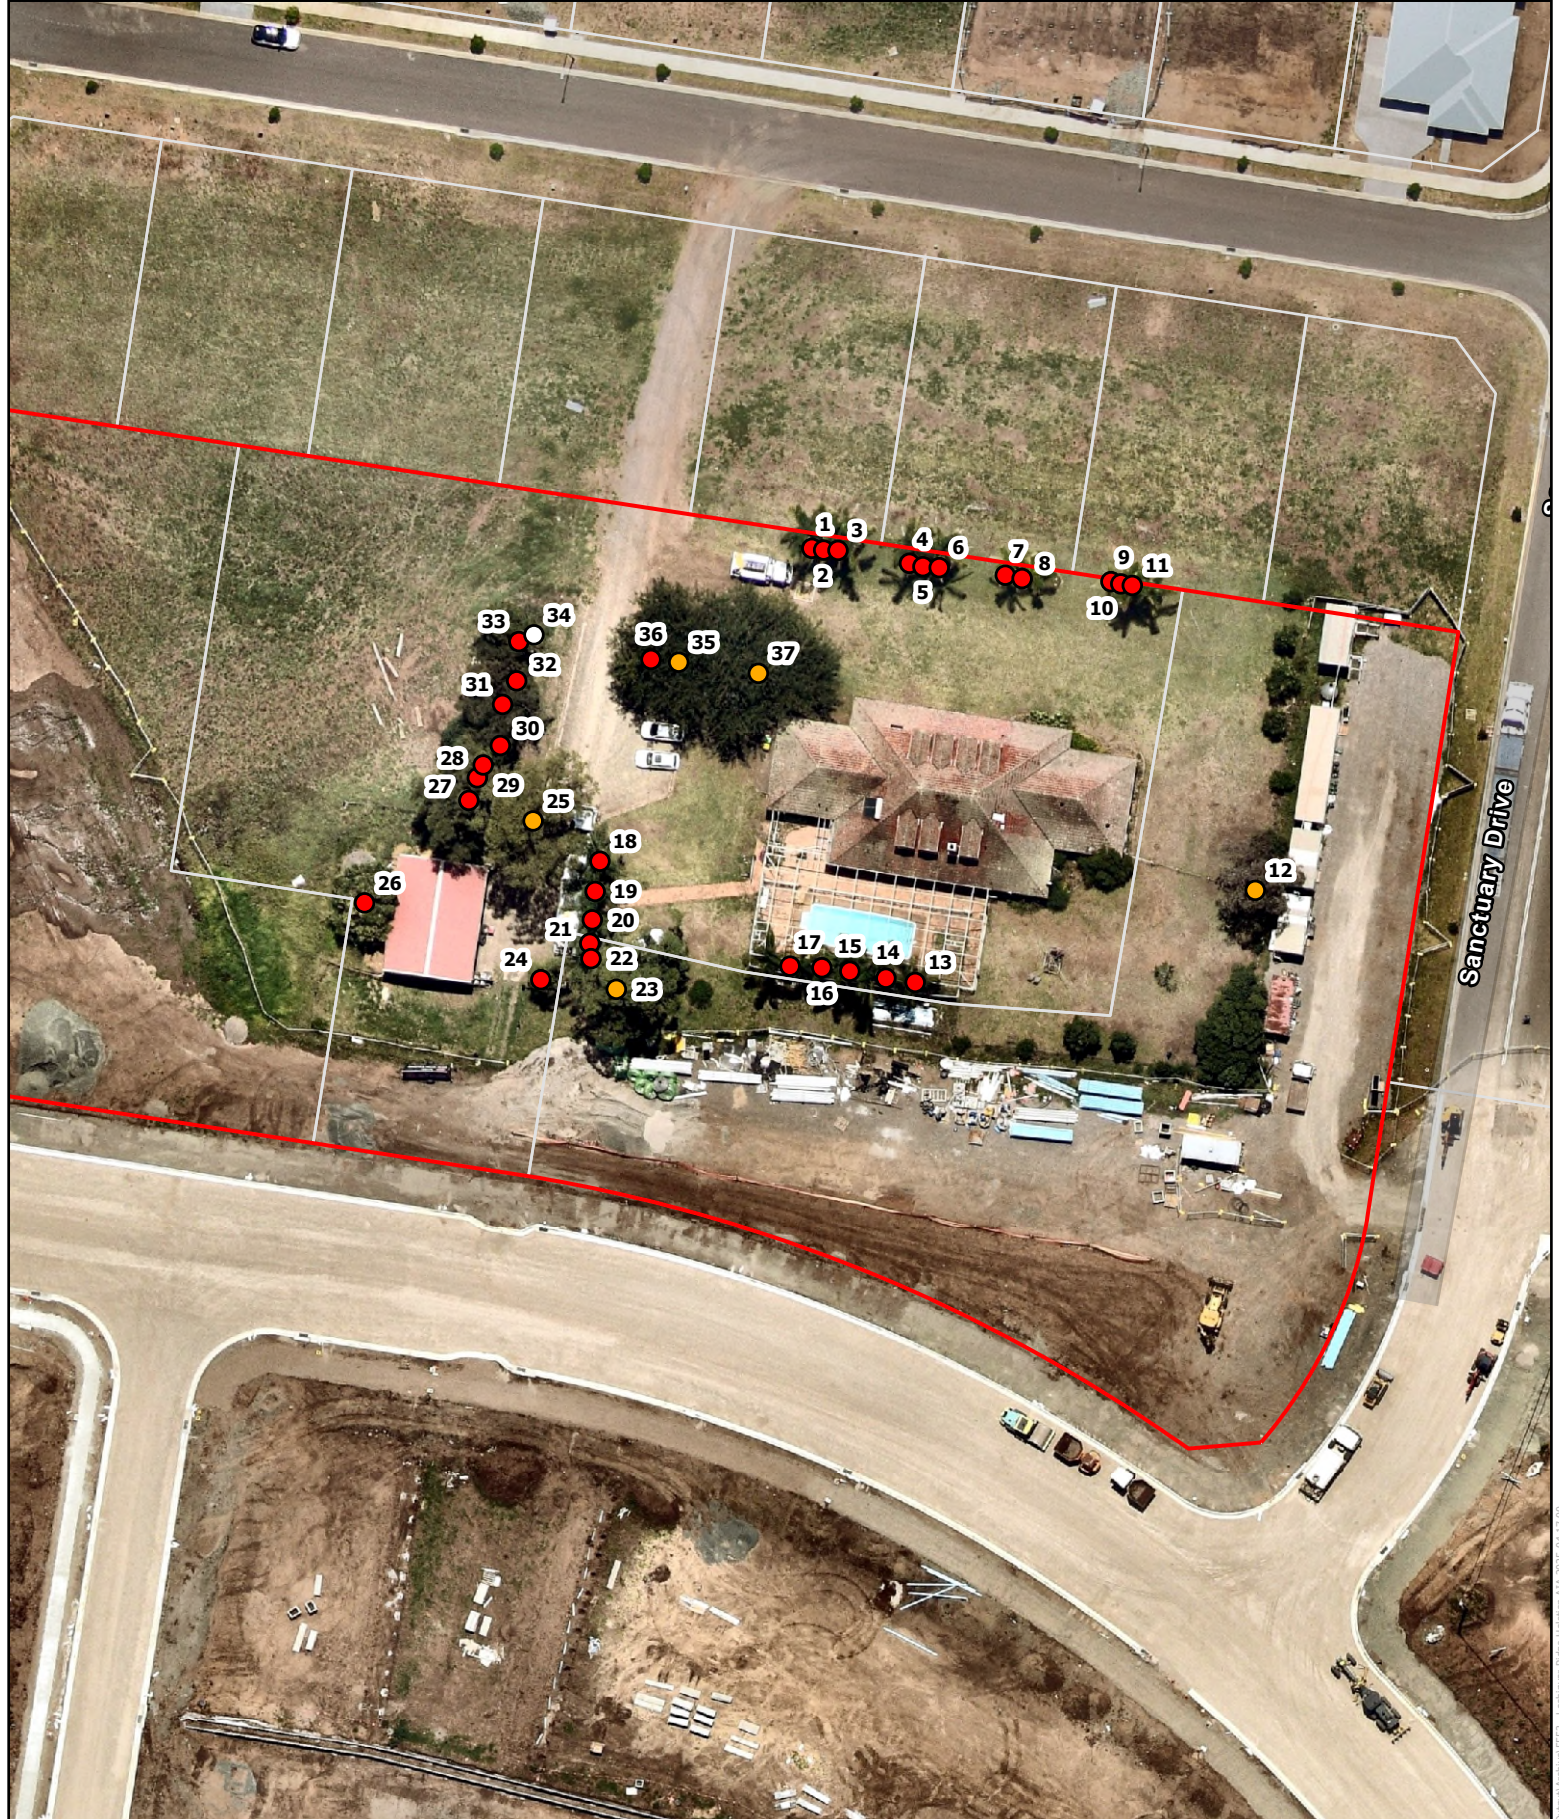
**Figure 3 - Tree Locations**

A total of 37 trees identified within the site and neighbouring properties were assessed. Observations were made for each assessed tree (**Appendix A**). Tree locations are shown in **Figure 3**.

- Five (5) 'Moderate';
- 31 'Low' and
- One (1) 'Very Low' Retention Value Trees.

No hollows were noted in the assessed trees. One (1) small stick nest in Tree 33 *Casuarina glauca* (Swamp oak), No animal activity was present at time of assessment.
