1 OAKHAMPTON ROAD MAITLAND

ARBORICULTURAL IMPACT ASSESSMENT

JULY 2025

Arboricultural Impact Assessment

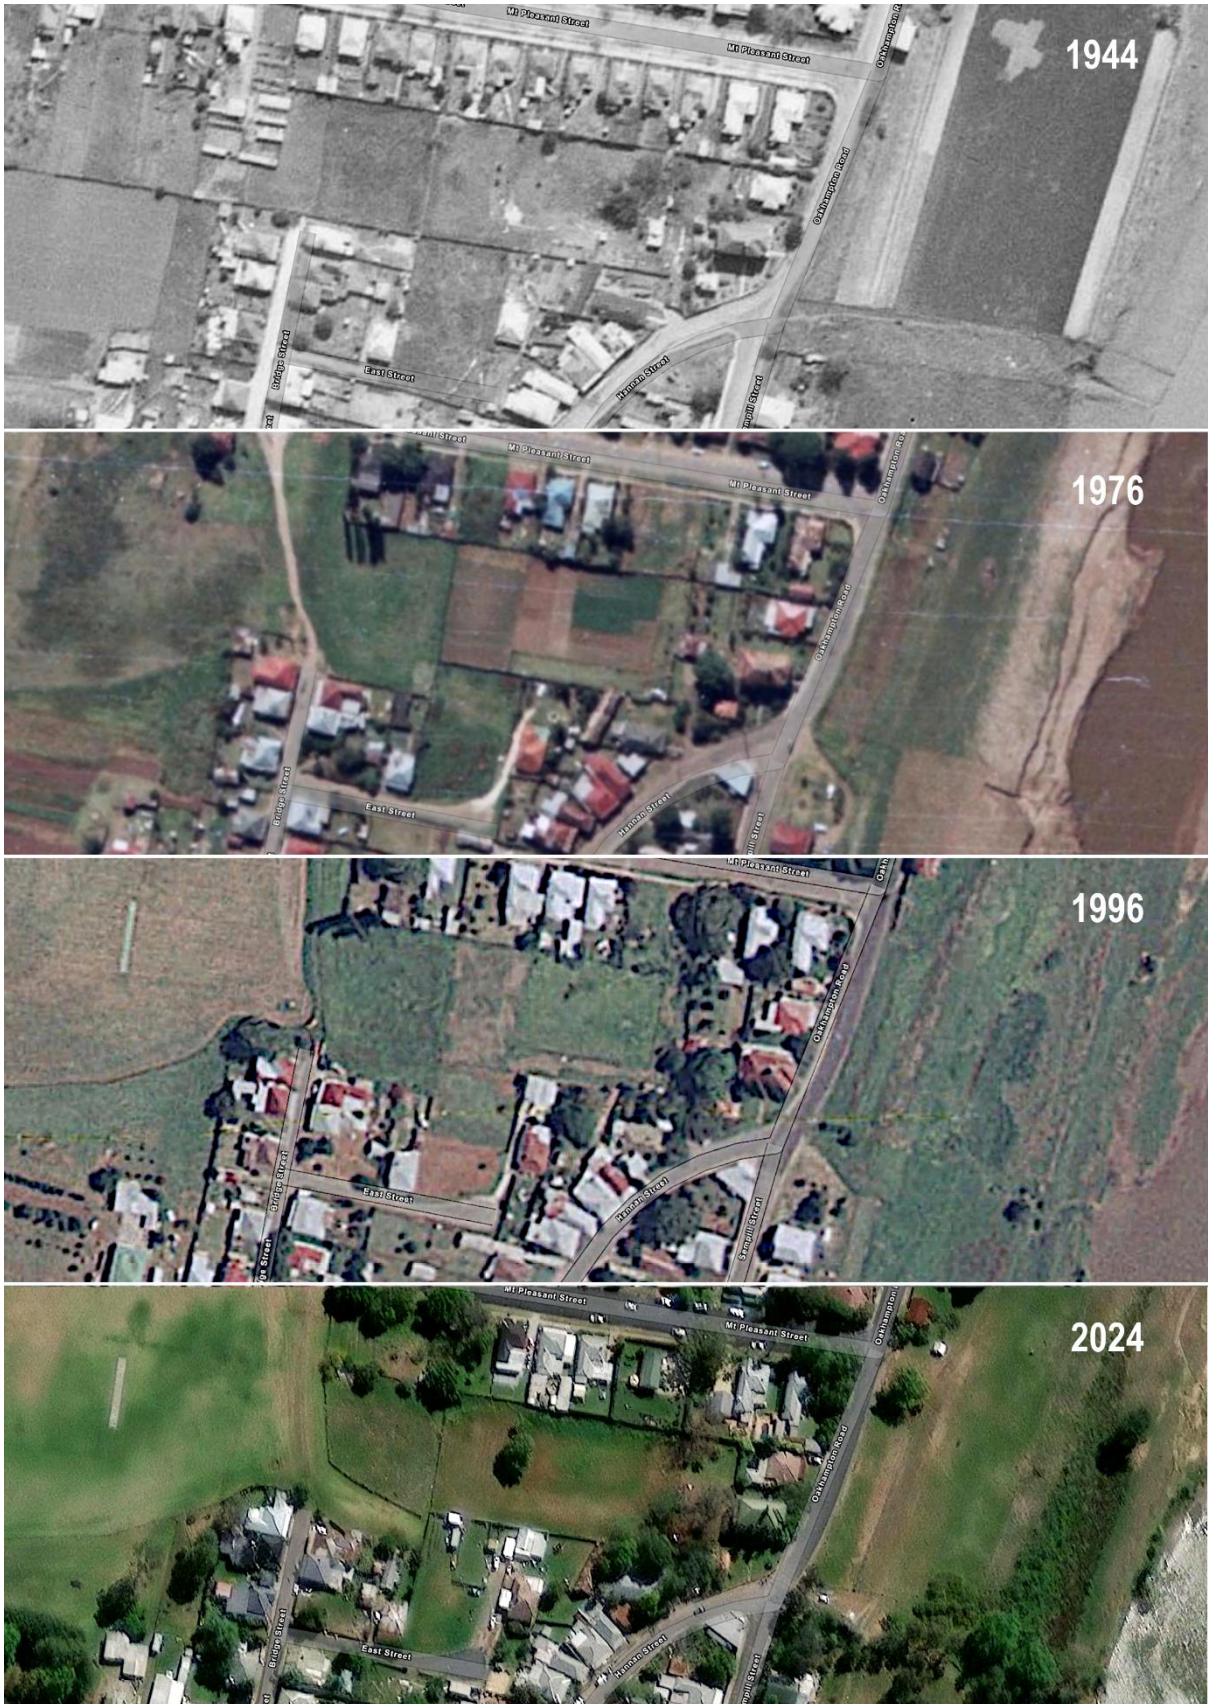
FIGURE 4: HISTORIC AERIAL IMAGE COMPARISON.
[AERIALS: Maitland Maps <https://maps-maitlandcc.hub.arcgis.com/>]

By using a comparison of historic aerial images (Figure 4), it would appear that Trees 9 (*Erythrina crista-galli*) and Tree 12 (*Jacaranda mimosifolia*) are the oldest trees occurring on site with an approximate age of between 80 and 100 years old. This is supported by their size and current condition. These two trees are the most significant trees on site based on size and landscape value but are unlikely to have strong historic associations to former residents, although this would need to be confirmed by the Heritage Consultant.

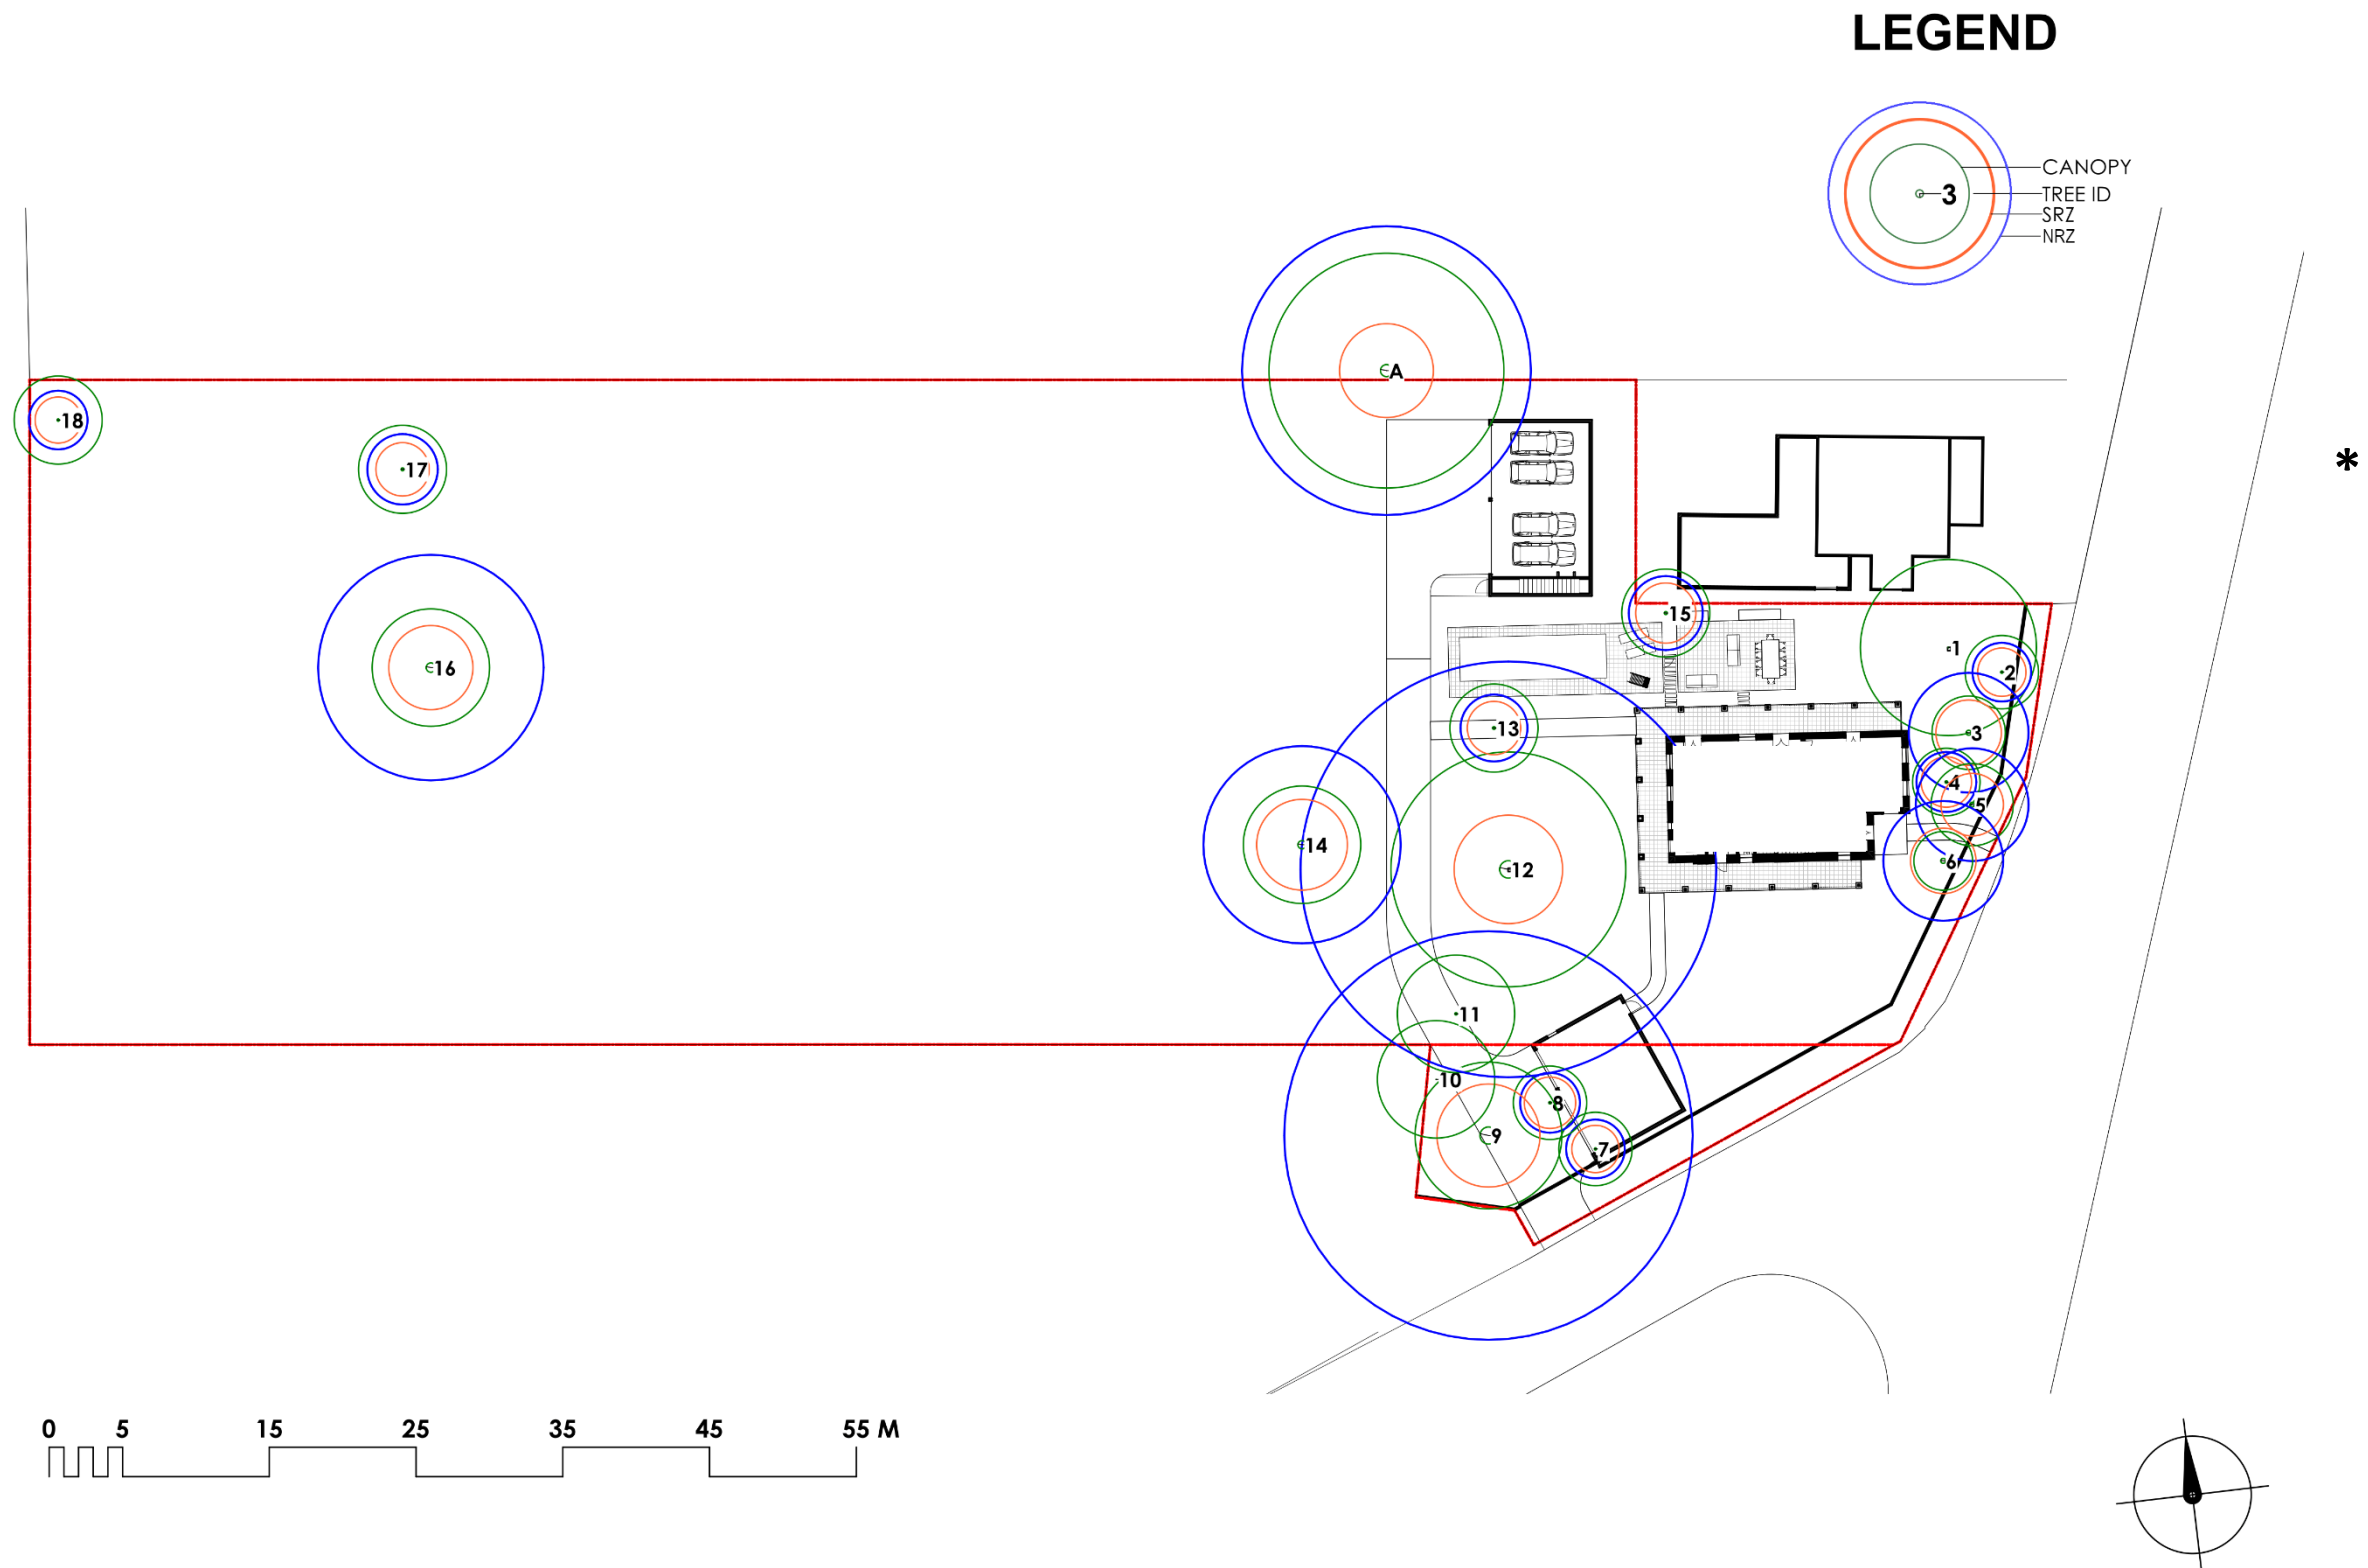
FIGURE C2 – TREE IMPACT ASSESSMENT DIAGRAM [BASE DRAWING SOURCE: HUTCH ARCHITECTURE & OCTOPUS GARDEN DESIGN]

Trees 7, 8, 10 and 11 are required for removal to enable the driveway and side fencing to be installed. Once again, these trees are not good specimens. It may be possible to retain Tree 10; however, its thick base, as the result of heavy past pruning, will make the installation of a fence difficult and requiring a large portion of the tree to be removed, hence the recommendation for its removal.
