## Walka Water Works

Conservation Management Plan

Maitland City Council

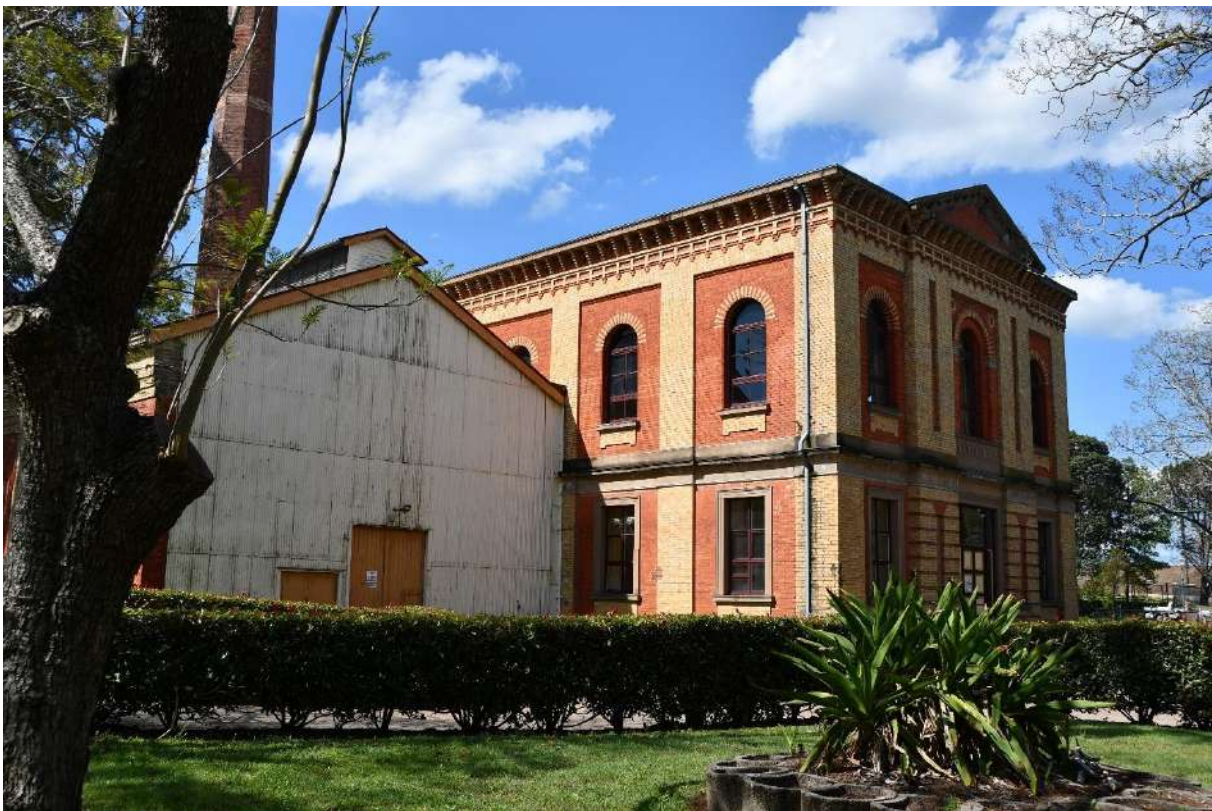
Figure 39: Southern and western elevation of the Main Pumphouse (Item A)

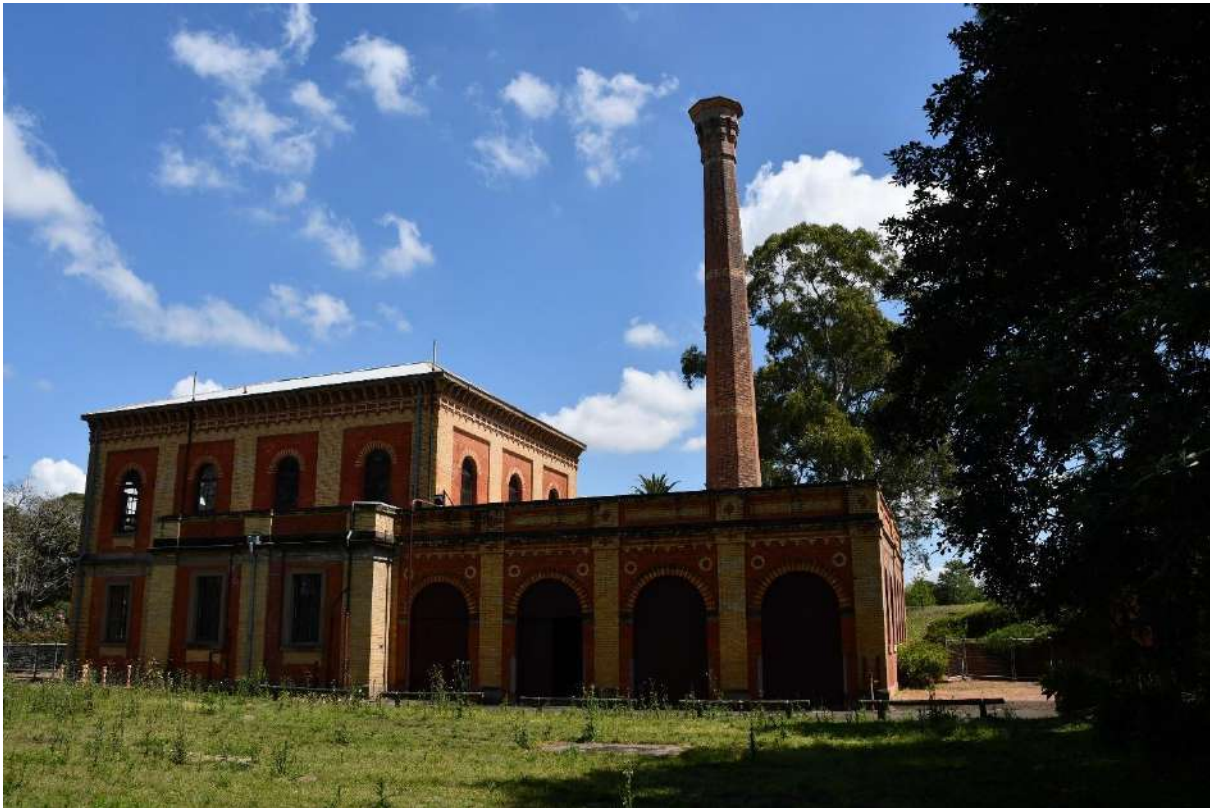
Figure 40: Eastern elevation of the Main Pumphouse (Item A), with Eastern Annex (Item D) and Boiler Room (Item B) visible.

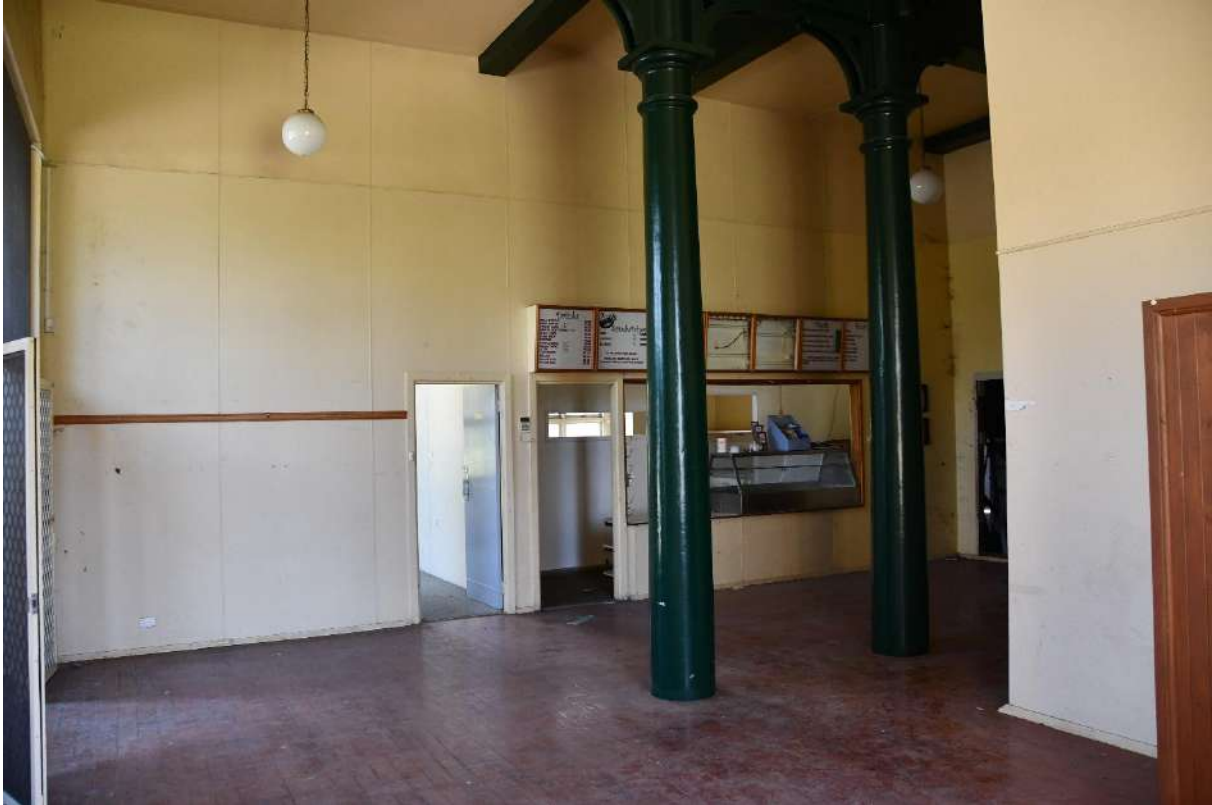
| Room | Known as | Key features | Condition / Integrity | Images |
|---|---|---|---|---|
| #01 | Main Office / Entrance | Original cast iron columns supporting beams that extend outwards. False panel board ceiling. Timber floors. Various fixtures and fittings including lights and power points | Columns original and in good condition<br>Good integrity to 1950s internal layout. Paint cracking and some mould on external walls | Figure 42, Figure 43 |

Figure 42: The Main Office (Room #01) in Main Pumphouse (A) looking towards Room #02 and #03. Note the original columns with 1950s floors and internal partitions creating the additional rooms.

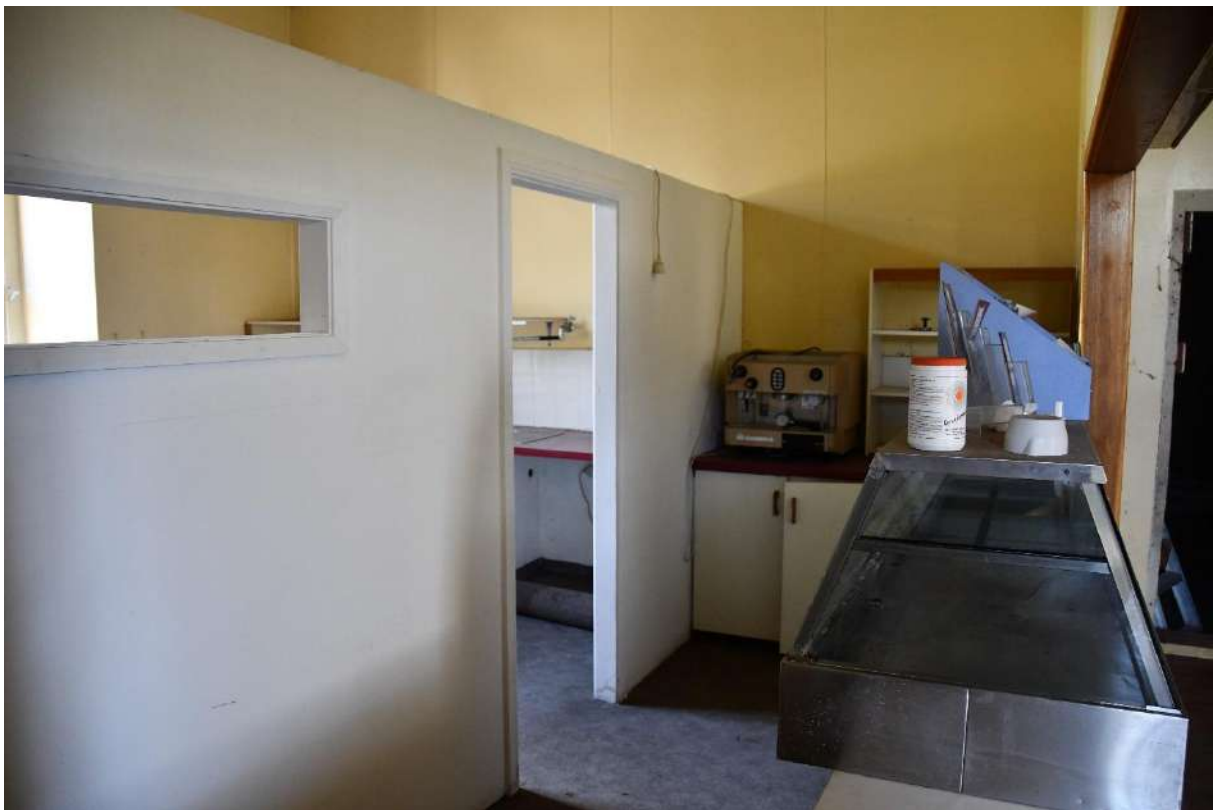
| Room | Known as | Key features | Condition / Integrity | Images |
|---|---|---|---|---|
| #03 | Laboratory / Kitchen | Original cast beam, false ceiling, linoleum floor, possible 1950s cabinetry, serving hatch | General good condition. Low dividing wall in centre | Figure 45, Figure 46 |

Figure 45: The front section of the Kitchen/Laboratory (Room #03). The low partition wall is of an unknown date but likely was installed along with the kitchen equipment in the 1990s.

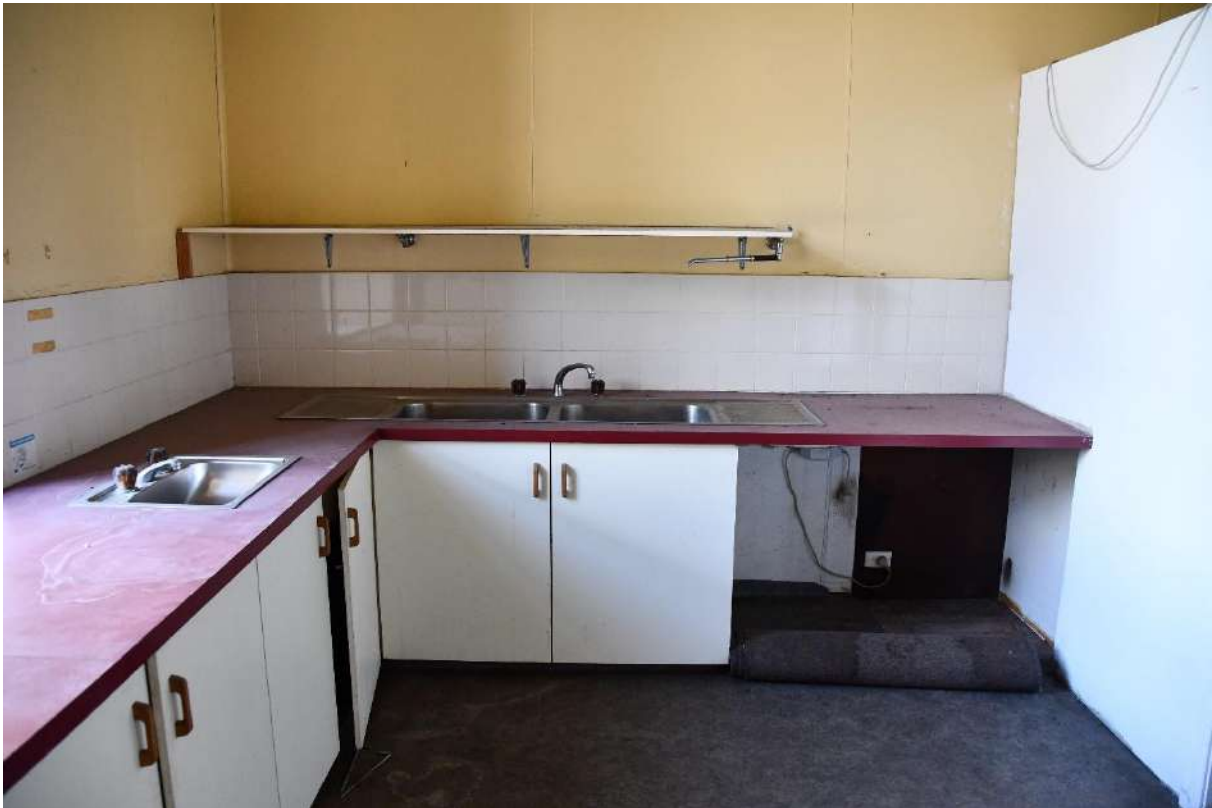
Figure 46: The rear area of Room #03 showing the 1990s cabinetry and sinks.

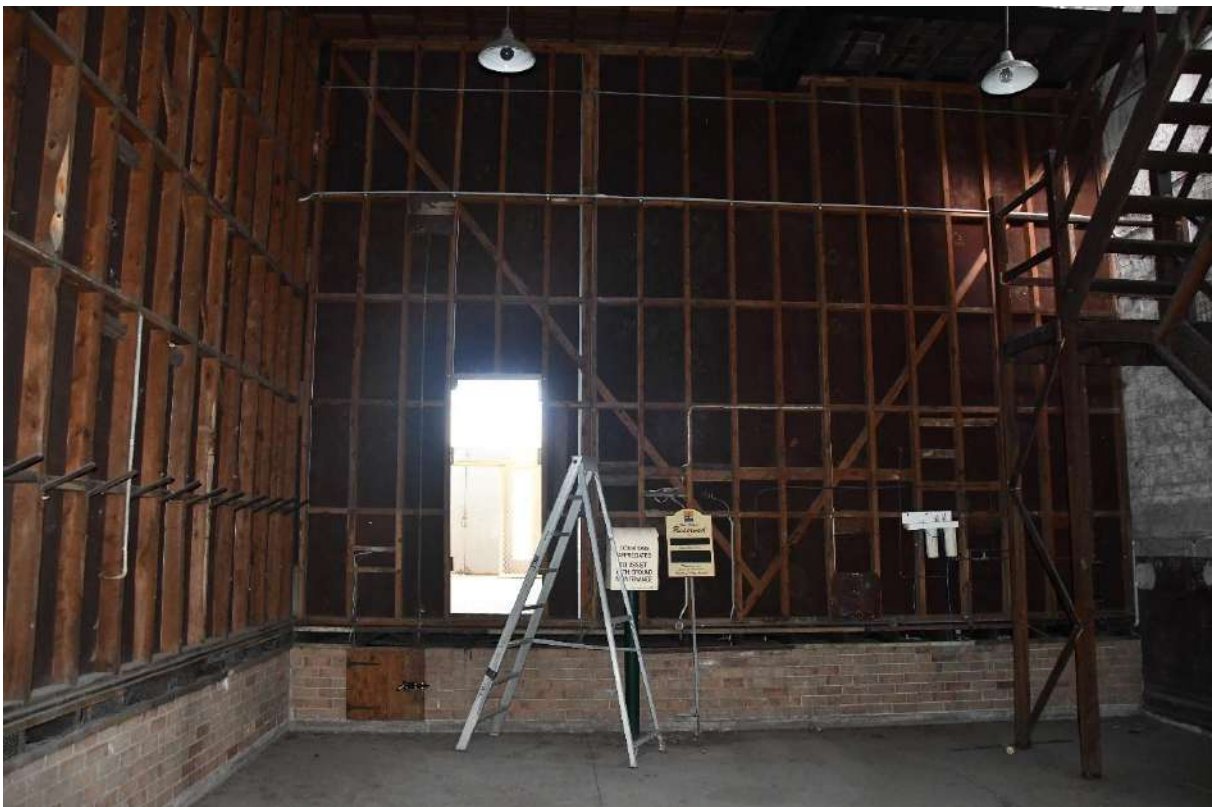
| Room | Known as | Key features | Condition / Integrity | Images |
|---|---|---|---|---|
| #04 | Pumphouse Lower | Exposed brickwork and stud work demonstrating construction. Concrete floor, no ceiling showing exposed floorboards of upper storey. Wire mesh enclosed staircase | Clear evidence of construction techniques from numerous phases. Stairs from 1950s alterations. Floor 1950s but closer to original level | Figure 47, Figure 48 |

Figure 47: The Pumphouse Lower room (Room #04) looking south. The floor level in this room is lower than the adjoining rooms and it features exposed wood stud work and various Power Station features.

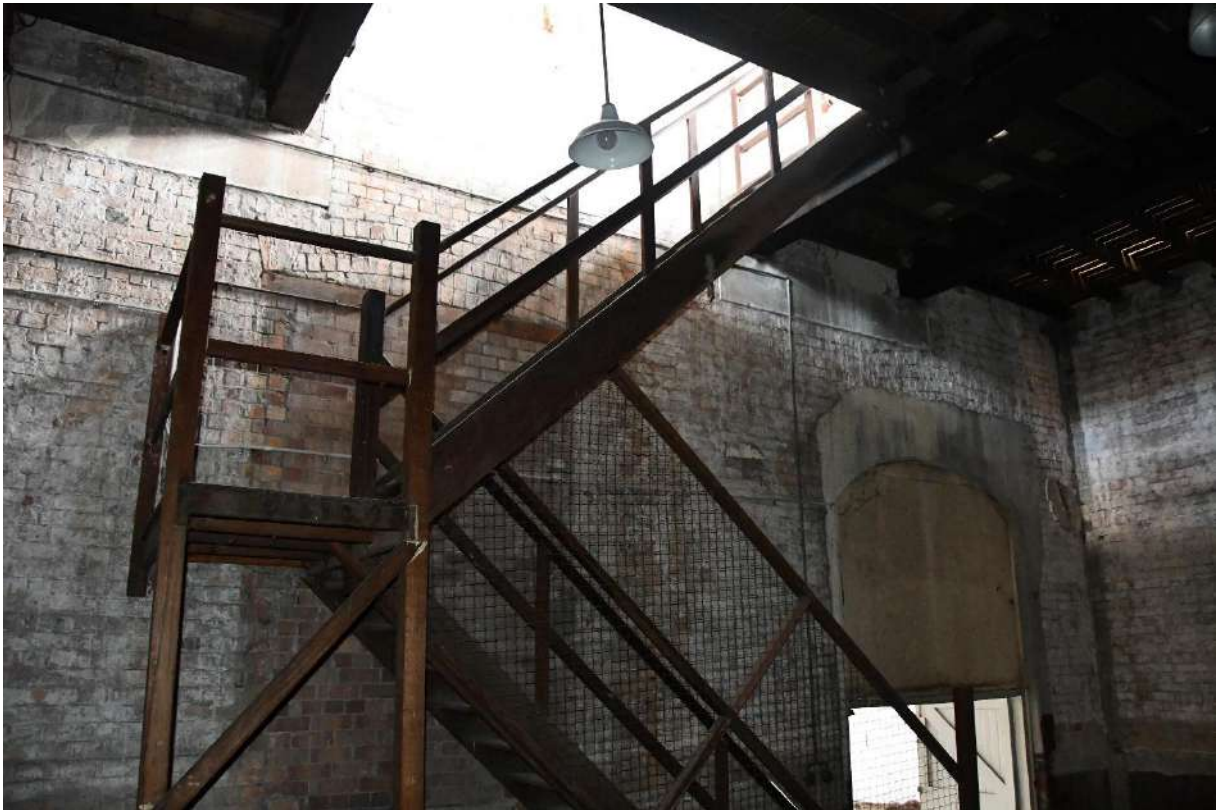
Figure 48: The 1950s internal staircase that links Room #04 to Room #09 above.

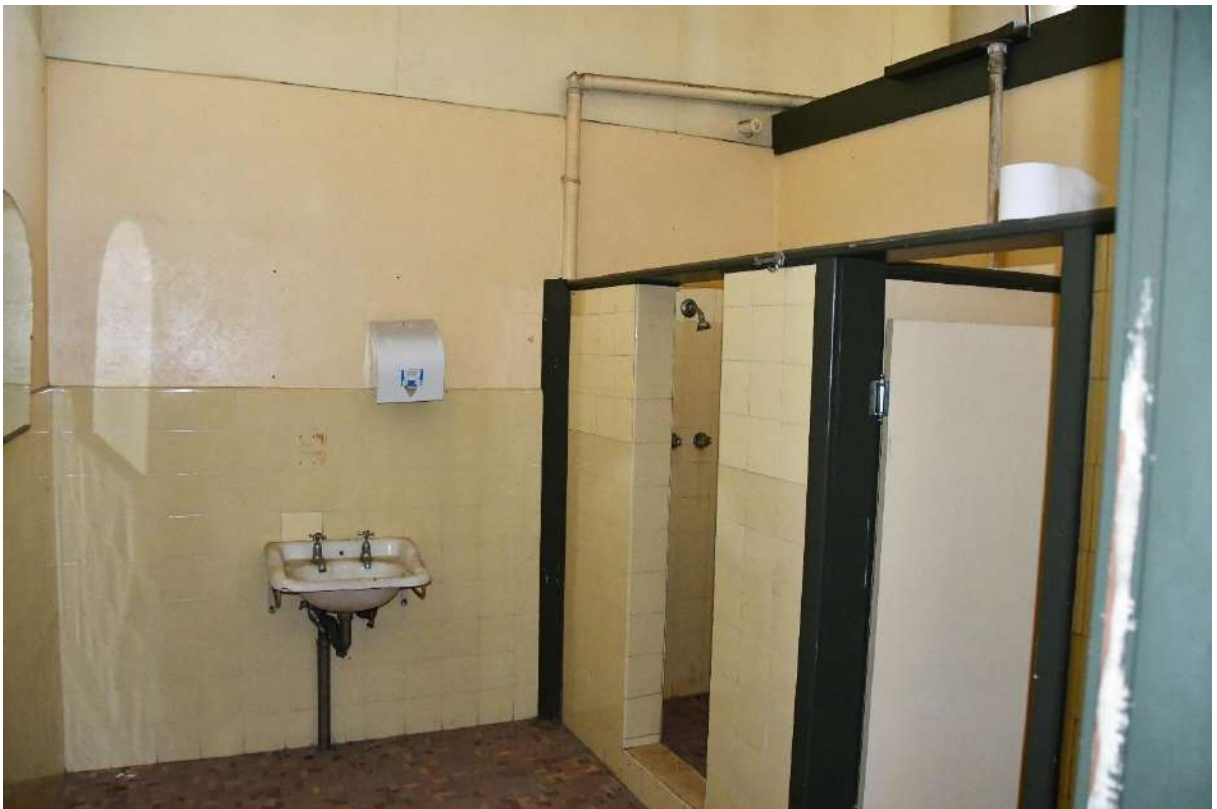
| Room | Known as | Key features | Condition / Integrity | Images |
|---|---|---|---|---|
| #05 | Toilets | Low false ceilings in some parts. Various extractor fans and pipework. Some ornate mirrors/hinges etc. 1950s fixtures | Largely intact 1950s toilet block | Figure 49, Figure 50 |

Figure 49: Toilets (Room #05) within the Main Pumphouse (Item A) with original tiled walls and herringbone floor.

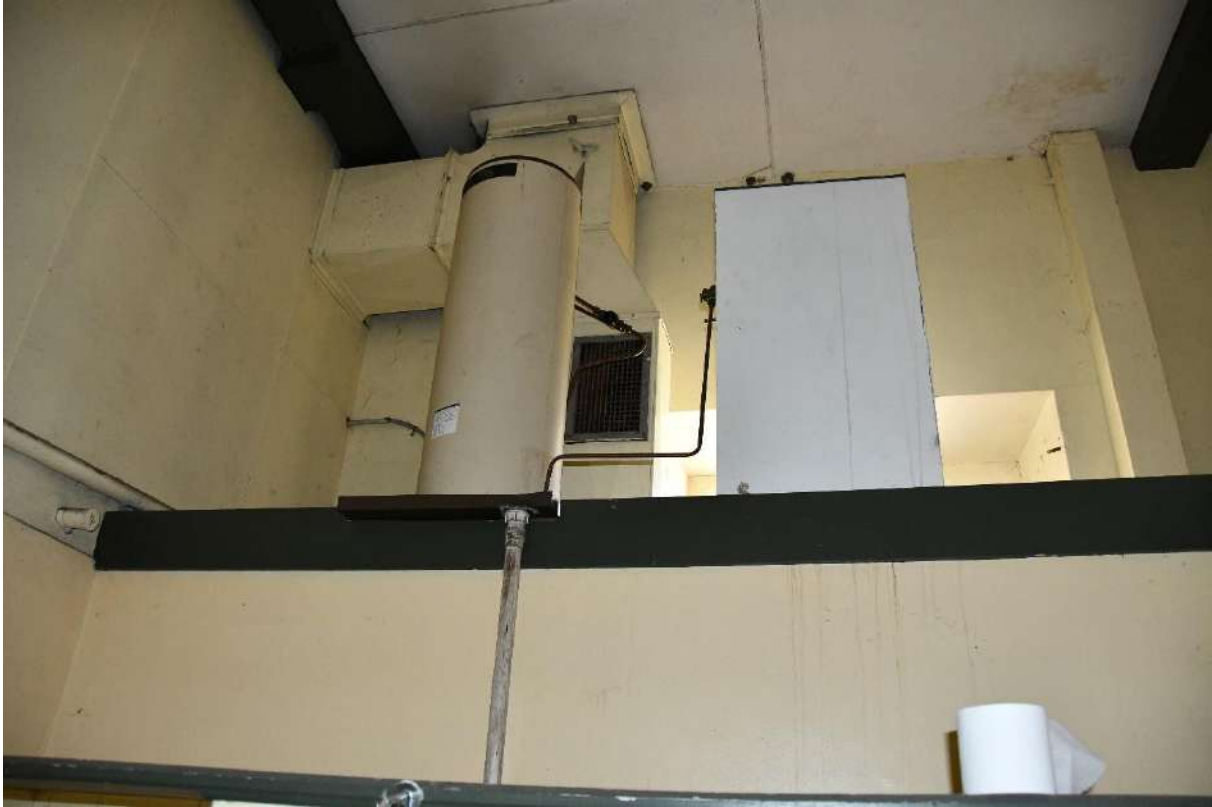
Figure 50: The false ceiling and various vents within the Toilets (Room #05)

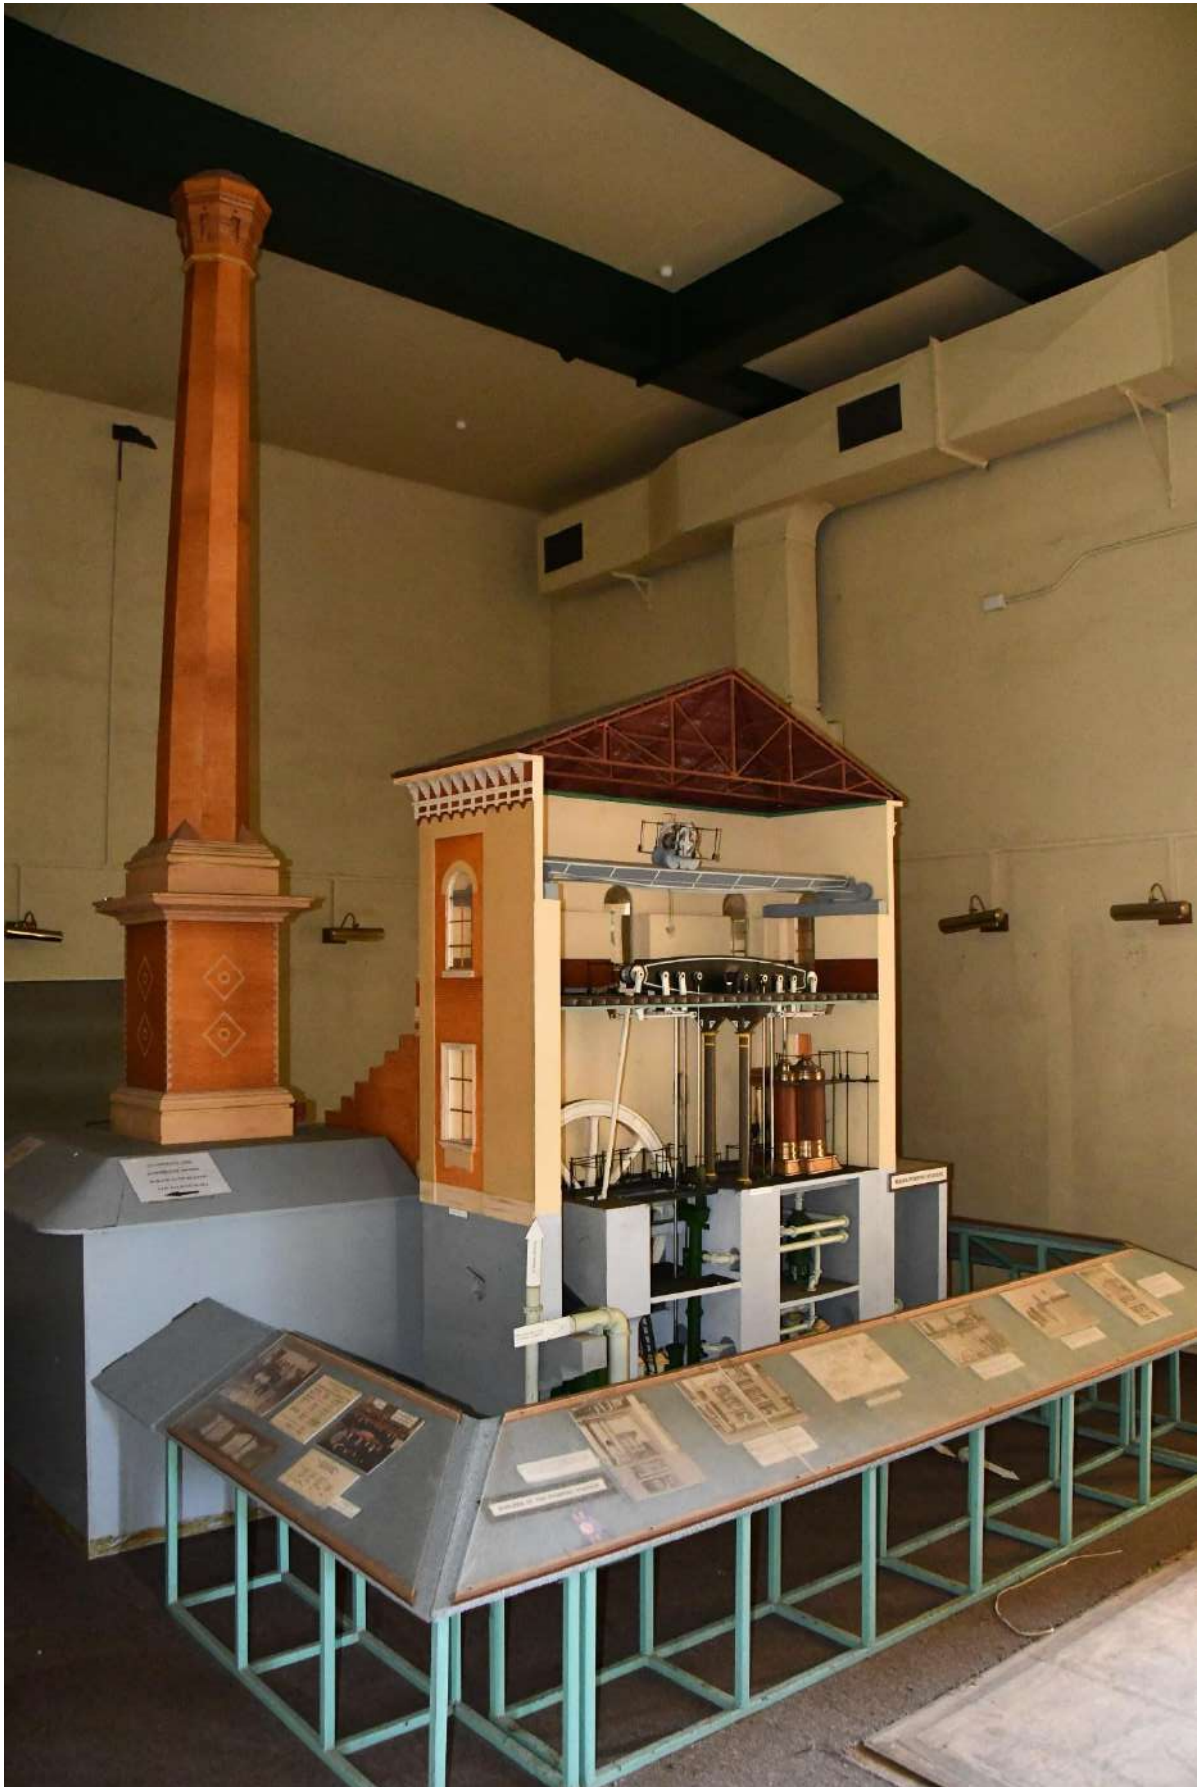
| Room | Known as | Key features | Condition / Integrity | Images |
|---|---|---|---|---|
| #06 | Change room / Museum | Original cast beams continue, internal wall panelling. Thin grey carpet with some floorboards exposed. Scale model of waterworks | Plans show 1950s change rooms with further partition wall. Original beams in good condition, no original 1950s features | Figure 51 |

Figure 51: The scale model of the Water Works within the Museum (Room #06). The continuation of the original columns and beams are visible.

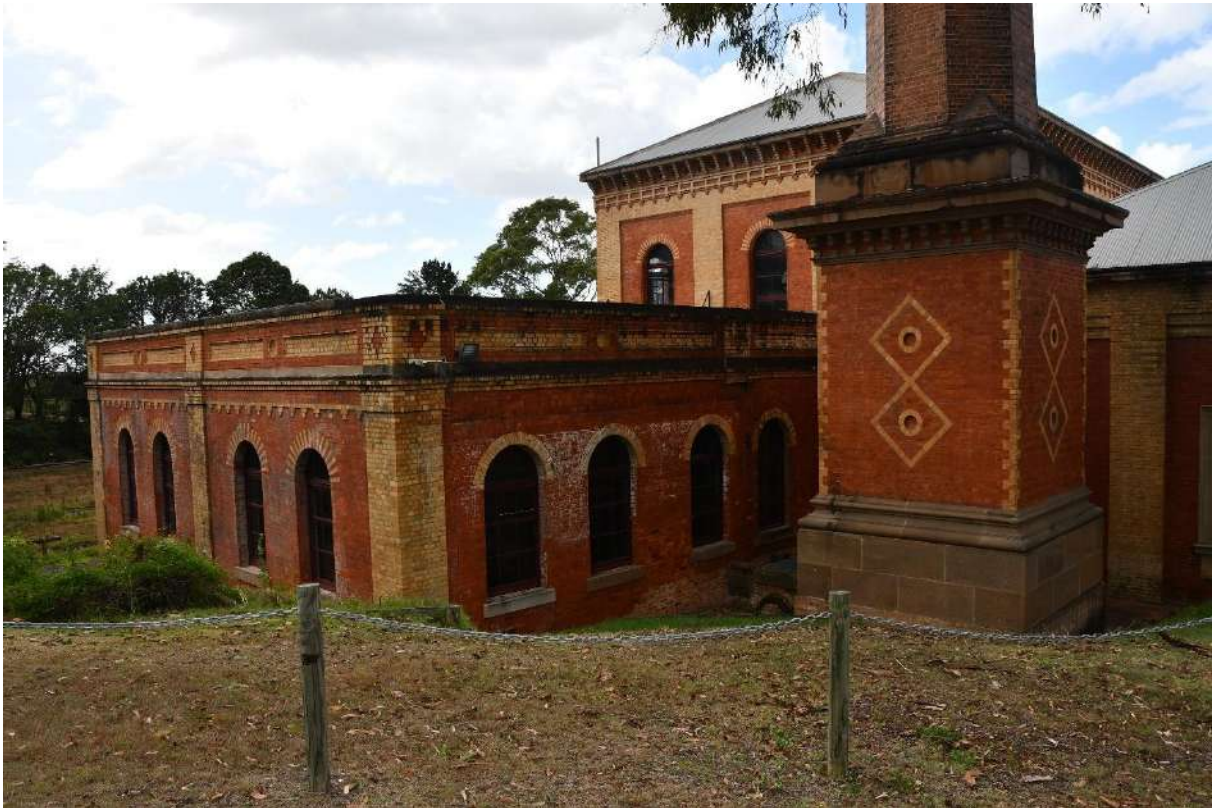
Figure 57: The northern and eastern elevation of the Boiler Room (Item B) showing the paired windows beneath the relieving arches and decorative brickwork.

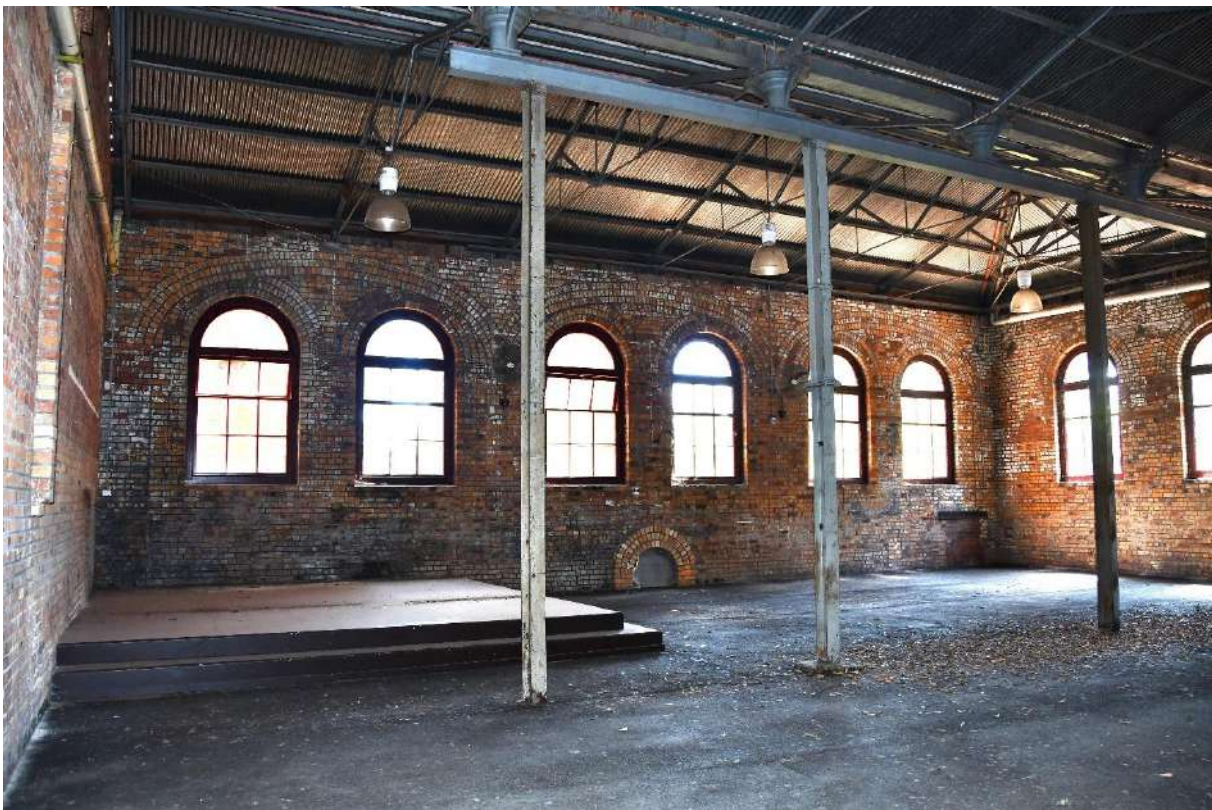
Figure 58: General interior view of the Boiler Room (Item B) showing the western wall with relieving arch.

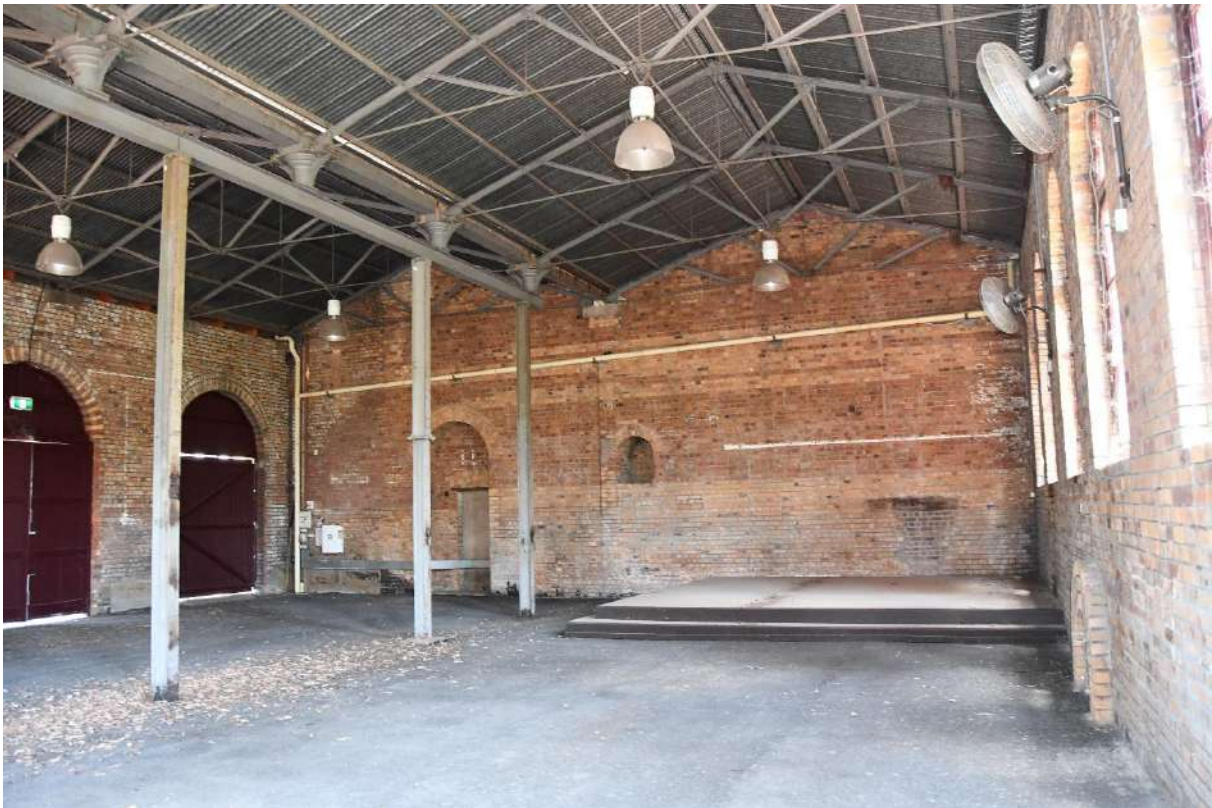
Figure 60: The southern wall of the Boiler Room (Item B) where the various previous access points to the Main Pumphouse (item A) can be seen.

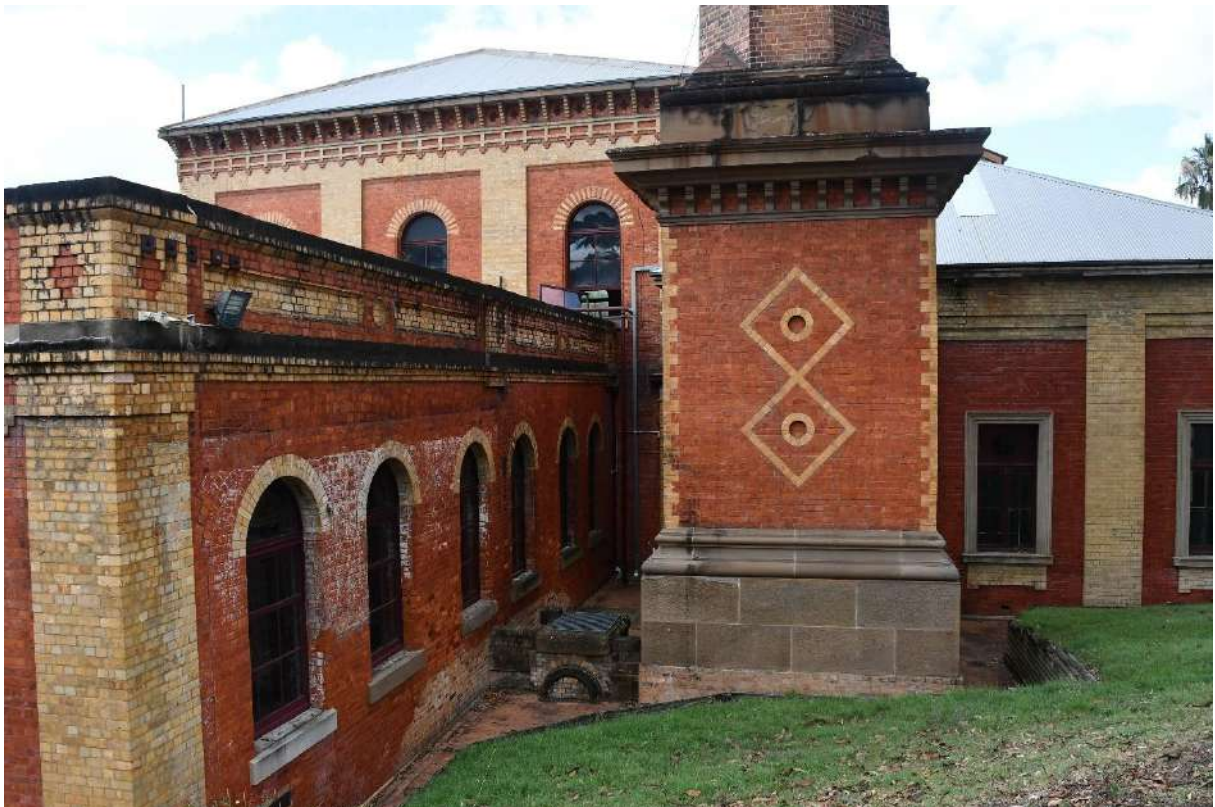
Figure 63: The lower section of the chimney (Item C) viewed from the north with the diamond and circular motif and sandstone base visible.

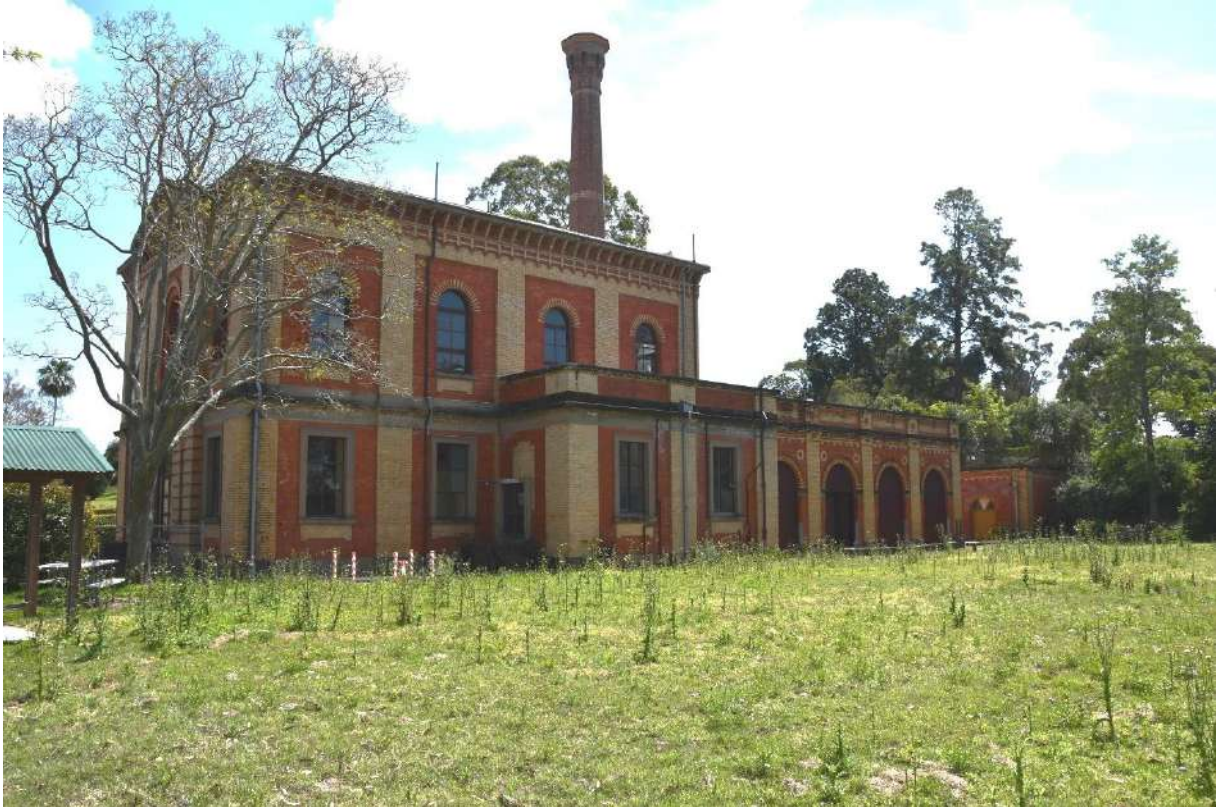
Figure 67: The Eastern elevation of the Pumping Station showing the location and features of the Eastern Annex (Item D). The unsympathetic 1950s doorway is visible on the southern facade of the annex.

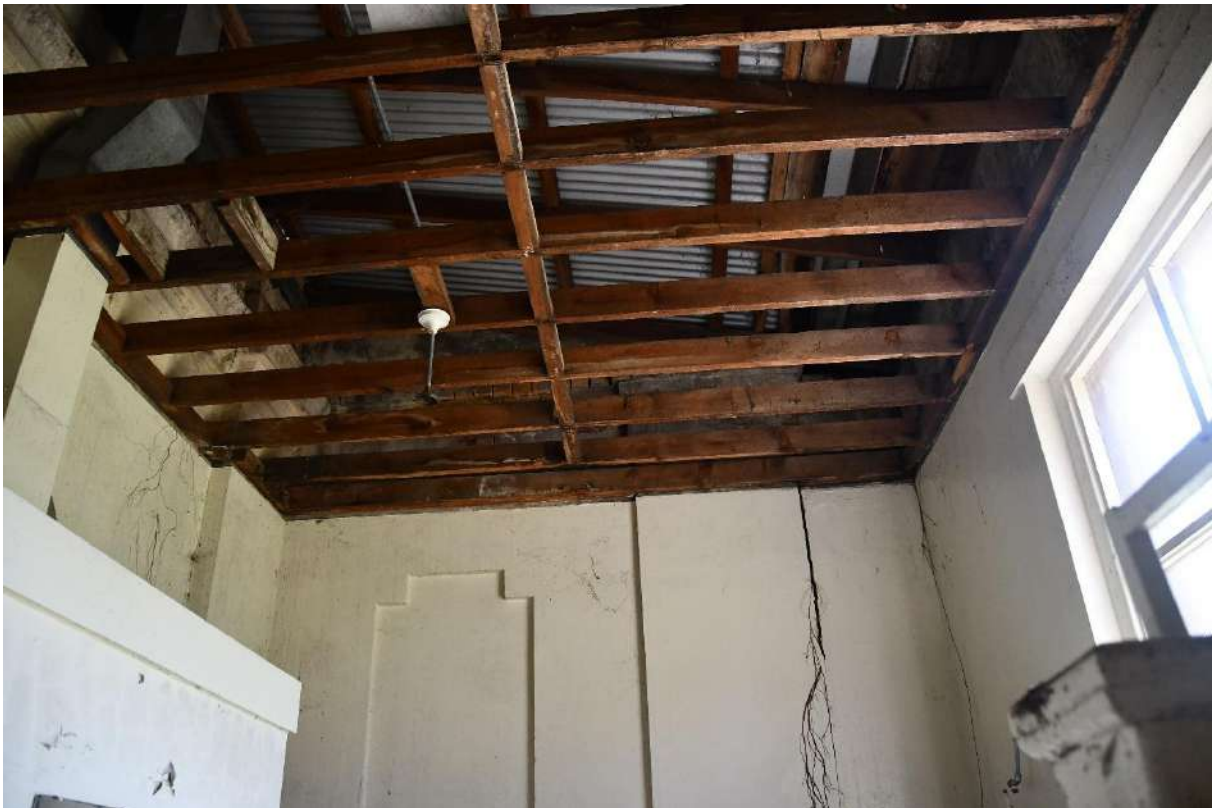
Internally the Eastern Annex consists of two rooms, a bathroom and a tearoom. The bathroom has no ceiling showing the exposed joists and roof trusses above (Figure 68). There are substantial cracks to the external walls visible. The floor and lower walls are tiled and the fixtures and fittings are largely intact. Based on style and material, the majority appear to be 1950s (Figure 69). These include sinks, urinals, and shower cubicles. The tearoom, to the south, has a carpeted floor and contains some museum remnants (Figure 70). The ceiling is intact in this room. Both rooms open into Room #06 of the Main Pumphouse.

Figure 68: Northern wall of the Eastern Annex (Item D) with corrugated roof visible above.

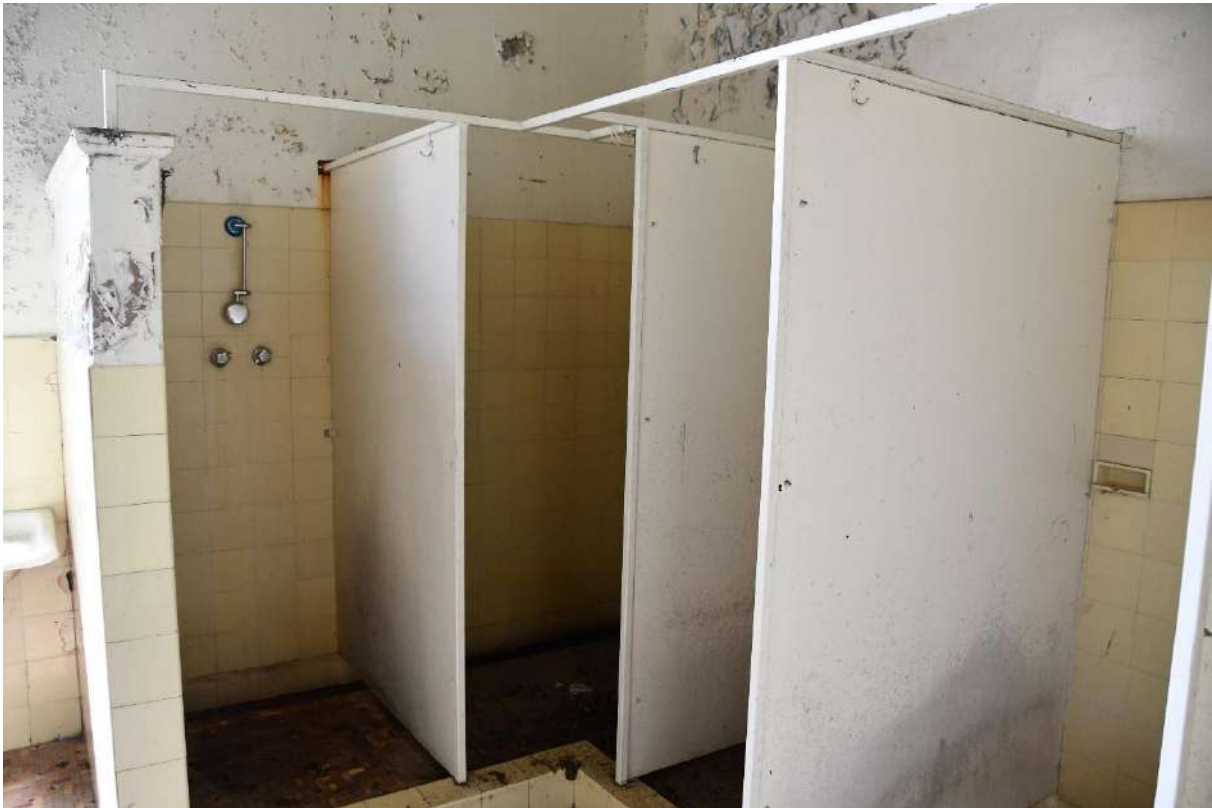
Figure 69: Showers within the northern room of the Eastern Annex showing flaked paint and tiled walls.

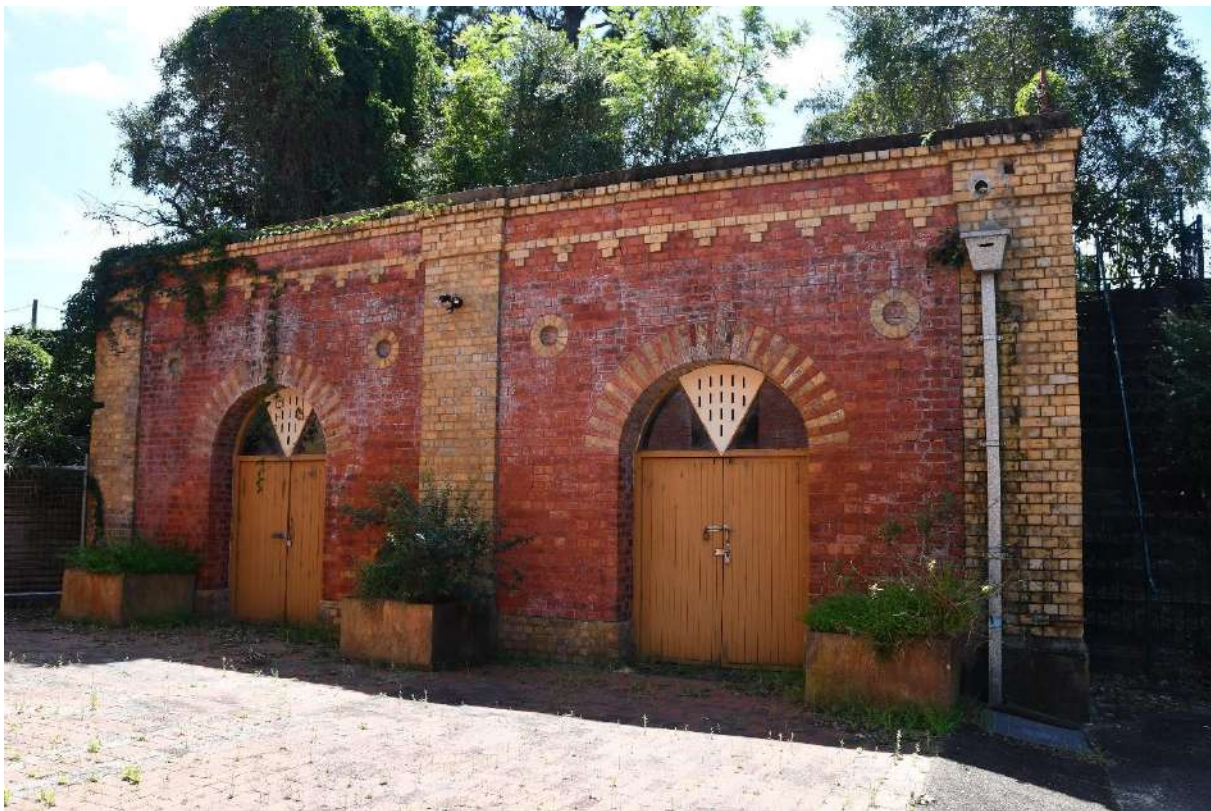
Figure 71: Southern Elevation of the Coal Store / Workshop (Item E). the stairs to the upper street level can be seen on the right of the image.

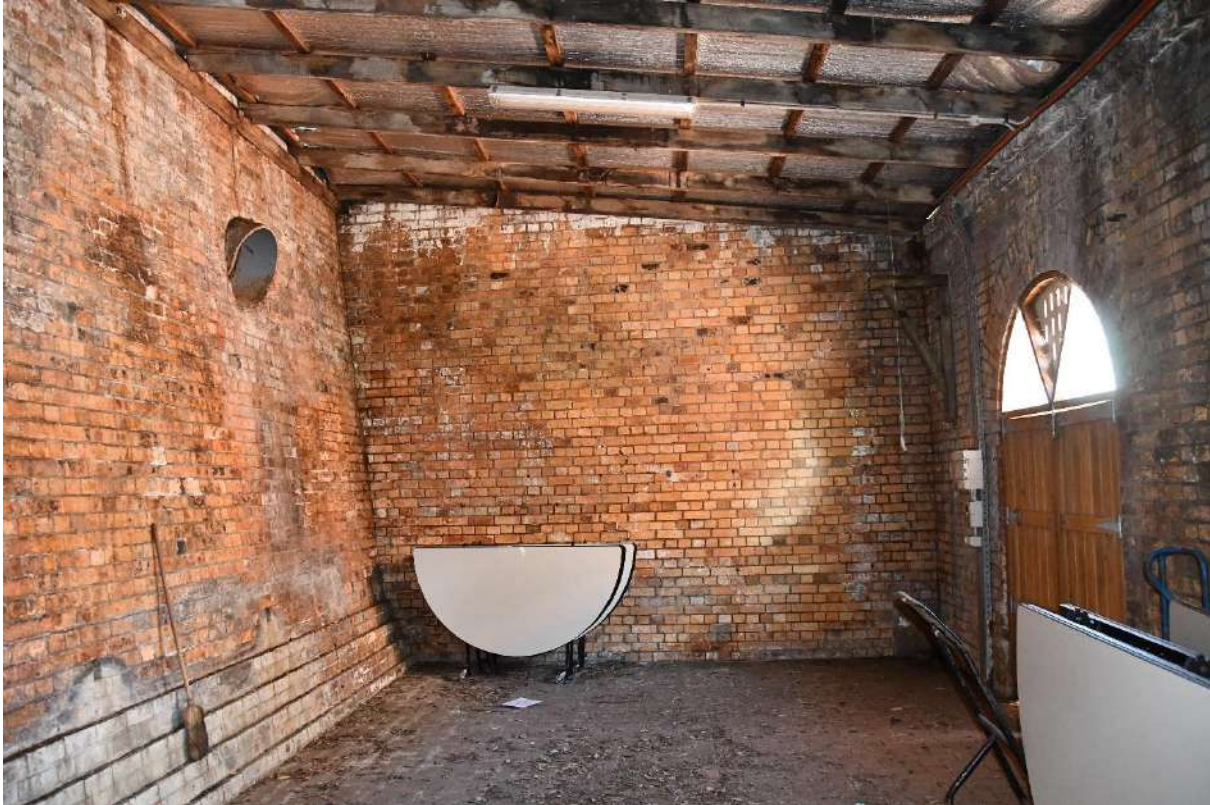
Figure 72: Internal view within Item E facing the eastern wall. The chute for coal delivery can be seen in the northern wall on the left of the image.

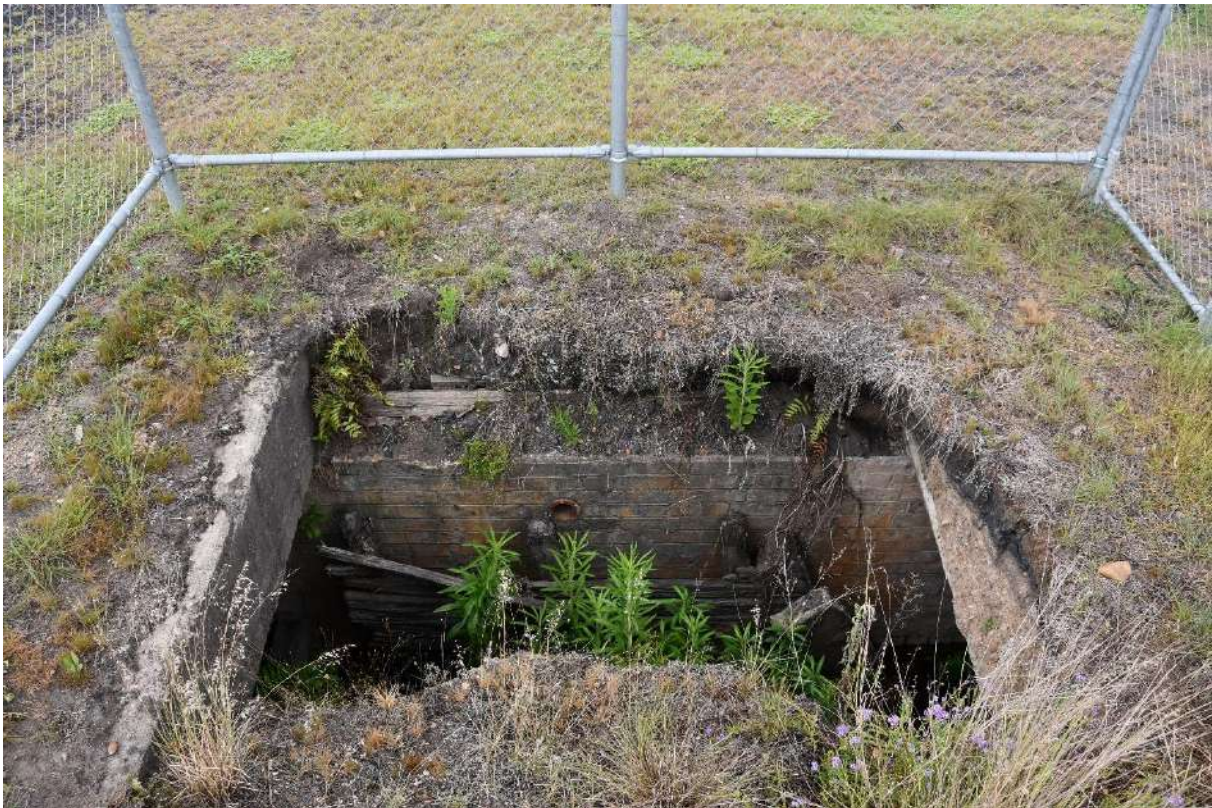
The southern most of these has been entirely backfilled with only a shallow brick lined depression remaining. Here the bricks are sandstock single cant facing inwards towards the void bonded with a hard grey mortar (Figure 116). The central access point remains largely open and is of poorer construction than the others indicating it is not original. It consists of a rectangular void lined with a concrete beam on the northern side but with the other three sides open. This demonstrates that is likely not an original opening. Through the void the well-built brick tunnel that houses the pipes is visible. The northern-most access point is open and in moderate condition. It is rectangular and features the same cant brick coping as its southern most counterpart. Beneath this is a well-built brick wall that continues downward on all sides except to the south where a concrete beam supports to coping to create the start of the tunnel. Within the void the large main iron pipe is still present in addition to various artefacts including small beams, pipes and valves.

Figure 116: The southern access point where only the upper course of bricks remains visible. View to the north
