## Walka Water Works

Conservation Management Plan

Maitland City Council

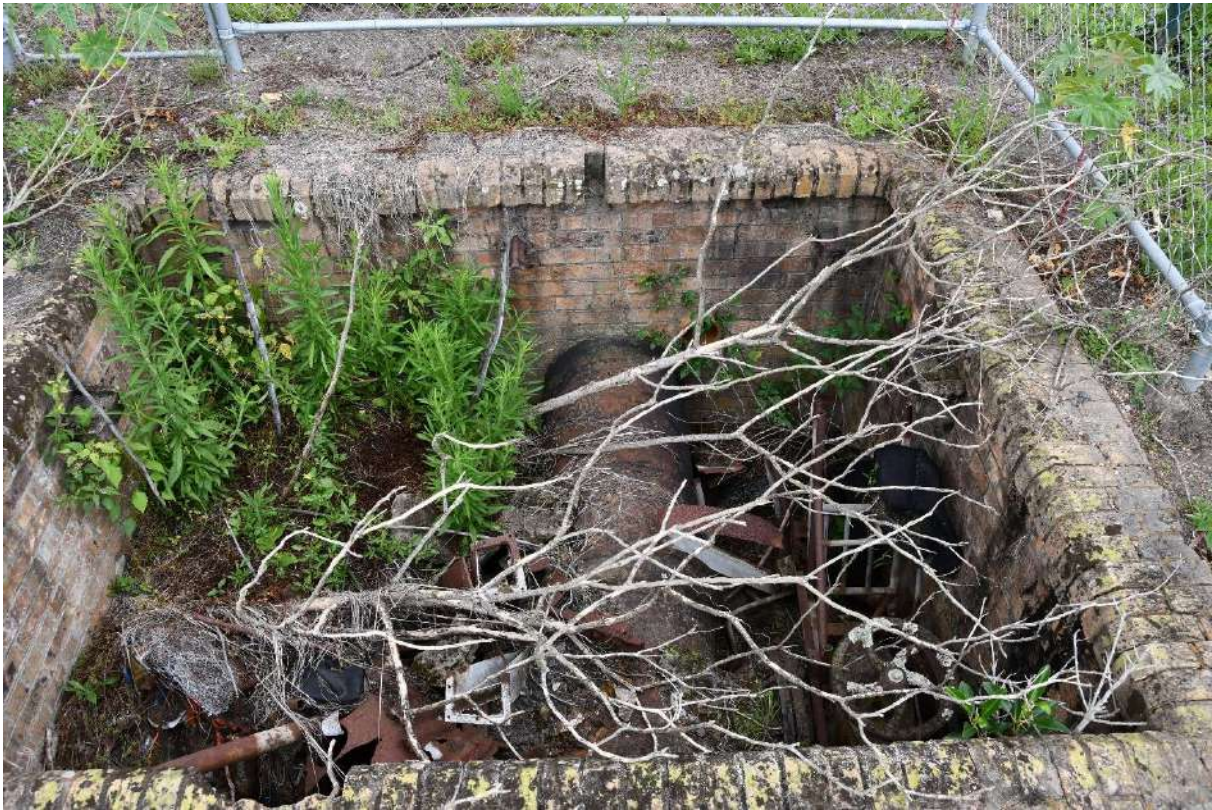
Figure 117: The central access point which is unlikely to be original. The brickwork on the tunnel is clear. The large central iron pipe is obscured by a small collapse of the surrounding topsoil. View to the east

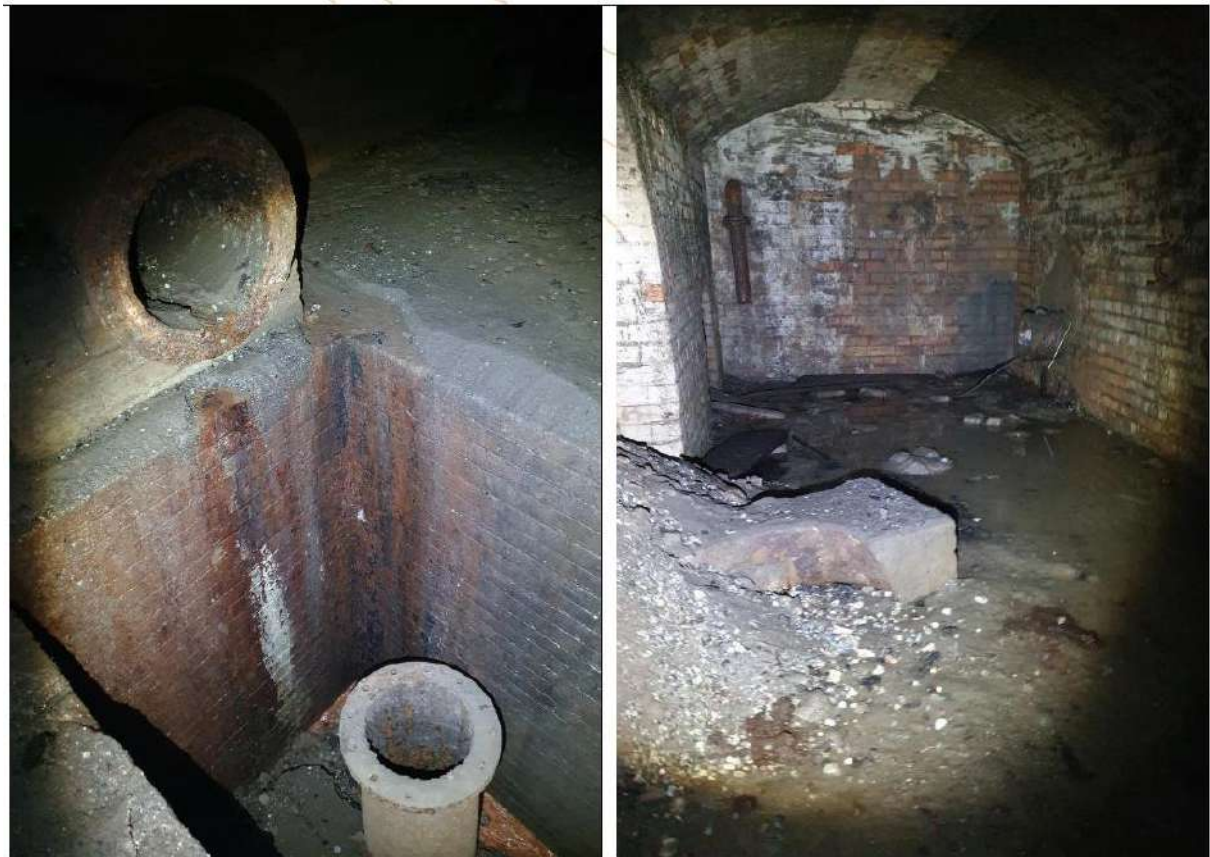
Figure 118: The intact northern most access point where the brick work, main pipe and numerous other fixtures and fittings are visible. View to the north.

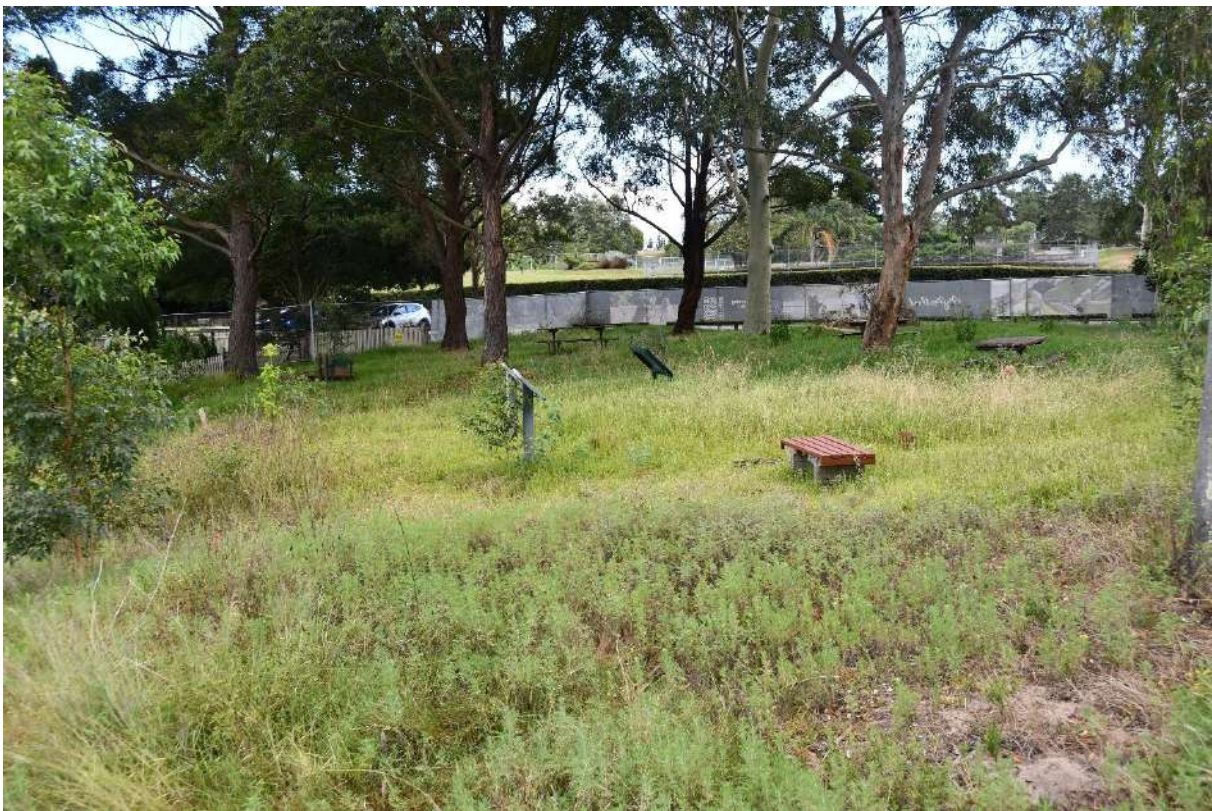
Figure 132: The beach area where Pumphouse No 9 was located. Currently the area is overgrown. View to the west

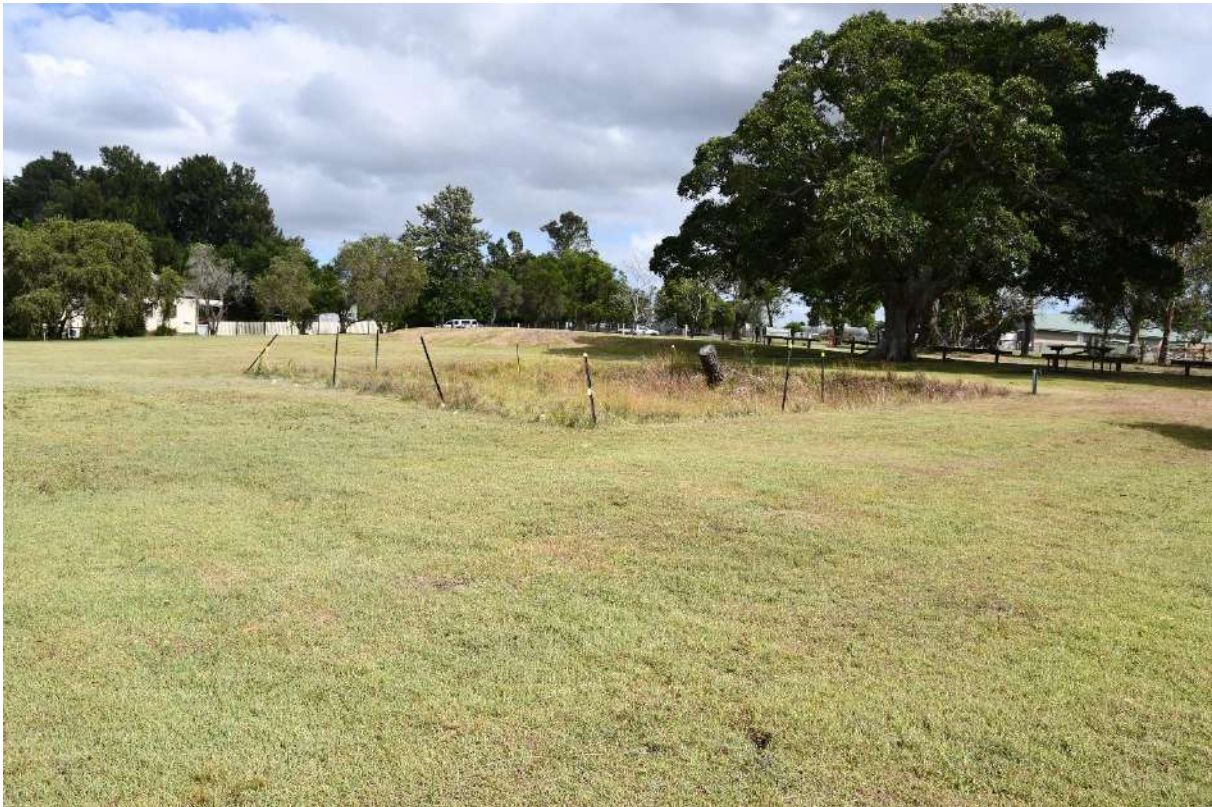
Figure 144: The northern part of the Northern Levelled Area (Item Y). Part of the area here appears sunken and is fenced off. View to the northwest
