# Site Classification Investigation

**Client:** Stanford  
**Agility Job No:** 2025193  
**Designer:** Your home designs  
**Designer Job No:** -  
**Site Address:** No.8 Allan Street, Lorn  
**Fieldwork Date:** 14/04/2025  
**Fieldwork By:** JH  
**Reported By:** JH  
**Reviewed By:** MS

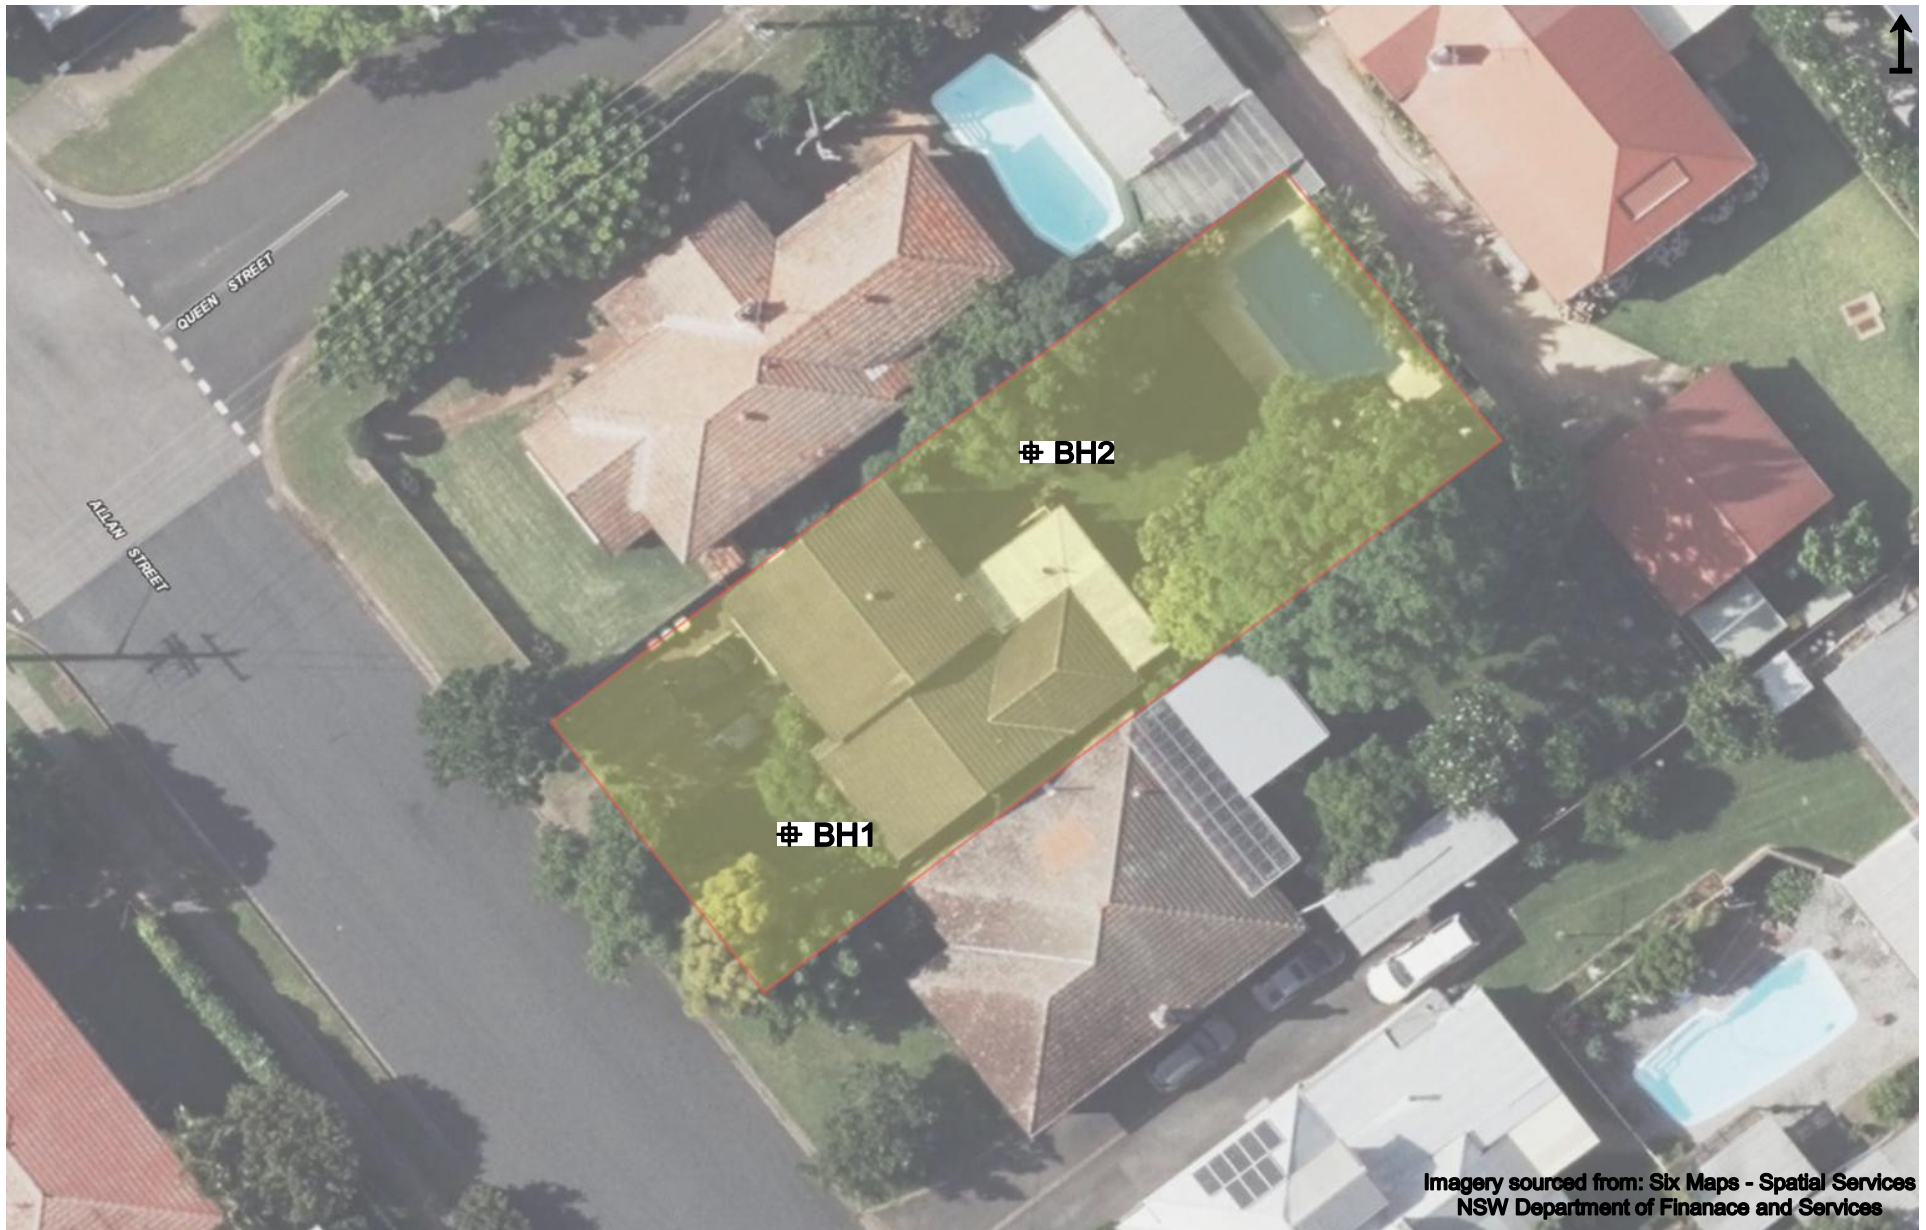
TITLE: Approximate Test Location Plan (Not To Scale)  
CLIENT: Stanford  
ADDRESS: No.8 Allan Street, Lorn  
AGILITY JOB No: 2025193

## Borehole BH1 Location: See site plan

## Borehole BH2 Location: See site plan
