Project 81251.10
23 December 2019
R.002.docx
MPG

**Waste Classification Assessment Procedure
Proposed Aged Care Facility
Morpeth Road, Morpeth**

1. Introduction

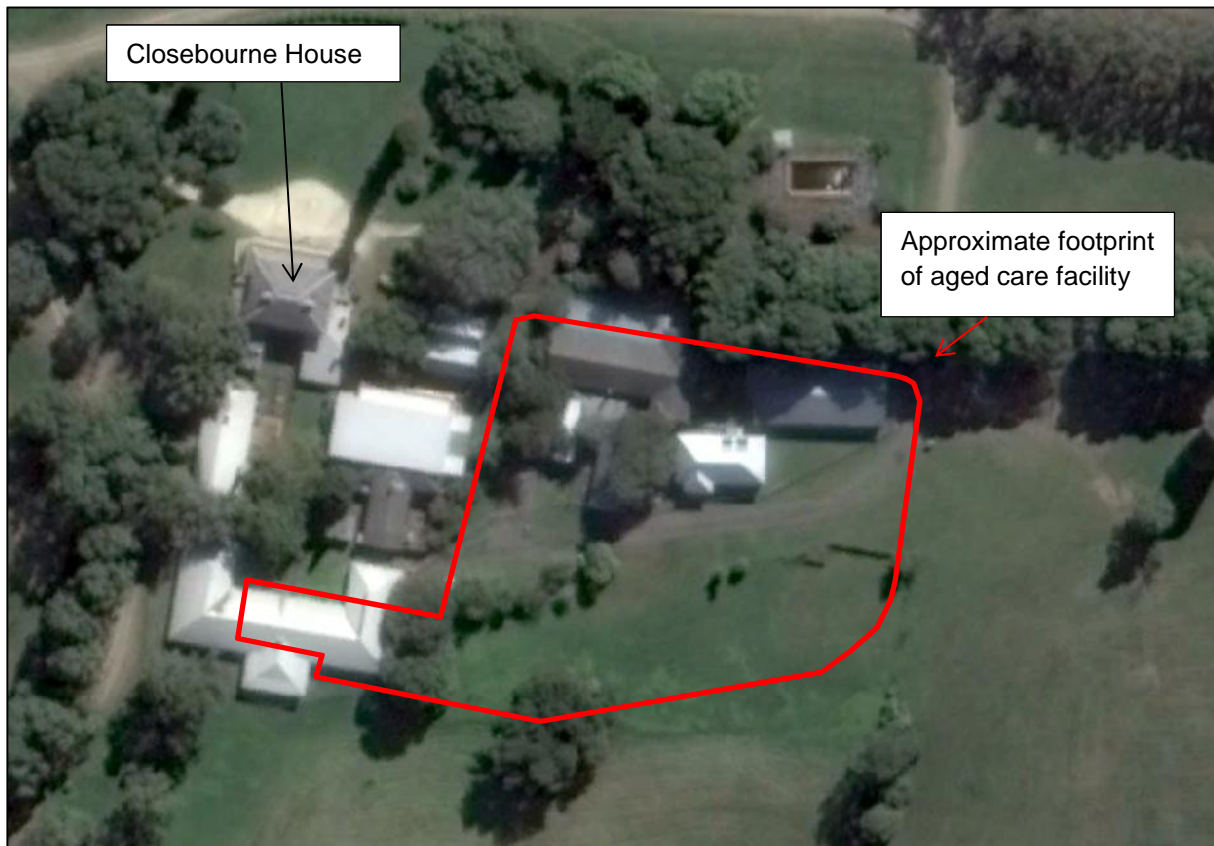
Figure 1: Aerial image of site with approximate aged care footprint (sourced from Google Earth)

The site is located within Closebourne Estate at Morpeth, which is situated along Morpeth Road approximately 500 m west of Tank Street, Morpeth. The proposed aged care will be located to the east of the existing Closebourne House (refer Figure 1).
