Arboricultural Impact Assessment for a proposed subdivision at No's 51, 134 & 146 Station Lane, Lochnivar NSW

Revision	Details	Date	Amended By
А	AIA (Final Draft)	05/05/2022	John Whyte
А	AIA (Final)	06/05/2022	John Whyte

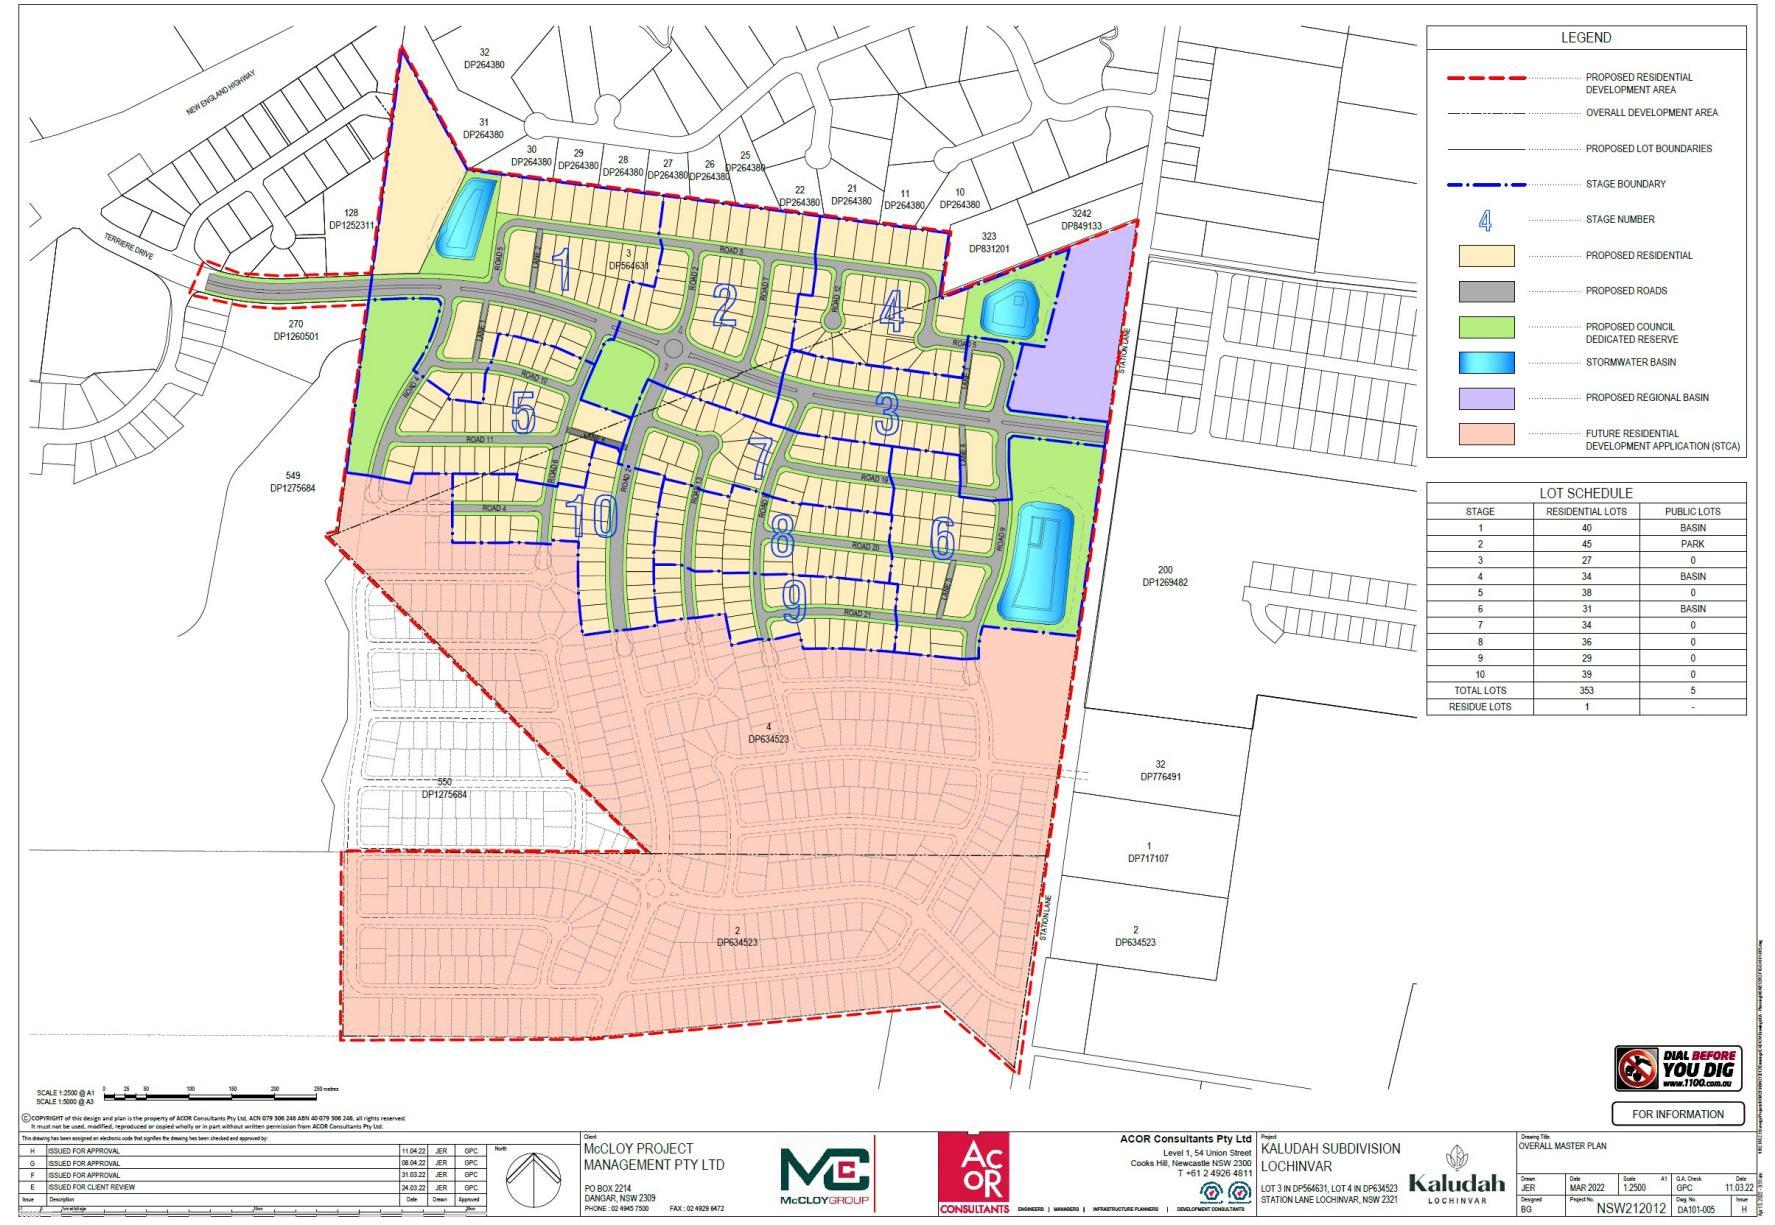
Figure 1-1 Proposed development

Enviro Ecology have been engaged by Mr Jeffrey Bretag of McCloy Project Management Pty Ltd C-/O McCloy Station Lane Pty Ltd to carry out an Arboricultural impact assessment (AIA). This AIA has been prepared in support of a subdivision (Figure 1-1) at No's 51, 134 & 146 Station Lane, Lochnivar NSW, within Maitland LGA, hereafter referred to as the study area (Figure 1-1).

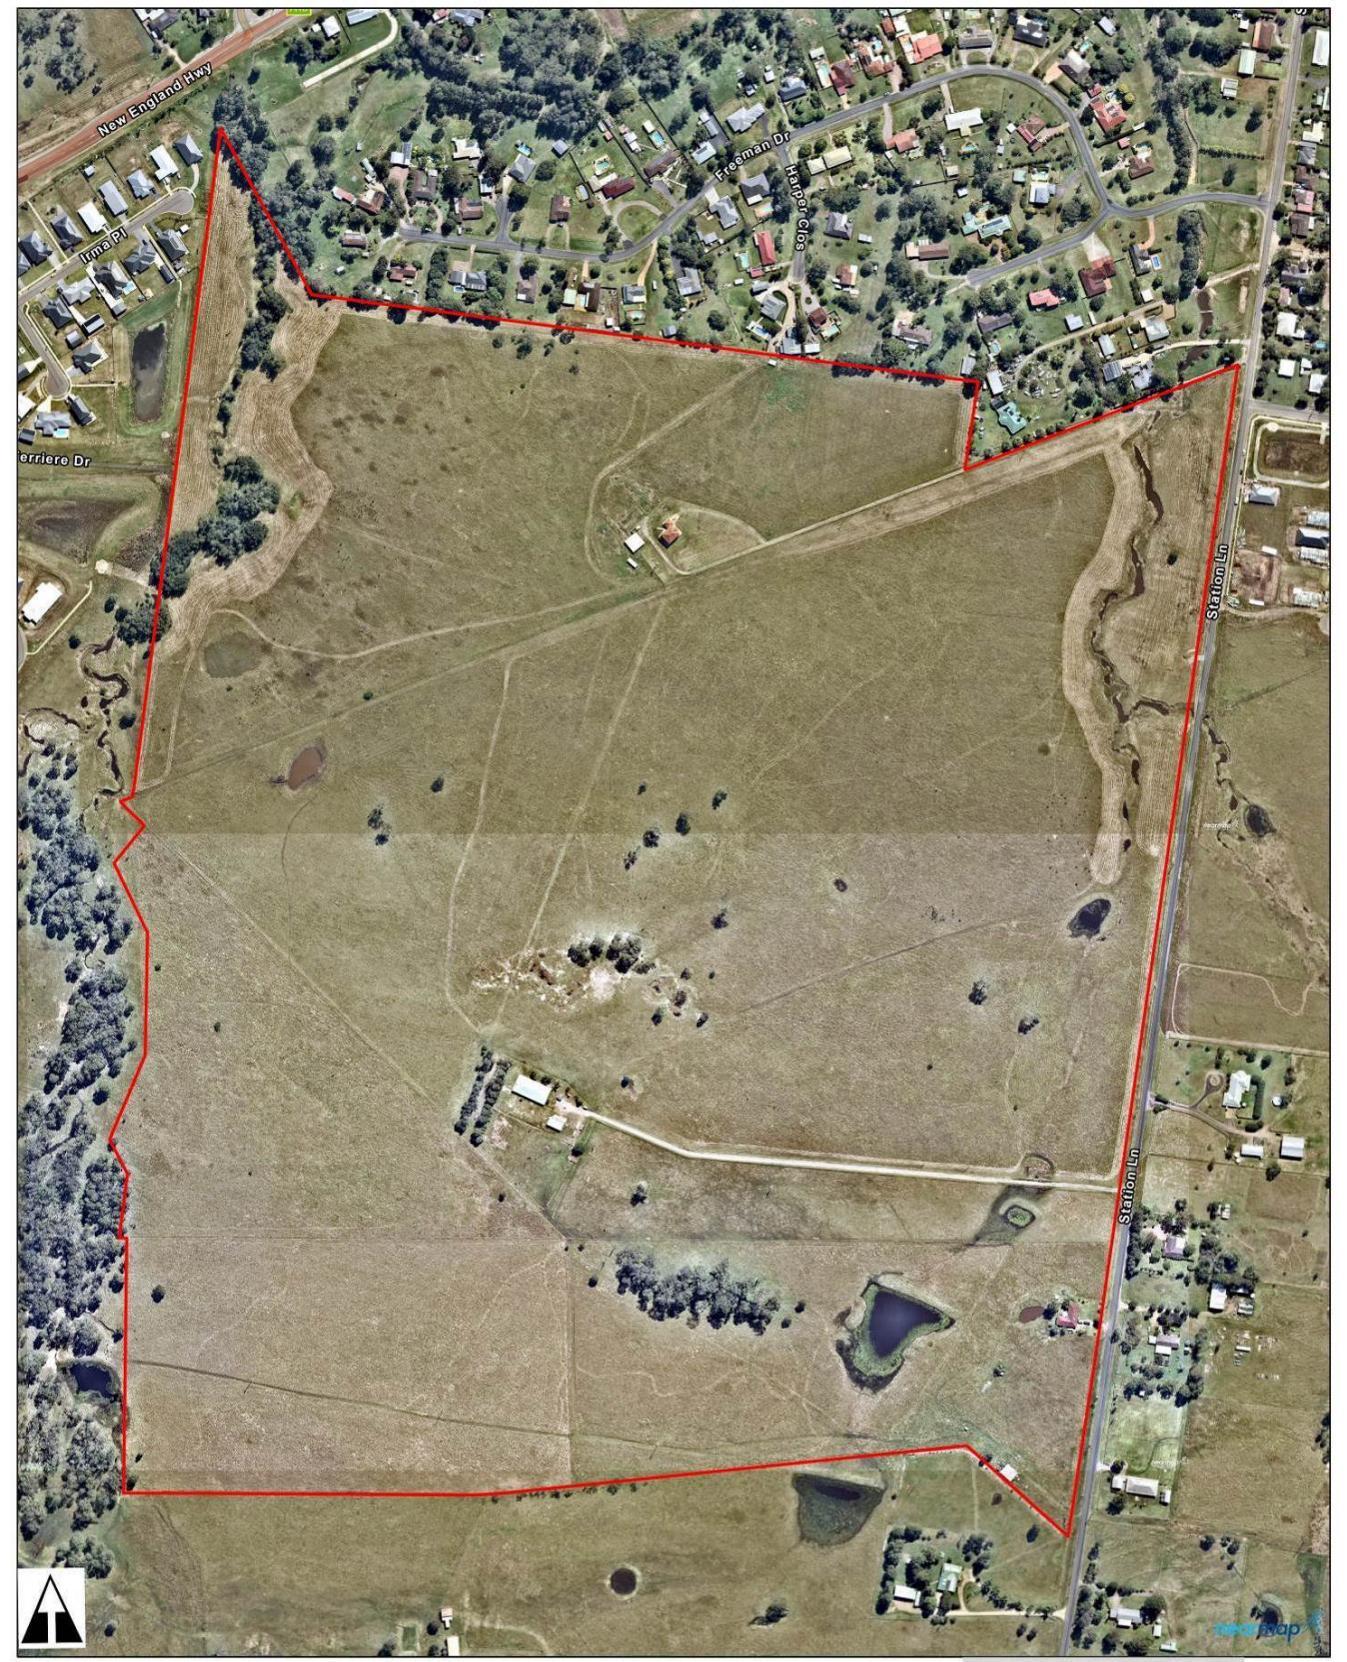
Figure 1-2 Study Area

The planning and cadastral details of the study area are provided in (Table 1-1). The study area is bordered by residential development to the north, east by Station Lane, west by Lochinvar Creek and to the south by rural residential (Figure 1-2).

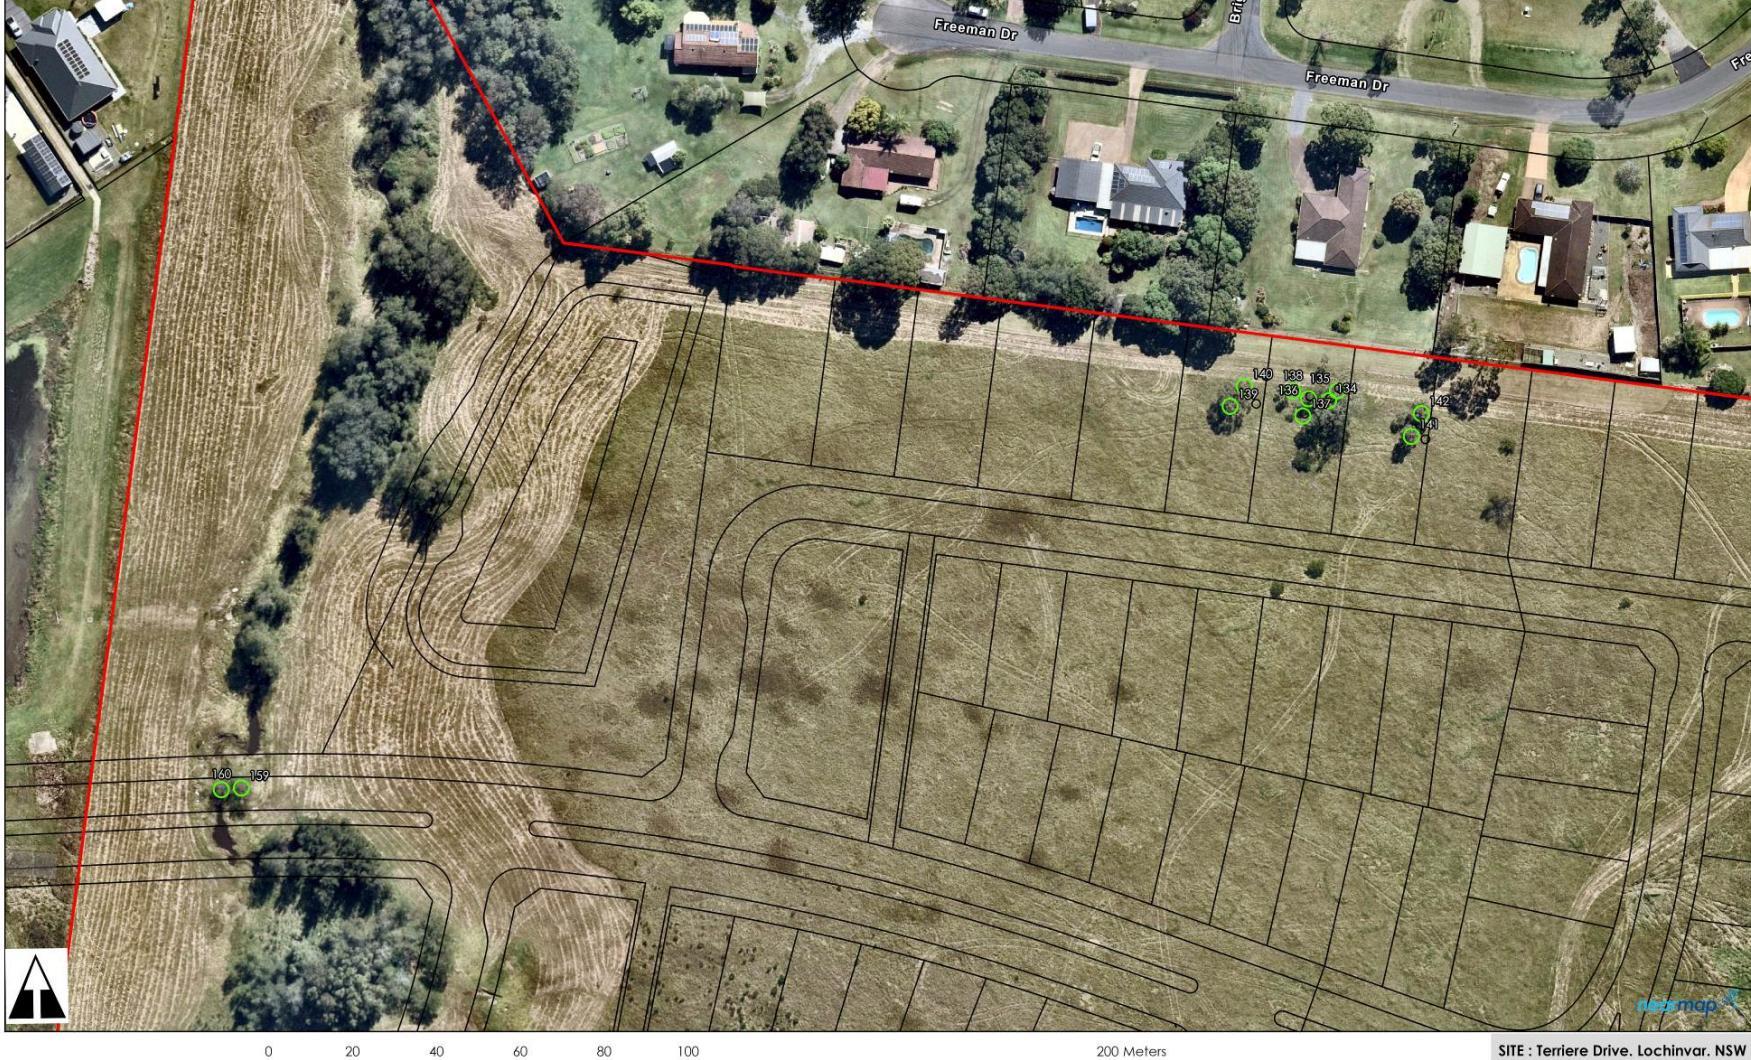
Figure 1-4 Proposed development & Tree survey locations

<u>+ + + +</u>	 1 1	Scale: 1:1,000	
Tree Survey - MAP A	DATE : 05/05/2022	Map Version : 1_2	
Subject Site	Projected Coordinate System	: GDA 2020 Zone 56	and the
Contraction Contraction	Subject Site, Lot boundaries impo Aerial Imagery: Nearmap - 04/04/ Although all care has been taken from the use or inaccuracies of th Copyright © WiZarDTech Spatial So	rted from CAD file. For illustration purposes only. 2022 - WiZarDTech accepts no responsibility is map and spatial data. ervices 2022.	WiZarDTech Spatial Services

Trees assessed were surveyed and placed onto Figure 1-3, Figure 1-4, Figure 1-5 and Figure 1-6.

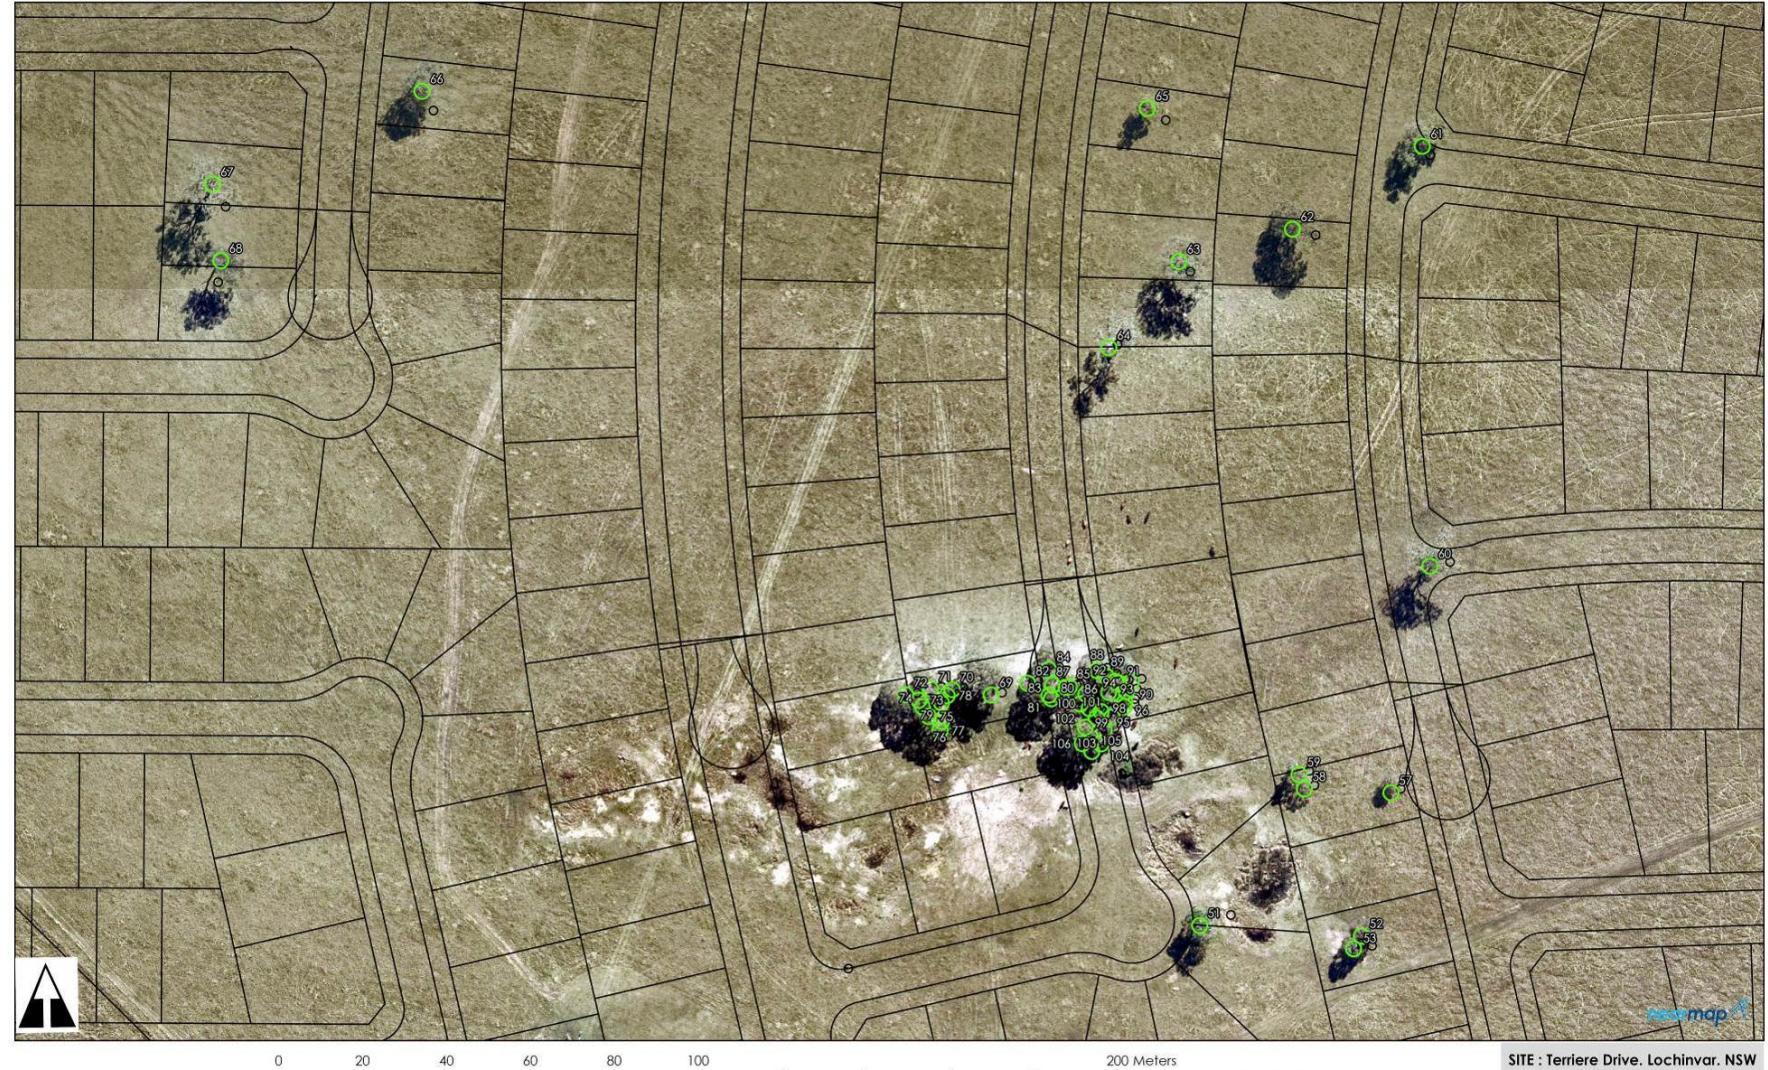
Figure 1-5 Proposed development & Tree survey locations

0 20 40 60	80 100		200 Meters	SITE : Terriere Drive. Lochinva
	· · ·	1 1 1	Scale: 1:1,000	
Tree Survey - MAP B		DATE : 05/05/2022	Map Version : 1_1	
Subject Site		Projected Coordinate System	1 : GDA 2020 Zone 56	-Au-
Lot Boundaries Tree Survey Location		Subject Site , Lot boundaries impo Aerial Imagery: Nearmap - 04/04 Although all care has been taker from the use or inaccuracies of th Constrict MUKTARD task sectial C	orted from CAD file. For illustration purposes only /2022 n - WiZarDTech accepts no responsibility nis map and spatial data.	WiZarDTech Spatial Services

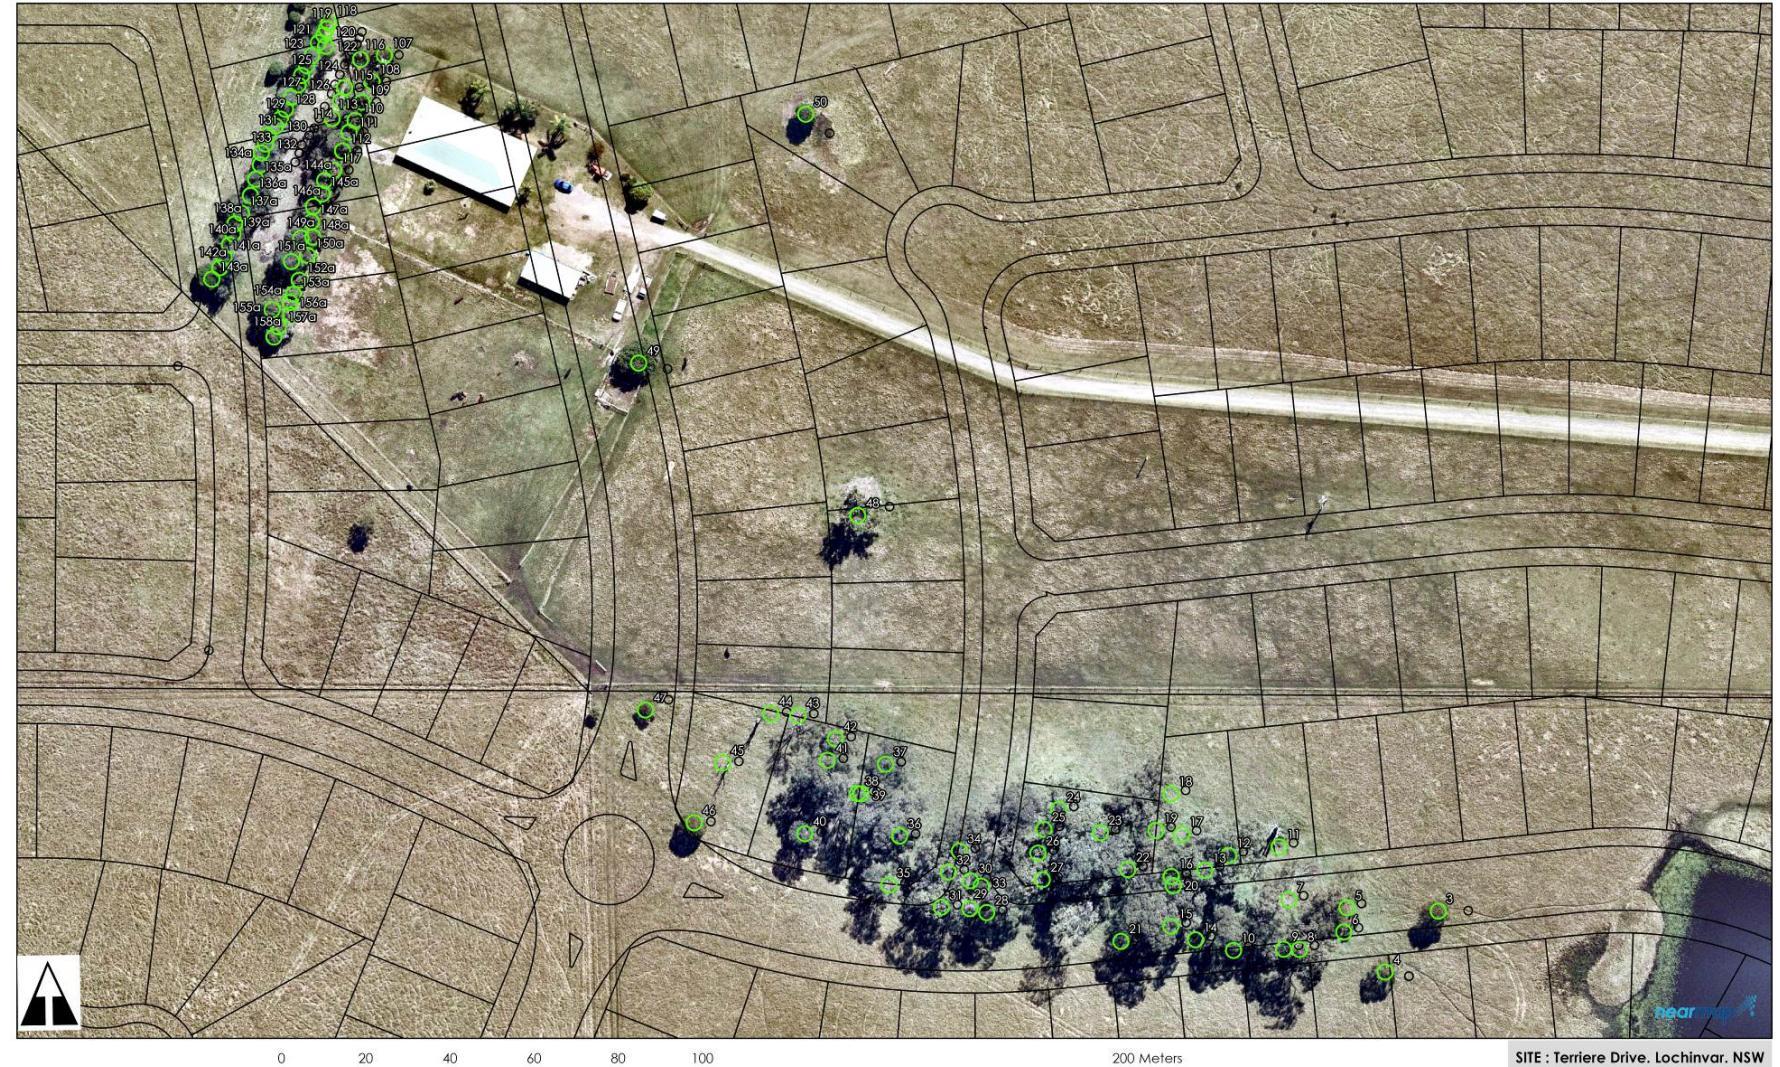
Figure 1-6 Proposed development & Tree survey locations

0 20 40 60	80 100		200 Meters	SITE : Terriere Drive. Loch
 			Scale: 1:1,000	
Tree Survey - MAP C		DATE : 05/05/2022	Map Version : 1_1	
Subject Site		Projected Coordinate System :	GDA 2020 Zone 56	An
Lot Boundaries Tree Survey Location		Subject Site , Lot boundaries impor Aerial Imagery: Nearmap - 04/04/2 Aithough all care has been taken- from the use or inaccuracies of this Copyright @ WizarDitech Spatial Se	ted from CAD file. For illustration purposes only. 2022 - WiZarDTech accepts no responsibility s map and spactial data. arvices 2022.	WiZarDTech Spatial Services
