## Aquatic Ecology Assessment

20 & 20A Cantwell Road and 60 New England Highway, Lochinvar,  
NSW

**AEP Ref: 4951**

**Revision: 05**

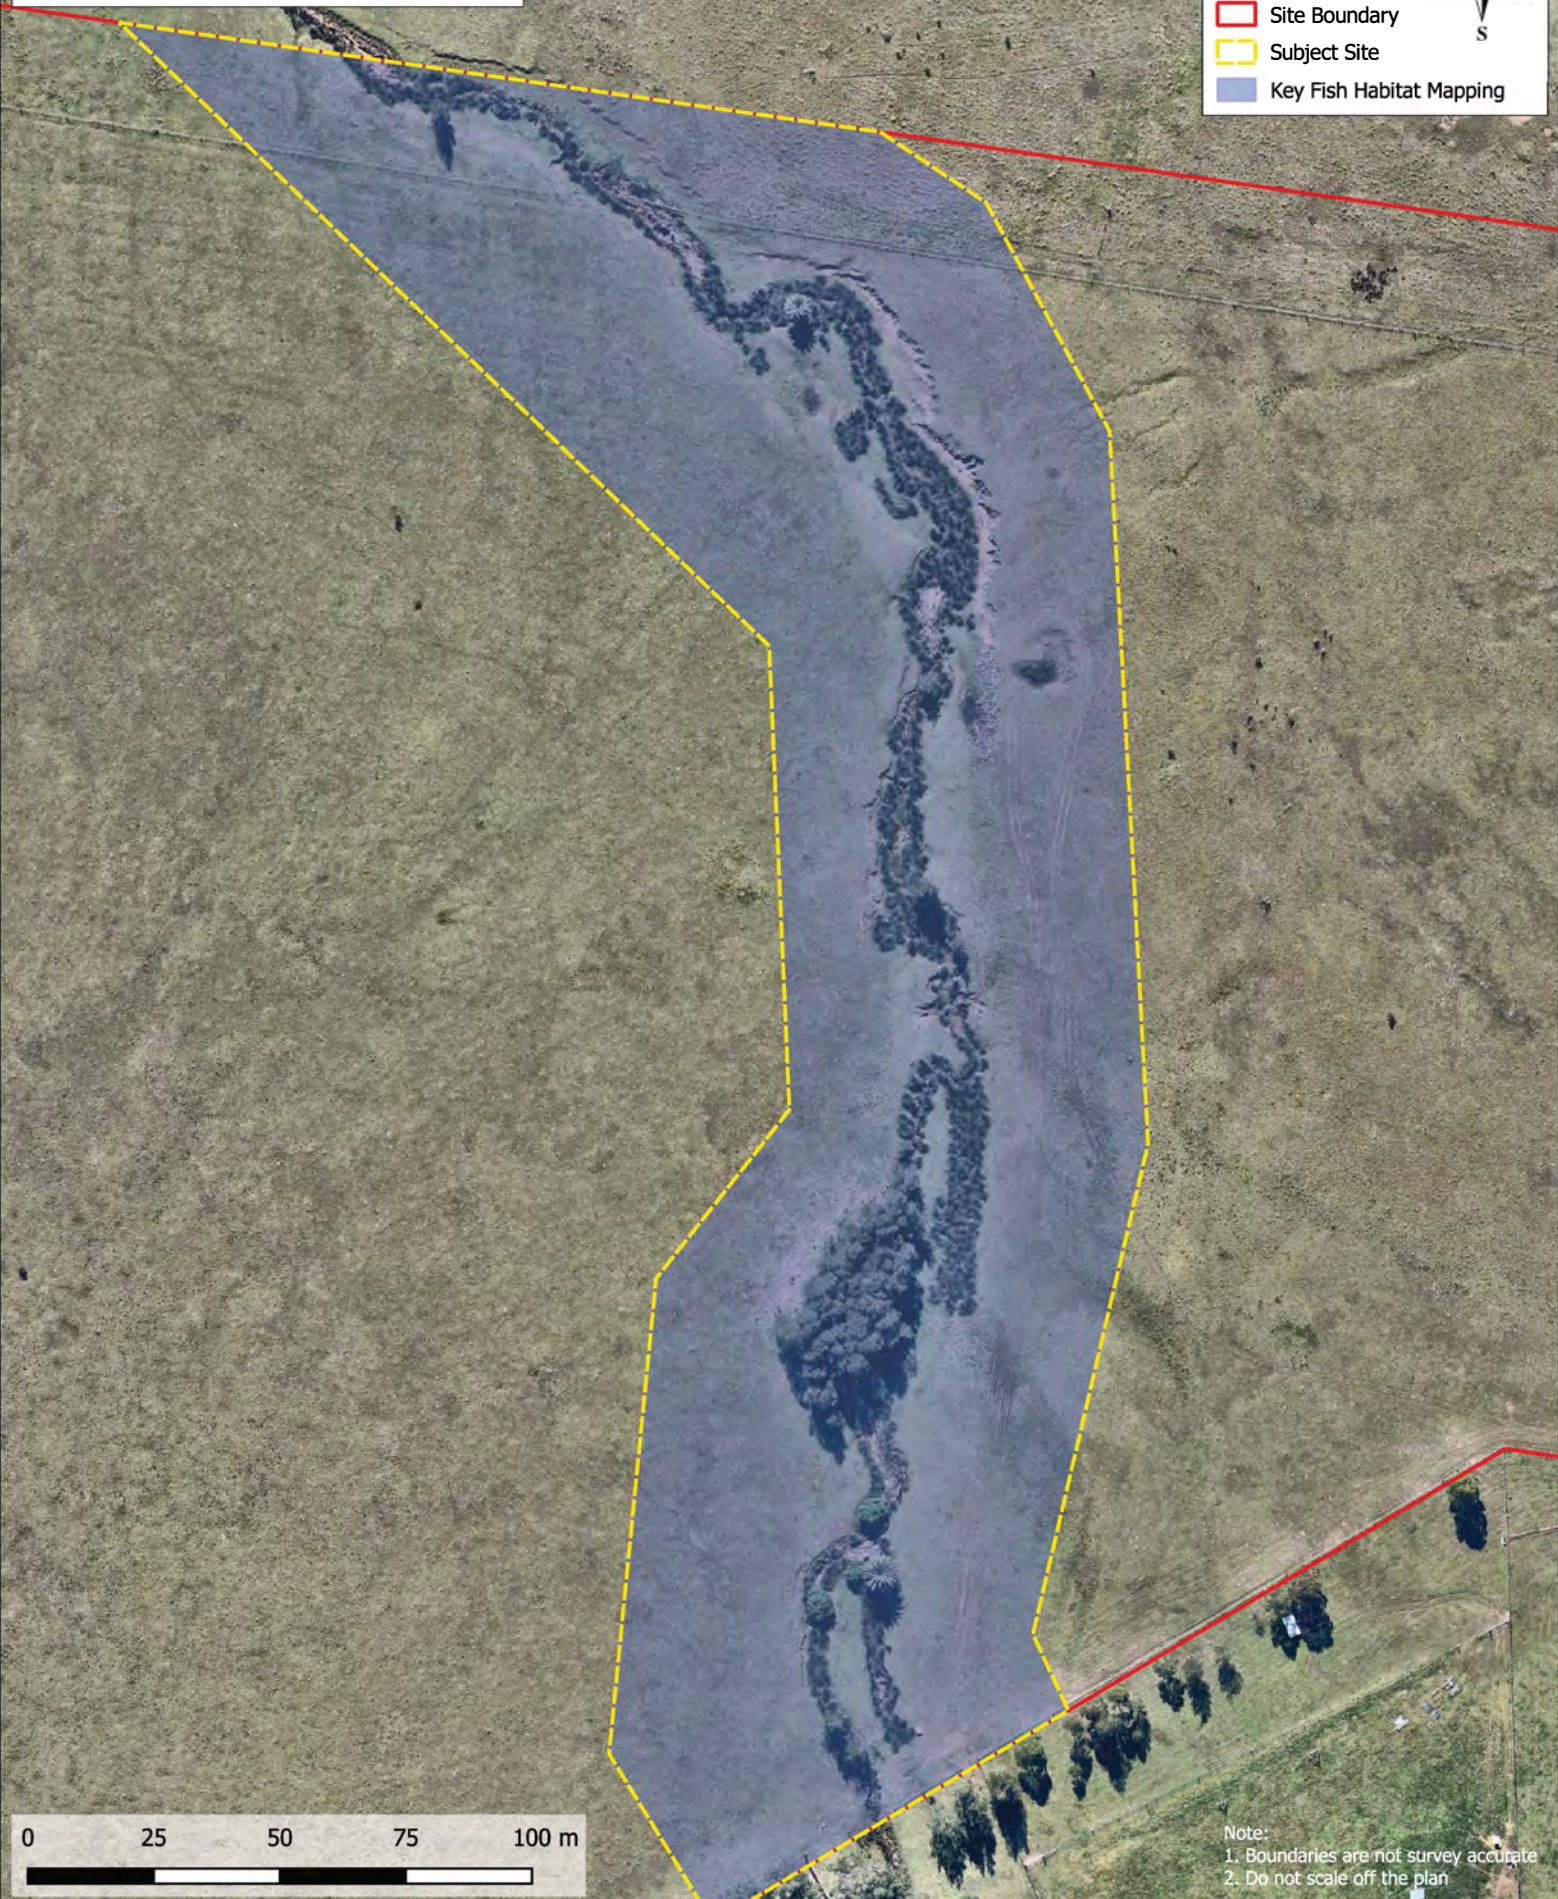
Figure 4 - Key Fish Habitat Mapping

Key Fish Habitat Mapping

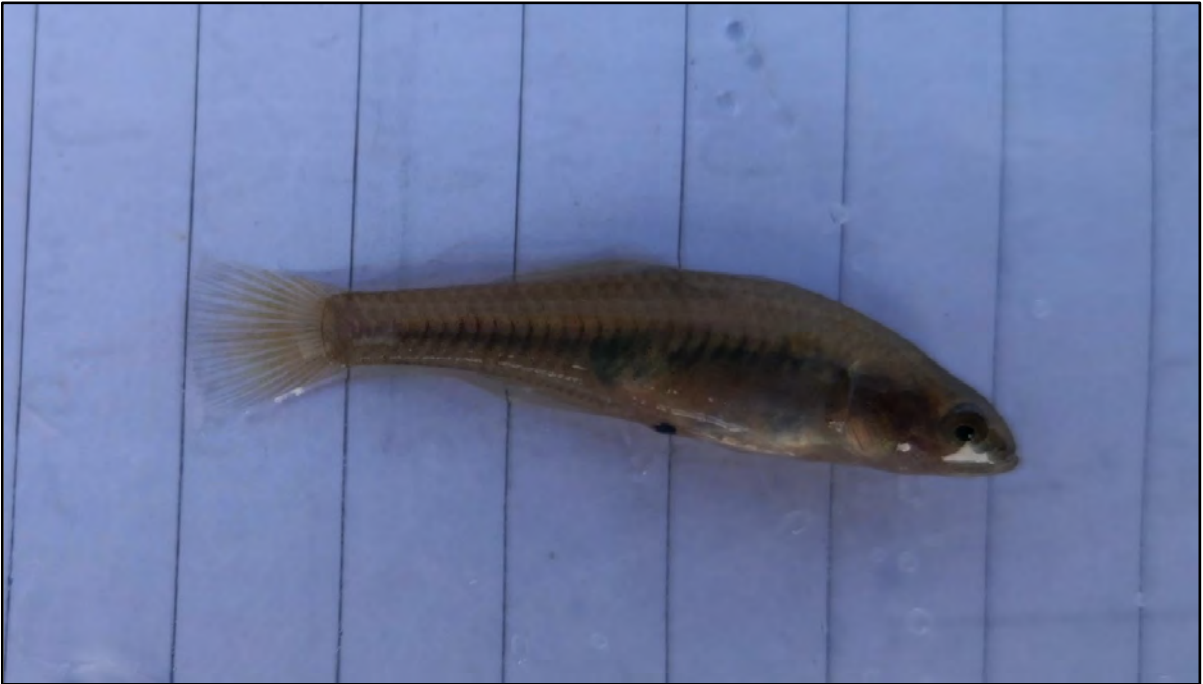
Plate 1: *Hypseleotris* spp. (Carp Gudgeon)

Two fish species were observed during field surveys; one (1) native species, Carp Gudgeon (*Hypseleotris* spp.) (**Plate 1**) and one (1) exotic species, Gambusia (*Gambusia holbrooki*). The native fish was caught between the two instream obstructions, therefore is not likely to breed outside of extreme high flow events. Over 100 Gambusia were collected throughout the entire Creek.
