AEP

Biodiversity Management Plan – Retained Land

Lots 1 & 2 DP1299958 – 20 & 20A Cantwell Road, Lochinvar, NSW

Date: January 2026

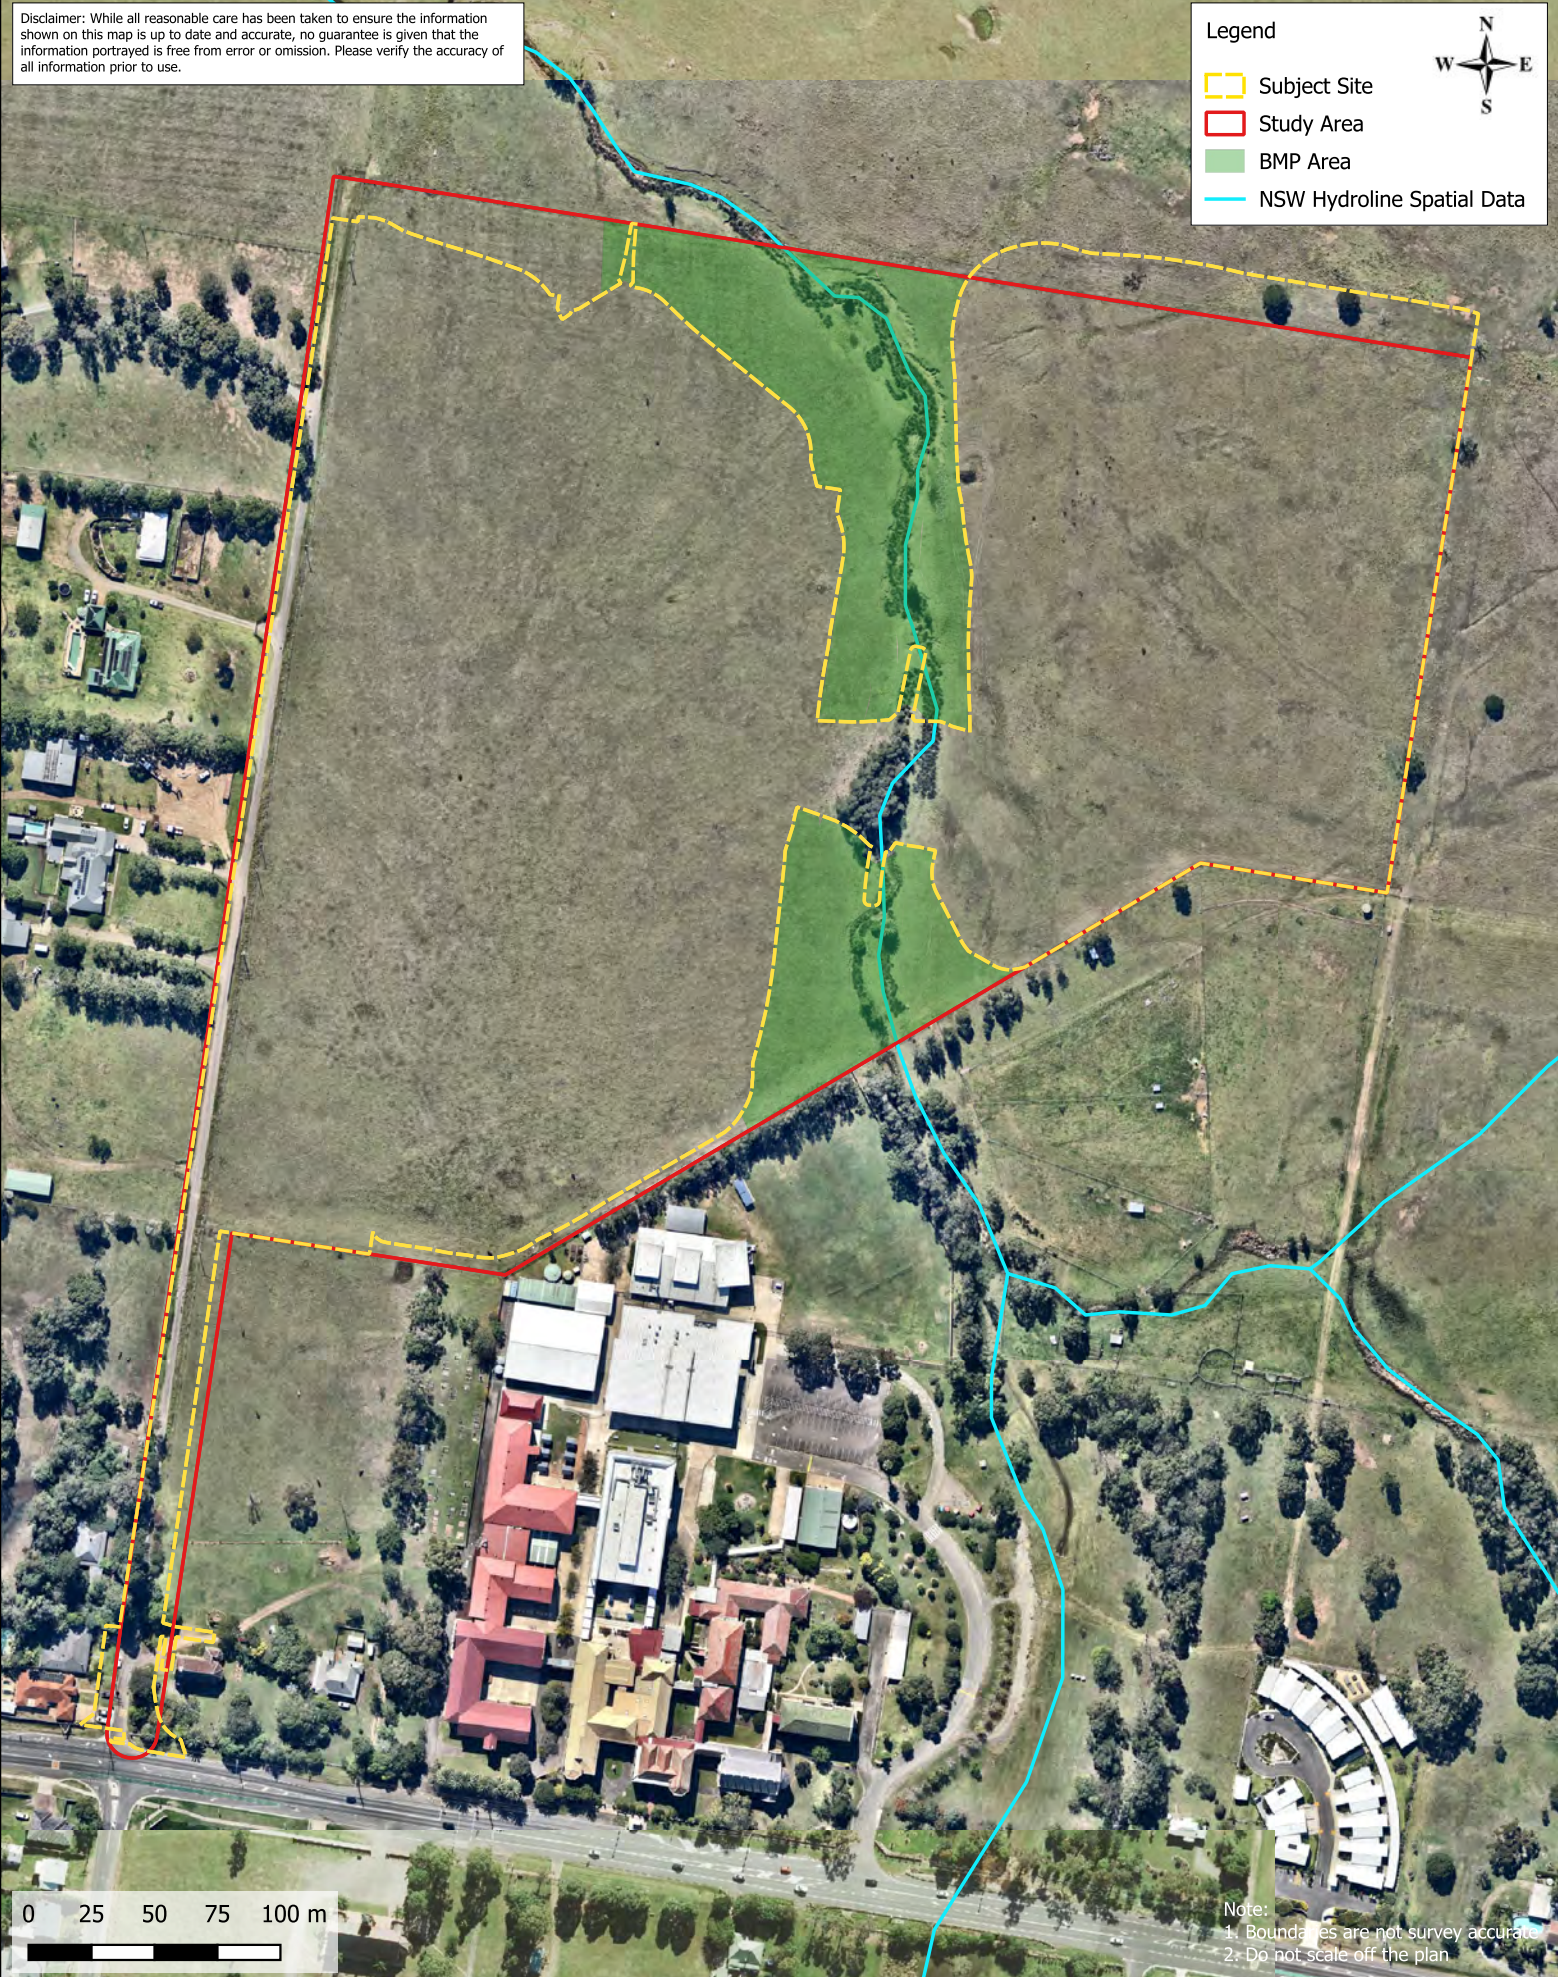
Figure 1 - Site Location
Location: 60 New England Highway, Lochinvar NSW
Client: Monteath & Powys Pty Ltd
Date: January 2026
AEP ref: 4951.01

Figure 1 shows the location and area of the Biodiversity Management Plan Land (BMP Lands) where this report applies. The remainder of the C3 Zoned land will be managed under a Landscape Plan and a proposed road crossing.

The proposal will regenerate approximately 2.3ha of native vegetation which provides both core habitat and landscape connectivity for a number of native fauna species including fish in the area. **Figure 1** shows the site location.

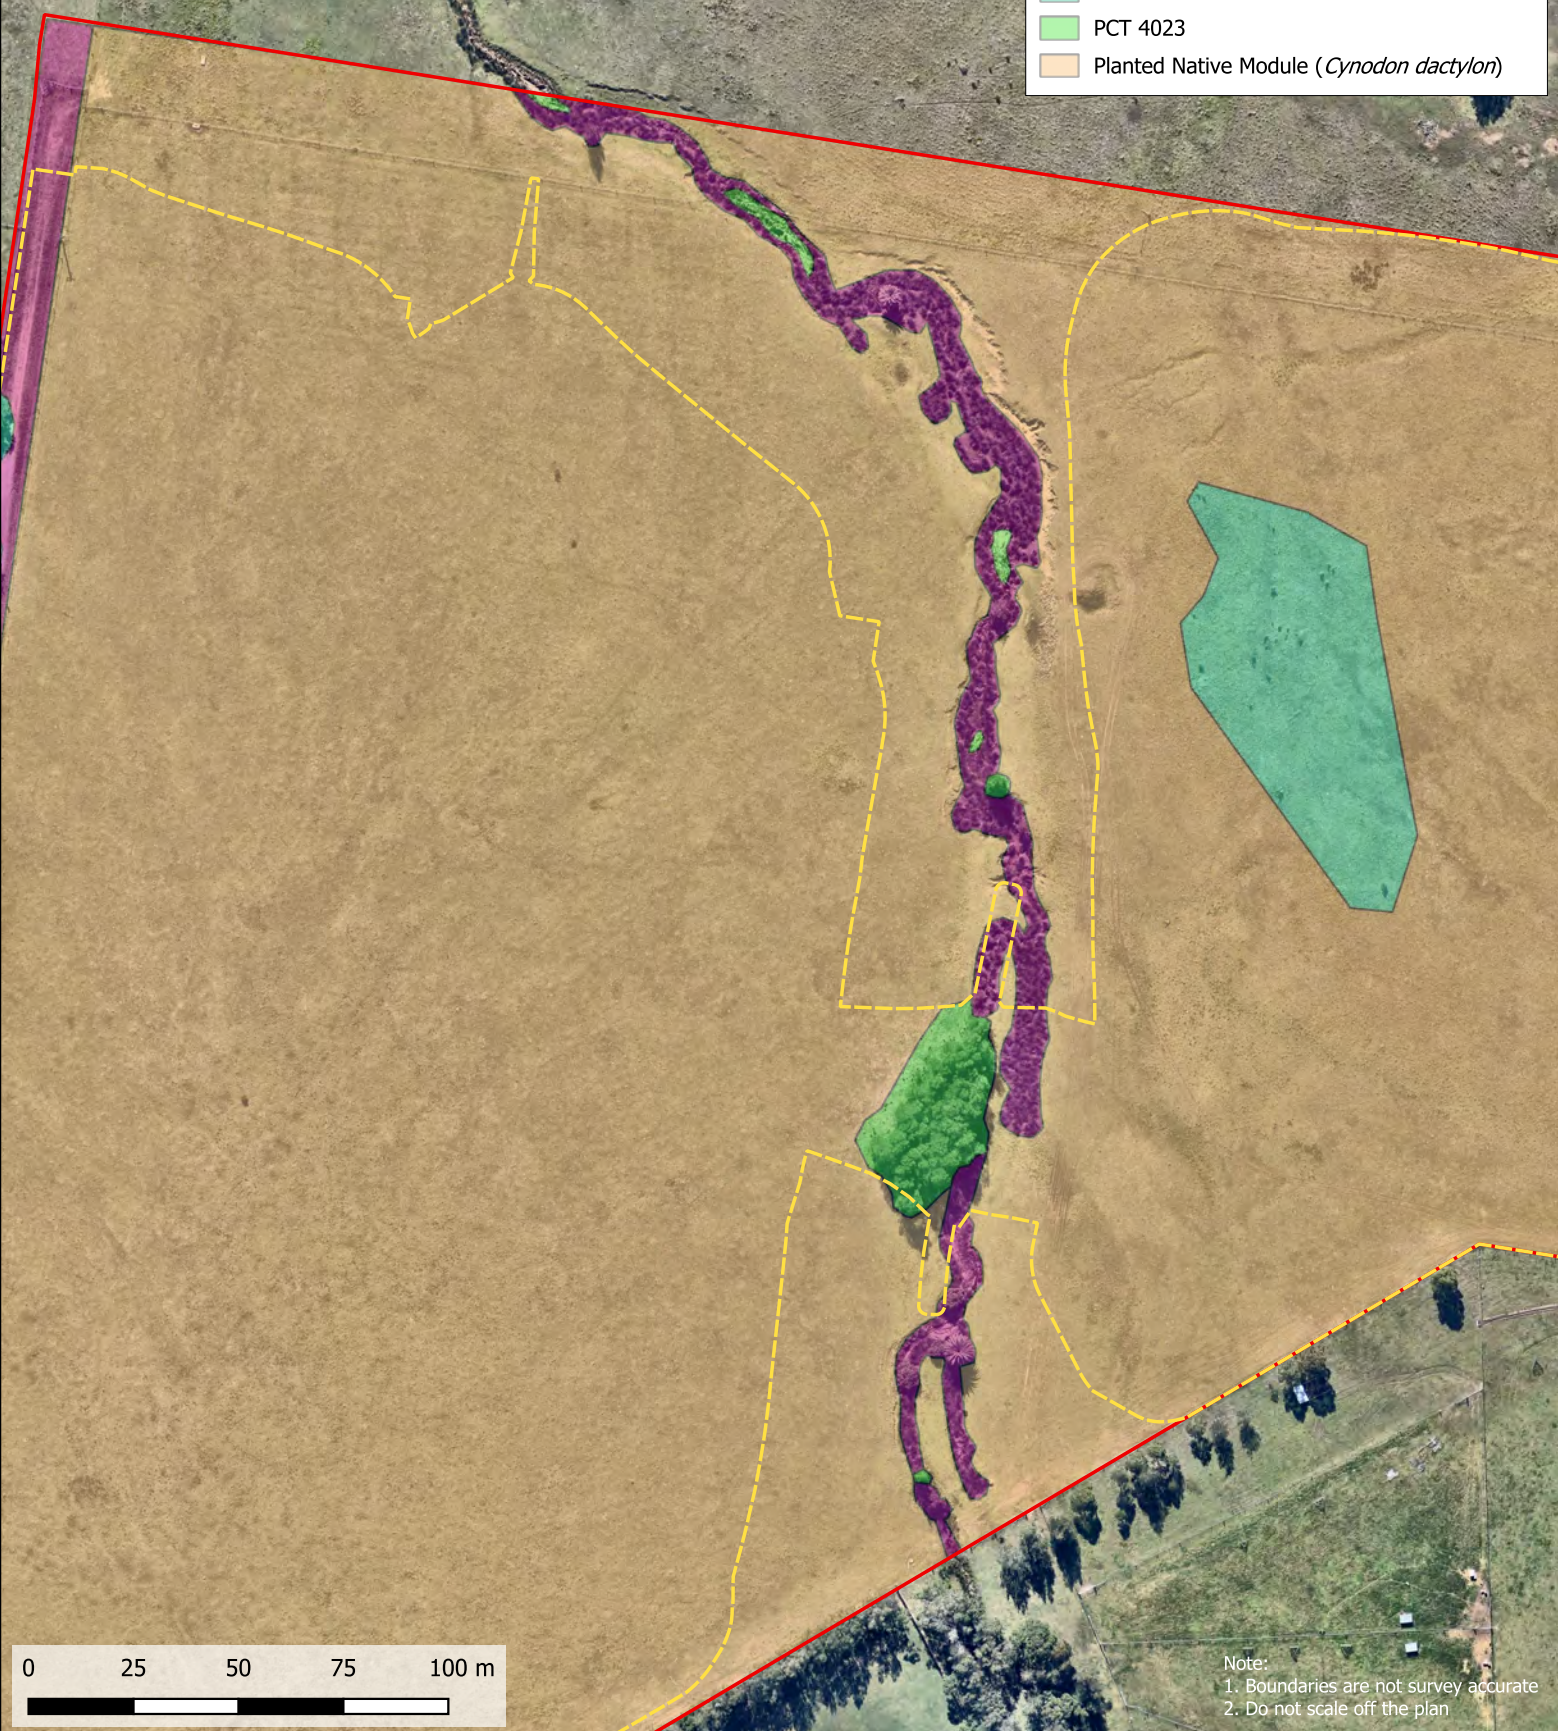
Figure 2 - Ground-truthed Vegetation
Location: 60 New England Highway, Lochinvar NSW
Client: The Trustee for EXP CANTWELL Unit Trust

The location of remnant PCT 4023 within the BMP Lands is presented in **Figure 2**. The PCT has been further segregated into management Zones (MZs) according to vegetation conditions as described in **Section 3.2** below.

Areas of PCT 4023 in poor condition with existing canopy. These have a high influence of edge effects associated with continued disturbance. Weed densities are high and include *Cestrum parqui*, *Ehrharta erecta*, *Olea europaea* and *Paspalum dilatatum*.

Areas of PCT 4023 in Poor condition without canopy have a high influence of edge effects associated with continued disturbance. Weed densities are high and include *Juncus acutus*, *Paspalum dilatatum*, *Senecio madagascariensis* and *Sporobolus africanus*.

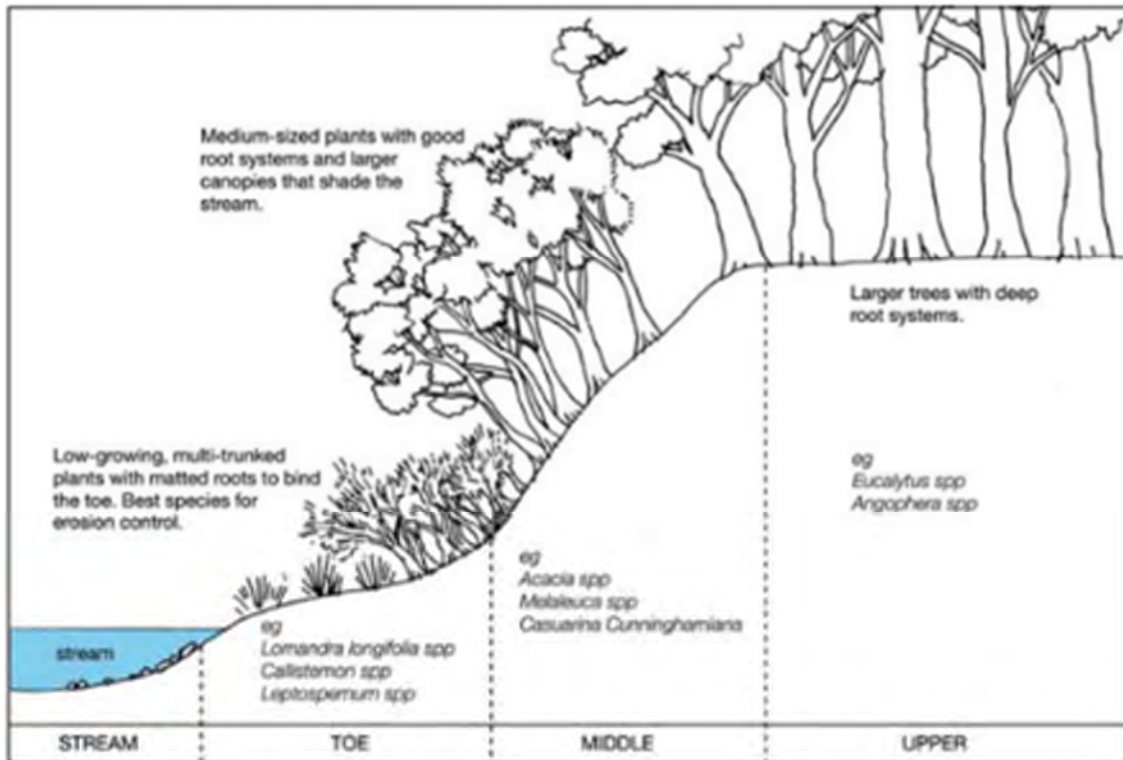
Plate 1 - Cross Section of Riparian Corridor (NSW Water, 2022).

Plate 1 shows a cross section of watercourse to assist with the location of each zone.

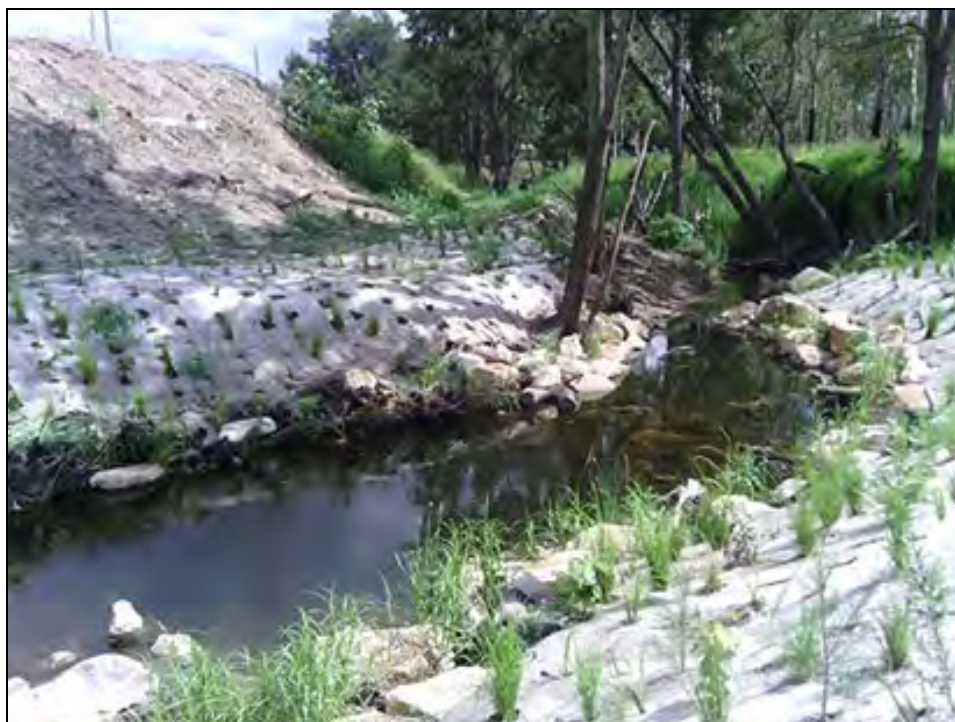
Plate 2 – Bundamba Creek Regeneration works (Australian Wetland Consulting, 2018)

A review of the current literature showed that reinstating a natural channel within the creek would ensure key features are present within the creek, and result in improved water quality and habitat for terrestrial and aquatic organisms. **Plate 2** shows an example of a natural channel design.

This BMP provides the concept plan for the channel design, detailed engineering plans should be prepared prior to guide construction.

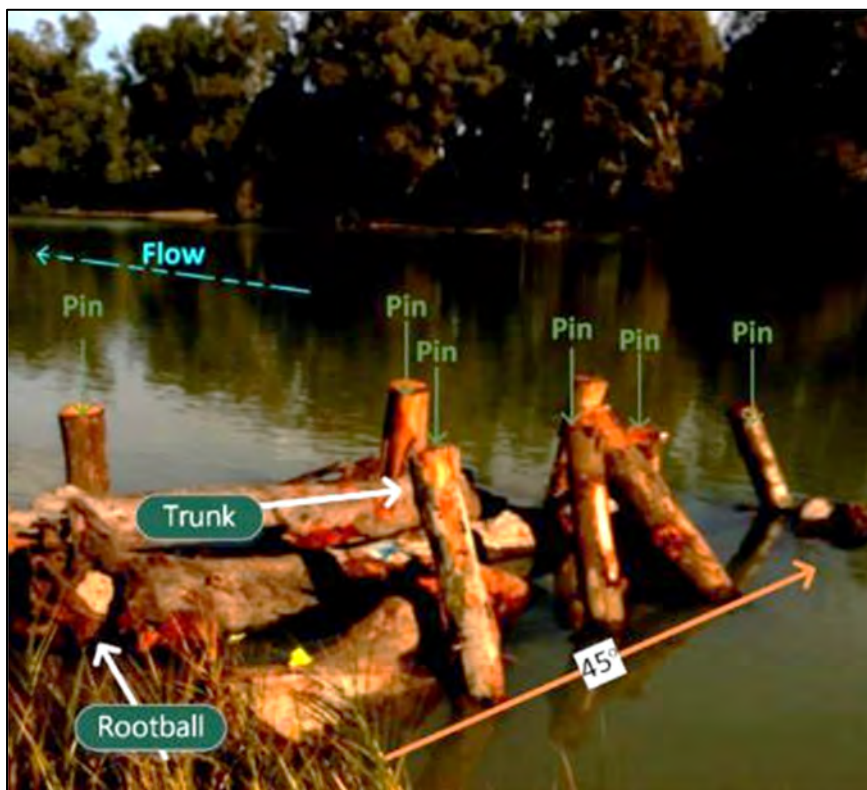
Plate 3 – Re-snagging Guidelines for the Lower River Murray (DEW Technical Report 2021)

- Snags should be installed as a priority before mulching, erosion control or planting takes place to prevent damage to other works;
- Position timber at a 45 degrees angle in a downstream direction from the edge of the bank with the base (or root wad) of the snag placed closely against the bank; and
- Once positioned, the structure must be pinned to secure it in the desired position or secured in a method that will not move or impact downstream river users.
- Any fill required during reclamation works must consist of only natural material. Contaminated material, tyres, building and demolition rubble or acid sulphate soils (ASS) should not be used as fill in any aquatic environment.

Plate 3 provides an example configuration.

The most suitable timber for re-snagging is native Australian hardwood which has been recently legally felled. Exotic trees felled as part of the proposal should not be used due to the potential for invasive species to propagate downstream.

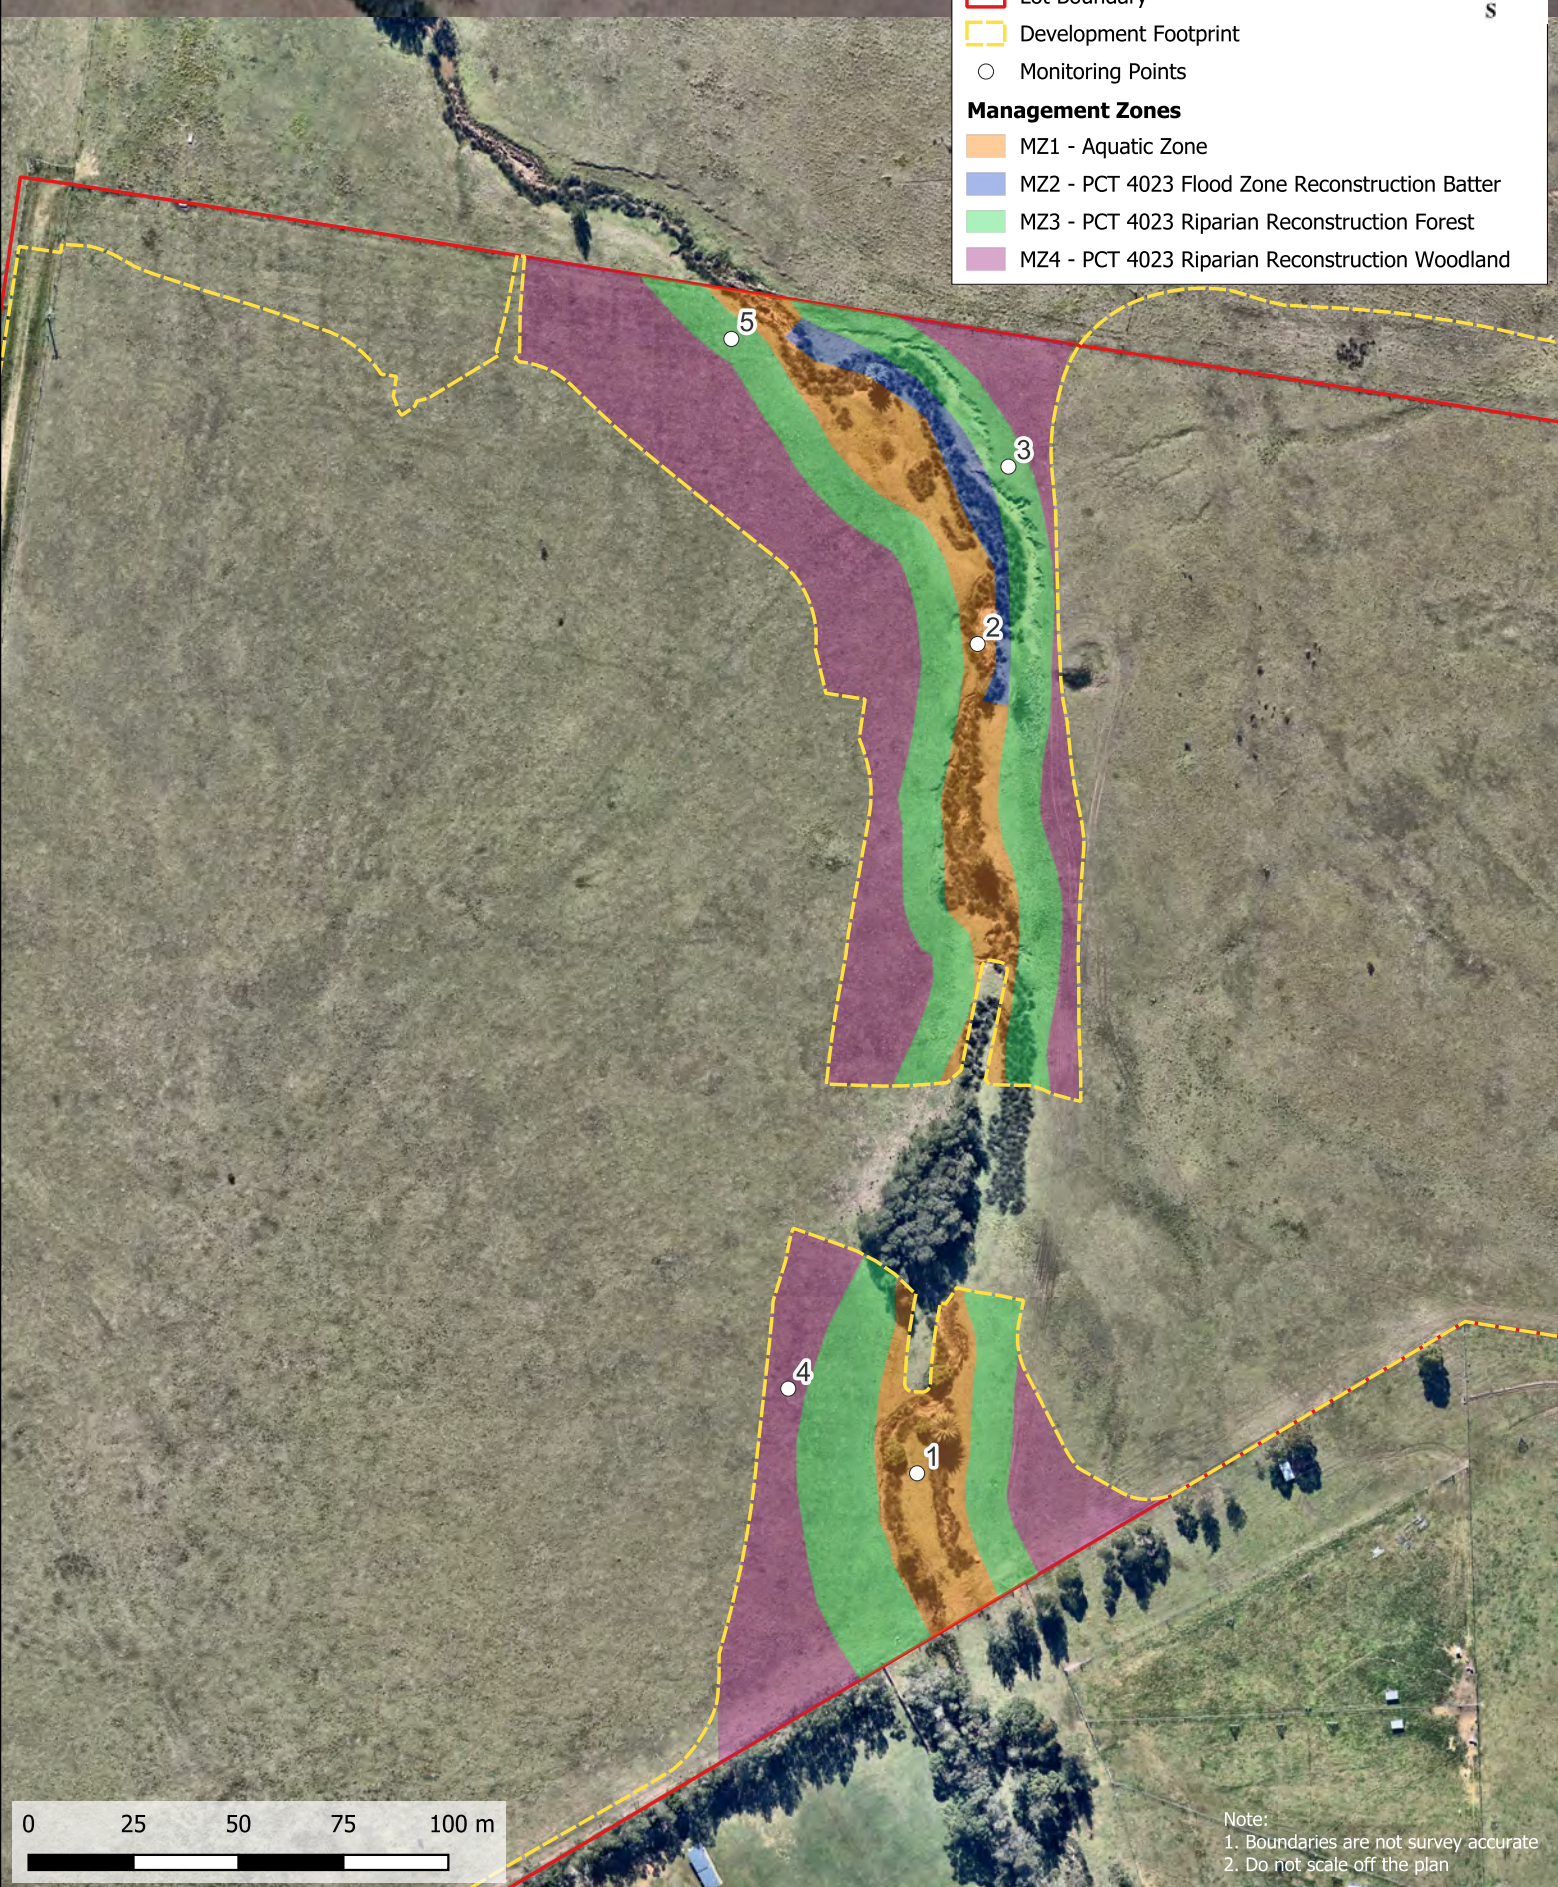
MZ3 - PCT 4023 Riparian Reconstruction Forest

MZ4 - PCT 4023 Riparian Reconstruction Woodland

Installation of monitoring and data collection points are to be undertaken by the Project Ecologist and BRC prior to site preparation. It is recommended that a minimum of four (4) monitoring points one in each MZ consisting of a 10m x 10m quadrat marked with two 1.8m star pickets located at the northeast and southwest corner. The location of the northeast corner should also be marked with a GPS waypoint to facilitate identification in the field and will be used as photo monitoring point.
